Because of the variable conditions that exist in Management Segment 3, further delineation of the segment was necessary to facilitate data collection and analysis. Based on general valley morphology, physical stream character, and the proximity of the business district, Segment 3 was broken into three stream reaches (3a, 3b, 3c) to further describe the area in more detail (**Map VI-4**).

Reach 3a (CR 65 Hensonville to Concrete Dam Above SR 296)

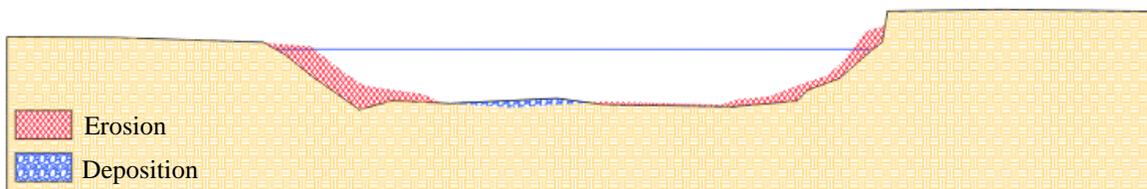
Figure VI-29: Overlay of 1998 and 2000 cross sections taken downstream of the confluence with Silver Lake tributary.

A detailed assessment of channel stability was initiated in 1998 with the installation of two monumented cross sections. The cross section was placed to monitor observed lateral migration of the channel. The cross section is positioned immediately downstream of the Batavia Kill's confluence with the Silver Lake tributary at a drainage area of 21.3mi². The stream at this cross section is classified as a C4 stream type, which is typical of the entire reach. During the monitoring between 1998 and 2000, the bankfull channel has widened by 4.5 feet, with aggradation of the streambed of approximately 0.8 feet (**Figure VI-29**).

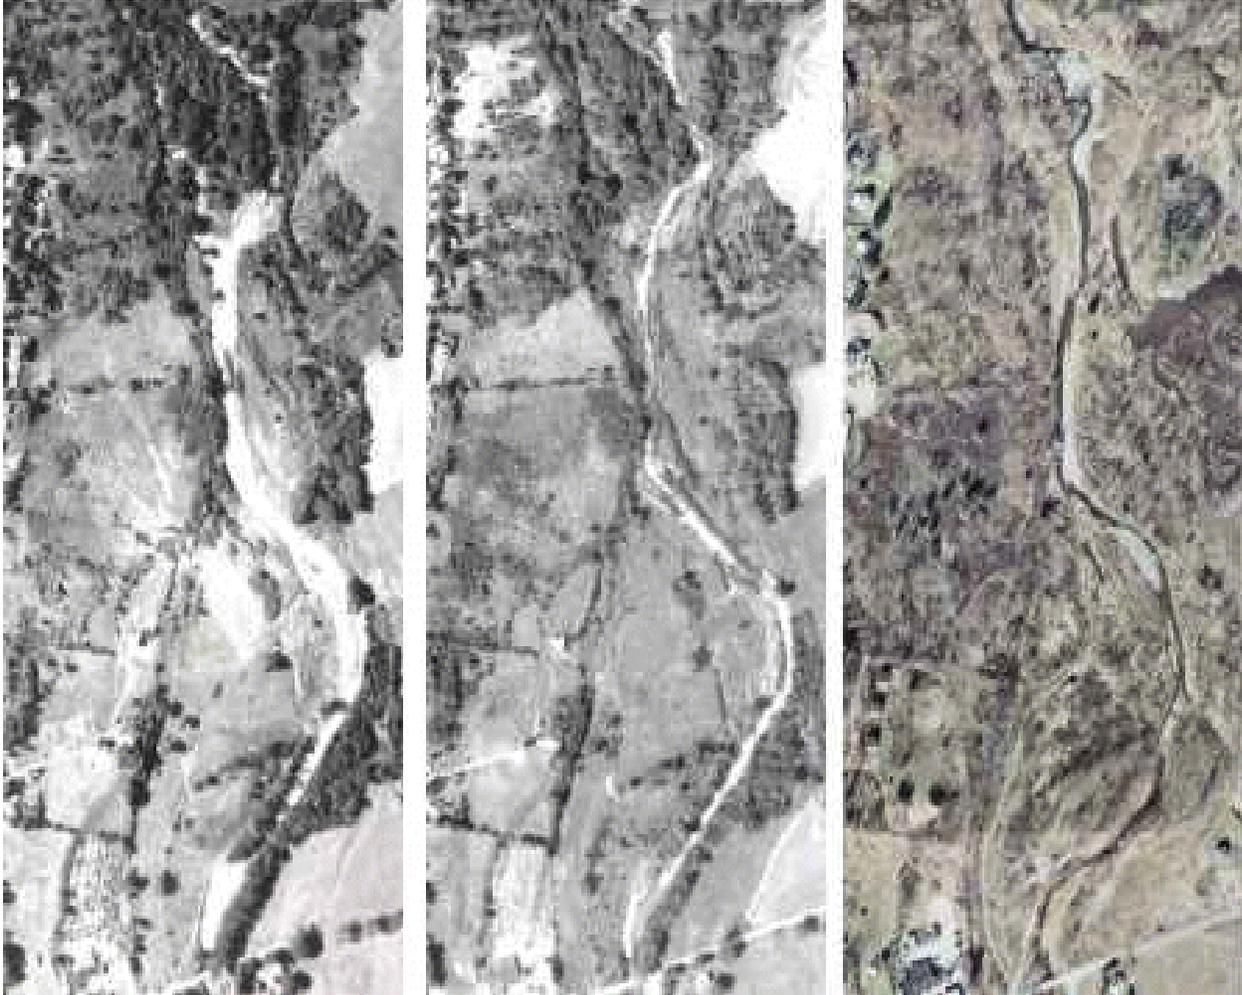
Figure VI-31: Aerial view of upper end of reach 3a from 1959 (left), 1967 (center) and 2000 (right). Bridge at County Route 65 in Hensonville is seen at bottom-center of each photo

A review of aerial photographs from 1959, 1967 and 2000 (**Figure VI-31**) indicates that the reach has been experiencing relatively slow, but continual lateral adjustments in planform. There are several abandoned channels located within the reach presumably caused by channel migration and the rapid formation of chute cutoff during large flow events. The aeriels show that the reach is characterized by significant sediment storage, starting at the point below the confluence with the Silver Lake tributary. A June 1980 aerial photograph shows evidence of active gravel mining through the floodplain in the upper extent of the reach.

Though the GCSWCD did not conduct a detailed riparian buffer assessment in Reach 3a, the Phase I inventory and assessment, recent inspections, and review of historical photographs has shown that most of the reach exhibits fair to poor riparian conditions. While some smaller sections of the reach have somewhat adequate forested buffers (**Figure VI-32a photo B,D & Figure VI-32b photo A,C,D**), the majority of the reach has no riparian vegetation other than grasses and forbes that provide limited stability to the streambanks. In the areas of active erosion, often there is no woody vegetation present and the grasses do not provide adequate rooting depth to prevent bank failure (**Figure VI-32b photo F**). The reach also contains a significant population of Japanese knotweed. As shown in **Figure VI-31**, the reach has exhibited poor riparian conditions as far back as 1959.

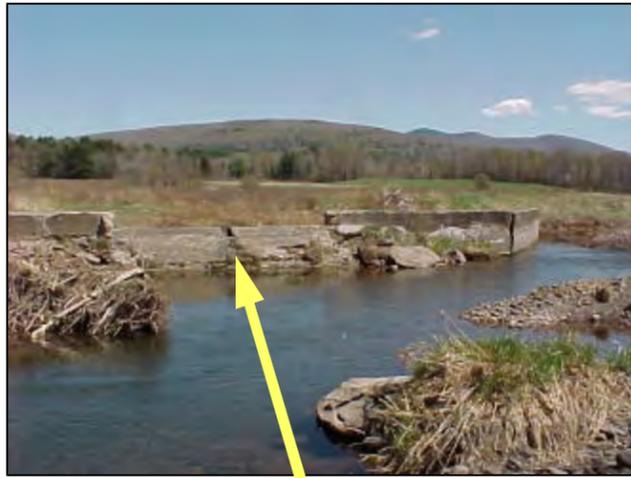
A

The Phase I Inventory and Assessment identified two concrete dam structures in Reach 3a. The first concrete dam structure is located at the confluence of a small unnamed tributary on the Police Anchor Camp property (**Figure VI-32a photo A, Figure VI-32b photo D**). The structure measures approximately 100 feet long and is nearly nine feet high. The structure is characterized as being in poor condition, with extensive sedimentation. The tributary has eroded around the east wall of the structure. Currently, the structure impacts both the tributary, as well as the main stem of the Batavia Kill. Stream flow and sediment transport are being impacted, and the channel is migrating laterally.

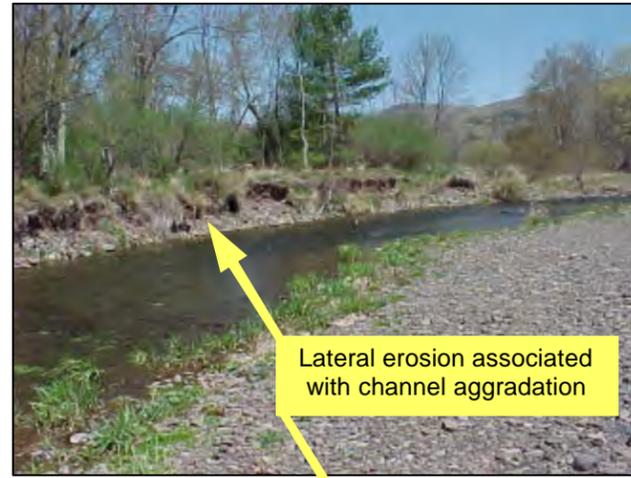
C

The Phase I Inventory & Assessment conducted in 1997, indicated that the middle of the reach appeared to be in an unstable state with several areas of bank instability. Nearly 20% of the streambanks through reach 3a were experiencing active erosion at the time of the inventory and assessment. The reach was characterized as having an average of 1.14 ft² of exposed streambank per foot of streambank length. The principle failure mechanism was noted to be slumping due to hydraulic forces eroding the streambank toe, and is presumed to be the result of ongoing adjustments in planform (**Figure VI-32a, Photos C,G, Figure VI-32b photos F,G**). Streambank height throughout most of the reach is fairly low, averaging around 5 feet, with a well defined floodplain throughout much of the reach

(Figure VI-32a photo C,D,E,G,H and Figure VI-32b photo F,G).

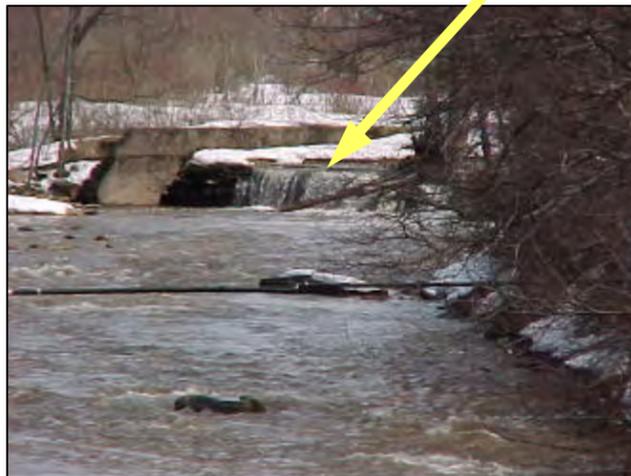
E

The second concrete dam is located near the bottom of the reach, in the area behind the Thompson House (**Figure VI-32b photo E**), with the structure located across the mainstem of the Batavia Kill. In general, this structure is in better condition than the first dam, and while some higher flows by-pass the structure, the stream has not breached the dam. The structure does impact stream slope by causing a localized slope reduction and modification of the streambed elevation above the structure. The structure is also believed to contribute to the stream bank erosion upstream through Reach 3a, due to the reduction in slope and transport capacity of the bedload being delivered from the Silver Lake tributary and ephemeral tributaries. Aggradation, followed by lateral streambank erosion, is typical of situations where check dams are created across a channel.

reach. Although the dam structure is effective at providing local vertical stability in the Batavia Kill, the dam presents a barrier to fish migration. The presence of the structure prevents fish migration between the dam and the CD Lane Park flood control dam, effectively cutting off several miles of stream. The structure also cuts off fish access to a significant portion of the large tributary coming from East Windham (Silver Lake).
