Reach 3c (Church Street to CR 12 South Street)

Figure VI-37a Reach 3c-Upper

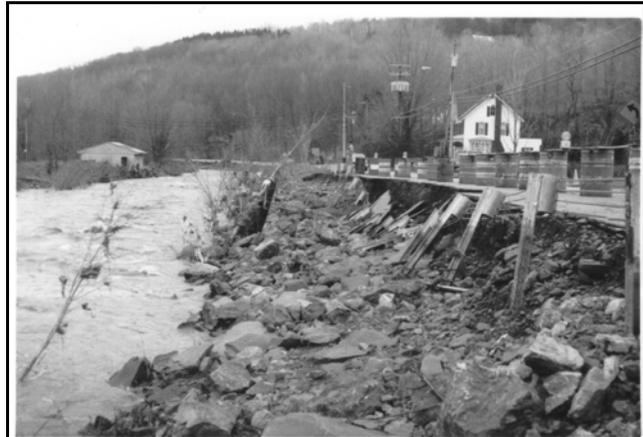
Figure VI-34: Severe streambank erosion along NYS 23 below GNH Lumber after 1961 flood.

In the area near GNH Lumber, and running downstream along NYS Route 23, the stream has experienced significant erosion in the past. New York State Route 23 was washed out in a major flood in 1961, and has required repairs to the rip rap adjacent to the roadway in 1996 and 1999. A long section of reach 3c between GNH Lumber and Theo's Restaurant

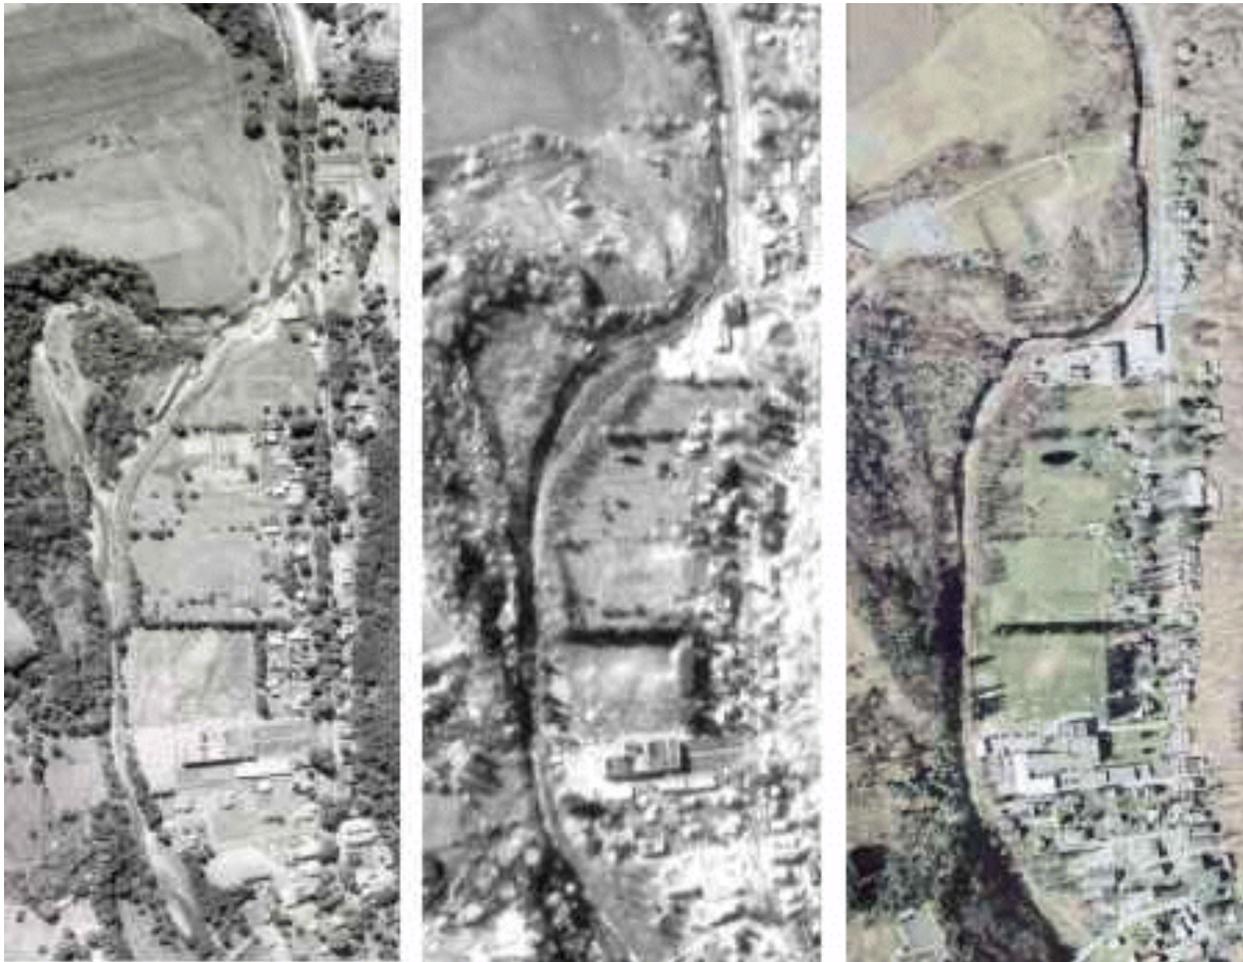
To evaluate stability of the channel's planform in reach 3c, the GCSWCD examined a series of aerial photographs taken between 1959 and 2000. The historical photographs were assembled and compared to evaluate channel planform changes, as well as to inventory any potential channel modifications that may have occurred. While the channel planform in the lower half of the reach has remained fairly consistent over the 40 years of photographic record, the upper section of the reach between South Street and GNH Lumber (**Figure VI-35**) was shown to have been more active. The aerial photographs

indicate that the reach was once split into two channels behind GNH lumber, with only a single channel present in 2000.

Figure VI-35: Aerial view of western end of Windham hamlet, 1959 left, 1980 center, 2000 right. Note double channel to the left side of photos.

The owners of GNH provided the GCSWCD with drawings dating from the mid 1960s showing plans to dredge the single channel, which cut off a large meander right behind GNH Lumber. As the channel is located in this area, the GCSWCD assumed that this work had been done, though that could not be directly confirmed. The GCSWCD did not note any active headcuts in the reach, and the erosion of the streambanks does not appear to indicate any active adjustment in planform. It is possible that the channel has already responded to this channelization.

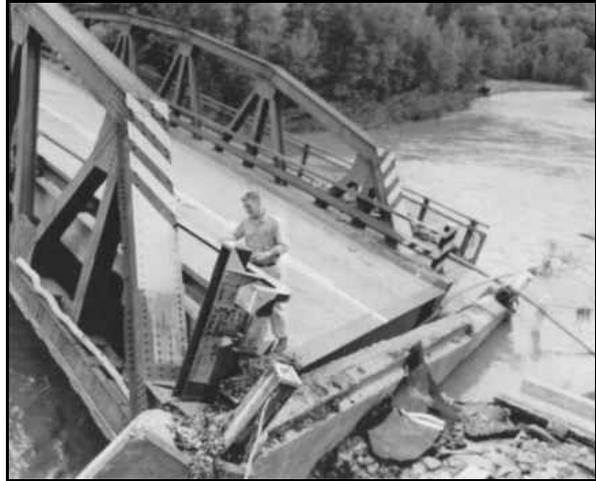
Other issues related to flooding in this reach include the recurring flooding of NYS Route 23, just west of GNH Lumber, and the threat of erosional damage to the bridges. West of GNH Lumber, the roadway has been washed out several times, and in the larger floods such as 1996 and 1999, the moderate entrenchment in the reach has resulted in the stream flooding the roadway. Earlier floods in the 1950's and 1960's resulted in significant infrastructure damage, with both bridges in reach 3c experiencing total loss. As shown in **Figure VI-36**, the stream channel migrated around the bridge abutments causing them to fail. Since the time of these floods, the Batavia Kill Watershed District flood control structures have been constructed, and it is unlikely that future flood will result in such extensive damage to the bridges.

Figure VI-36: 1961 flood damage to Church Street bridge located in Reach 3c.

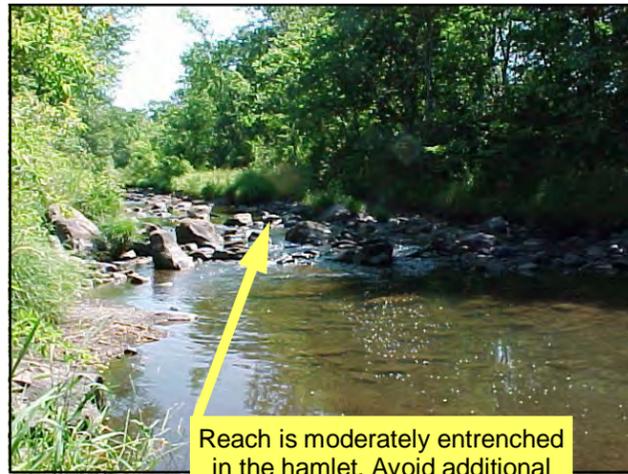
Reach is moderately entrenched in the hamlet. Avoid additional floodplain fills.

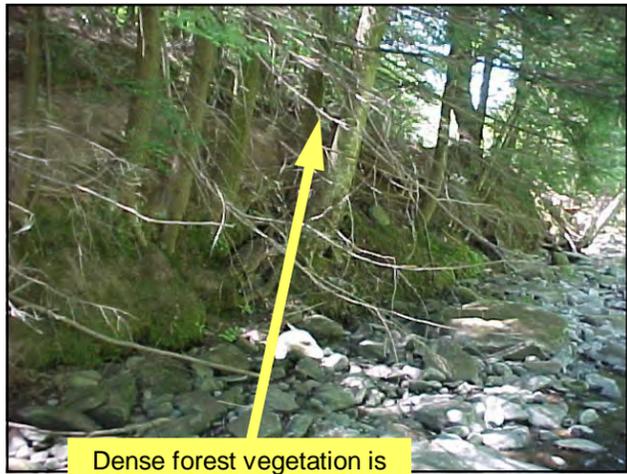
Dense forest vegetation is critical to stability of steep slopes along the high terrace

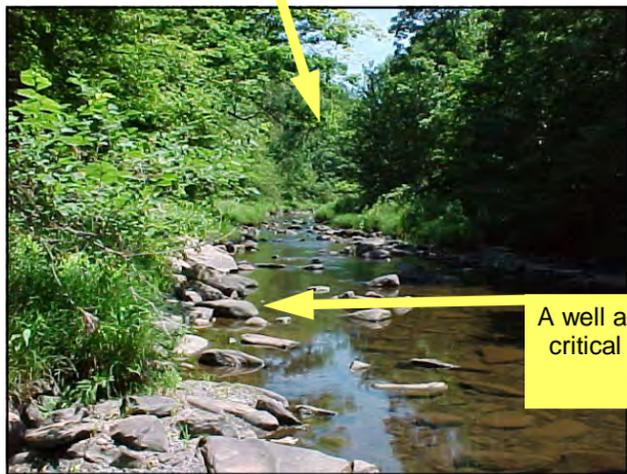
A well armored stream bottom is critical to stability. Disturbance must be avoided
