Reach 5d (Below Conine to Schoharie Creek)

Reach 5d Summary

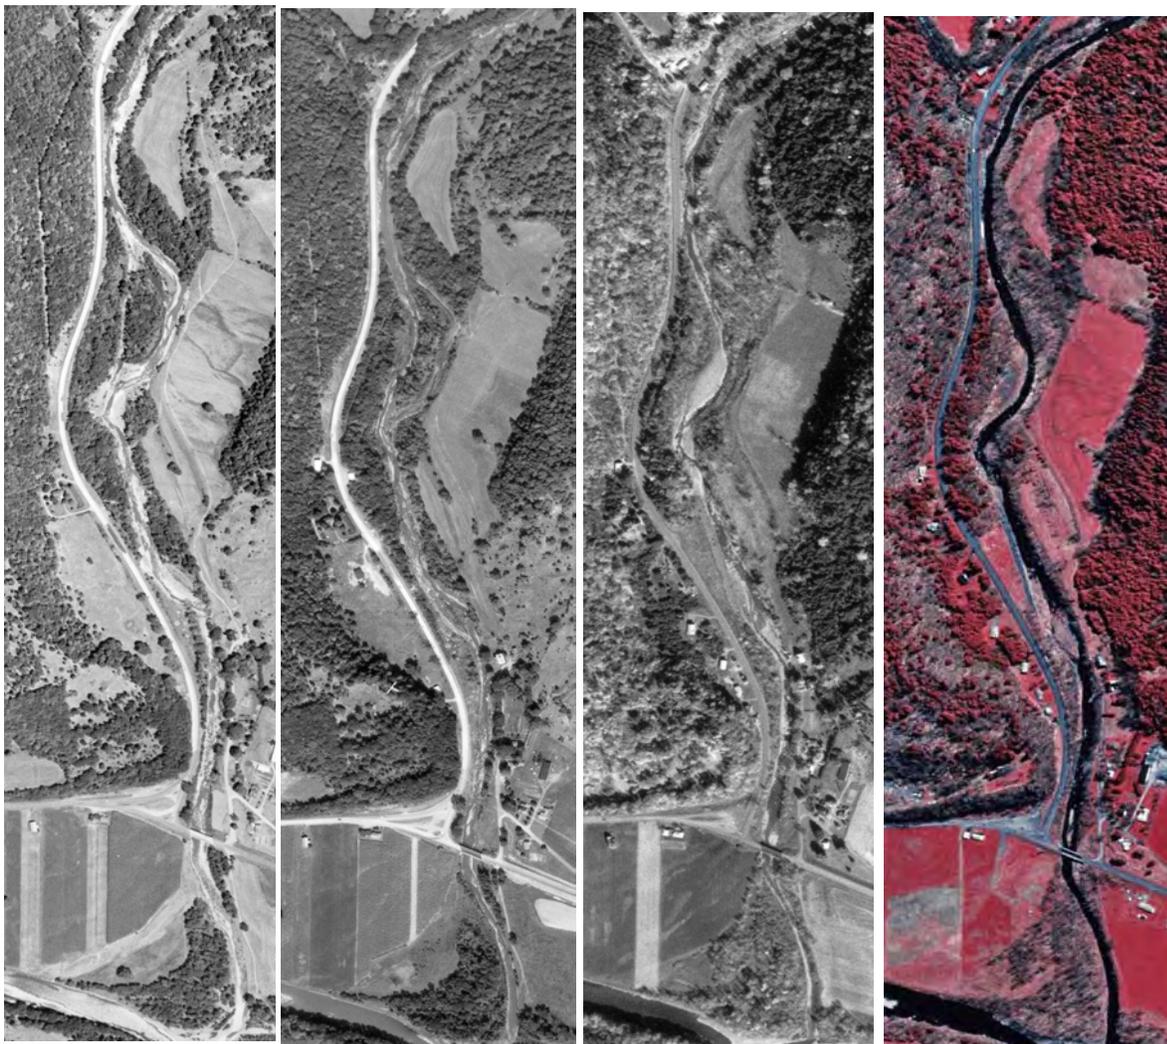
Figure VI-98: Historical aerial photograph progression, Reach 5c, left to right 1959, 1967, 1980, 1995.

A review of historical aerial photographs from 1959 to present, revealed a generally stable plan form through most of the reach. Channel planform adjustments in the reach appear to have been predominately in 2 isolated areas near the center of the reach (**Figure VI-98**). In the 1959 photograph (left, below) an significant side channel was developing approximately 2,450 feet upstream of the RT 23A bridge. This side channel extended upstream approximately 950 feet. By 1967, the side channel has enlarged and appears to be the dominant watercourse. The side channel had effectively cut off the larger and longer meander bend, thereby shortening the overall channel length. By 1980, the same section of the reach has reformed a single channel back in its original (1959) location. Between 1980 and 1995, the Batavia Kill has experienced minimal planform change at this site.

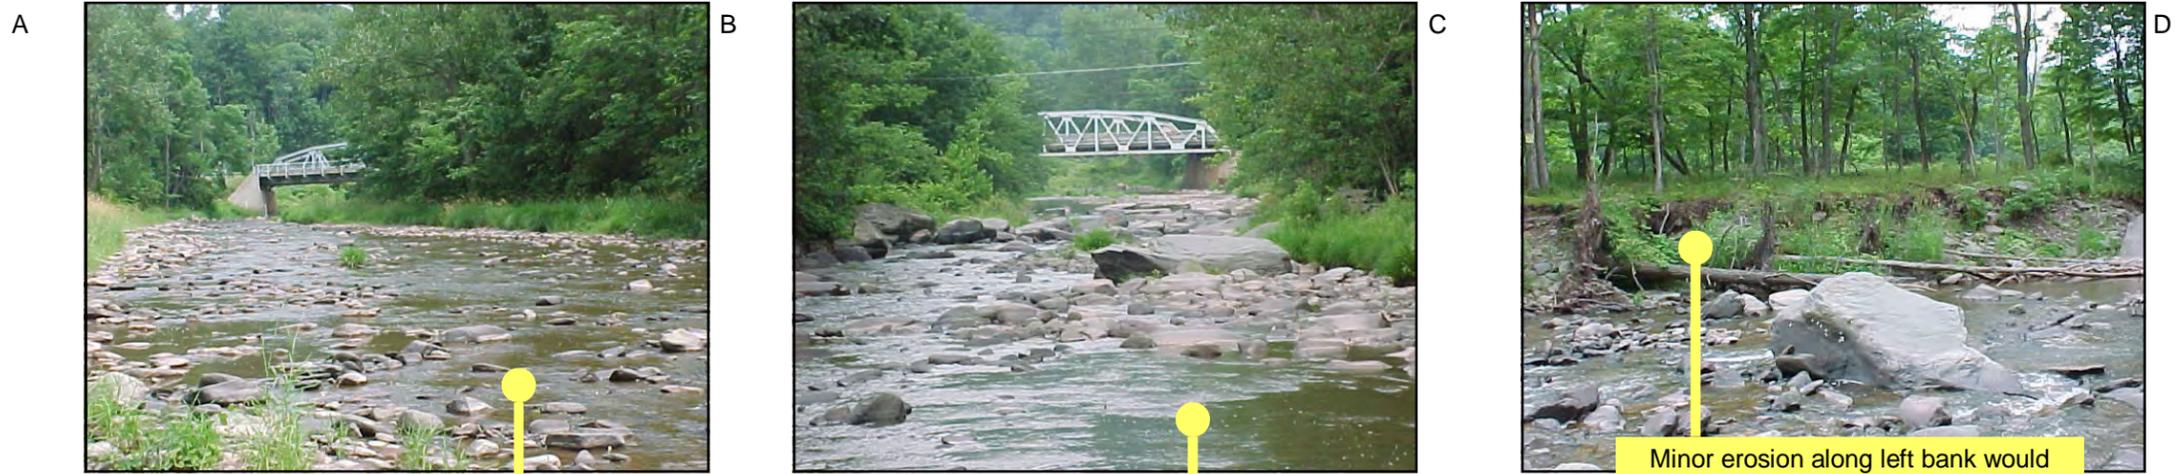
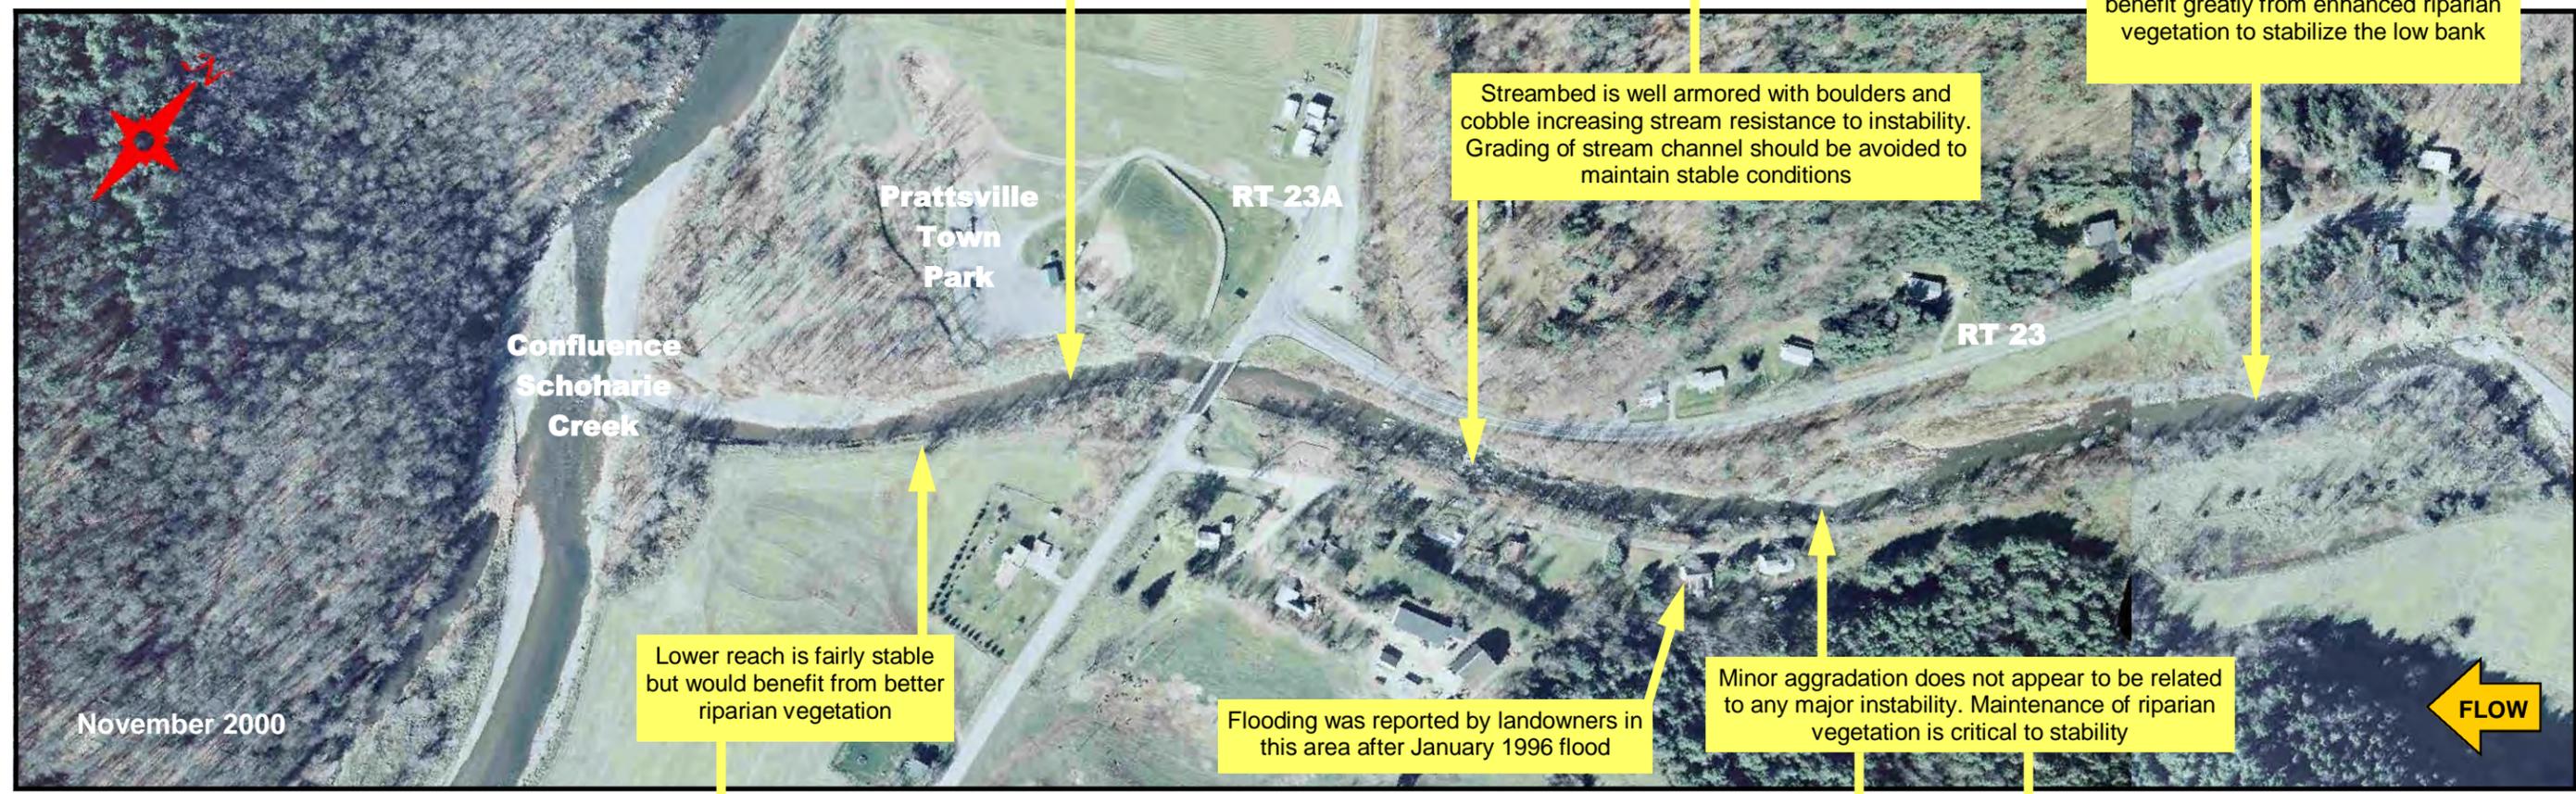
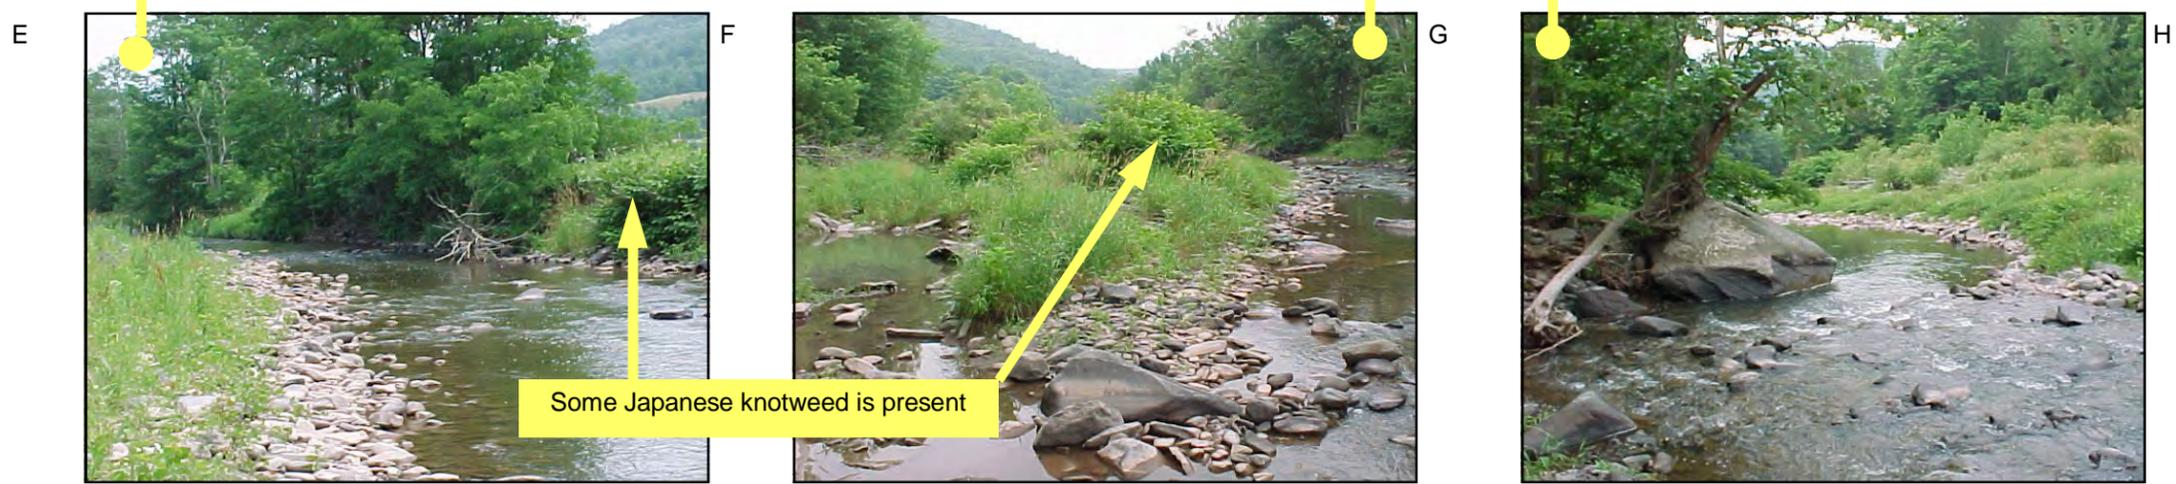
Figure VI-98b Reach 5d-Lower

The riparian condition in reach 5c has remained fairly consistent since at least 1959. In general, the riparian vegetation is in relatively good condition, with a good mix of trees, shrubs and herbaceous species. In several isolated areas (**Figure VI-99a photo A, H & Figure VI-99b photo D**) localized streambank erosion is actively degrading the riparian buffer, with the vegetation present not adequate to maintain bank stability. The change in density and type of vegetation in reach 5d has been minimal. Some Japanese knotweed is present.

Some Japanese knotweed is present
