FEBRUARY 2003

PROJECT REPORT

Broadstreet Hollow Stream Restoration Demonstration Project

Greene County Soil & Water Conservation District

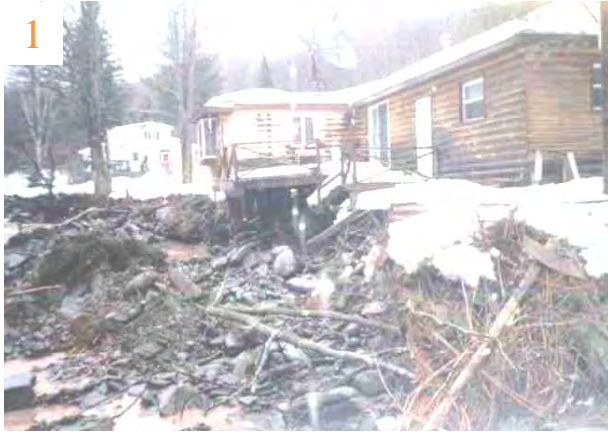
- Photograph 1: Structural and property damage at the Torregrossa residence resulting from the 1996 flood event.
- Photograph 2: Structural and property damage at the Torregrossa residence resulting from the 1996 flood event. The close proximity of the residential structures along the left floodplain are prone to future threat by erosion and bank failure caused by the channel instability.

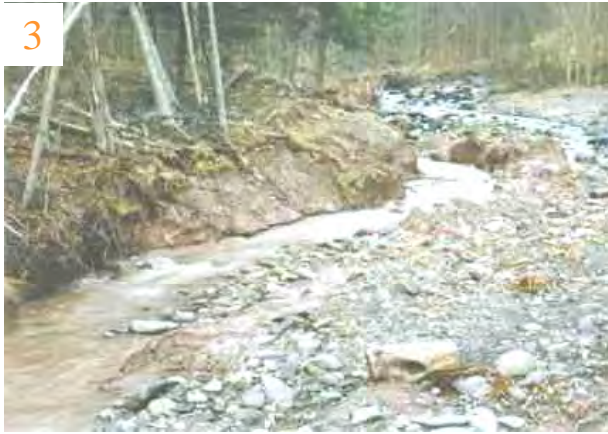
- Photograph 3: Channel degradation occurring through glacial clay at the base of the adjacent rotational failure. The rotational failure is denoted by the erosion and angled vegetation along the left portion of the photograph, as well as the bulging formation of clay in the center of the stream channel. The artesian formation is present in the right portion of the image contributing high turbidity during low flow periods.

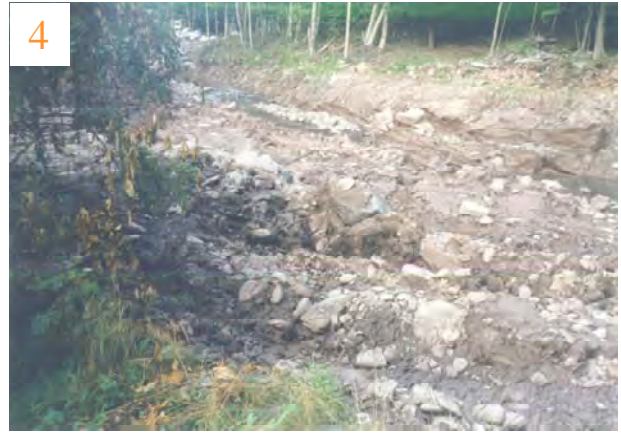
- Photograph 4: The EWP stabilization utilized natural channel armor (boulder & cobble) material for fill to replace the eroded streambank which exposed the underlying glacial clay. Extreme difficulty resulted in the completion of EWP construction and the instability of the channel increased.

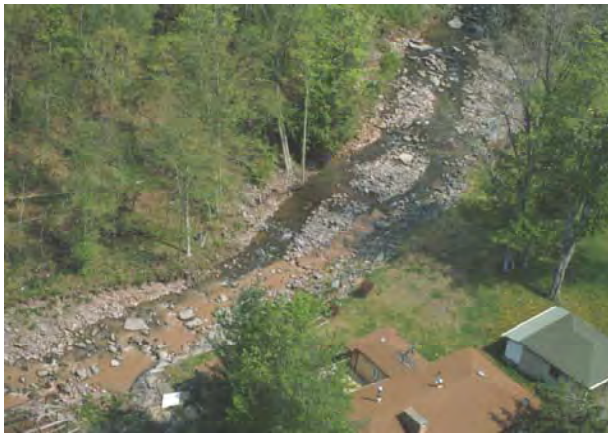
- Photograph 5: 1999 aerial photograph showing the extreme turbidity produced from the from the artesian formation during base flow conditions. The rotational bank failure is present in the left of the photograph.

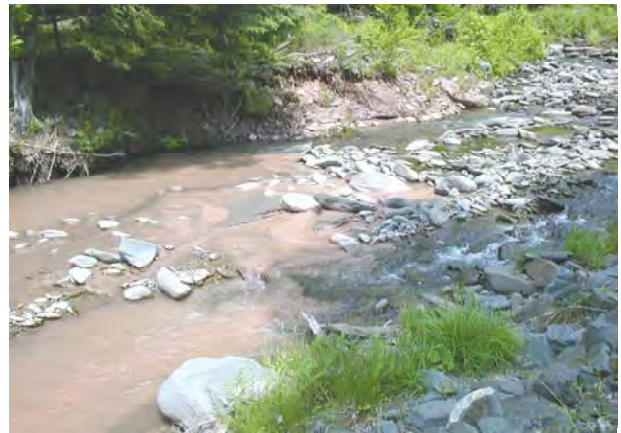
- Photograph 6: The artesian formation producing highly turbid flow during base flow conditions.

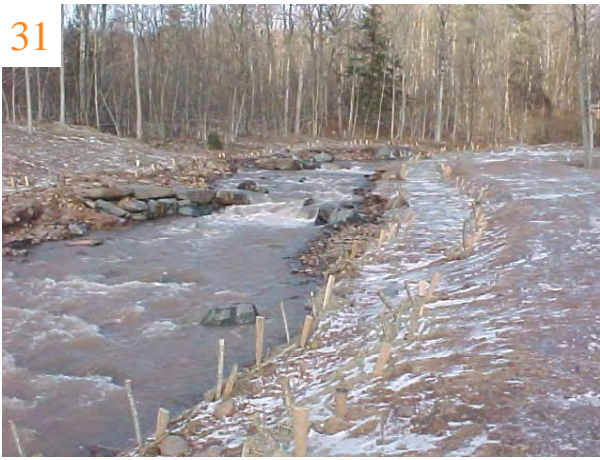
31

- Photograph 31: The image displays the channel condition looking upstream through the project reach the day after the December 17th flood event. Minor erosion was noted through this portion of the reach and two cross vanes were noted with structural damage.
- Photograph 32: The photograph shows the channel condition looking downstream from the same point as photo 31. Vegetation had not been established through the project reach before the flood event.

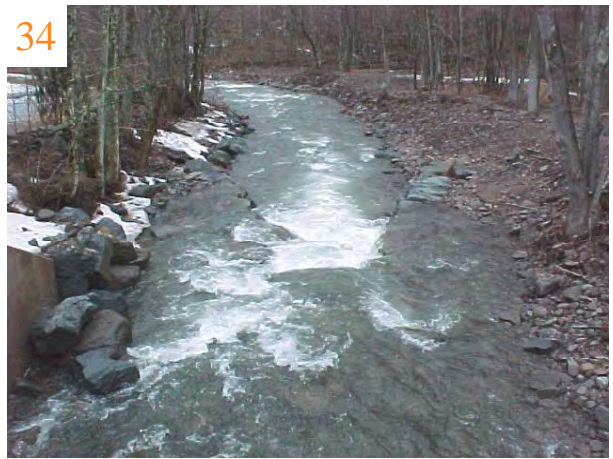
34

- Photograph 34: The image displays the channel from the uppermost bridge looking downstream in April of 2001. Cross vane structures appear to be functioning properly despite several problems caused by the December 2000 flood event.

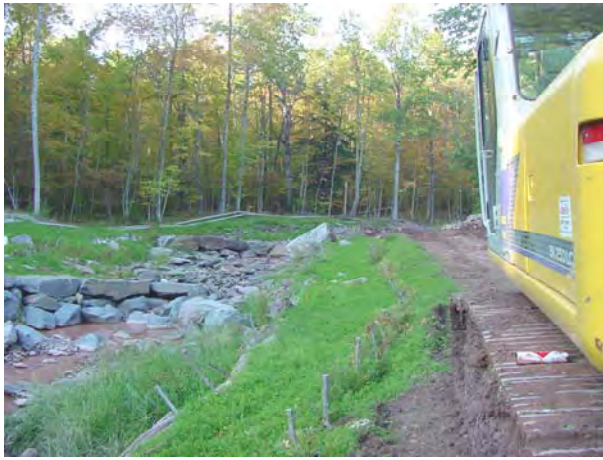
- Photograph 37: Repair and maintenance was made to the project in October 2002. The stream channel was de-watered and repairs were made to the structures show in the photograph.

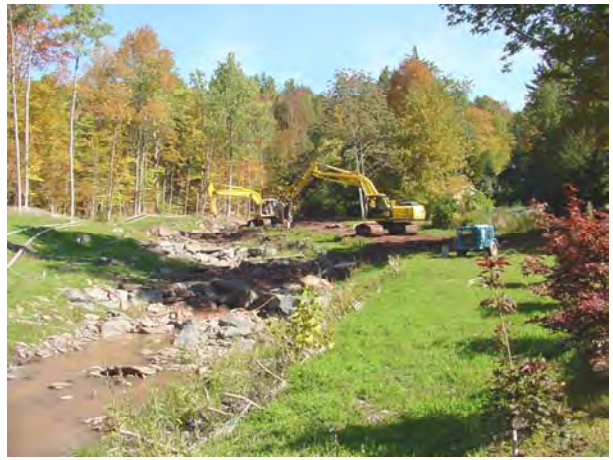
- Photograph 38: Excavators were used from the top of the streambank to make repairs and modifications. The area receiving the most damage during the flood event is shown in the photograph.

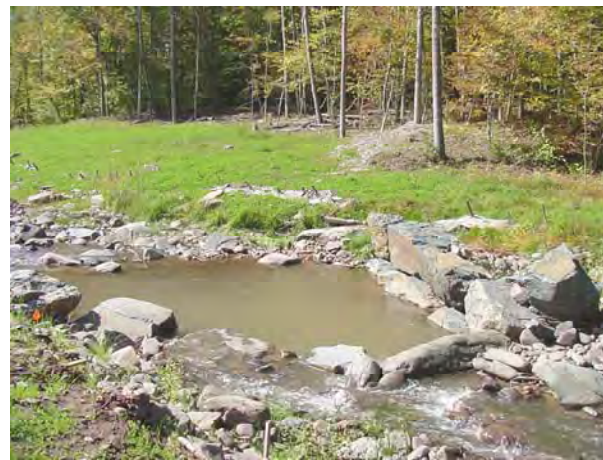
- Photograph 40: Cross vane #1 after the completion of repair and modifications.
- Photograph 41: Cross vane #5 prior to the repair and modifications. Noted on the right of the photograph is a large boulder dislodged from the upstream cross vane and transported during the flood event.

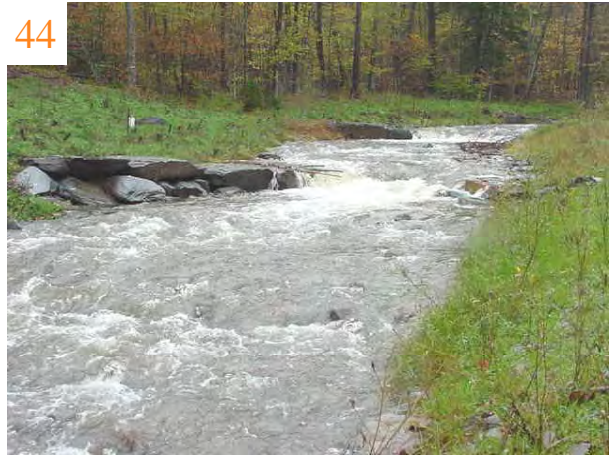
44

- Photograph 44: Repaired cross vanes structures functioning during a moderate flow event on October 12, 2002. This area received the most damage in the December 2000 event and a majority repair work in 2001. Apparent is the continued vegetative growth and properly functioning structures.

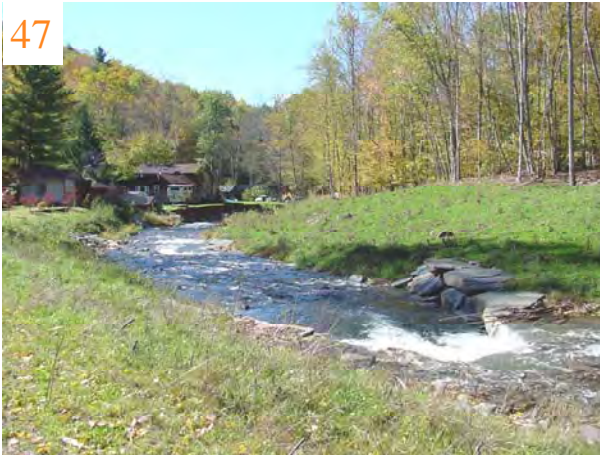
47

- Photograph 47: After the recession of the October 12, 2002 flow, the middle and lower portion of the project appears to be functioning properly during normal flow. (Reference image #45)

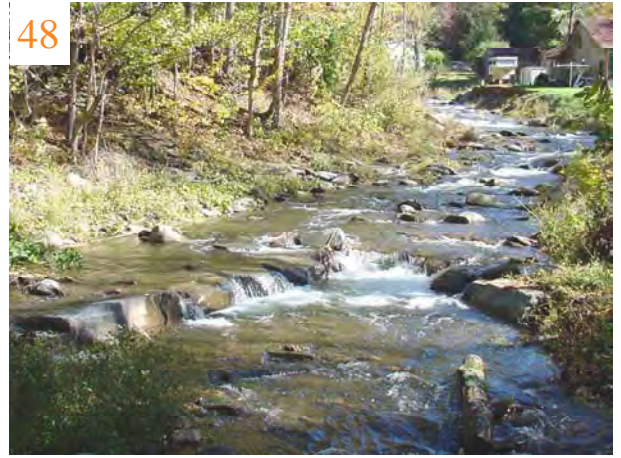
48

- Photograph 48: The lower portion of the project appears to be functioning properly under normal flow conditions.
