Broadstreet Hollow Management Unit 5

General Description:

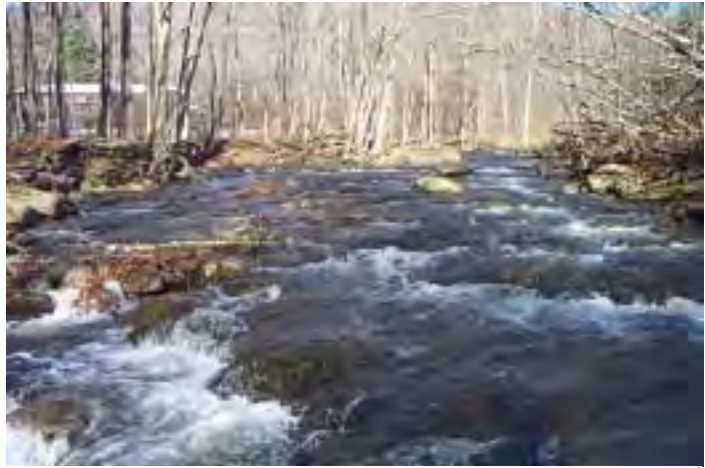
Photo 1. Looking upstream near the top of MU5, Broadstreet Hollow Road at the left, valley wall hillslope at the right.

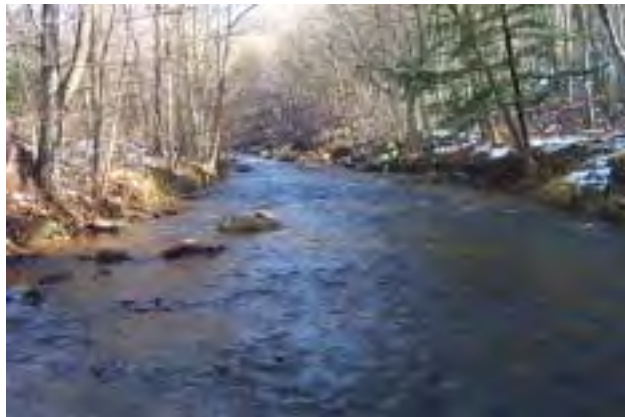
Photo 2. Looking upstream at the bottom of MU5, cobble berm at the left, valley widens on the right at the bottom of the unit.

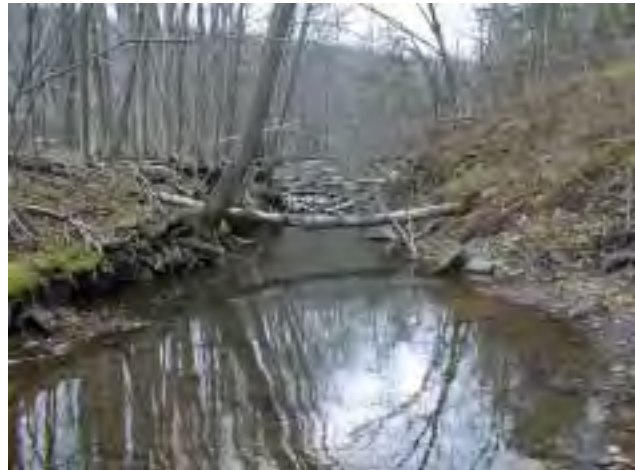
The structural shape, or *morphology*, of the stream (i.e., slope, width and depth) is fairly uniform in this unit, with few individual *reaches* having distinct morphologic character, or *stream type*⁵. Though the valley in MU5 isn’t particularly narrow compared with other units, the stream runs directly along the valley wall on the left (looking downstream), cutting down through an extensive exposure of glacial lake clay along this hillslope, and producing a predominantly *entrenched* stream shape (Photo 3). Typically stable stream types associated with this type of

Photo 3. Looking upstream at eroding bank at monitoring cross-section 18, slumping clay bank at right, undercut trees at left.

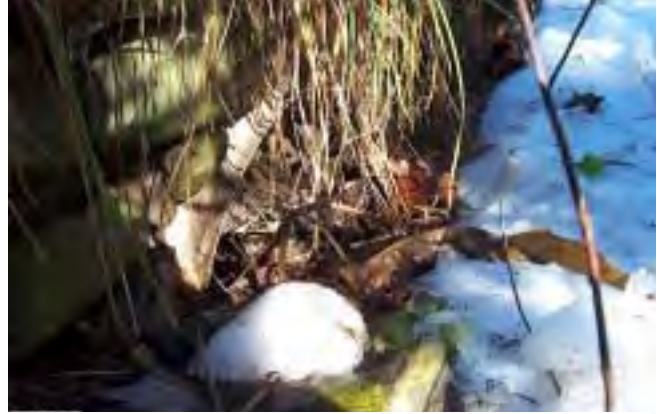
Broadstreet Hollow Road is composed of oiled crushed stone in this unit. The centerline distance from the deepest part of the stream channel, or *thalweg*, ranges from 50 feet in the upper portion of the Unit to 260 feet in the lower part of the Unit. There is one culvert near the top of MU5 on the right bank (Photo 4). Flow conditions under high or low flow are unknown, though the culvert is more than half filled with sediment and debris at the outlet and should be replaced and upgraded in size. However, the outlet did not appear unstable at the time of the survey in 2001. Inlet conditions were not documented as part of the survey in 2001.

Photo 4. Corrugated metal culvert, right bank, stream out of the frame to the right.

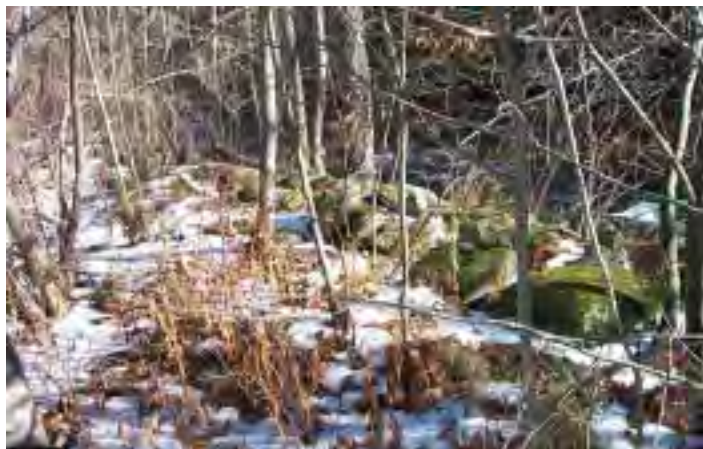
Although there are generally no hardened or stabilized banks within MU5, a pushed up mound of earth and rock, or *berm*, along the road extends approximately 65 feet (5% of the stream bank length) into the top of MU5 from MU4, as the stream curves away from the road into the valley wall on the opposite side (Photo 5)³. This berm appears to have been constructed along the roadway to protect the road either from flood inundation or washout.

Unfortunately, berms such as these generally do not offer much protection from flooding, and can cause stream entrenchment and higher local flood *stage* (height of water surface) by preventing floodwaters from flowing over the floodplain, cutting off an important function of these flat areas.

Photo 5. Looking upstream at right bank cobble berm at the top of MU5, stream to the right, flow from left to right, Broadstreet Hollow Road at left out of the frame.

stage in downstream areas. The majority of Broadstreet Hollow stream floodplains consist of small, low, discontinuous floodplain benches that perform the important floodplain functions in small mountain streams. As the road and stream move farther apart in the top portion of MU5, an area of floodplain bench could be returned to the stream by removing some of the berm material, providing an important section of floodplain function and potentially reducing some pressure on the opposite bank³. Because this berm is well vegetated and the section in MU5 is short, berm removal or reconfiguration should only be considered in the context of stream management in MU4.

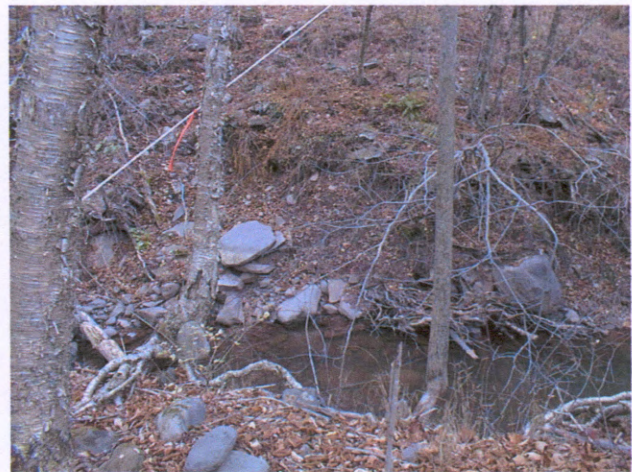
Stream assessment in 2001 showed 470 feet, or 35%, of the stream bank in MU5 is actively eroding. This erosion occurs in one continuous piece along the valley wall hillslope on the left bank, starting at the top of the unit (Photo 6, and see Photo 3 above). A representative location was chosen and permanently marked, or *monumented*, for future monitoring (designated as “monitoring cross-section 18”) to determine erosion rates and priority for potential restoration³. This site has been assessed and ranked based on calculation of a *Bank Erodibility Hazard Index* (BEHI) using data collected at the time of the stream assessment survey in 2001⁴.

Photo 6. Eroding left bank at valley wall hillside, monitoring cross-section 18 (flow from left to right).

Mature trees sliding down the hillslope and failure scarps (large cracks in the hillside created as blocks of land slide downhill) show multiple *rotational failures* and bank *slumping*. This failure mechanism is fueled by stream erosion at the bottom, or *toe*, of the slope, continually delivering soil, rocks and vegetation into the stream and preventing an adjustment of the stream channel to a stable shape⁴.

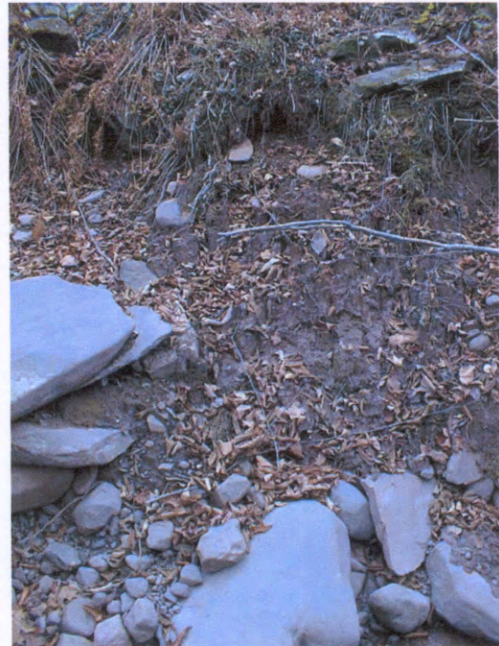
In addition to approximately 470 feet of exposed clay along the left bank where the stream runs directly against the valley wall (Photo 7), an additional 20 feet (2%) of bank at the bottom of the unit has exposed clay in the bank and bed (Photo 8)⁴. Nearly 40% of the stream bank length in MU5 contains exposed fine sediments (*silt* and *clay*) in the banks and bed that may cause increased *turbidity* during high flow.

Due to the inherent instability of the valley wall hillslope, the extent of the clay exposure and the generally poor quality of streamside, or riparian, vegetation due to the thin soils, the potential for large inputs of silts and clays into the stream during floods will continue to be a problem unless the reach is restored.

Photo 7. Close-up of eroding left bank at monitoring cross-section 18, showing glacial lake clay exposure.

Structural revegetation, or *bioengineering*, should be considered in conjunction with a full-scale restoration of the stream channel morphology in this reach, to reduce ongoing erosion pressure on the valley wall hillslope. Additionally, the hillslope failure should be assessed to determine the extent of *geotechnical* failure mechanisms, as well as to advise the appropriate solution for this continued problem⁸.

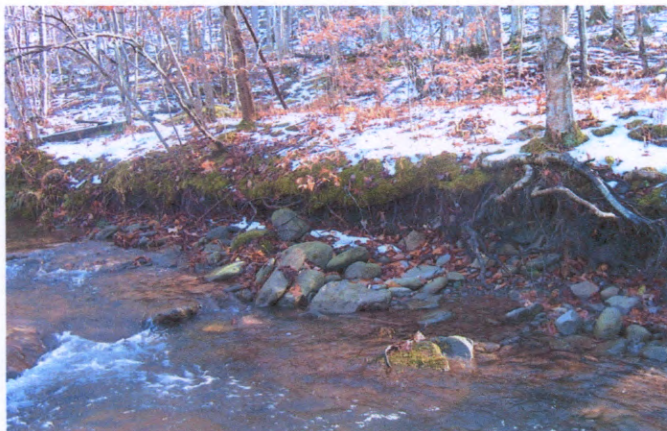
Photo 8. Clay exposure on the left bank, at the bottom of MU5 (flow from left to right).

Clay exposed at the stream bed at the bottom of MU5 is part of a larger exposure continuing into MU6 downstream. In general, this exposure is much less extreme, and appeared to be stable at the time of the stream assessment in 2001. This reach should be monitored visually to assess any change in stream channel condition that could result in increased bed erosion in this area.

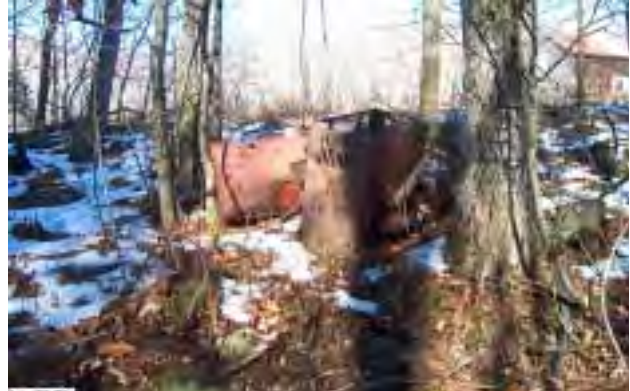
Approximately 50 feet (4%) of dumped materials, primarily large metal objects, was mapped along the right bank in MU5 in 2001 (Photo 9). This comprises approximately 4% of the bank length in this Unit. Planning efforts to organize cleanup of sites like this were initiated in 2002, and should continue, as labor and funding are available.

Photo 9. Landfill/dumping site, right bank near the bottom of MU5, composed mostly of large, old metal products.
