Broadstreet Hollow Management Unit 7

General Description:

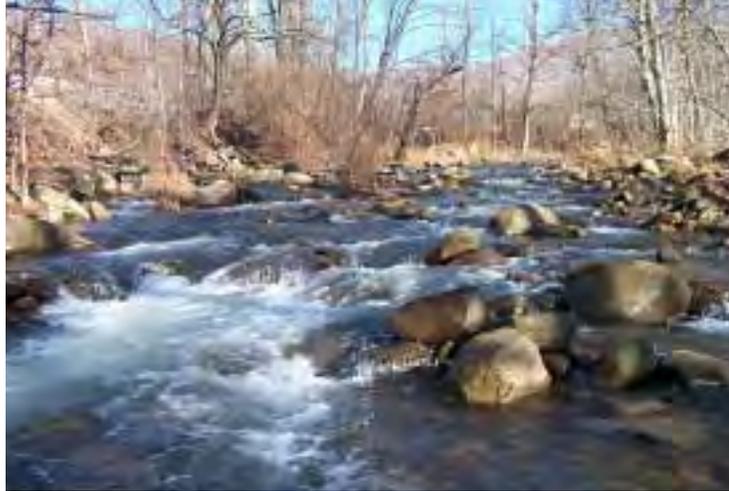
Photo 1. Looking upstream into the top of MU7, Broadstreet Hollow Road at

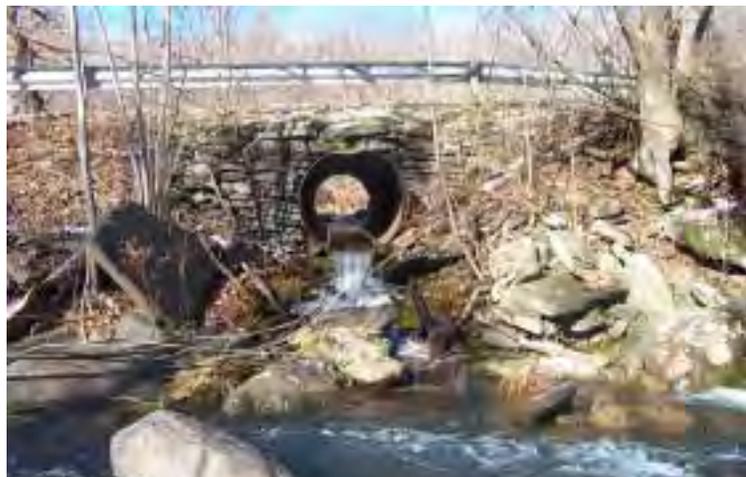
Two culverts were found during the stream assessment survey in 2001. One large culvert (approximately 4 feet in diameter) provides a road crossing for a major tributary stream to the main Broadstreet Hollow (Photo 2). The tributary was flowing at the time of the survey, during the lowest stream flow period of the year, or *summer base flow*, following drought conditions in summer, 2001. Culvert function under flooding conditions was not

Photo 2. Four-foot diameter culvert, providing a crossing over Broadstreet Hollow Road for a major tributary to the main Broadstreet Hollow Stream. Flow in the main stream is from right to left.

documented, though culvert outlet condition appeared to be relatively stable at the time of the survey, despite evidence of previous stabilization measures (very old concrete slabs and rip-rap, primarily) along the road fill.

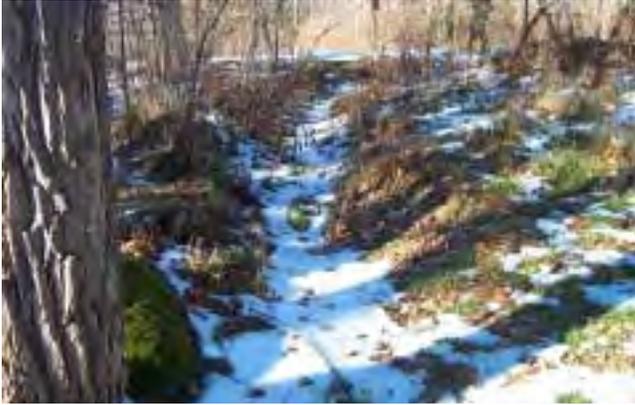
Photo 3. Culvert outlet swale on floodplain, right bank, Broadstreet Hollow stream is behind the viewer, flowing right to left.

(Photos 3 and 4). The culvert outlet swale is in good condition and well-vegetated, reducing erosion that can be caused by flowing water concentrating into a gully. Culvert inlet condition was not documented as part of the stream assessment survey in 2001. There may be other culverts within this unit the survey did not observe.

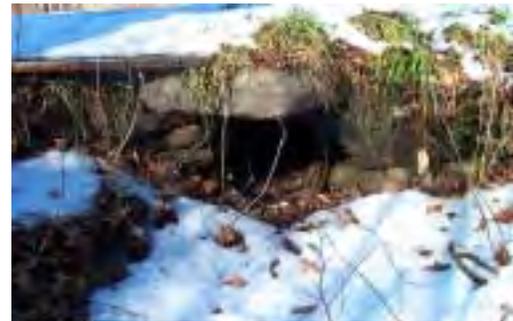
Photo 4. Close-up view of culvert outlet under Broadstreet Hollow Road (see also Photo 3).

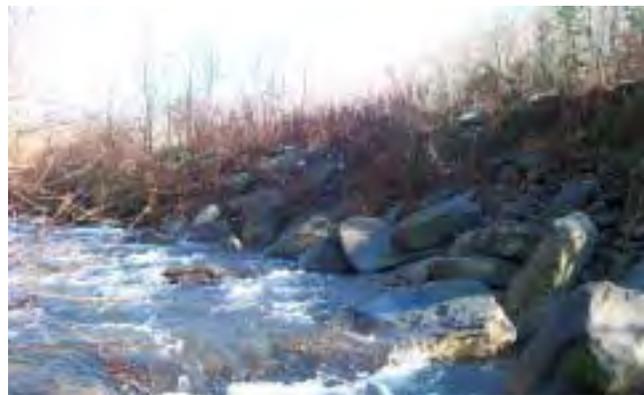
The lower rip-rap section is older (actual age unknown), at the bottom of MU7 (Photo 5). This rip-rap covers approximately 200 feet on the left bank (looking downstream), is partially vegetated, and consists of large boulders, either *non-quarried natural boulders* from outside the stream, or local, *native* material from the stream channel itself^{3&7}. Much of the rip-rap in this section is falling into the stream, as the bank in this area is fairly steep, poorly vegetated and between five and ten feet high.

Photo 5. Looking upstream at slumping riprap on left bank of MU 7.

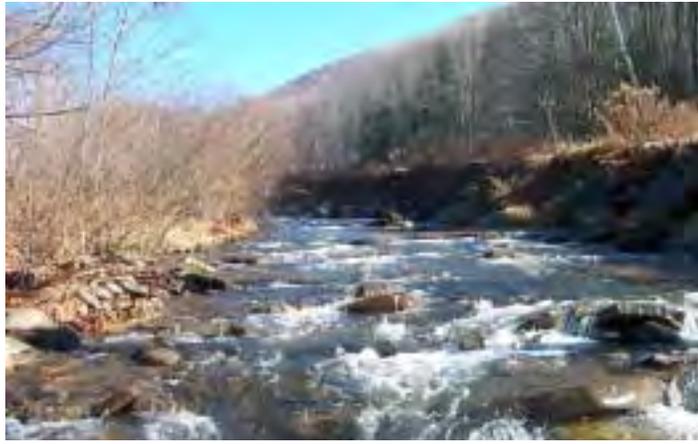
The top of the bank is at a maintained field, vegetated primarily with grasses, with a few small shrubs near the crest of the bank (Photo 6).

This rip-rapped bank is flanked on each end with an eroding bank area, a common feature at the edges of hardened stream banks (upstream eroding bank is described below, downstream eroding bank is in MU8). Rip-rap tends to act to accelerate water over its relatively smooth surface (compared to a bank covered with trees and small shrubs, see the opposite bank in Photo 6). A transition between a hardened area of stream bank and a “softer” area tends to produce erosion, especially if the banks are disturbed or unprotected by vegetation, which is often the case following stream bank work. Both the rip-rapped bank area and the two eroding bank areas on either end would benefit from additional vegetation, or *bioengineering*, to increase and preserve bank stability and other benefits of a healthy streamside, or *riparian area*^{3&8}.

Photo 6. Looking upstream at native boulder rip-rap on left bank at the bottom of MU7.

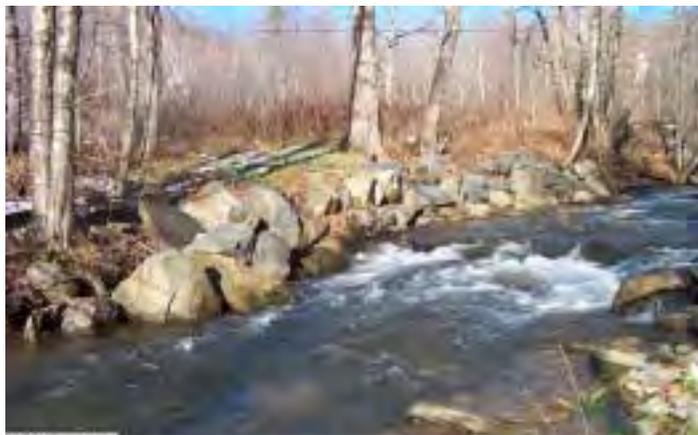
Photo 7. Looking upstream at stacked rock wall revetment on the right bank of MU 7.

The upstream revetment consists of approximately 50 feet of newer stacked rock wall (Photo 7) along the right bank in the upstream half of MU7. The bank behind this wall is lightly wooded, and contains several large trees that provide shade riparian, habitat function⁷.

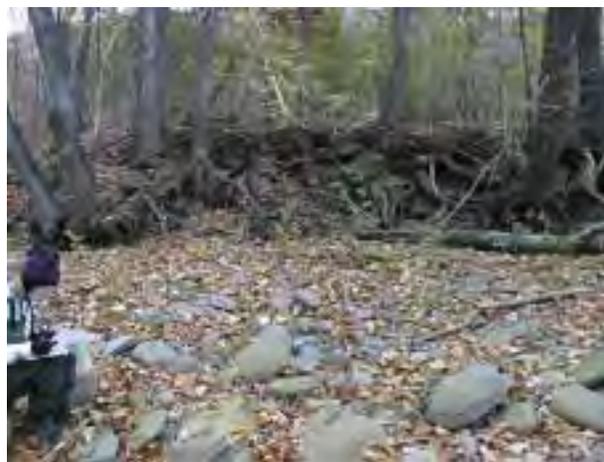
Approximately 60 feet, or 6%, of the stream bank in MU7 was mapped as eroding or exposed bank area in 2001, in one section just upstream of the Lower Rip-rap section (Photo 8). The eroding bank has been monumented at a representative location for future monitoring (designated as “monitoring cross-section 17”) to determine erosion rates and priority for potential

Photo 8. Eroding bank at forested floodplain on left bank, just above lower rip-rap section at the bottom of MU7, monitoring cross-section 17.

restoration³. This site has been assessed and ranked based on calculation of a *Bank Erodibility Hazard Index* (BEHI) using data collected at the time of the stream assessment survey in 2001⁴. Riparian vegetation on these banks consists of a narrow riparian area with large trees and some saplings. There is some marked erosion on the residential lawn on the opposite bank⁷.

The eroding bank at monitoring cross-section 17 may cause increased turbidity in this reach from fine sediments (silt and clay) coming from stream bank and bed material (see Photo 8). In addition to this eroding area, stream assessment survey in 2001 documented a 20 foot exposure of *glacial lake clay* in the stream bed near the right bank opposite the eroding bank at monitoring cross-section 17 (Photo 9)¹⁰. This section should be visually monitored to assess any changes in stream bed condition in MU7 that may contribute to further instability or water quality problems, but no further detailed assessment or management is recommended at this time. This location did not appear to be actively eroding at the time of the stream assessment survey in 2001.

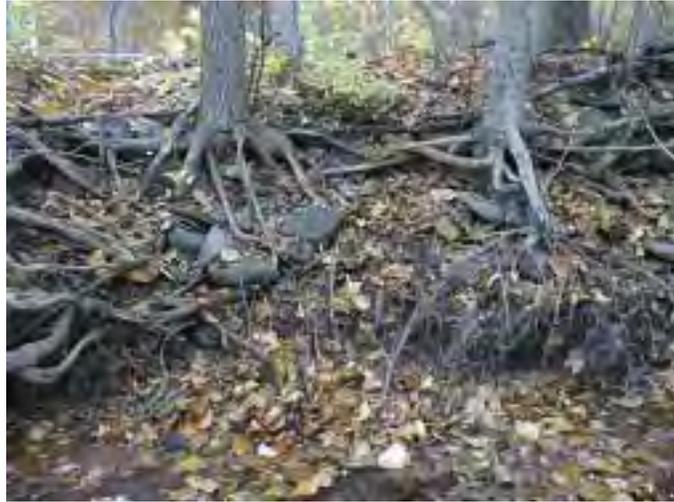
Photo 9. Stream bed clay exposure near monitoring cross-section 17, stream flow from right to left. Note riparian trees holding stream bank in place, despite high stream energy.

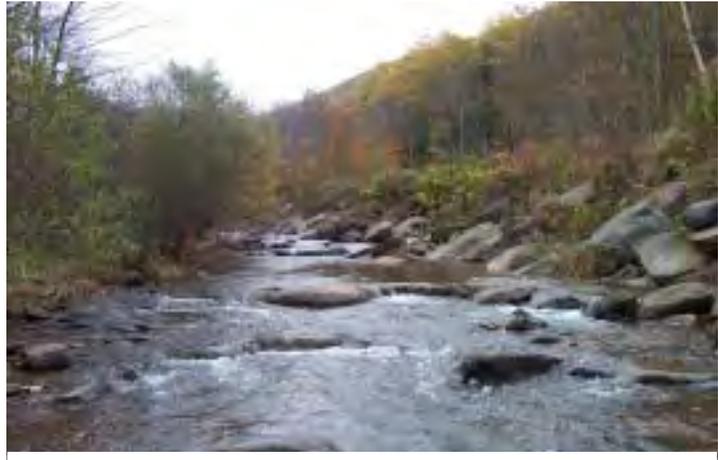
Photo 10. Looking upstream at native boulder rip-rap on left bank at the bottom of MU7. Note dense native riparian vegetation on the opposite bank, and sparse vegetation all along the rip-rap bank.

locations is insufficient to provide the full benefits of a healthy riparian zone. Under-vegetated areas in the vicinity of the stacked rock wall, the eroding bank at monitoring cross-section 17, and the long rip-rap section at the bottom of MU7 (Photo 10), should be vegetated with a mixture of native riparian species to improve shade, cover and water temperature conditions for aquatic habitat^{7&9}. The vegetation will also improve bank stability and reduce the need for ongoing or future bank stabilization work that could cause or increase stream ecosystem disturbances³.
