Broadstreet Hollow Management Unit 9

General Description:

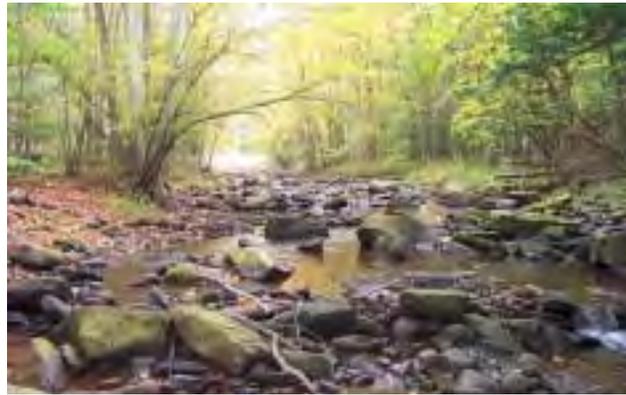
Photo 1. Looking upstream from the bottom of MU9, note grassy floodplain bench areas to the right (see discussion below).

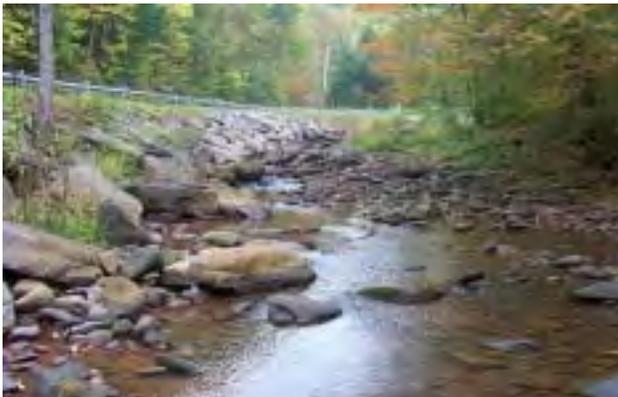
Photo 2. Looking upstream into a meander bend near the top of MU9, large boulder rip-rap shown along road embankment, wooded floodplain area on the opposite side (see discussion below).

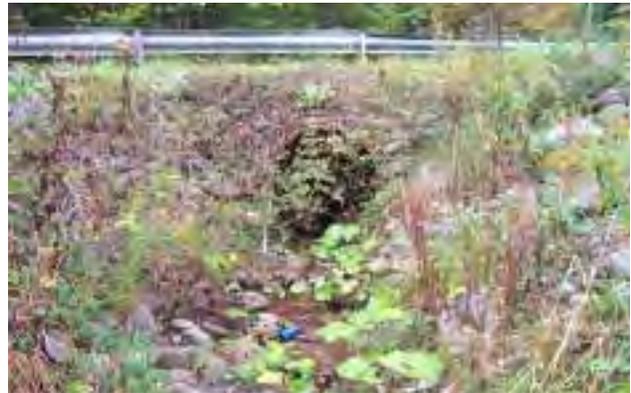
Two culverts were found in MU9 during the *stream assessment survey* conducted in 2001. One of them provides a road crossing for a small perennial (flows year round) side stream, or *tributary*, to the main channel (Photo 3). *Confluence* areas (where two streams join) tend to be unstable by nature's design, as the smaller stream delivers pulses of flood waters and sediment to the main stream³.

Photo 3. Looking upstream into tributary culvert under Broadstreet Hollow Road. Stream flow in the main channel (behind viewer) is from right to left.

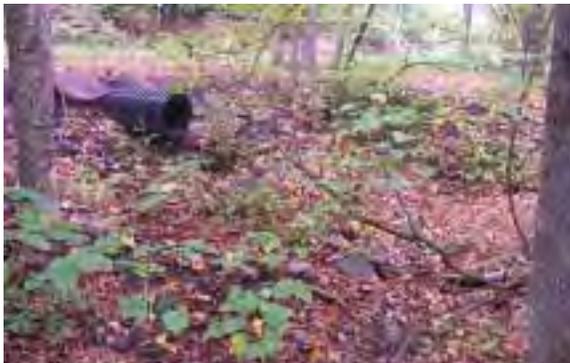
Photo 4. New culvert, right bank, MU9 – road above, Broadstreet Hollow stream behind and to the right of the viewer.

The second culvert, replaced in 2002, was dry at the time of the survey (Photo 4). Culvert flow under flooding conditions was not documented, though both culvert outlets appeared in relatively good condition, with no apparent immediate threat to stream bank or road fill stability. The new culvert could benefit from additional vegetation at the outlet, to dissipate energy of concentrated water flow, and encourage sediment deposition and nutrient or road runoff reduction, or attenuation⁷ (see also water quality discussion below). Water currently falls

from some height above the stream bank, and may have greater erosive potential as it falls and hits the stream bank below⁵.

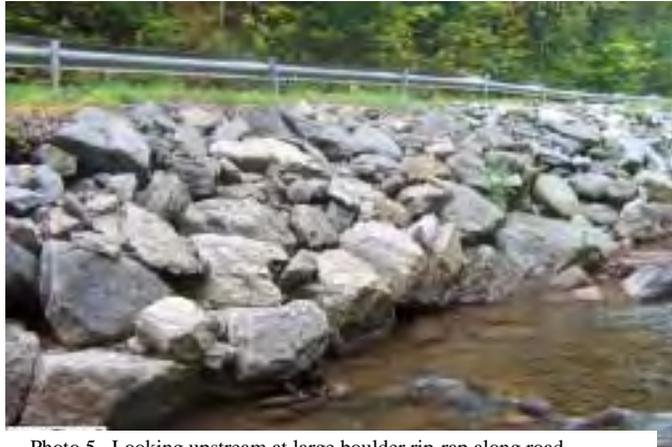
Approximately 900 feet, or 54%, of the stream banks in MU9 have been altered or hardened (Table 1)³. Quarried boulder rip-rap comprises the greatest length of revetment used along the road in the unit, and remains primarily under-vegetated (Photos 5). Augmenting rip-rap areas with *bioengineering*, or re-vegetation, should be considered to

Photo 5. Looking upstream at large boulder rip-rap along road embankment, constructed following January 1996 flood.

improve bank stability and enhance riparian functions in these areas. Bare banks and un-vegetated rip-rapped areas store heat from the sun, and can increase stream temperature by contact with stream flow and rain runoff. Additionally, they do not afford any shading to the stream or stream banks that keeps water temperatures low. Elevated aquatic temperatures may adversely affect water quality and stream ecology. Un-vegetated rip-rap in this unit should be “inter-planted” (planting small shrub or tree species between the rocks to provide some vegetative cover without compromising the structural integrity of the wall) with a mixture of native riparian species to improve shade and cover conditions for aquatic habitat, as well as to improve bank stability and reduce the need for ongoing bank stabilization work that causes or increases stream ecosystem disturbances⁷.

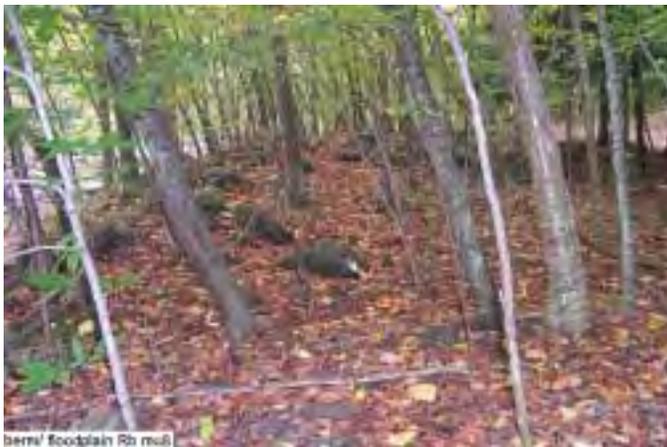
Photo 6. Berm on the left bank, opposite the road, near the top of MU11. Berm viewed looking toward the stream (flow toward the viewer), land surface sloping downward to the right into the floodplain.

The 120-foot berm on the left bank near the top of the unit appears to be material pushed into that area in response to 1996 (and perhaps earlier) flooding damages to the road embankment³ (Photo 6). This practice of “cleaning” the gravel out of a stream in this way is thought to increase flood capacity by creating a larger stream channel.

Unfortunately, berms such as these generally do not offer much if any protection from flooding (there are no structures on the floodplain, and the berm is uneven) and can cause

stream entrenchment and higher flood level, or stage, upstream and downstream by

preventing floodwaters from flowing over the floodplain, cutting off an important function of these flat areas.

Floodplains function to reduce flood velocity, increase absorption of floodwaters, encourage deposition of silt and fine sediments (keeping them from being washed further downstream) and decrease flood stage, or height, in downstream areas⁵. The majority of Broadstreet Hollow stream floodplains consist of small, low, discontinuous floodplain benches that perform the important floodplain functions in small mountain streams. Because this particular berm is on the inside and upstream end of a large stream meander, it can cause acceleration of flows around the outside of the bend, putting more pressure on the road embankment on the right bank. Therefore, removal or restructuring of this berm should be considered to add floodplain function to this area and increase protection for the road³.

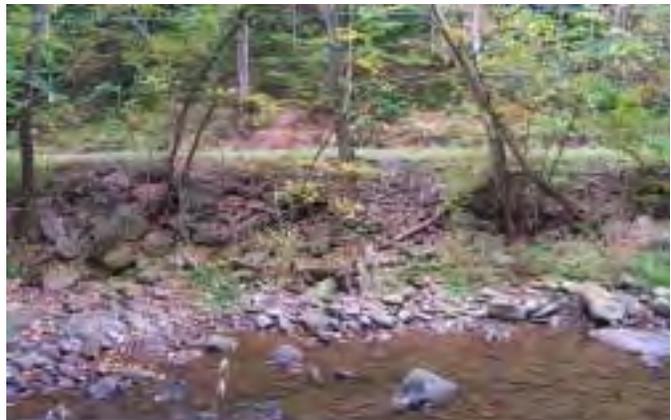
Finally, the lower portion of MU9 is characterized by a long straight stretch of stream, with dumped rock fill on the right bank along the road embankment, and a long area of floodplain and floodplain benches, on the left bank opposite the road. Dumped rock fill comprises the rest of the bank revetment on the road side of the stream, much of which continues to wash or fall into the stream during and following flood events, and typically remains an ongoing maintenance problem for Town and County Highway Departments.

Photo 7. Dumped rock fill, along road fill/embankment on right bank, MU9 Stream flow is from right to left

The dumped rock fill extends for approximately 330 feet at the downstream end of MU9 (Photo 7). Broadstreet Hollow stream can transport very large rocks, or *sediment*, along the stream bed (sediment in transport is called *bedload*). The size of sediment in dumped rock fill is often smaller than the bedload. As a result, rocks on the bank continue to wash downstream over time, needing periodic replacement. Continuing disturbance of the bank area prevents streamside, or *riparian*, trees and other vegetation from becoming established⁷. Further, some riparian tree species become stressed and weakened when their trunks are buried, so existing trees that may be providing some bank protection are eventually killed by ongoing maintenance, reducing long-term bank stability, as well as compromising other important habitat and aesthetic benefits. Alternatives to dumped rock fill should be considered, to reduce maintenance costs and preserve riparian areas (see Stream Bank Stabilization Methods and Alternatives section)³.

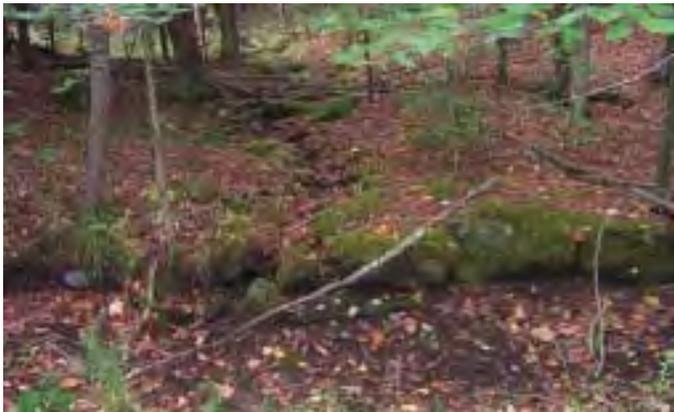
Another small tributary enters the main channel on the left just upstream from the downstream end of the unit, into a broad flat floodplain area uncharacteristic of most of the Broadstreet Hollow valley, showing the unique character of stream confluences (Photo 8). This tributary, unlike the one culverted from the right under the road upstream, appears to carry primarily fine sediments once it reaches the valley bottom and enters the main stream. Because this small stream runs fairly flat along the valley bottom after it descends from the hillside, the energy of the stream is reduced, allowing much of the fine sediment to drop out, or deposit, on the floodplain (the process itself forming the floodplain flat over hundreds of years). This reduces the amount of fine sediment added to the main stream,

Photo 8. Looking upstream into the mouth of the lower tributary, (main stream behind the viewer, running left to right). Note gentle slope, and fine sediment deposited in the foreground in a side channel running left to right, parallel to the main stream.

and increases the stability of this confluence area. Though this was not specifically investigated as part of the stream assessment survey, this area may provide localized valuable wetland habitat and potential water quality improvement functions.
