Broadstreet Hollow Management Unit 10

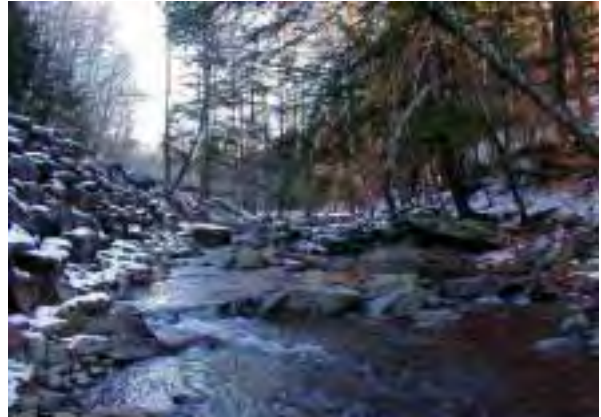
Management Unit 10 (MU10) is a long straight stretch of the Broadstreet Hollow, in Ulster County, NY, beginning where the guiderail starts along the road just upstream of the stacked rock wall installed in 2002 (Photo 1). MU10 extends approximately 650 feet, through a private bridge, and ends approximately 100 feet downstream of the end of the guiderail^{1&2}.

Photo 1. Looking upstream near the top of MU10, Broadstreet Hollow Road at left, valley wall at right.

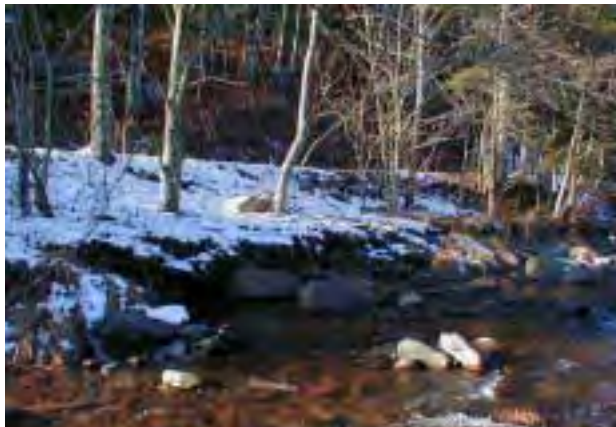
discontinuous floodplains entirely on the banks near the road except near the bottom (Photo 2), and for much of its length on the opposite bank as well where the valley walls are particularly close.

Photo 2. Right bank near the bottom of MU10, showing partial discontinuous floodplain bench, with grasses and trees between the stream and Broadstreet Hollow Road. Stream flow is from right to left.

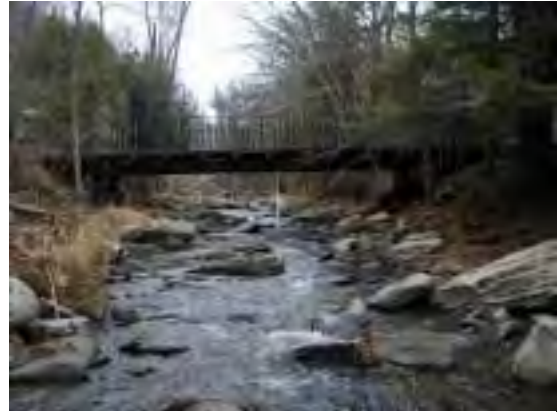
The one private stream crossing (bridge), serving one house on the stream is at 158 Broadstreet Hollow Road, serving the (Photo 3). This bridge, with a span of about 43 feet, appears to be constructed with an appropriate width for the stream, which averages 37 feet in width upstream and downstream of the bridge structure. No further management of the bridge is recommended at this time, though with the narrow valley and proximity to the main road, this bridge could be at increased risk from flood damages, so should be visually inspected yearly to detect any structural problems or stream bank erosion that could indicate increased potential for structural problems⁸.

Photo 3. Looking upstream at private bridge crossing, serving property at 158 Broadstreet Hollow Road (road is at left).

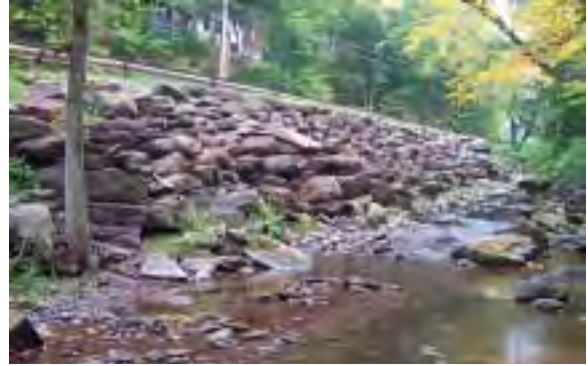
Revetment in MU10 is dominated by a new length of stacked rock wall stabilizing the right stream bank along the road near the top of the unit, installed by the Town of Shandaken Highway Department in 2001³ (Photo 4). By using a stacked rock wall, they were able to preserve existing stream morphology and maintain the road width, with a minimum of disturbance to the stream bed in this area.

Photo 4. Looking upstream at stacked rock wall along road embankment, installed 2002 by Town of Shandaken Highway Department.

Augmenting stacked rock walls with *bioengineering*, or re-vegetation, should be considered to enhance riparian functions in these areas. Bare banks and un-vegetated rip-rapped areas store heat from the sun, and can increase stream temperature by contact with stream flow and rain runoff. Though stacked rock walls produce less of a heating effect because they contain less surface area for the same degree of slope stabilization, they still do not afford any shading to the stream or stream banks that keeps water temperatures low. Elevated aquatic temperatures may adversely affect water quality and stream ecology. Un-vegetated stacked rock wall in this reach should be “inter-planted” (planting small shrub species with small root systems between the rocks to provide some vegetative cover without compromising the structural integrity of the wall) with a mixture of native riparian species to improve shade and cover conditions for aquatic habitat, as well as to improve bank stability and reduce the need for ongoing bank stabilization work that causes stream ecosystem disturbances⁷.

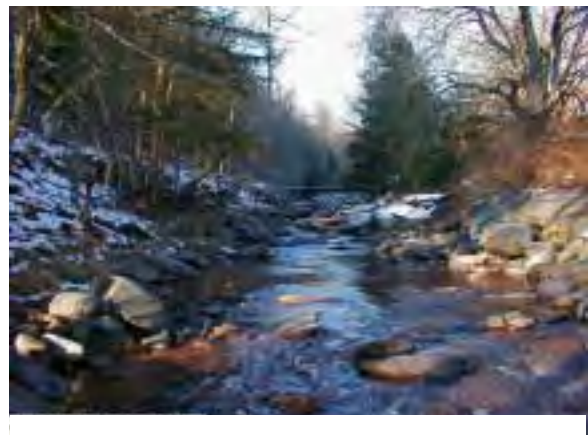
Approximately 95 feet, or 7% of the stream bank near the bottom of MU10 have been rip-rapped primarily with large boulder material (Photo 5). As discussed above, un-vegetated rip-rapped areas such as this do not provide the benefits of a healthy riparian zone, the boulders acting as a heat sink and lack of vegetation preventing longer term bank stability. This rip-rapped bank is flanked on each end with a short eroding bank area, a common feature at the edges of hardened stream banks (the upstream eroding bank is described below). Rip-rap tends to act to accelerate water over its relatively smooth surface (compared to a bank covered with trees and small shrubs)^{3& 8}. A transition between a hardened area of stream bank and a “softer” area tends to produce erosion, especially if the banks are disturbed or unprotected by vegetation, which is often the case following stream bank work. Both the rip-rapped bank area and the two eroding bank areas on either end would benefit from additional vegetation, or *bioengineering*, to increase and preserve bank stability and other benefits of a healthy streamside, or *riparian* area⁷.

Photo 5. Looking upstream near the bottom of MU10, upstream end of rip-rap section at right, downstream of eroding bank at residential lawn area, Broadstreet Hollow Road at left.

Monitoring cross-section 9 was set up to document erosion of the left bank lawn area opposite the log crib wall location, approximately 50 feet upstream from the boulder rip-rap section (see right side of Photo 5). Bank instability in this section is primarily due to lack of deeply rooted vegetation, and may be exacerbated by the narrowness of the valley

in this section. The hardened right bank does not allow excess stream energy to be dissipated by moving the channel in that direction, so stream forces will preferentially erode the “softer” surface. This area received a “moderate” BEHI rating, indicating an ongoing but not serious or acute potential for continued erosion. No structures are threatened, though the drainage pipe in this bank may be of concern. Continued monitoring of this section is recommended to detect any changes that could lead to additional instability. Minimally, riparian vegetation should be augmented on the left bank lawn area, with additional grasses and shrub or tree species as appropriate for additional stability and to reduce further erosion and property and soil loss⁷.

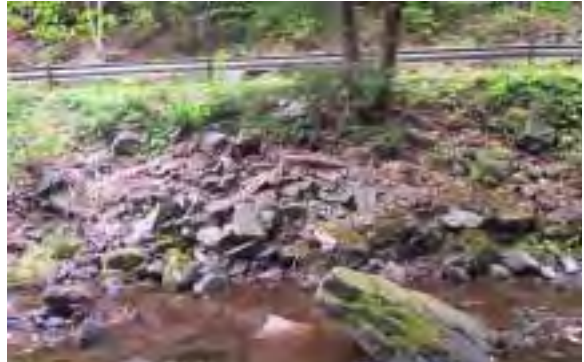
Much of this revetment continues to wash or fall into the stream during and following flood events and remains an ongoing maintenance problem for Town and County Highway Departments (Photo 6). Though not mapped as such, there is also a small section (about 50 feet) of bank run gravel material on the stream bank at the top of MU10 (photo 7).

Photo 6. Right bank dumped rock fill, along Broadstreet Hollow Road embankment near the top of MU10. Stream flow is from right to left.

Both of these types of bank fill methods are problematic³. Broadstreet Hollow stream can transport very large rocks, or *sediment*, along the stream bed (sediment in transport is called *bedload*). The size of sediment in dumped rock fill is often smaller than the bedload, and gravel or bank run material is always smaller than the bedload. As a result, rocks on the bank continue to wash downstream over time from the toe, needing periodic replacement⁵. Continuing disturbance of the bank area prevents streamside, or *riparian*, trees and other vegetation from becoming established, reducing the likelihood

the bank area can stabilize on its own. Further, some riparian tree species become stressed and weakened when their trunks are buried, so existing trees that may be providing some bank protection are eventually killed by ongoing maintenance, reducing long-term bank stability, as well as compromising other important habitat and aesthetic benefits⁷. Alternatives to dumped rock fill or use of bank run gravel material should be strongly considered, to reduce maintenance costs and preserve riparian areas³.

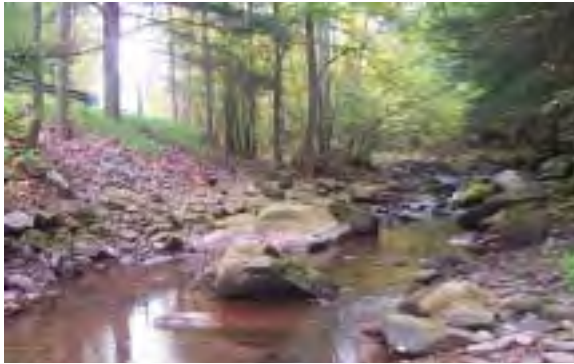
Photo 7. Looking upstream into the top of MU10, dumped rock fill at left in foreground, bank run gravel material at left in background, Broadstreet Hollow Road at top of bank.

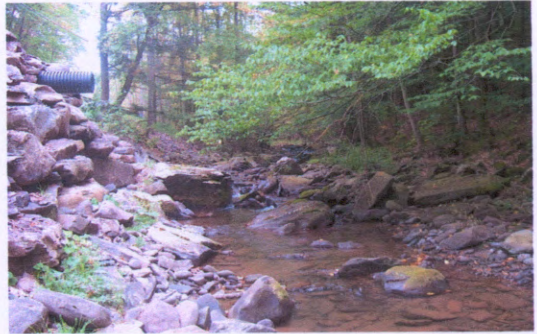
The upstream-most culvert was installed as part of the new stacked rock wall constructed by Town of Shandaken in 2002, and provides drainage from the *inboard* roadside ditch (along the valley wall), crossing the road to enter on the right stream bank (Photo 8). This culvert outlet is high above the stream, potentially increasing erosive power as water falls to the stream bed below, though currently the number and arrangement of boulder material at the toe (base) of the wall in the stream bed appears to be sufficient to absorb this energy. This should be visually inspected yearly to detect any changes in stream bed stability that could impact either stream function or threaten the rock wall structure.

Photo 8. Looking upstream, black plastic corrugated culvert in stacked rock wall at left, draining inboard roadside ditch on Broadstreet Hollow Road.

Additionally, this wall is un-vegetated, as discussed above, so may add heat to the water as it falls and flows over the rocks before it enters the stream. A mix of vegetation should be added to this wall, particularly in the vicinity of the culvert, to shade the culvert (which is black, so may absorb a greater amount of solar heat before water even reaches the rocks) and the rocks below to preserve cool temperatures both for water quality and aquatic habitat functions.

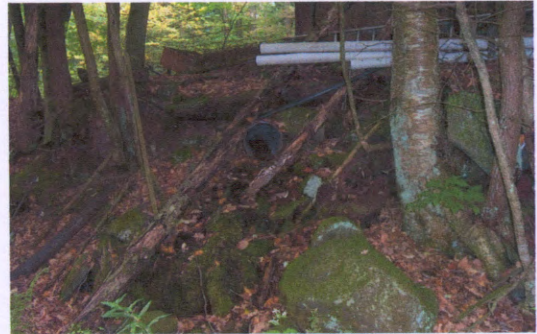
Photo 9. Corrugated culvert in left bank landfill/dumping site. Stream is behind the viewer, flow from left to right.

The second culvert from the top of MU10 drains through an old dumping site along the stream bank across from the road (the left bank looking downstream) approximately 50 feet upstream of the private bridge crossing (Photo 9). Despite refuse materials in this area, the relatively steep angle of the bank and height of the drop, the culvert outfall appears stable, with large rocks and boulders in the bank well covered with moss, showing little if any erosive power at work in this area. No monitoring or amendments are recommended at this time for this culvert.

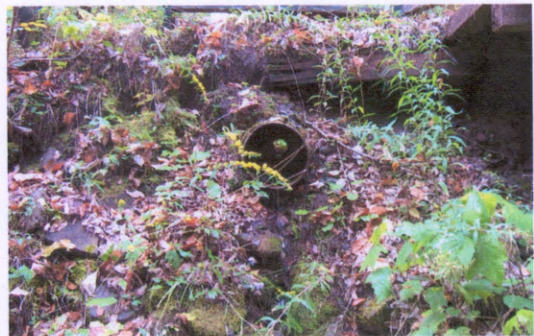
Photo 10. Smooth metal culvert on right bank, draining inboard ditch on Broadstreet Hollow Road, just downstream of private bridge crossing. Stream is behind the viewer, flow from right to left.

The third culvert provides inboard ditch drainage for Broadstreet Hollow Road, entering the stream on the right bank (looking downstream), just downstream of the private bridge (Photo 10). The outlet is

several feet above the stream bed on a steep bank, with some erosion evident below. Because of the steepness of the bank, and the lack of strong woody riparian vegetation, this culvert outlet should be inspected frequently to detect any problems, and should be augmented with additional vegetation to reduce streambed erosion at the toe (base) of the bank that could eventually lead to compromising structural integrity of the bridge.

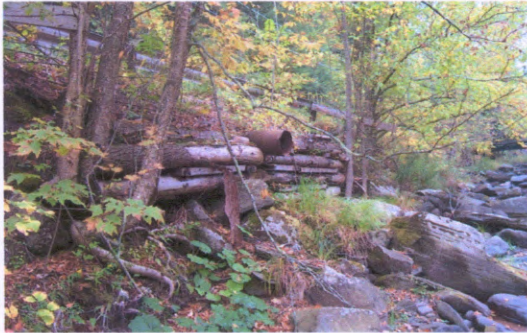
Photo 11. Looking upstream toward smooth metal culvert in log crib wall on right bank, along Broadstreet Hollow Road embankment. Culvert was dry at the time of the 2001 stream survey.

The fourth culvert, the only one that was dry at the time of the stream survey in 2001, is part of a section of log crib wall, of unknown age, along the road embankment, entering the stream on the right bank (Photo 11). Though this culvert and the crib wall could benefit from additional riparian vegetation to improve stability and preserve cool water temperatures, boulders at the base of the wall appear to be functioning to dissipate the energy of water falling from the culvert outlet. Other than potentially augmenting this

area with additional riparian vegetation and annual visual inspection, no further action on this culvert or the crib wall is recommended at this time.

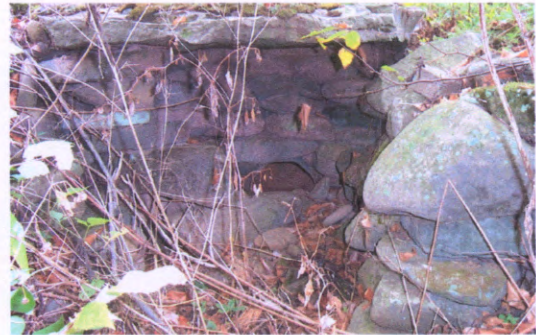
The downstream-most culvert provides drainage under the private road on the opposite side of the stream (along the left bank, looking downstream) and parallel to Broadstreet Hollow Road (Photo 12). The outlet is well protected with boulder walls, and enters the stream at a low angle, set back far enough from the active stream channel, making this the most stable culvert in MU10. No additional management is recommended for this culvert at this time.

Photo 12. Culvert providing drainage for private road, on the left bank opposite and parallel to Broadstreet Hollow Road. Stream is behind the viewer, flow from left to right.

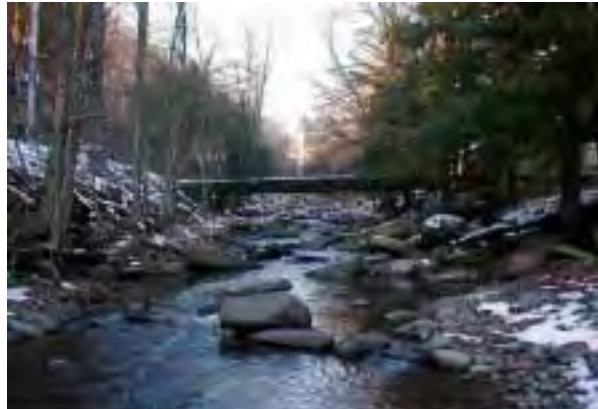
Monitoring cross-section 10 was set up to document ongoing erosion along the road embankment in this particularly narrow reach of stream (Photo 13). While vegetation along this bank generally includes a mix of herbaceous (small, annuals and grasses) and woody (shrub and tree species) vegetation, the proximity of the stream to the road, and the steepness of the bank, prevent a fully functioning riparian zone from holding this bank in place. This area also received a “moderate” BEHI rating, but due to the shape of the stream channel here, the potential for ongoing erosion is likely higher, as the main flow of the stream is right up against the bank with high energy, compared to cross-section 9, in which there is a gravel bar deposited against the toe of the bank, indicating a depositional zone and lower stream energy. Continued monitoring of this section will be critical to ensuring integrity of the road embankment. Augmenting with additional vegetation should also be implemented, including woody, deep-rooted species that can provide

Photo 13. Looking upstream into reach with monitoring cross-section 10, eroding bank along road embankment associated with inadequate riparian vegetation and very steep slope, close to the stream.

structural bank stability in addition to reducing soil and embankment material losses to the stream⁷.

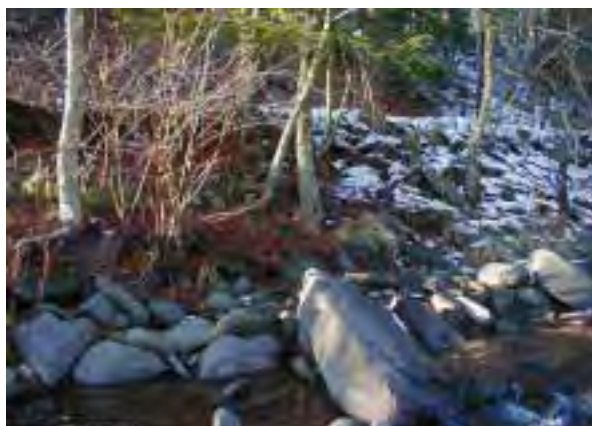
Photo 14. Right bank along Broadstreet Hollow Road embankment, showing steep slope, leaning trees and active stream processes at the toe (base) of the bank. Stream flow from right to left.

In addition to mapped areas of active bank erosion, stream assessment in 2001 documented generally lower level bank instability along the road embankment (Photo 14). The active bank erosion was evidenced by some exposed soil areas, very steep banks and stressed vegetation (including the classic “pistol-butt” shape of tree trunks that indicate a continual, slow downward movement of the slope (see Photo 13), as well as trees leaning

streamward from the slope). Additionally, landowners in this area have noted that fill material and past stream bank work has been eroding through this reach, though not necessarily catastrophically or all at once³.

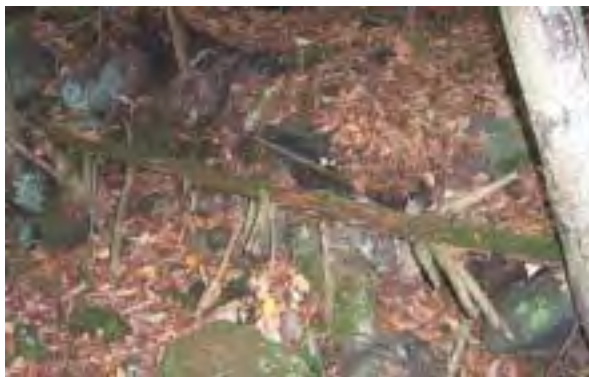
Approximately 227 feet (18%) of MU10 was mapped as a single dumping site, the longest, though not the densest, documented in 2001^{1&2} (see photo 15). This site appears not to contain any materials that could contribute to water quality impairment from leaching of toxic materials.

Photo 15. Close-up of left bank landfill/dumping site in MU10. At 227 feet, this is the longest landfill documented in the watershed, though isn't very densely littered.

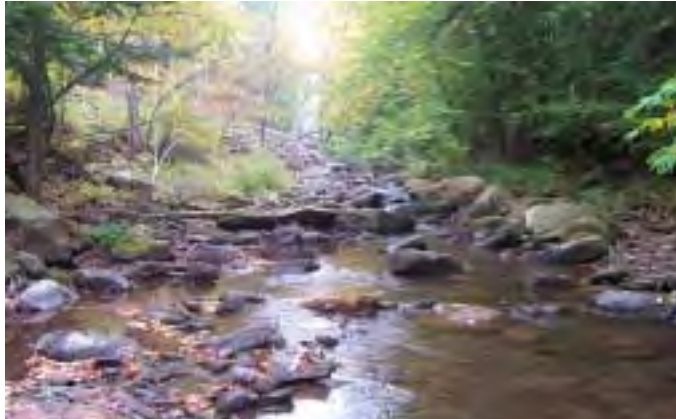
could generally affect stream stability, flooding or erosion threats, water quality or aquatic habitat for trout species. Based on these general observations, riparian vegetation throughout MU10 is insufficient to provide the full benefits of a healthy riparian zone to this section of stream through the length of MU10, though has some healthy sections especially opposite the road in the upstream section of the unit (Photo 16).

Photo 16. Looking upstream in MU10, just above private bridge crossing, stacked rock wall at left in the background. Riparian vegetation at the right is healthy, away from the steep road embankment at left. The road embankment area should be augmented with additional vegetation.

areas in the vicinity of the stacked rock wall, dumped rock fill, rip-rap and non-hardened road fill sections in this reach should be vegetated with a mixture of native riparian species to improve shade, cover and water temperature conditions for aquatic habitat⁹, as well as to improve bank stability and reduce the need for bank stabilization work that could cause or increase stream ecosystem disturbances³.
