Broadstreet Hollow Management Unit 12

General Description:

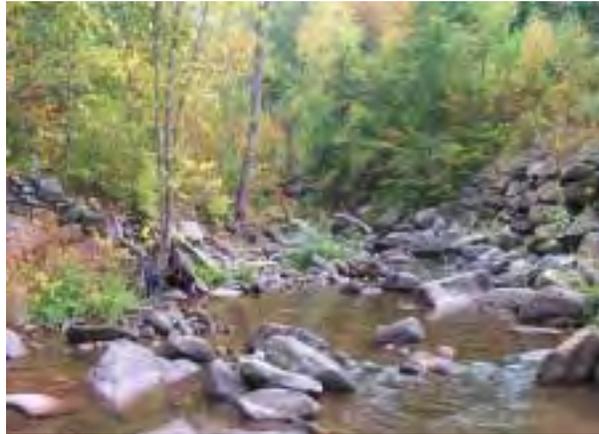
Photo 1. Looking upstream into the top of MU12.

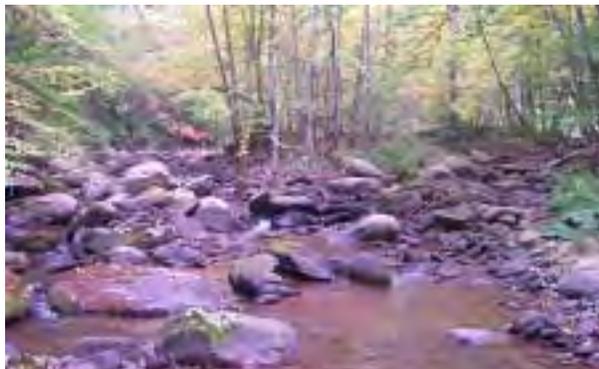
Photo 2. Looking upstream toward the split channel reach in MU12, note the well-vegetated center island, with large trees, and coarse boulder structure of the stream bed.

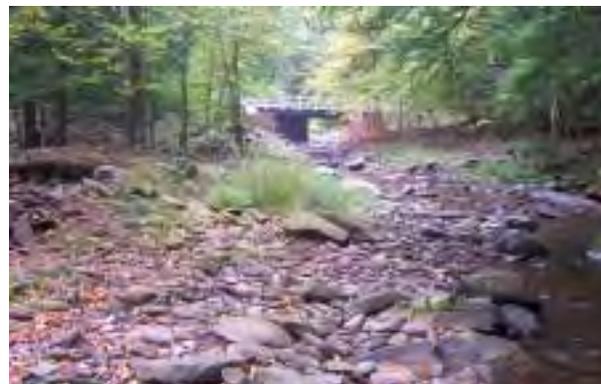
Photo 3. Looking upstream from the bottom of MU12, County Bridge 3-34671-0 in background.

maintain a stable shape, and better riparian vegetation to stabilize the banks and provide other habitat benefits^{5&7}. MU12 maintains some of these discontinuous floodplain bench features, even in the entrenched sections, excepting in areas with intensive revetments⁵ (Photo 3).

The span under County Bridge 3-34671-0, just upstream from 108 Broadstreet Hollow Road and rebuilt in 2000, is less than 30 feet, compared to the average natural stream channel width both upstream and downstream from the bridge location of between 40 and 50 feet (see Photo 3). Additionally, due to the valley and road configuration, this bridge was built at an angle to accommodate the road direction. The result is that the stream is directed into the right abutment (looking downstream) during high flow, possibly increasing potential for bridge structural instability and stream bed scour over time. Because sheet piling was used primarily in bridge abutments and wing walls (extending along the stream banks upstream and downstream from the primary bridge structure), the bridge is probably not threatened. Stream banks at the margins of sheet piling may be at greater risk for increased erosion. Though sheet piling may be necessary where space is limited.

This bridge and/or the stream channel upstream and downstream, will likely have maintenance problems over time, unless it is reconstructed to accommodate the natural width of the stream⁸. Addressing stream bank stability separate from amending the bridge will likely only offer a temporary fix, though increased vegetative stabilization may reduce ongoing maintenance problems.

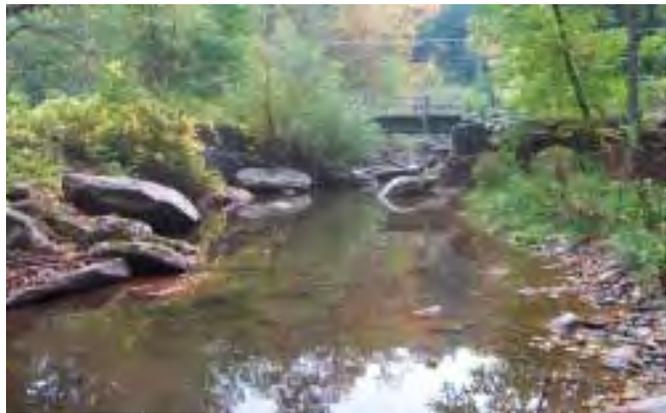
The span under the David Merwin Bridge appears to be appropriately sized to match the natural stream channel dimensions in this reach (Photo 4). The bridge span (measured in the field during the stream assessment in 2001) is approximately 40 feet between the old concrete abutments, and 48 feet between the newer abutments, compared to the average natural stream channel width upstream from the bridge location of approximately 42 feet.

Photo 4. Looking upstream toward County bridge 2-22457-0. Willows just downstream from the bridge (at the left) may help prevent further bank and stream bed erosion, while allowing the passage of water through them during floods.

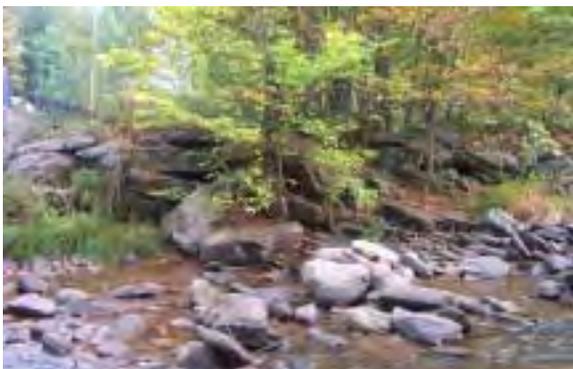
Photo 5. Boulder rip-rap on the right bank, just upstream from the David Merwin bridge. Stream flow is from right to left.

Rip-rap on both banks upstream from the David Merwin Bridge is in fairly good condition, showing little evidence of undercutting or potential failure, partially owing to the low slope and short banks they protect, as well as the presence of large trees between the rocks, which help maintain stability (Photos 5 and 6).

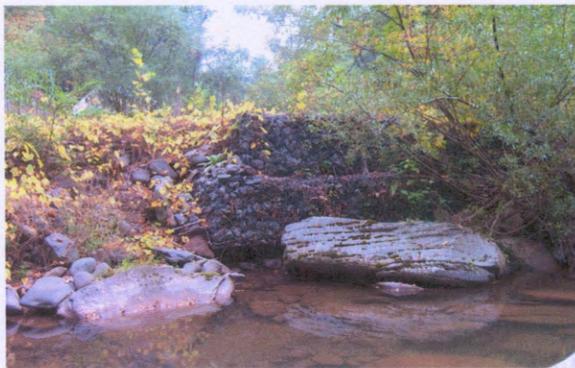
Photo 7. Gabion basket stream bank revetment, with willows upstream on right bank just downstream from the David Merwin Bridge, with minor "eddy erosion" on the downstream edge. Stream flow is from right to left.

Sixty feet (3%) of bank below the bridge, in two sections (one on each bank), has been reinforced by large wire-mesh baskets filled with rock material or *gabions*^{2&3} (see Photos 7 and 8). Unfortunately, gabion revetment is not typically recommended in a stream setting like the Broadstreet Hollow, especially where stream energy is high, because the action of cobbles and boulders in transport, or *bedload*, can

Broadstreet Hollow stream can transport very large rocks, or *sediment*, along the stream bed. The size of sediment used to fill the wire baskets is often smaller than the bedload, so when they break open, the sediment simply washes downstream, providing no bank protection^{3&8}.

being quite flexible, and do not typically allow large wood to hang up in them causing debris jams. Small, low-growing shrub willow species should be used in settings such as this to improve stream bank and bed stability without causing undue flood flow constriction⁷.

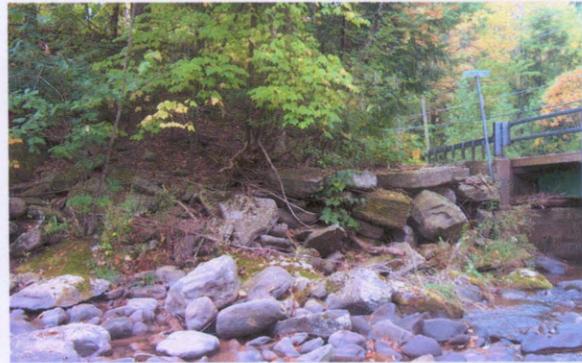
Photo 6. Large boulder rip-rap on left bank, just upstream from the David Merwin bridge. Stream flow is from left to right. Note partially stacked structure increases rip-rap stability.

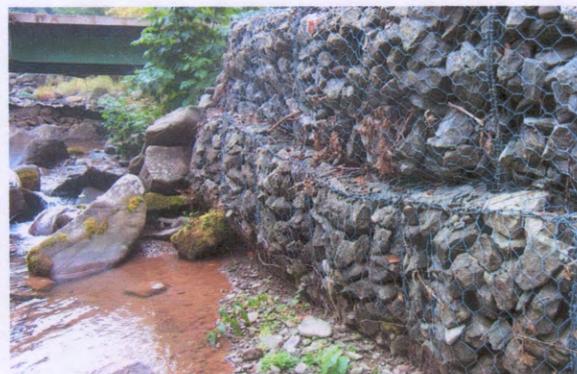
Photo 8. Looking upstream, gabions on left bank, downstream of David Merwin County Bridge 2-22457-0.

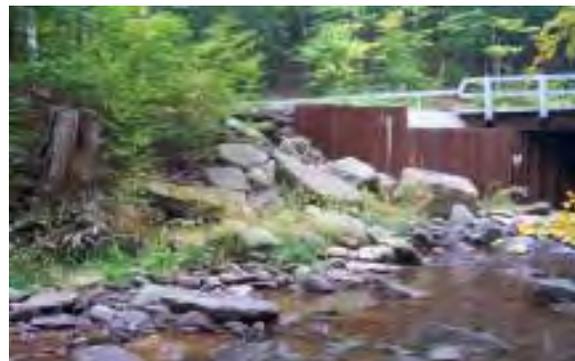
Photo 9. Looking upstream toward rip-rap and sheetpiling (bridge wing wall) along downstream from County Bridge #3346710. Stream flow is from right to left.

The combination of flow constriction at the bridge and similar rip-rap configuration against the bank downstream of the bridge may make this section of rip-rap vulnerable to the same undercutting process, though this section isn't constructed on such a steep angle, and appears to contain much larger boulders, so this area may be able to resist eddy scour on the bank and rip-rap failure into the stream bed^{3&8} (see Photo 9).

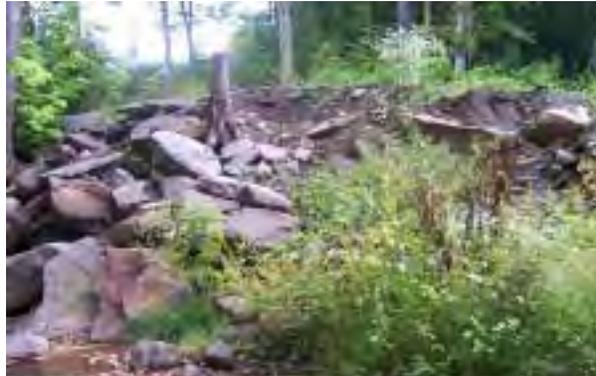
This appears to be occurring in the rip-rap section on the left just upstream from County bridge 3-34671-0, where much of the slope above and behind the rip-rap boulders is falling into the stream, and the rocks at the toe (base) of the slope are sliding downward out from under the rest, *destabilizing* the entire wall (Photo 10). This slope is also the highest and steepest in the unit, so would experience the greatest potential for erosion.

Photo 10. Partially failing rip-rap along left bank, just upstream of County Bridge 3-34671-0. Stream flow is from left to right.

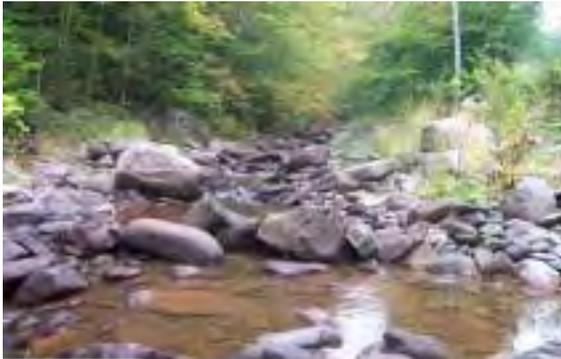
Photo 11. Looking upstream from just above County Bridge 3-34671-0. Steep valley wall to the left, Broadstreet Hollow Road fill and rip-rap bank to the right.

Additionally, this reach of stream in MU12 runs against the steep valley wall opposite the road, so greater stream energy will be focused in this section during flood events (Photo 11).

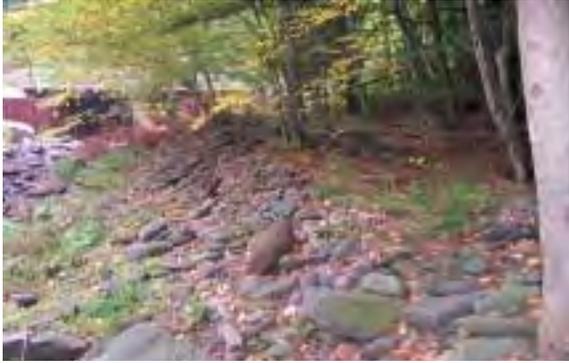
The *berm* on the left bank just downstream from the bridge, appears to be material pushed up onto the banks in response to 1996 flood damages in the vicinity of County bridge 3-34671-0³ (Photo 12). This practice of “cleaning” the gravel out of a stream in this way is thought to increase flood capacity by creating a larger stream channel, but in this case acts to further constrict flow and potentially increase eddy scour bank erosion downstream from the bridge. Unfortunately, berms such as these also generally do not offer any protection from flooding (inundation) due to their short length, and can cause stream

Photo 12. Looking upstream at cobble berm along left bank, downstream of County Bridge #3346710. Stream is to the left.

entrenchment and higher flood stage locally by preventing floodwaters from flowing over the floodplain, cutting off an important function of these flat areas. In addition, increased flood stage and flow concentration, with higher banks formed by the berm, can encourage erosion of berm material, delivering it back into the stream channel to wash downstream.

(keeping them from being washed further downstream) and decrease flood stage, or height, in downstream areas. The majority of Broadstreet Hollow stream floodplains consist of small, low, discontinuous floodplain benches that perform the important floodplain functions in small mountain streams. Because MU12 is particularly entrenched and confined in the vicinity of both bridges, with little floodplain storage in these areas, removal or restructuring of this berm should be considered to add floodplain function to this area³.

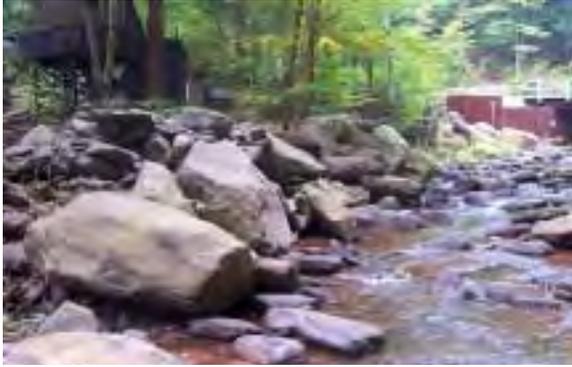
Photo 13. Looking upstream at right bank boulder berm, just downstream from County Bridge 3-34671-0.

The berm area directly across the stream from the berm associated with County Bridge 3-34671-0, on the right bank downstream from the rip-rap area just below the bridge, is at 108 Broadstreet Hollow Rd, and was not constructed in association with the bridge¹ (Photos 13 and 14 also see rip-rap in Photo 9).

During low flow and some low magnitude floods, the berm is probably effective, keeping water from flowing over the surface and into the side channel along the toe (base) of the hillside. Unfortunately, during higher floods the berm will inevitably overtop. Flood waters cascading down the other side of the berm will be falling from a much greater height than they would have done without the berm present, and will therefore have much greater erosive power. In this way, this berm may cause even greater damage to both the hillside and the berm itself in larger floods.

The solution to the flood damage problems in this reach may not be simply to build a taller berm – conceivably, eventually there would be a large enough flood to overtop it. Rather, remediation in this reach should include an assessment of the stream channel pattern and evolution, the function of the split channels, and provision for some way to allow water to flow near the hillside without eroding or scouring at the toe (base) of the hillside and threatening structures or property values. This could be

accomplished with a combination of some stream channel reconstruction, including removal or restructuring of berms on both banks below the bridge, provision of additional floodplain bench areas along stream banks on the hillside, and intensive re-vegetation, or bioengineering, to improve longer-term structural stability of the hillside^{3,5,7 & 8}.

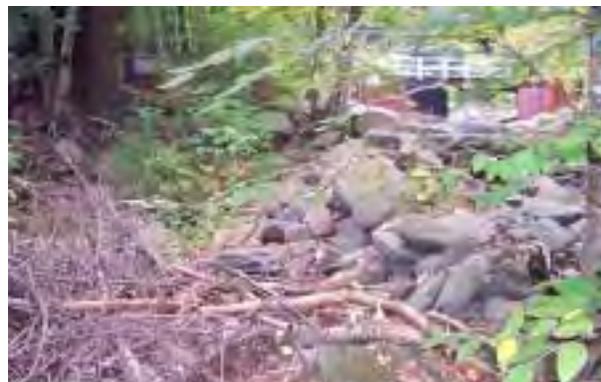
The house is up on the hillside, between the road and the stream. The stream splits just above this property, and one of the side channels has eroded into the hillside, threatening streamside improvements constructed by the landowner. This berm is constructed primarily of boulders and cobble material, with some large wood, for the purpose of prevention of flood inundation and erosion protection for this property at the base of the hillside below the house and lawn area. The berm is designed to deflect water away from this side channel, downstream in the main channel, away from the hillside.

Photo 14. Back side of boulder/debris berm at 108 Broadstreet Hollow Road property, stream to the right.

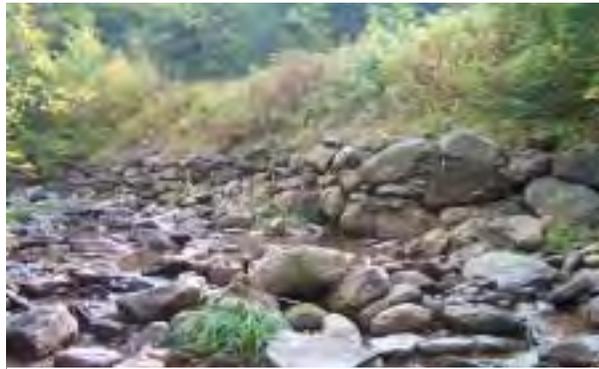
A stacked rock wall has been constructed along 115 feet, or 5%, of the stream bank in MU12, in one section on the left bank at the top of the unit, around the outside of a meander bend ¹ (Photo 15). The embankment above this revetment is very steep, though appears not to be slumping or eroding, and has dense grass and small shrub vegetation. By using a stacked rock wall, existing stream morphology has been preserved, and road width maintained, with a minimum of disturbance to the stream bed in this area.

Photo 15. Looking upstream at left bank stacked rock wall, at the top of MU12. Private drive at the top of the bank.

Augmenting stacked rock walls with *bioengineering*, or re-vegetation, should be considered to enhance riparian functions in these areas. Bare banks and un-vegetated rocks store heat from the sun, and can increase stream temperature by contact with stream flow and rain runoff. Though stacked rock walls produce less of a heating effect because they contain less surface area for the same degree of slope stabilization (i.e., they can hold an almost vertical slope), they still do not afford any shading to the stream or stream banks that keeps water temperatures low. Elevated aquatic temperatures may adversely affect water quality and stream ecology. Un-vegetated stacked rock wall in this reach should be “inter-planted” (planting small shrub species with small root systems between the rocks to provide some vegetative cover without compromising the structural integrity of the wall) with a mixture of native riparian species to improve shade and cover conditions for aquatic habitat, as well as to improve bank stability on the slope above the wall, and reduce the need for further bank stabilization work that causes stream ecosystem disturbances⁷.

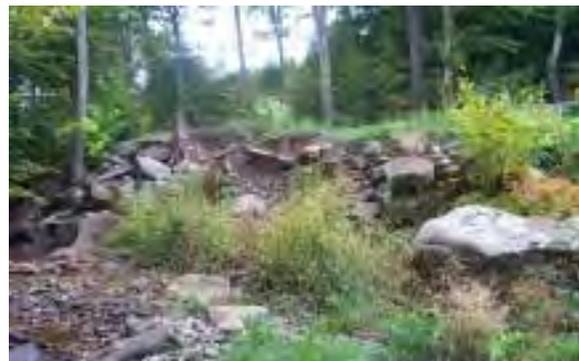
Stream assessment conducted in 2001 did not reveal any significant eroding or exposed banks that currently warrant extensive stabilization or monitoring. However, areas of localized bank erosion were noted associated with the ends of gabion-hardened banks and rip-rapped areas, as discussed above (Photo 16, and see Photos 7 and 10). Larger-scale erosion associated with the rip-rap on the left bank upstream from County Bridge 3-34671-0 could threaten the road, so should be

Photo 16. Left bank rip-rap and road fill erosion, upstream from County Bridge 3-34671-0, Broadstreet Hollow Road at the top of the bank. Stream flow is from left to right.

visually inspected annually to detect any changes or ongoing instability. A section of stacked rock wall may be considered in this area, particularly with the close proximity

between the stream and the road, and the fact that this already narrow reach may put additional pressure on the bridge and adjacent stream banks. No monumented monitoring cross-sections have been installed to document the extent or rate of potential erosion⁴.
