Broadstreet Hollow Management Unit 15

General Description:

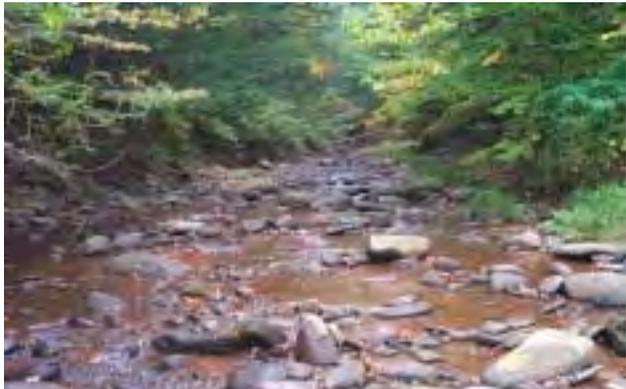
Photo 1. Looking upstream into the top of MU15, just upstream of residential water diversion.

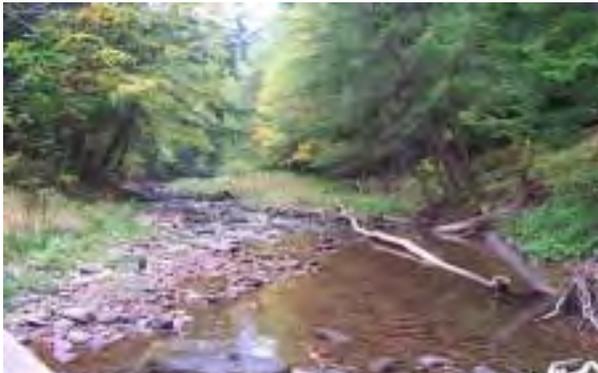
Photo 2. Looking upstream into the top half of MU15, showing vegetated gravel bar areas and healthy riparian forests on both banks (some trees leaning into the stream to the right associated with a long eroding hillside, discussed below).

unit, creating four smaller sections, or *reaches*, with discrete morphologic character, or *stream type*⁵. Though the valley isn't particularly narrow through MU15, the stream runs against the valley wall on the left (looking downstream) opposite the road, and has cut into its bed enough that the wide flat area between the road and the stream that used to be the floodplain is now a *terrace*, functioning as a floodplain only at during very high flows. The upstream half of MU15 has not cut into its bed enough to produce an *entrenched* stream shape, though there is active stream bank *erosion* over a large section of the terrace bank (Photo 2).

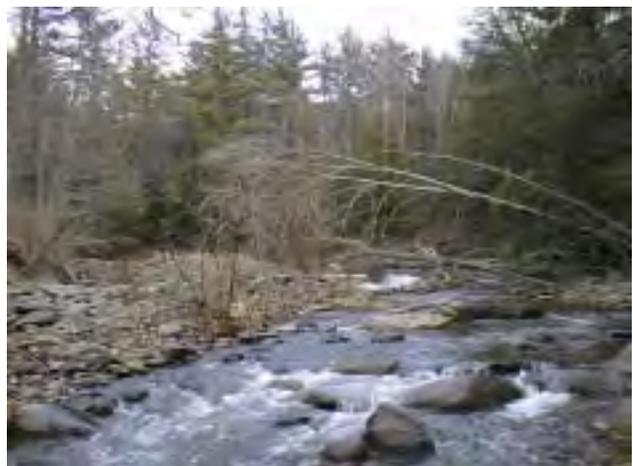
The downstream half of MU15 is in considerably worse condition, or *unstable*, with an entrenched stream shape showing the stream is confined by its valley and bank conditions in this reach (Photo 3). One of the most extreme eroding hillsides documented in Broadstreet Hollow in 2001 is contained in this section (described below), and a long section of over-widened stream with multiple, unstable channels exacerbating bank erosion on both banks.

Photo 3. Looking upstream from near the bottom of MU15, into an over-wide, unstable section characterized by shifting gravel bars, eroding banks and multiple fallen trees.

benches, or *discontinuous floodplains*, that function as overflow areas during floods and provide areas for healthy streamside, or *riparian*, vegetation. Less steep areas with more floodplains have more space in which to maintain a stable shape, and better riparian vegetation to stabilize the banks and provide other habitat benefits^{5&7}. MU15 maintains some of these discontinuous floodplain bench and vegetated side gravel bar features in the upstream reach on the non-eroding bank, but lacks these features entirely in the lower reaches, adding to instability in this section. Additionally, the shifting bar pattern in the middle of the stream in the lower reaches of MU15 contributes to ongoing bank erosion in this area⁵ (see Photo 3).

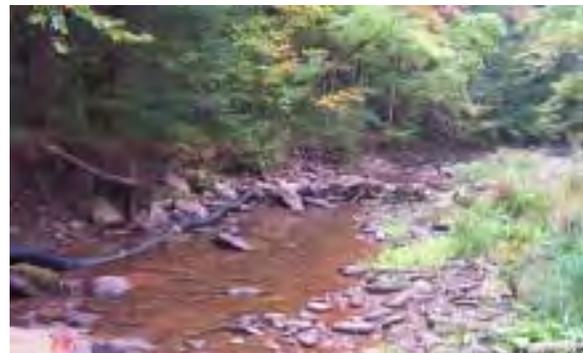
A hand-built water diversion, consisting of a low cobble dam with corrugated pipe, feeds a small pond on the right bank¹ (Photo 4).

Photo 4. Looking upstream near the top of MU15, showing hand-built water diversion cobble dam, and corrugated pipe.

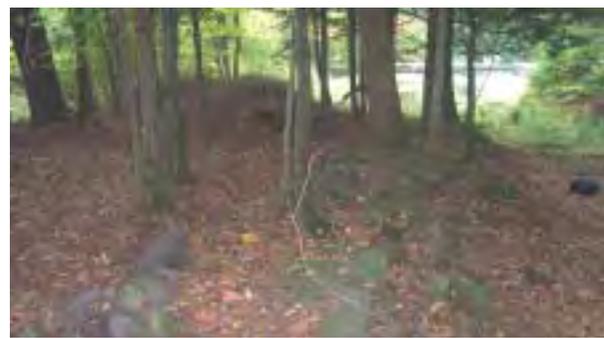
Stream assessment survey in 2001 documented one section of altered stream bank, approximately 295 feet, or 17% of MU15 by length, consisting of a linear mound of earth, or berm, along the stream bank forming an embankment for the small pond³ (Photo 5). This feature, while preventing the pond from stream inundation and damage, contributes to the

Photo 5. 295-foot earthen/cobble berm on the right stream bank, forming an embankment for the small pond. Pond is visible in the background to the right, stream is out of the frame to the left.

entrenched stream channel shape in this reach, though the actual impact to stream stability was not determined. Both stream banks are eroding in this reach (monitoring discussed below⁴), including fill material comprising the berm (Photo 6).

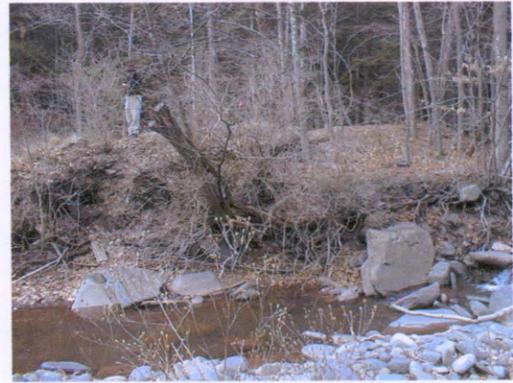
Photo 6. Right bank berm protecting the pond, showing ongoing erosion, protected to some extent by shrubs and other riparian vegetation. Stream flow in side channel is from right to left.

Structural revegetation⁷, or *bioengineering*, should be considered in conjunction with a full-scale restoration of stream channel morphology in this reach, to reduce ongoing erosion pressure on the valley wall hillslope and berm area next to the pond. Additionally, the hillslope failure should be assessed to determine the extent of *geotechnical* failure mechanisms, as well as to advise the appropriate solution for this continued problem⁸.

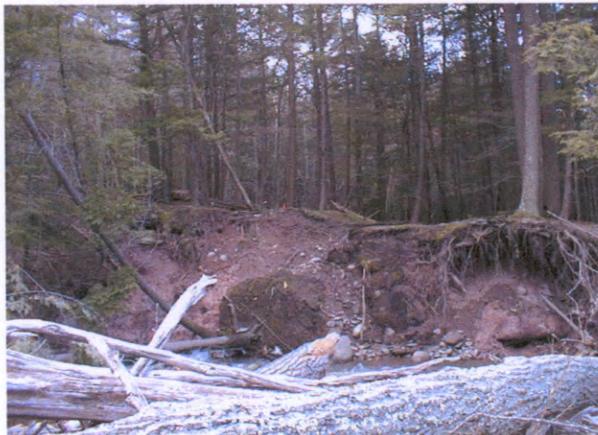
Photo 7. Eroding left bank clay hillside, at unstable reach in MU15, monitoring cross-section 5. Stream flow is from left to right.

This clay comprises the entire hillside, similar to the eroding banks at the bottom of MU8 and the middle of MU5, over which the riparian forest is sliding and slumping into the stream in large sections, despite the presence of large healthy trees (Photo 8, and see Photo 7). A representative location was chosen and permanently marked with metal rebar, or

monumented, for future monitoring (designated as “monitoring cross-section 5”) to determine erosion rates and priority for potential restoration (see Photo 7, orange flagging at the top of the bank above the large fallen tree marks cross-section location)^{3&8}. This site has been assessed and ranked based on calculation of a *Bank*

Erodibility Hazard Index (BEHI) using data collected at the time of the stream assessment survey in 2001⁴. This bank received a BEHI rank of “high” potential for further erosion, with the greatest threat from this bank to water quality from the clay (see discussion below). No structures or other development are currently directly threatened by erosion at this site.

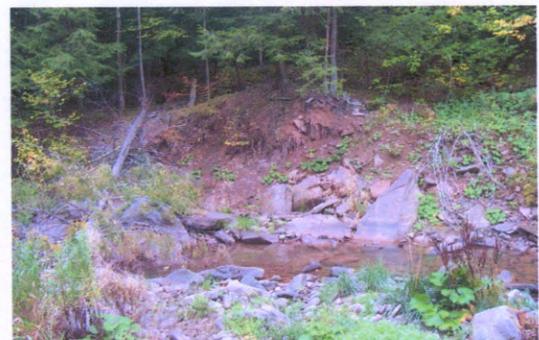
Photo 8. Upstream section of eroding left bank clay hillside, upstream from location shown in Photo 7. Stream flow is from left to right.

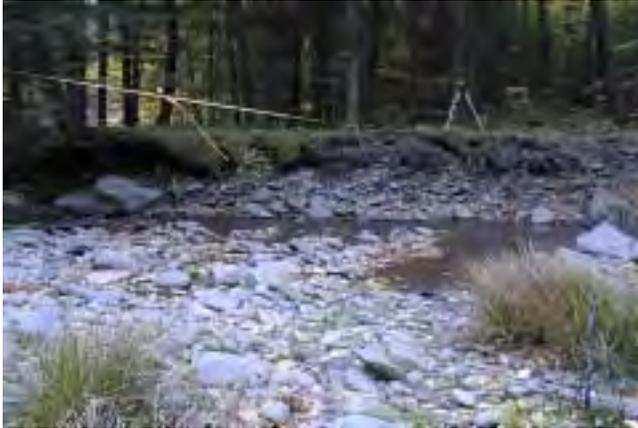
Photo 9. Eroding right bank, at forested riparian terrace, monitoring cross-section 6. Stream flow is from right to left.

The eroding right bank in the upstream half of MU15 (Photo 9) is quite different in character from the downstream eroding clay hillside (see Photos 7 and 8). This bank, monumented and designated “monitoring cross-section 6”, comprises an eroding section of terrace, approximately six feet from top of bank to the toe, or base of the bank, in the stream channel. The top soil layer is held together by fairly dense riparian forest trees, though roots do not penetrate deeply enough to hold the entire bank in place. This bank

received a BEHI rank of “moderate” potential for further erosion, though the concentration of stream energy against this bank due to the shape of the stream channel increases this potential⁴. No structures or other development are currently directly threatened by erosion at this site.

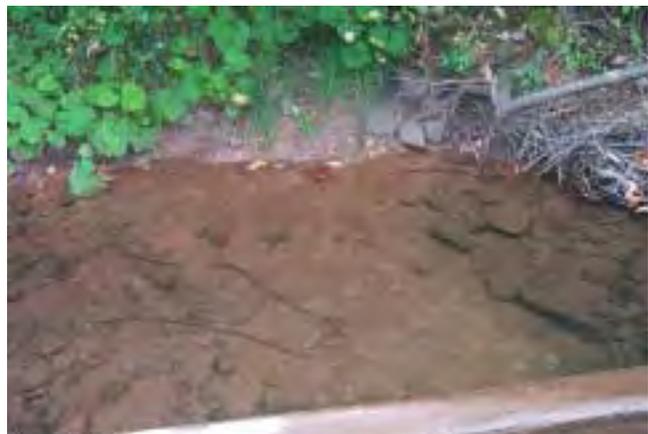
In addition to exposed clay along the left bank at monitoring cross-section 5, where the stream runs directly against the valley wall (see Photos 7 and 8), an additional 65 feet (4%) of exposed clay was documented on the left bank and stream bed just upstream⁴ (Photo 10). Approximately a quarter of the stream bank length in MU15 contains exposed fine sediments (*silt* and *clay*) in the banks and bed that may cause increased *turbidity*, especially during high flows.

Photo 10. Glacial lake clay exposure, in the stream bed along the right bank, just upstream of the eroding right bank clay hillside at monitoring cross-section 5. Stream flow is from left to right.

Due to the inherent instability of the valley wall hillslope along the left bank in the lower half of MU15, the extent of the clay exposure and the generally poor stabilization ability of riparian vegetation due to the thin soils, the potential for large inputs of silts and clays into the stream during floods will continue to be a problem unless the reach is restored.

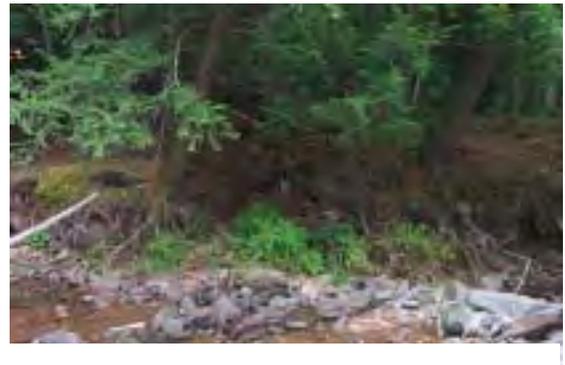
Photo 11. Ephemeral (runs only following storms) tributary, entering the main stream on the left bank between stream bed clay exposure and eroding left bank clay hillside at monitoring cross section 5. Stream flow in the main channel is from left to right.

One small, ephemeral (only runs after storms) side stream, or tributary, feeds into MU15 from the left, between the bed clay exposure and the eroding hillside at monitoring cross-section 5 (Photo 11). *Confluence* areas (where two streams join) tend to be unstable by nature's design, as the smaller stream delivers pulses of flood waters and sediment to the main stream. This confluence appears to be relatively stable, though could exacerbate suspension of clays from the stream bed during floods. No specific management of this tributary is recommended at this time.
