## **Chestnut Creek Stream Management Project Sites Detailed Descriptions**

In November 2002, SCSWCD put together a list and description of potential project sites noted during the 2001 Stream Assessment Survey. The Chestnut Creek Project Advisory Committee (PAC) was asked to vote on these sites to determine a Demonstration Restoration Site for the Stream Management Plan 2003. The following information was sent to the PAC and a meeting held to vote on the project site:

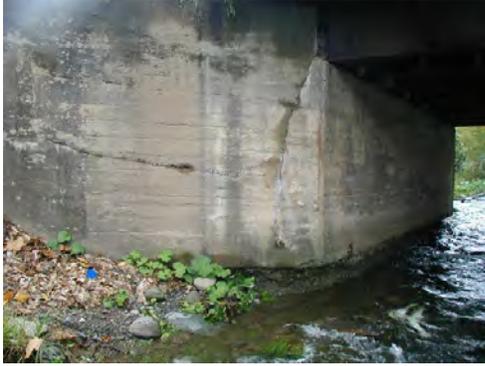
Crack in downstream right wing wall of Covered Bridge

Built as 1976 bicentennial, historically significant, provides access to Fair Grounds, Scour and erosion along bridge abutment and wingwall (14" undercut)—is this a threat? 1929 map-channel straightened (uncertain when), “cleaned”, moved away from road Upstream trees falling into stream as channel migrates, providing material to constriction flow 1963 aerial photograph shows more sinuous channel than currently 1991 Neversink Agricultural Society gained a permit to repair failed abutment NYSDOT conducts Biennial bridge inspection and Scour report, 2001 bridge failed scour report Runoff from parking lot scouring behind wooden wingwall

Complete historical aerial overlay to assess erosion rate and direction, as well as changes in plan form geometry at Covered Bridge, upstream to riprap near tennis courts.  
Begin assessment of the bridge and upstream area to determine changes in meander patterns  
Potential for “assisted” restoration  
Review of existing reports and designs as provided by Town  
A W-weir structure could redirect the stream and protect the bridge from future repairs as well as reduce gravel build-up

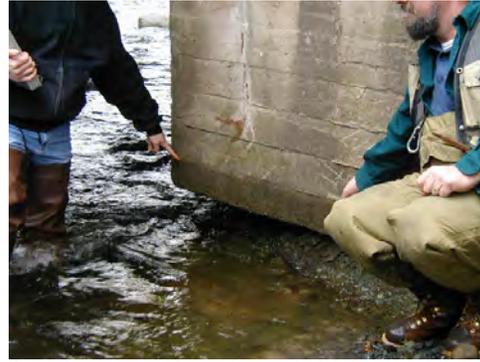
Crack in upstream right wing wall of Covered Bridge and 14 inch undercut

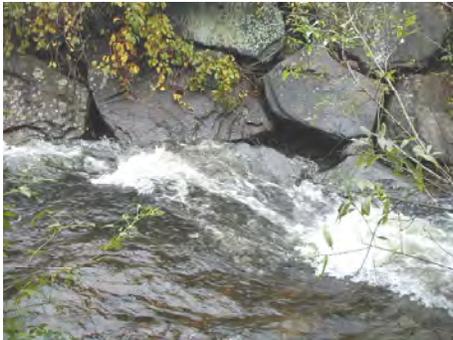
Split channel with riprap on right bank being undermined upstream of covered bridge, within 20' of Route 55

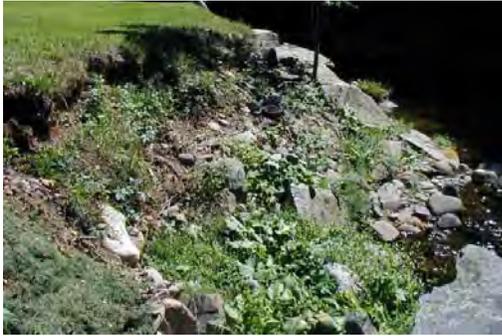
Dislodged riprap behind Town Hall

Riprap dislodged – may loose some bank along parking lot

Potential assisted restoration project (possible cross vane to reduce bank erosion, provide scour pool for dry hydrant.) This could stabilize the bank and make a dry hydrant viable.

Add bioengineering to increase riparian buffer and anchor existing or replaced riprap

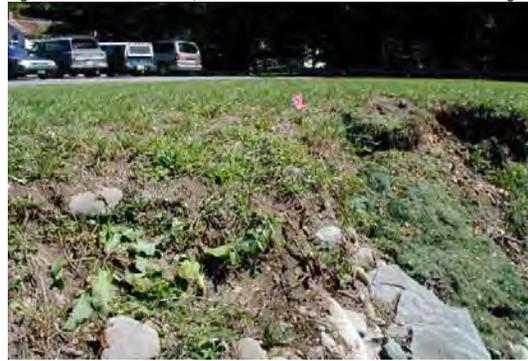
Eroded left bank and lack of vegetation behind Town Hall

Minor erosion along left bank near Town Hall Parking

Lack of vegetation and parking area “sheeting action” of rain runoff may affect water temperatures and bank stability

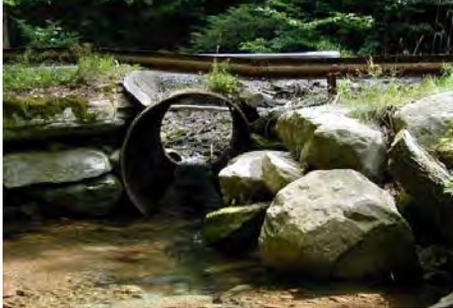
Looking upstream at culvert under Pepacton Hollow Rd.

Culvert has not been upgraded

Logs jam the upstream culvert invert (*Continued next page*)

Replace culvert with properly sized and angled culvert to fit the bankfull stage height and direction of stream flow. This could avert future rebuilding and maintenance after every high flow event

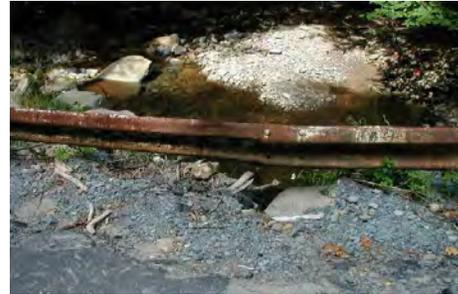
Erosion under guardrail above outlet end of culvert (2001)

Potential for floods that continue to damage the roadway and cause stream channel erosion

Flood water has crested the road and has caused substantial damage on several occasions—most recently in 1997 and 2000

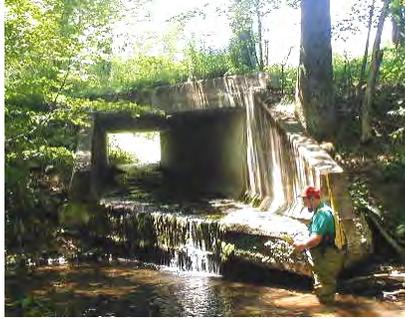
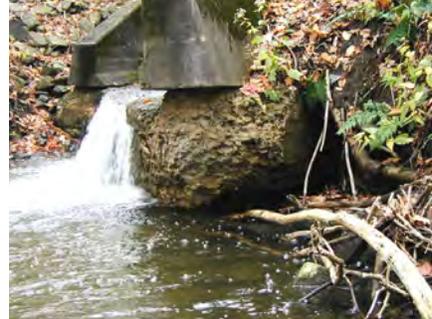
Undercut box culvert and scour pool under Rte 42, on tributary of Red Brook

Downstream end of undercut culvert with deep scour pool

Potentially limiting fish passage

Small areas of back eddy scour downstream

Possible threat to Route 42

Set up permanent BEHI monitoring station at culvert outlet to determine rate of scour

Monitor cracking in Route 42 pavement over culvert

Determine bankfull width above and below structure to see if the width is adequate

Determine natural slope of stream without structure present and the change caused by the hanging culvert

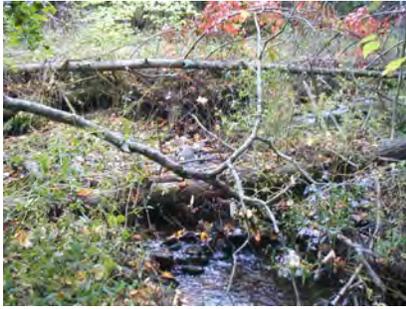
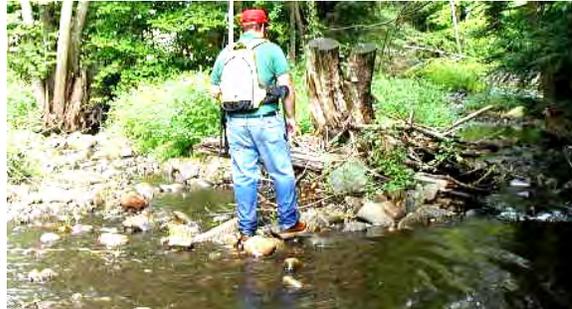
Head cutting erosion, center island, debris jam near back lot of Grey's Lumber

Located on Chestnut Creek Along Rt. 55, near Grey's Woodworking  
Severe debris jam in channel, split channel around central gravel bar  
Evidence of head-cut working upstream through left channel  
Flooding issue with upstream landowner, landowner believes area has aggraded

Begin monitoring the site  
Potential removal of blockage and regrading the slope.

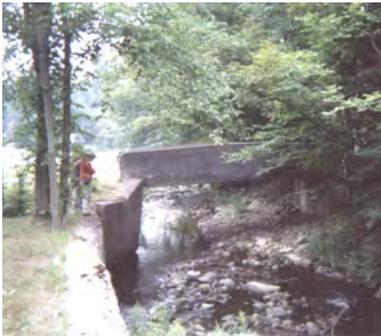
Concrete crib wall along Rte. 55 attached to failing abutment

The left bridge abutment is partially undercut and leaning toward the stream channel,  
The upstream wing wall is showing signs of erosion  
This abutment is directly attached to a concrete wall that lines the left bank near Rte 55  
Local NYS DOT is concerned that a bridge failure will affect the highway  
There is only one house accessed by this bridge

An inspection of the structure by the bridge engineer  
to determine its safety and anticipated design life.  
Possible replacement of structure designed and  
built to accommodate the stream flow and protect the road.

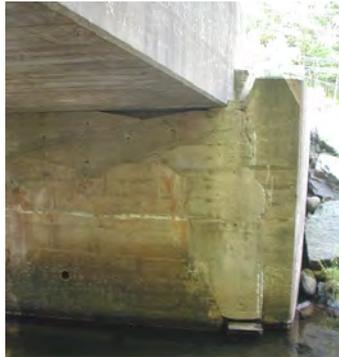
View looking upstream at Miller's Bridge

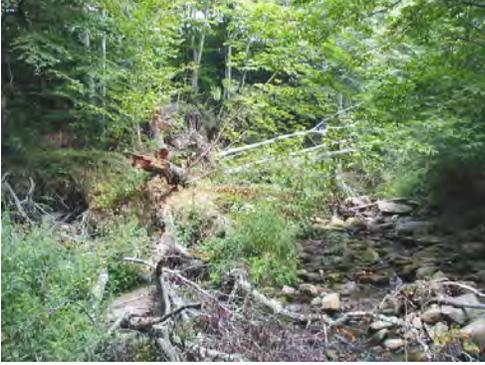
Scott Brook failing bank with fallen trees at Chestnut confluence

Located on Scott Brook at the confluence with Chestnut Creek  
Severely eroded high bank with undercut fallen trees  
Potentially large sediment supply available  
On private property – no roads or structures threatened  
SCSWCD has monumented cross section to monitor bank erosion rate

Determine rate of erosion from cross section monitoring  
Determine if bioengineering can stabilize bank  
Determine cause of erosion

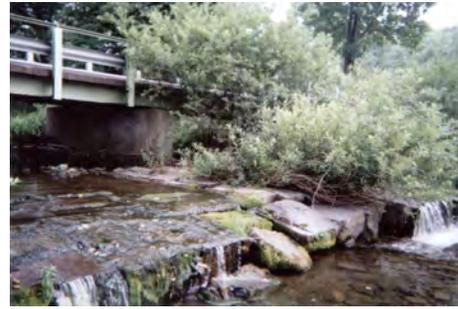
Looking upstream at eroded sewer line structure below Davis Lane Bridge

A stone structure, over a DEP sewer line, is scouring the stream bed downstream (+/-5' drop)

Is this a barrier to fish passage?

Sewer line should be reconstructed the proper under the streambed to be in accordance with current standards

Any stream channel work through this area would be best applied during future efforts to repair the bridge structure

A W-weir could be used to aid in directing stream flow properly through the double chambered bridge during high flow events

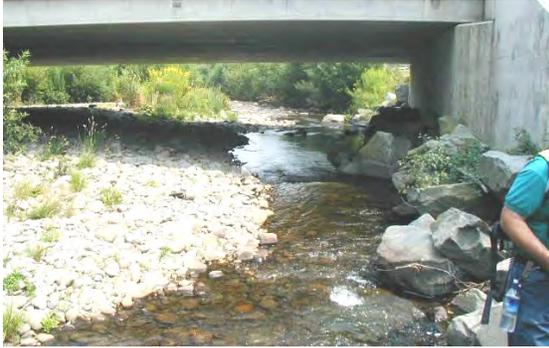
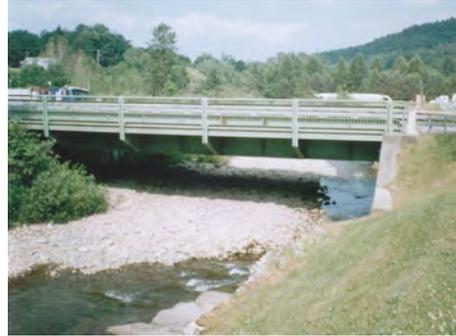
Route 42 bridge Grahamsville, overwidened channel with cobble filling in (right bank) / bridge abutment in main flow of water (left bank).

Stream thalweg now located along abutment

No current sign of scour or erosion

Recommend monitoring (use as-built survey to determine aggradation rate)

Model bridge opening with gravel bar for flood risk/damage when maintenance is needed.

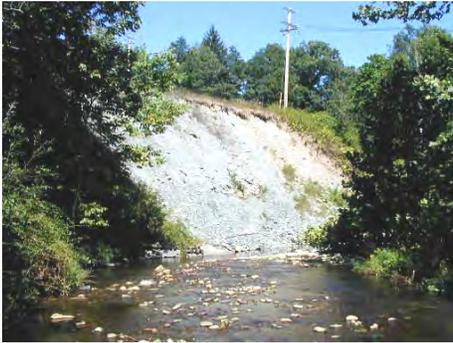
Looking downstream at high eroding bank DEP property

- Located on Chestnut Creek along Route 55
- High bank constructed from tunnel spoils
- Stream causing erosion along several hundred feet portion (+40' in height)
- Highway along the top of the bank is threatened
- Potential source of turbidity/ sediment loading
- Well-established adjacent floodplain
- Appears stable upstream and downstream

- Historical aerial overlay to assess erosion rate and direction, as well as changes in plan form geometry
- SCSWCD has 2 monumented cross sections in place to monitor erosion rate

- Move meander to historic location, with installation of natural design structures etc.
- Construct a Bankfull bench and use geomorphically-based rock structures to assist channel realignment
- Vegetate high bank; stop mowing to edge of fence

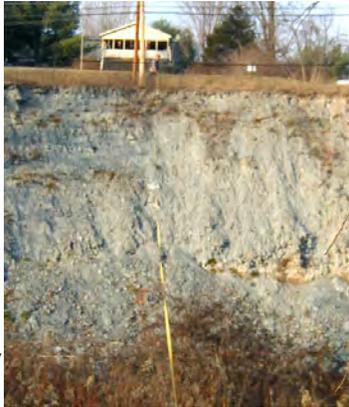
Looking at eroding bank with BEHI XS

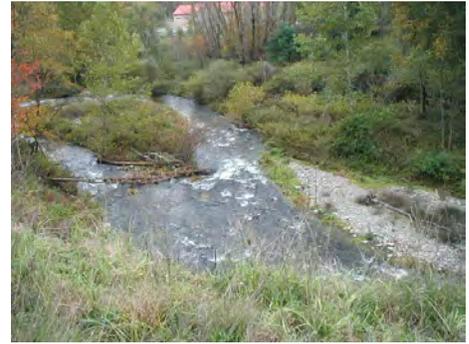
View from Route 55 top of RB looking Downstream
