A. Chestnut Creek Management Unit 1

1. Summary Description

Restoration and Management Recommendations Management Unit 1

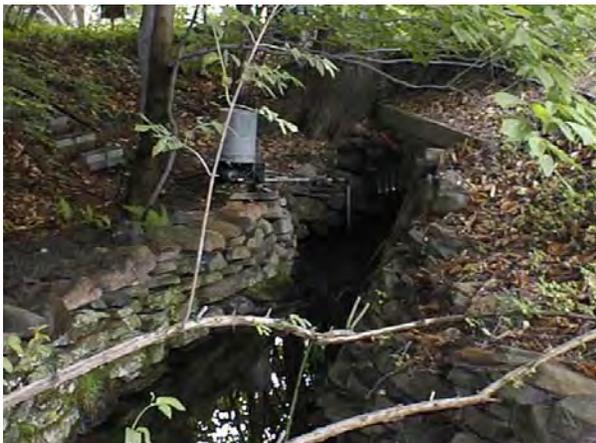
Photo 1. View looking upstream toward culvert under Mutton Hill Road. Laid-up stone walls on both banks, small pump on right bank.

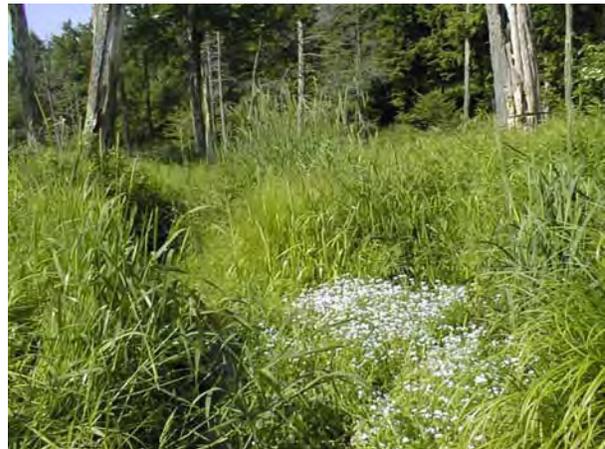
Photo 2. Looking upstream from MU2, trees and grassy flood-plain typical of this type of channel.

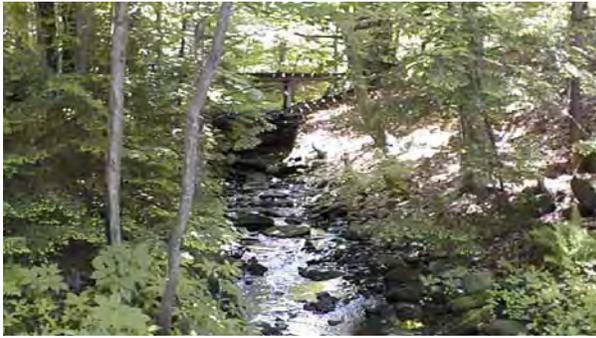
Photo 3. View looking upstream toward private foot bridge and waterfall from below XS-5. As seen here, riparian, or stream side vegetation plays an important role in the health of the stream and aquatic ecosystem.

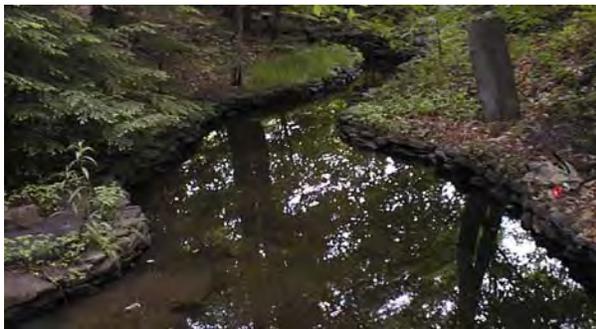
The landowner carefully maintains the upstream section of MU1, primarily with hand-worked stone on one or both banks throughout most of this section (Photo 10).

Photo 10. View looking upstream from private foot bridge. Both banks are laid-up walls.

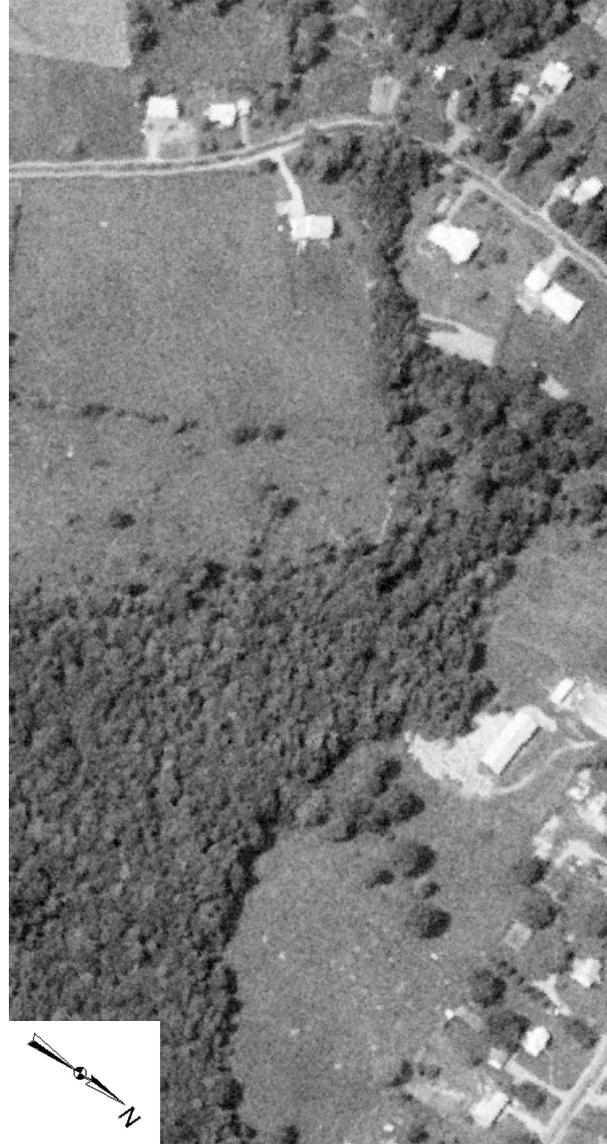
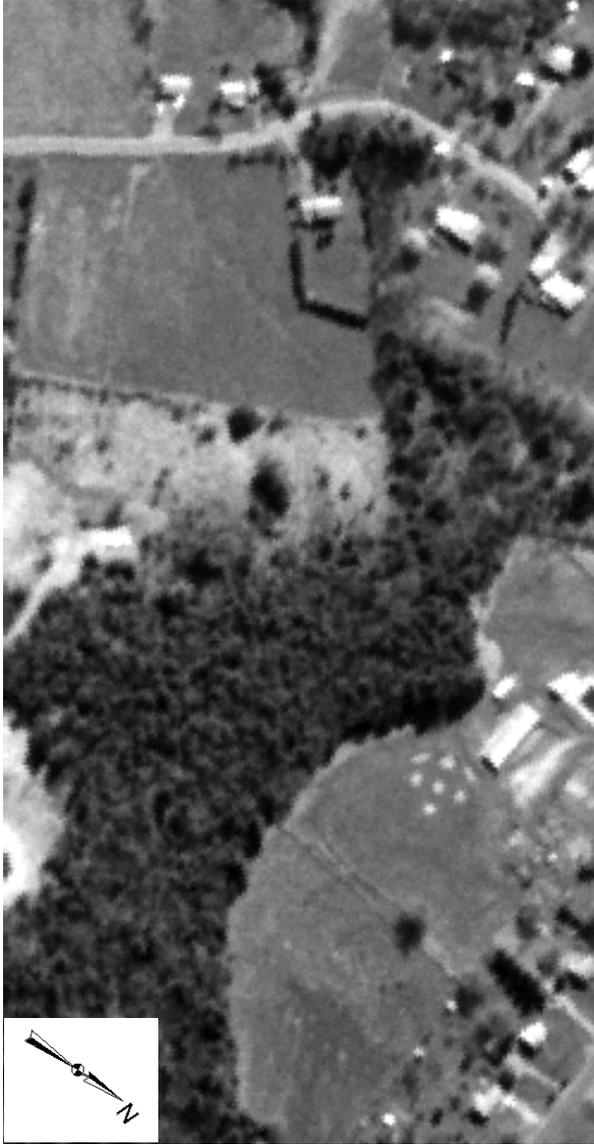
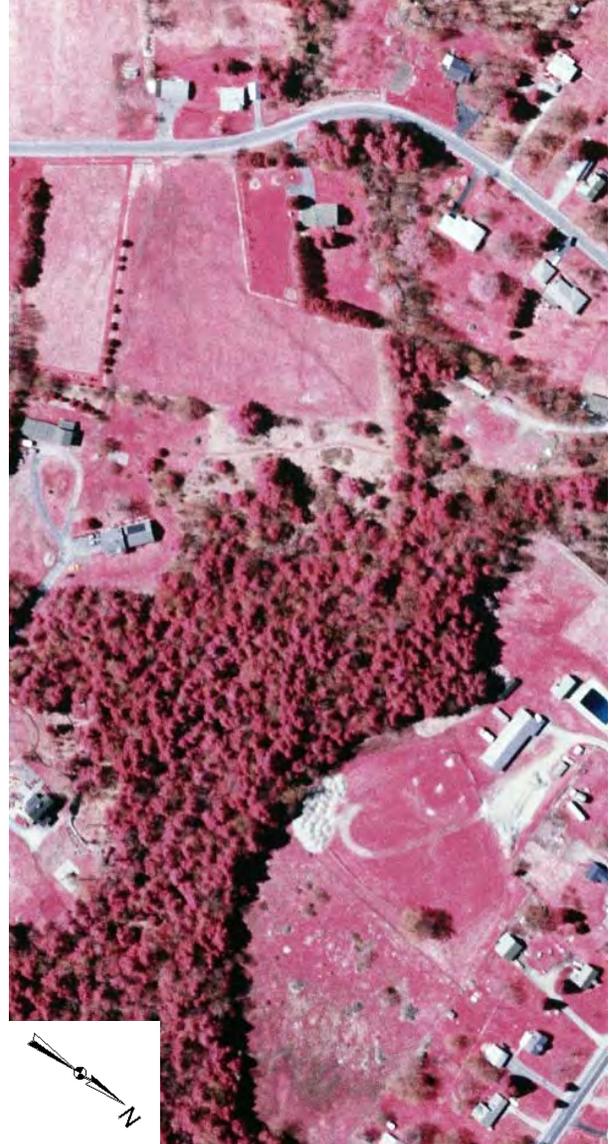
An analysis of a series of historic aerial photographs covering the period 1974-2001 indicates that routine channel maintenance has not been widespread through MU1, except in the immediate vicinity of Route 55, Mutton Hill and Meyers roads (Aerial Photos 4, 5, 6, 7, 8, & 9). The stream crosses through culverts under two roads and runs along a private road behind the Crystal Falls Farm quarry.

The effects of the channel maintenance and natural adjustments are most evident between the 1974 and 2001 aerial photographs. Apparent from the imagery is slight alignment changes near the culvert at Myers Road and some shifting of the channel south away from the road constructed to serve the Crystal Falls Farm quarry just upstream from the large meander bend near the bottom of the unit. This change has been gradual judging by the aerial photo series, associated with increased usage of land and road in the quarry area. The smaller channel area near the top of MU1 can only be seen as the line of riparian trees, apparent in each of the four photos, and appears not to have changed appreciably in the last 30 years.

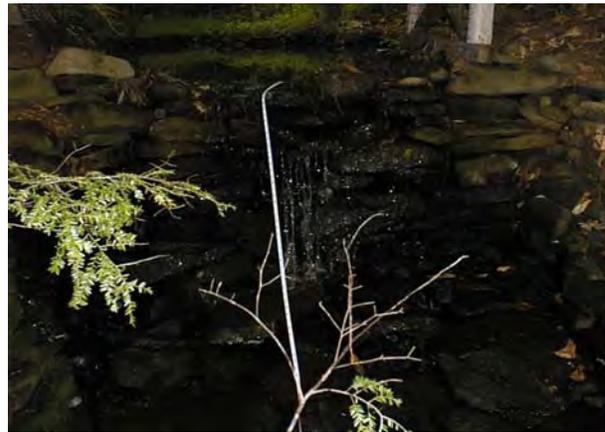
Much of the stonework is maintained with special attention to preserving riparian trees, adding to the stability of MU1, particularly in especially narrow sections near the top and in the vicinity of a private bridge crossing with a high, built step (Photo 11). These channel modifications have resulted in a somewhat confined channel with a low width/depth ratio (from 8 to 20 feet), but with very low *entrenchment* despite the steep slope (from 2% to nearly 8% slope in some sections) (Introduction to Stream Processes and Ecology, Volume I, Section III).

Photo 11. View looking upstream toward small step/pool waterfall below private bridge.

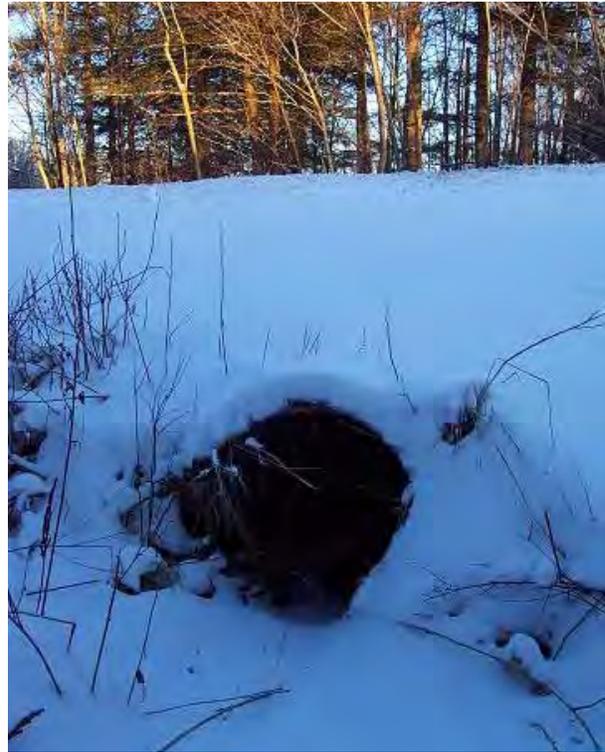
Maintenance of public infrastructure is always a concern for local municipalities. The Chestnut Creek crosses under Mutton Hill and Myers Roads in MU1 and is conveyed by use of culverts (Photos 13 & 14).

Photo 13. Tributary through culvert, Mutton Hill Rd.

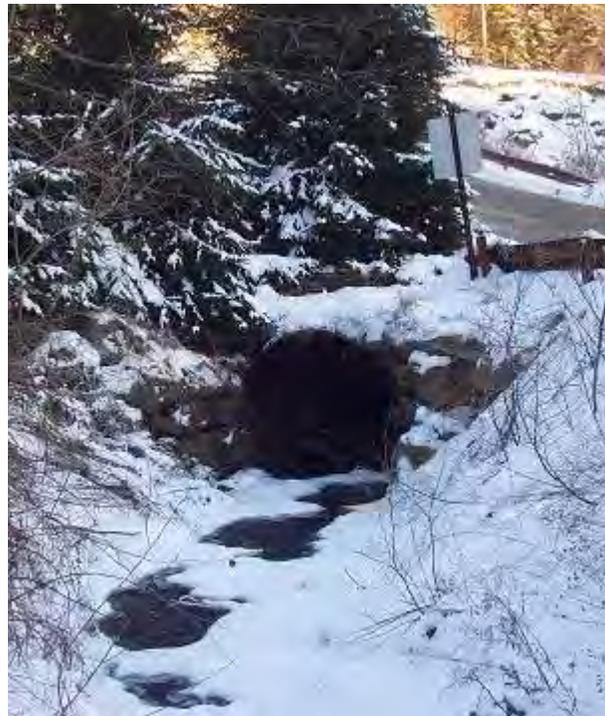
Photo 14. Tributary through culvert under Meyers Rd.

2. Evaluate the potential for reconstructing the channel and/or augmenting riparian vegetation along the historically active reach below the culvert at Myers Road. Evaluate the culvert at road crossing to determine the best method for reducing scour and improving sediment transport and conveyance of bankfull and flood flows, if this is determined to add to channel instability in this area. Install flow diverting structures (e.g., rock vanes, J-Hook vanes, etc.) at key points along the channel to reduce stress in the near bank region.

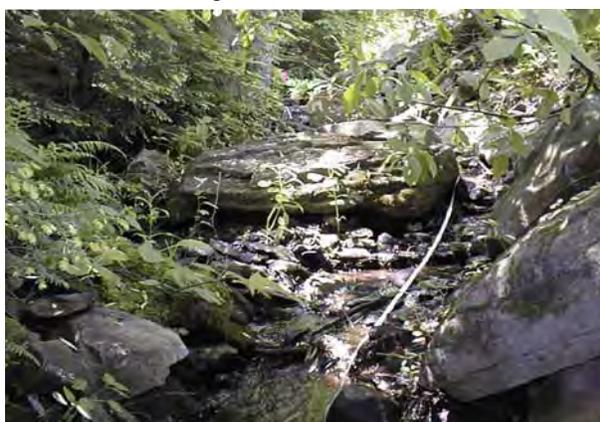
During the 2001 Stream Corridor Survey, MU1 was divided into 9 *reaches* on the basis of the Level II – Morphologic Description (Rosgen, 1996). The largest portion (47%) of this unit includes moderately entrenched channel types B and Ba (MU1 Stream Type & Cross Sections location map, Figure 2). With a low width to depth ratio (i.e., 11 – 16) and mature vegetation on the banks these types of channels tend to be very *stable* and are generally effective at moving *sediment* transported from upstream reaches. Although mature trees and shrubs provide lateral control along much of the management unit, channel maintenance activities in the upstream portion have left all of the reaches in this unit with moderate to low width to depth ratios making them more efficient at moving sediment (Photo 15), though not necessarily prone to severe *downcutting*, especially in reaches with coarser sediment in the lower reaches of the upstream section (Photo 16).

Photo 16. View looking upstream toward XS-9 and large boulder in stream bed.
