## B. Chestnut Creek Management Unit 2

### 1. Summary Description

## Chestnut Creek Stream Management Plan

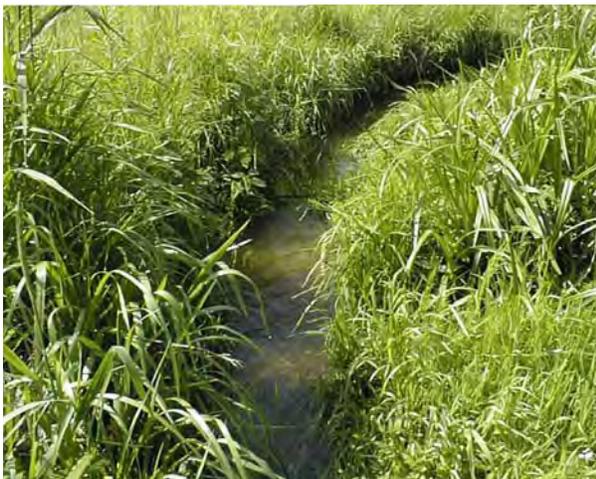
MU2 begins at the transition of the *corridor* from a forested wetland setting to a grass dominated meadow (Photo 1). The *channel* is narrower, less steep, and has a

Photo 1. View looking upstream toward XS-17.

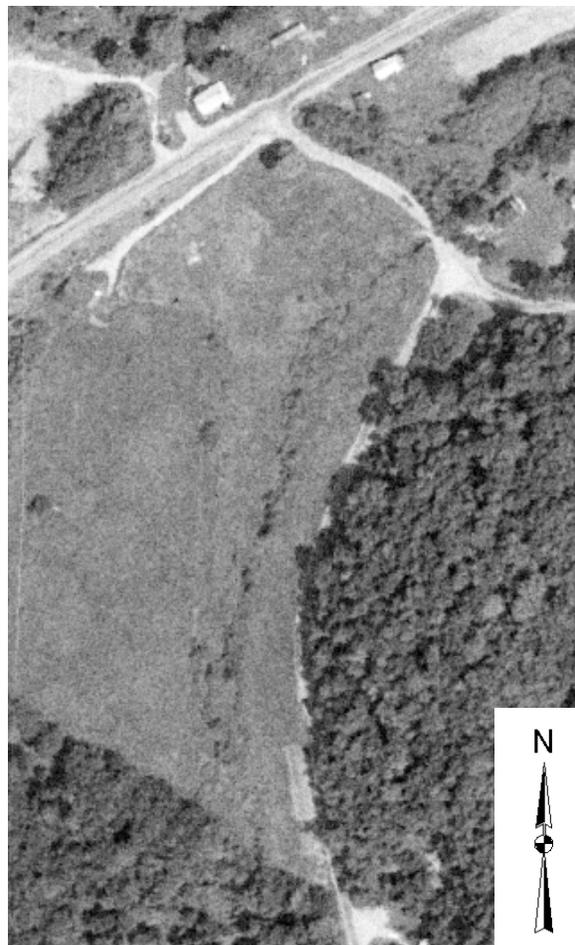
photographs covering the period 1974-2001 documents the stability of the reach and consistent land use. The area has remained grassland meadow with dense vegetation and minimal change in land use and riparian structure in the 30-year record. There was considerable evidence of channel lateral adjustment through the series, but deemed consistent with the stream types present. (Aerial Photos 2, 3, & 4).

Photo 2. 1974 Aerial Photograph of Management Unit 2.

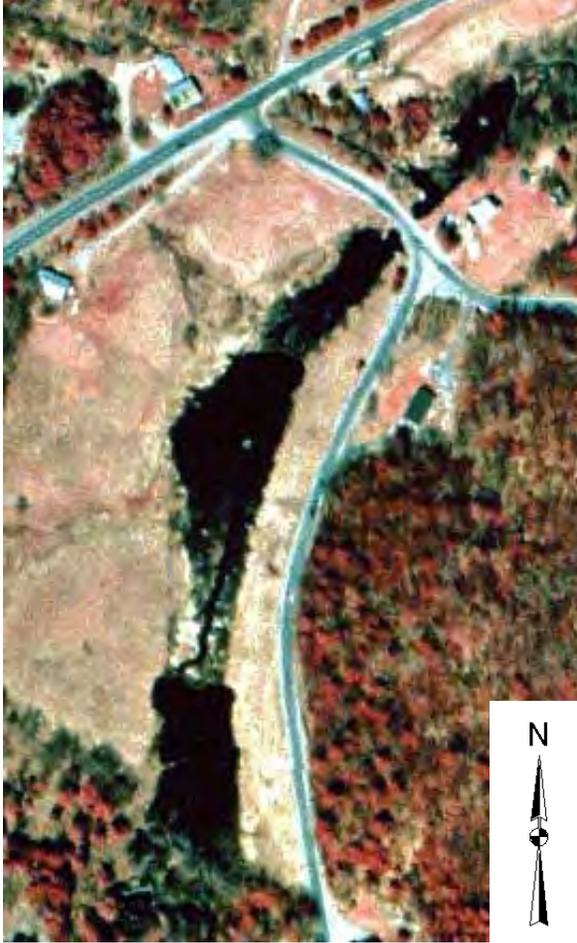
The 1995 aerial photo and the 2000 map backdrop show the area of Management Unit 2 inundated with water. Although the causes of the increased stage have not been investigated, it is presumably caused by a high flow event, a downstream channel or debris blockage, or beaver damming.

Photo 3. 1995 Aerial Photograph of Management Unit 2.

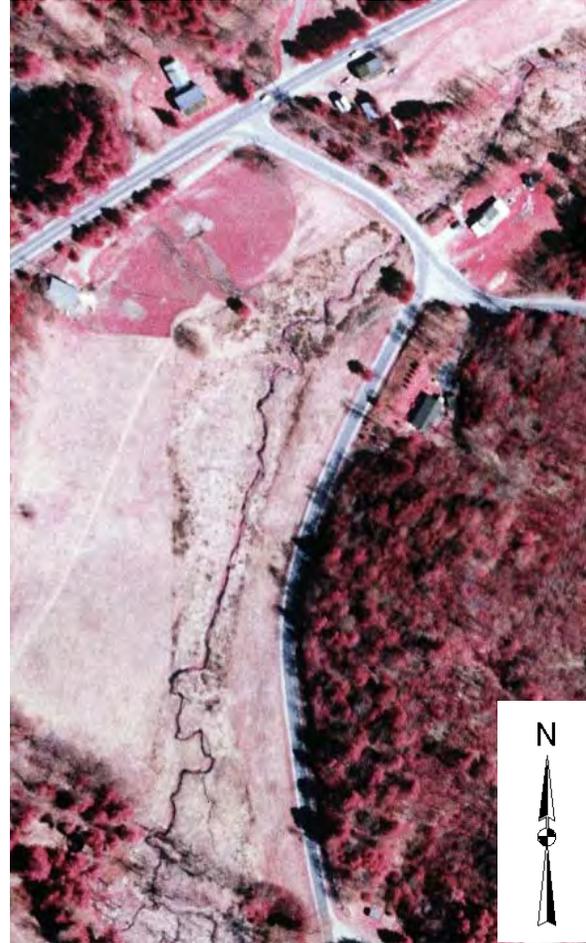
Photo 4. 2001 Aerial Photograph of Management Unit 2.

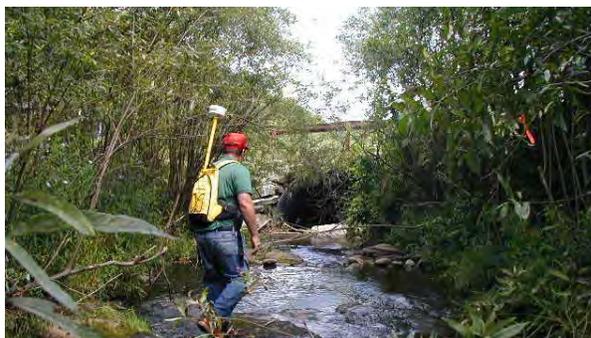
Maintenance and public infrastructure is generally a concern for local municipalities. The Chestnut Creek flows through one culvert under Benton Hollow Road in the lower portion of the unit (Photo 5). The construction of the road and culvert may affect the conveyance of

Photo 5. View looking upstream at culvert under Benton Hollow Road.

flows from the upstream drainage. As stated, the relative size (hydraulic opening) and elevation of the road base in relation to the floodplain, presents a management concern. Inspection of the culvert, in combination with assessments of upstream and downstream channel geometries or *planform*, determined that the width of the culvert opening is significantly less than the *bankfull* channel widths of surrounding reaches. This condition can generate a backwater effect above the culvert and potentially lead to sedimentation, accumulated channel debris and accelerated channel migration upstream of the structure and possibly affect the channel and properties downstream as well.

Management of the current culvert configuration should include field inspections of debris blockages at the culvert as well as evidence of upstream flood elevations after storm events. Scheduled replacement and future improvements should incorporate *geomorphic* considerations of stream shape and condition for both the upstream and downstream reaches. Design considerations should include the natural slope break of the valley surrounding the reach, potential for channel aggradation or degradation, and protection/enhancement of the current floodplain connection, as well as the size and placement of the structure.

4. Evaluate the existing culvert crossing for the ability to convey both bankfull and flood flow, as well as proper sediment transport. Additionally, any design modification should reduce scour and provide for fish passage.

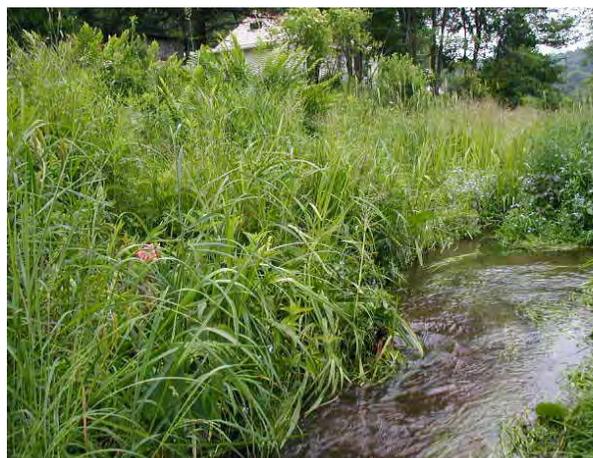
Photo 6. View looking upstream at XS-34.5.

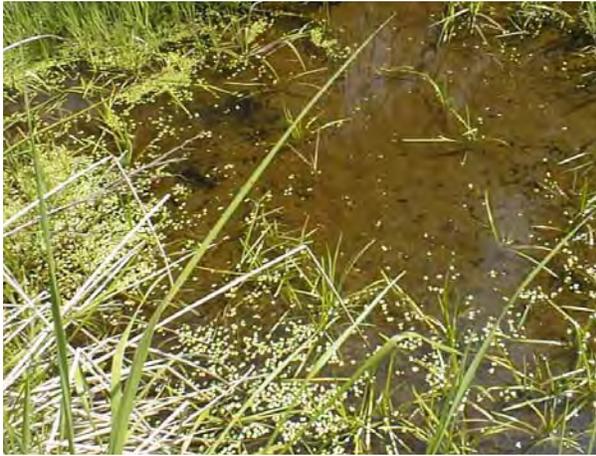
inputs into the system. Several small stable areas containing side channel ponding were noted through the reach providing additional habitat benefits (Photo 7) (Stream Processes and Ecology, Volume I, Section III).

Photo 7. View of pollywogs in side channel.

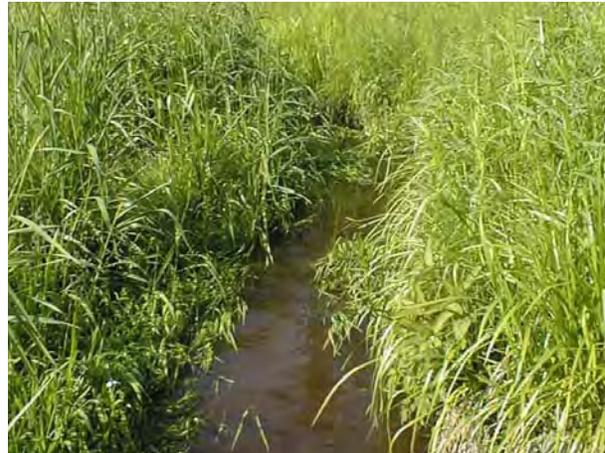
Photo 8. View looking upstream from bend downstream of XS-16.

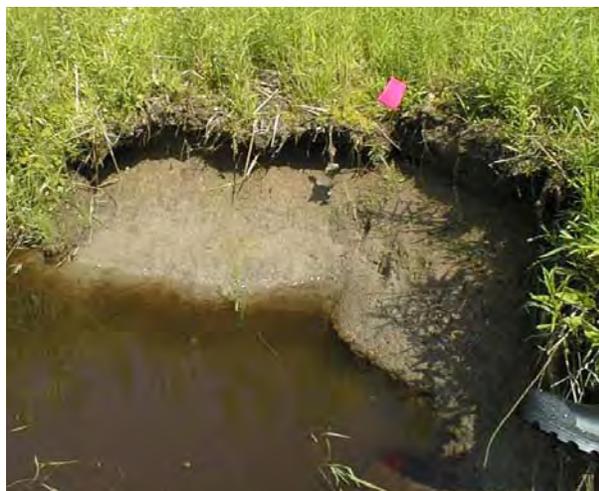
Preliminary observations indicate that the majority of the channel along this management unit is laterally stable (i.e., bank erosion rates are low). Mature grasses and shrubs provide lateral control along the majority of the management unit. There are two small sections of only a few linear feet cut low bank (Photo 9). The erosion appears local and within a natural

Photo 9. View looking upstream at XS-17 towards left bank at outside of meander bend, stream flow left to right.

range for this stream type and should require little or no intervention.

5. Perform stabilization techniques only where necessary using best management practices which promote and maintain a naturally functioning stream channel. Stabilization techniques should only include methods which assist in the natural recovery of the localized sections and which will benefit the reach.

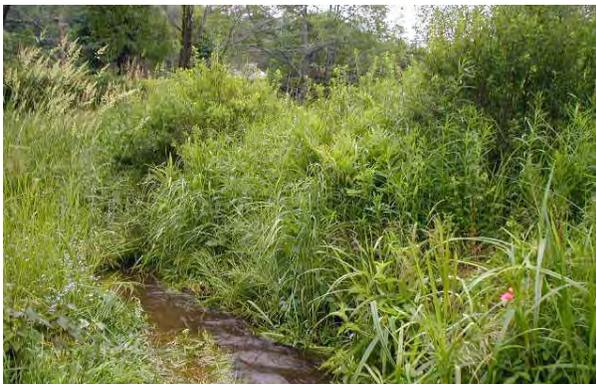
adverse impacts of human activities. Vegetated buffers facilitate stream stability and function by providing rooted structure to protect against bank erosion and flood damage. Streamside vegetation also reduces nutrient and sediment runoff, provides organic matter that can be used by aquatic life, while providing shade to dampen fluctuations in stream temperature (Photo 10).

Many of the species seen in this area are native, however reed canary grass, a highly competitive species, was noted. This

Photo 10. View looking downstream at XS-34.5.

species may crowd out native vegetation which have ecological as well as stabilizing benefits. Healthy diverse native plant communities appear to inhibit the growth of the invasive species. Management for the reach should include a more detailed inventory and assessment of the non-native species, and consider methods for eradication (Riparian Vegetation Issues in Stream Management, Volume I, Section IV.B.3, and Riparian Vegetation Management Recommendations, Volume II, Section II. A.1).

6. Continue to assess, inventory and identify invasive plant species within MU2 and consider methods of eradication to prevent future establishment and potential dispersal into downstream areas.

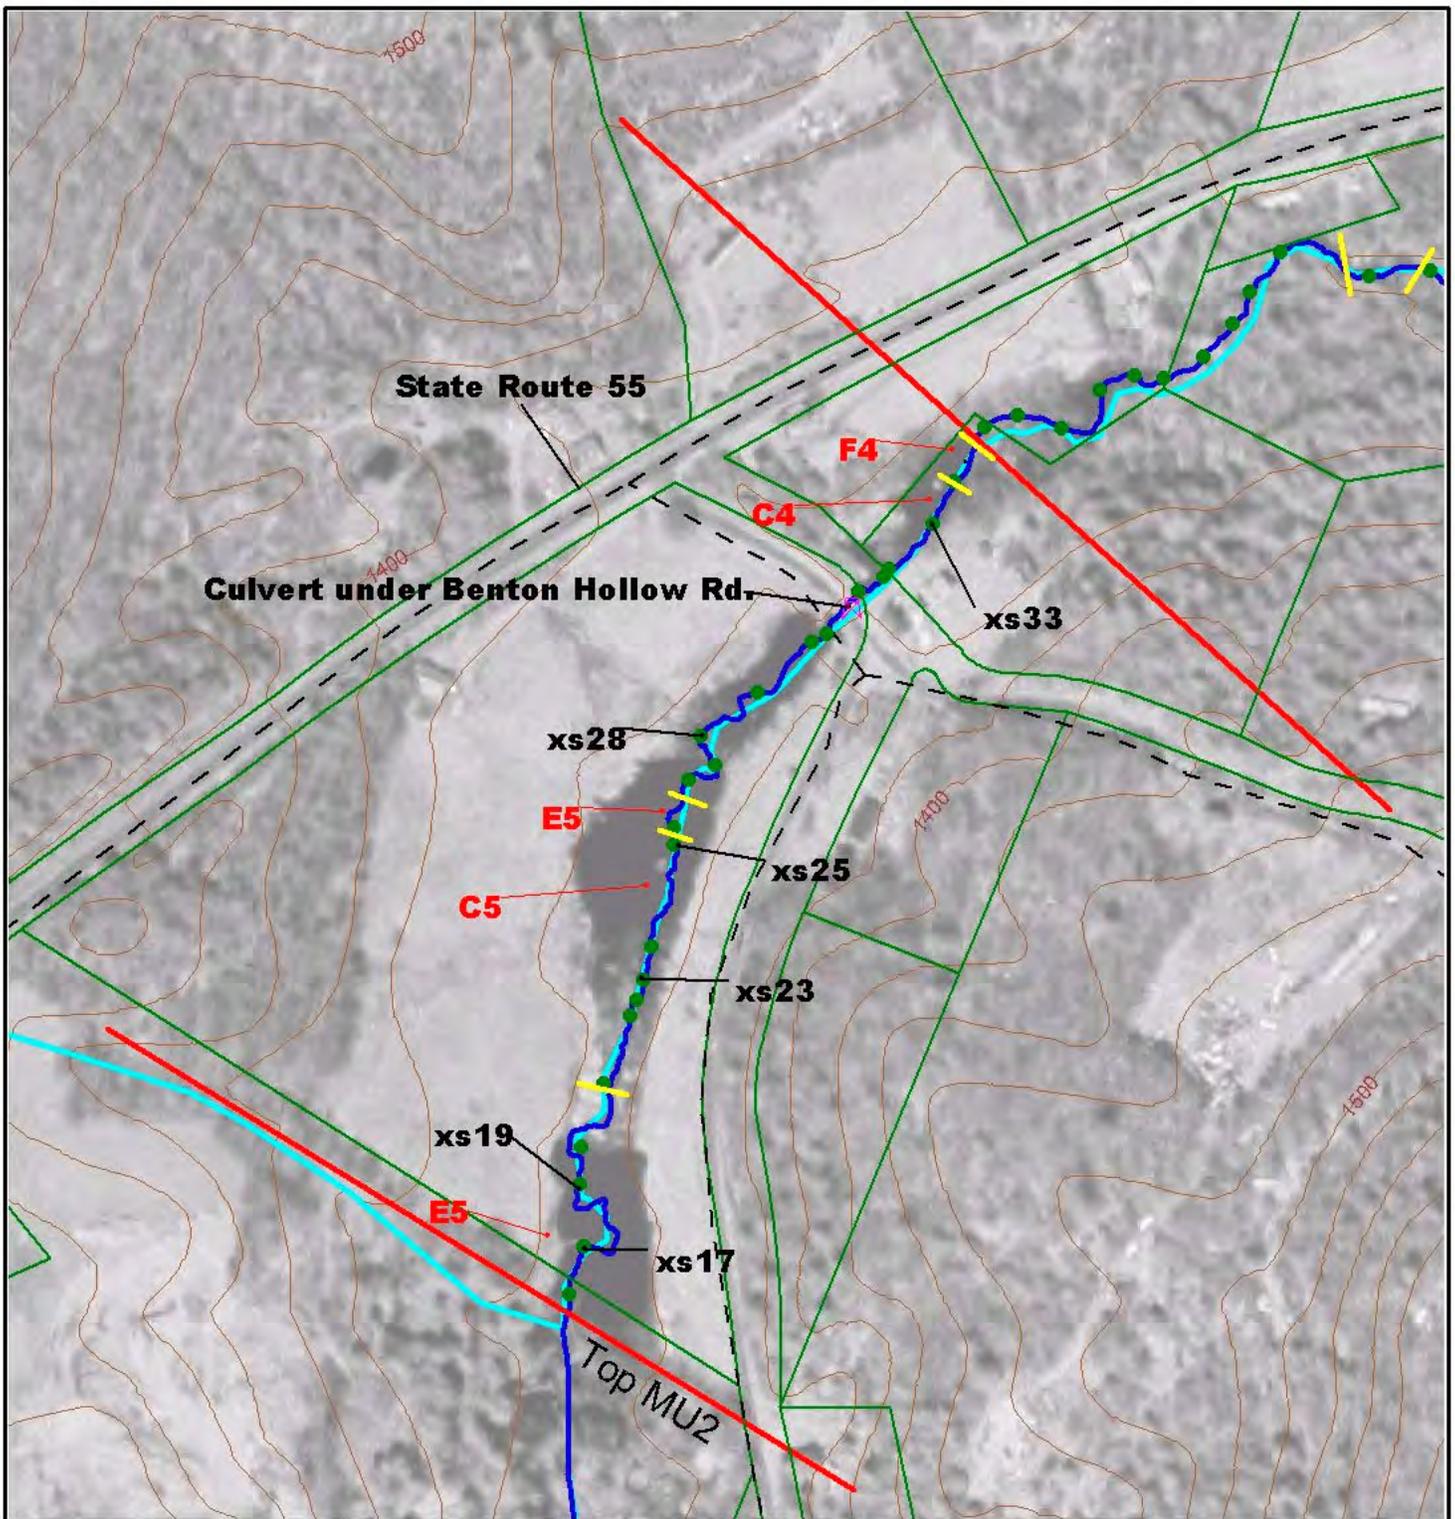
**Figure 2. Chestnut Creek MU2 Stream Types & Cross Sections**  
**Stream Assessment Survey 2001**

Highly *entrenched* reaches (i.e. F-types) account for 3.5% of the total length at the very bottom of the unit transitioning into MU3. Because they lack a floodplain area (i.e., an area adjacent to the channel where floodwaters can spread out and reduce the energy against the streambed and banks), entrenched reaches experience considerable stress during storm flow and tend to be more susceptible to stability problems, particularly bank erosion and bed scour or *degradation*. In addition, these types of channels route storm flow quickly to downstream reaches, further contributing to channel instability and flooding. A summary of morphological data collected through the unit is summarized in Table 1 and illustrated in Figure 2, Stream Type and Cross Section map.
