F. Chestnut Creek Management Unit 6

1. Summary Description

Chestnut Creek Stream Management Plan

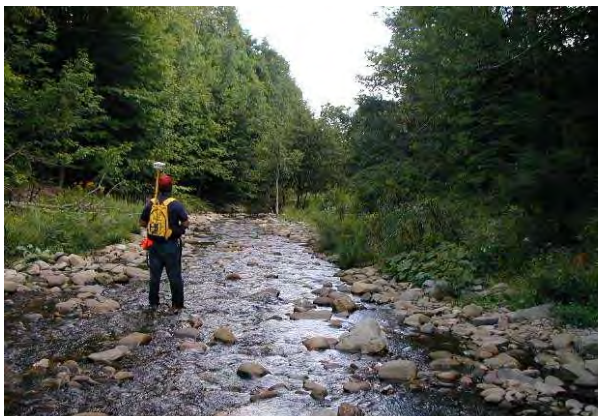
Photo 1. View looking downstream from cross section 136, Fairgrounds on right of photo, several hundred feet below Covered Bridge.

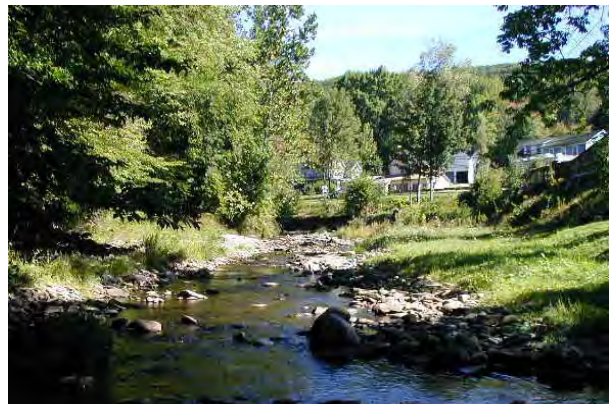
Photo 2. Looking upstream at cross section 151, half-way between Davis Lane and River Road bridges.

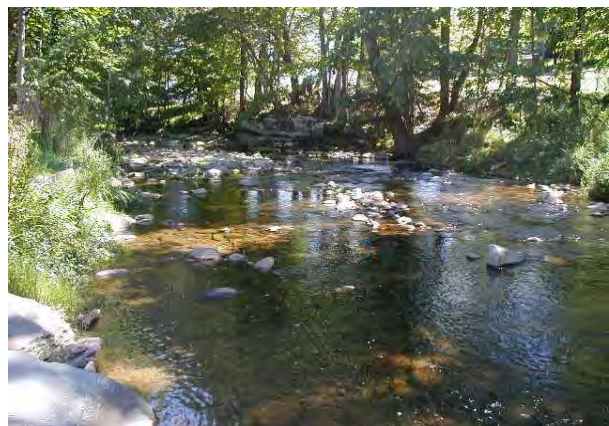
Photo 3. Reach-view looking downstream from left bank at cross section 161 behind fire house.

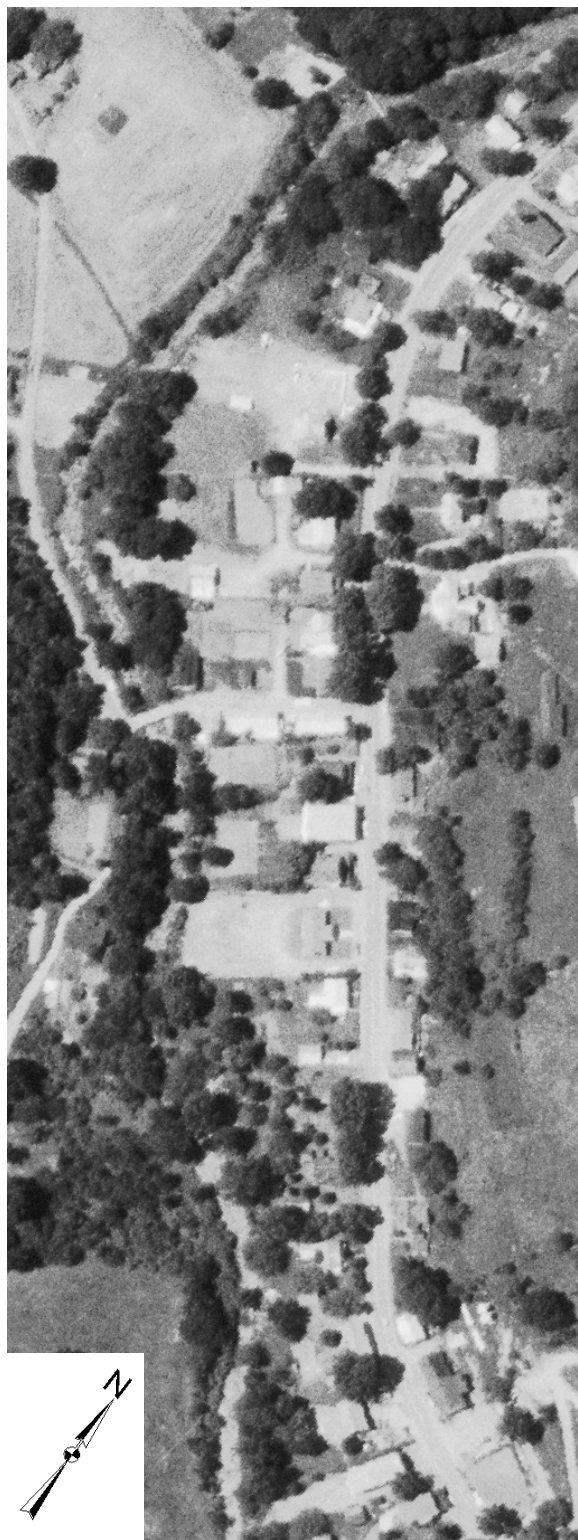
at some time in the past from information obtained from an historic 1929 DOT highway map. An analysis of a series of historic aerial photographs covering the period 1963-2001 verifies that any channel modifications occurred prior to 1963. The aerial photographic record also indicates that routine channel maintenance occurred until recently (Aerial Photos 4, 5 & 6).

Photo 4. 1963 Aerial Photograph of Management Unit 6.

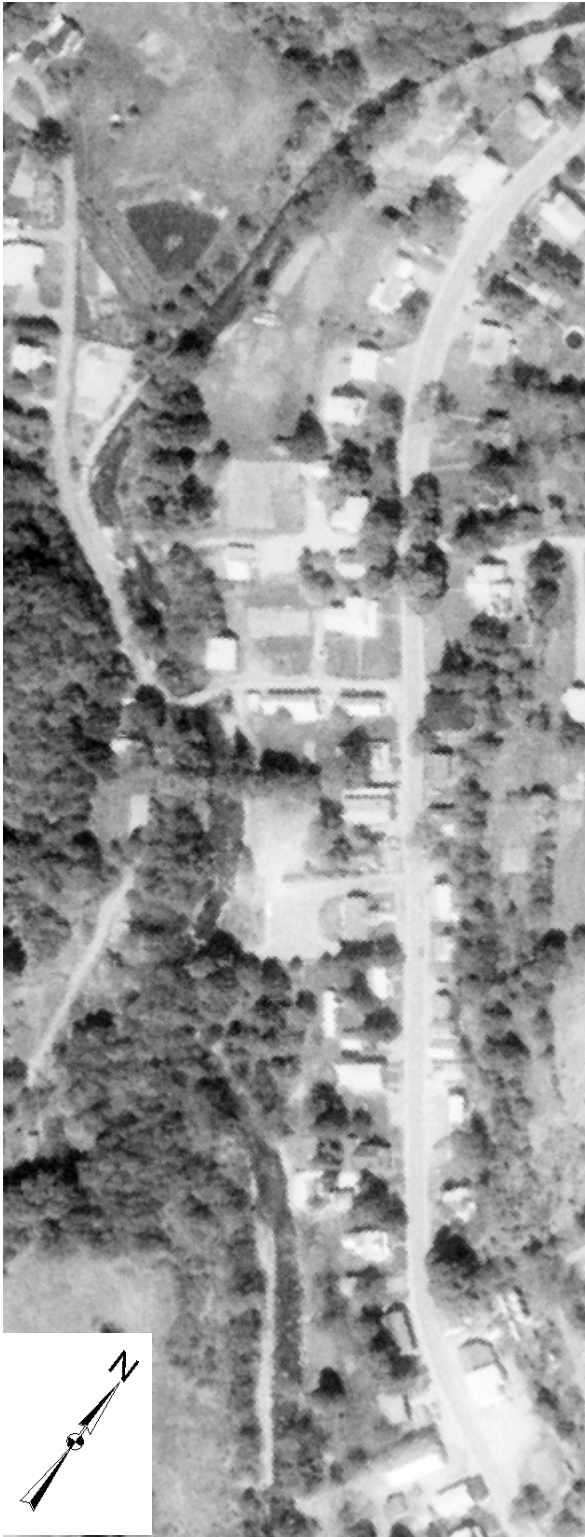
Photo 5. 1977 Aerial Photograph of Management Unit 6.

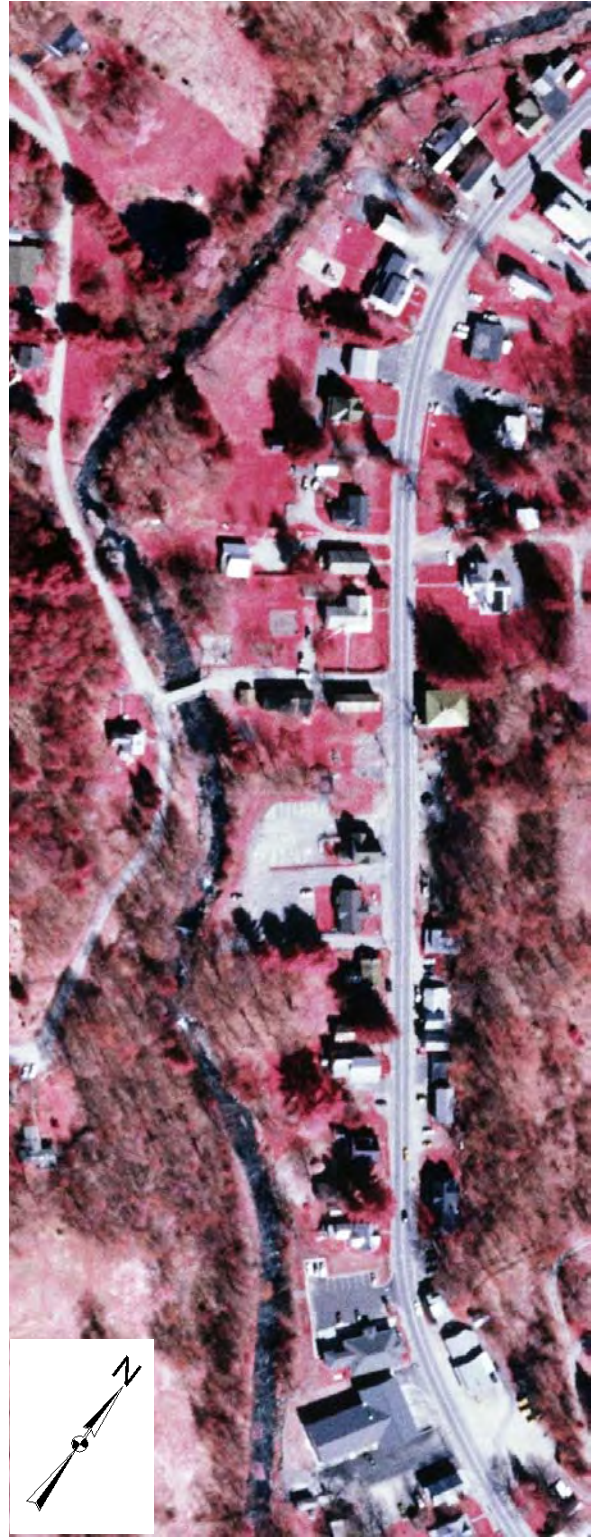
Photo 6. 2001 Aerial Photograph of Management Unit 6.

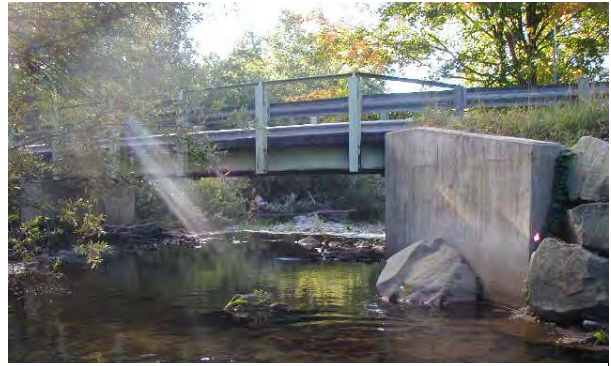
Photo 7. Looking downstream at right span of Davis Lane Bridge.

The Davis Lane Bridge was designed to convey the 25-year storm flow. The channel width in the vicinity of the bridge is 3 times wider than the *reaches* upstream and downstream. The high width to depth ratio of the channel and the presence of the bridge center pier has contributed to *aggradation* problems and large mid-channel bars have developed upstream and downstream of the bridge (Photo 10). These decrease stream effective width, enabling greater sediment transport capacity, reduced by over widening.

4. Reconstruct the channel in the vicinity of the Davis Lane Bridge by removing the mid-channel bars upstream and downstream of the bridge, narrowing the width to depth ratio, steeping the slope by reinstalling the sanitary sewer line downstream of the bridge under current construction specifications, and constructing a W-Weir to direct bankfull flows through one opening, while allowing flood flows to pass through both openings.

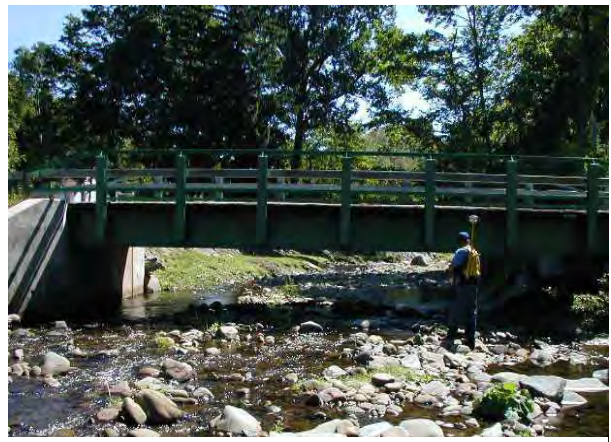
Photo 8. Looking downstream at River Road Bridge, just above Town Hall. Note the cobbles that are deposited upstream of the bridge in the foreground of the photo.

The River Road Bridge is also affected by aggradation. However, in this case the problem appears to be the result of a loss of stream energy due to a sharp (120°) meander bend and overwidened reach upstream of the bridge (Photo 12). In addition, the bridge span is narrower than the width of the channel along the reaches upstream and downstream. These factors cause water to back up on the upstream side of the bridge. Under this *backwater* condition, the flow velocity along the upstream reach drops reducing the stream's ability to transport its sediment load. As a result material accumulates along the upstream reach. Water backed up above the bridge during floods tends to form scouring eddies near the banks as the water rushes under the bridge, contributing to bank erosion and further widening of the channel.

5. Evaluate the River Road Bridge to determine the best method for improving sediment transport and conveyance of bankfull and flood flows.
6. Reconstruct the River Road reach to provide a larger radius of curvature and install rock vanes to divert flow away from the reconstructed banks.

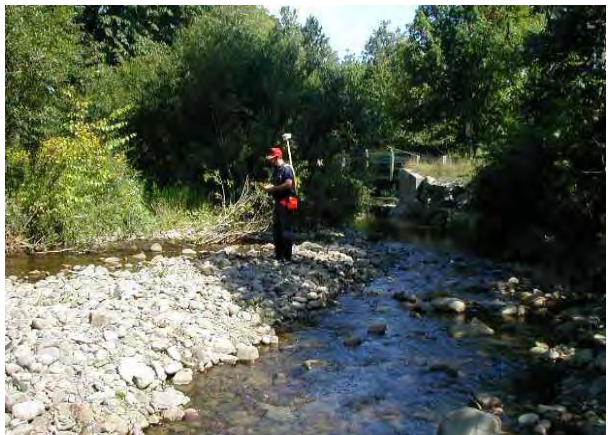
Photo 9. Looking downstream at left bank cross section 141 at end of center bar and split channel upstream of Davis Lane Bridge.

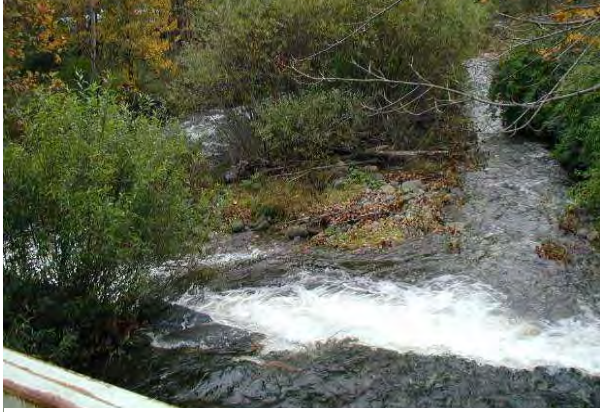
Photo 10. Looking downstream from top of Davis Lane Bridge at split channel below grade control at high flow. Right channel dry in 2001 at low flow. Center bar with cobbles and willow can be seen.

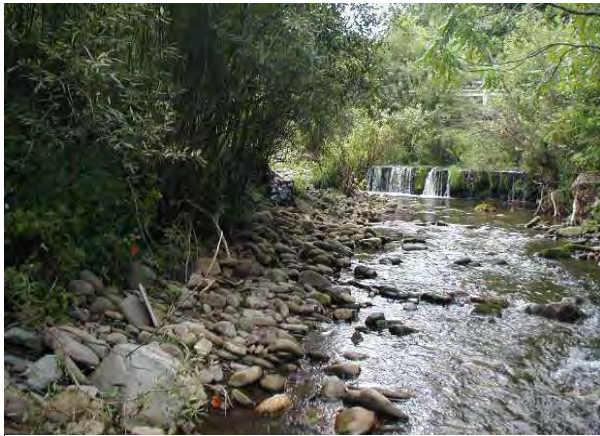
Another significant factor contributing to problems in this area was the effect of the sanitary sewer crossing downstream of the bridge on channel slope through this reach (Photo 11). In the 1950's, a sanitary sewer lateral was installed across Chestnut Creek immediately downstream of the Davis Lane Bridge to serve the Fairgrounds. After the sewer line was exposed by a

Photo 11. Looking upstream towards Davis Lane Bridge concrete grade control structure over sewer line.

storm in the 1960's it was reinforced with a grouted riprap encasement. The elevation of the original sewer line and subsequent encasement significantly raised the streambed in this reach. This resulted in an extremely flat channel gradient in the vicinity of the bridge upstream, which has undoubtedly contributed to the on-going aggradation problems previously mentioned. The combination of the high width to depth ratio, flat gradient, and center pier of the bridge ensures that material transported from upstream will routinely accumulate in this reach.

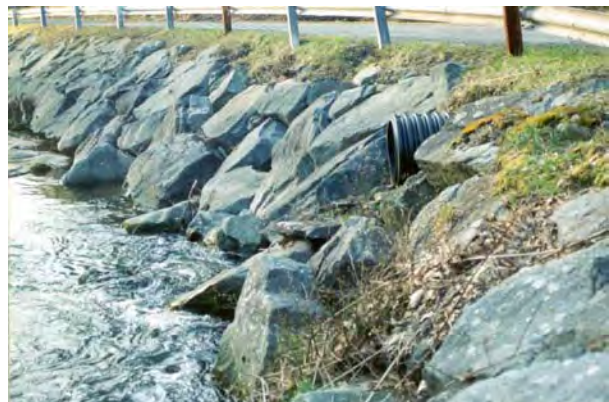
Photo 12. Looking downstream at rip rap along sharp curve and culvert on right bank, along River Road upstream of bridge. Flow hits directly into bank near culvert.

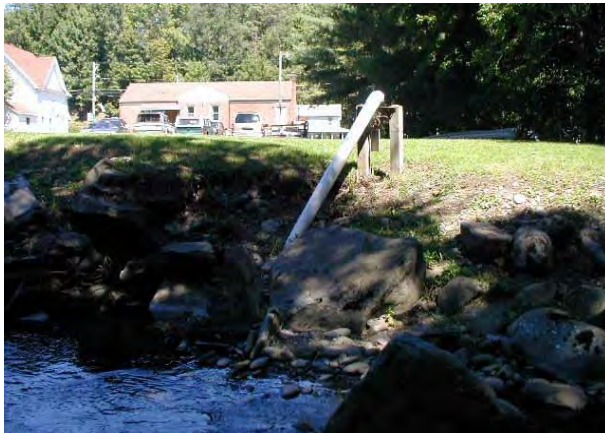
the Chestnut Creek Valley. To provide a readily available supply of water, dry hydrant facilities are maintained by the Fire Department at key points of access along Chestnut Creek (Photo 13). These facilities can only function if the water in the area of the pump intake is deep enough to accommodate continuous pumping without being drawn down during an emergency. As designed currently, gravel and other debris tend to accumulate in these areas reducing water depth and available pump volume. Standard practice has been to routinely remove these accumulated gravels to maintain proper function of the facility. An alternative design for dry hydrants that significantly reduces the need for maintenance should be addressed, possibly using structures suggested in the Recommendations at the end of MU6.

Photo 13. Dry hydrant (out of order, removed) and eroded bank behind Town Hall parking lot-view looking toward left bank & Town Hall from center of stream. (flow left to right)

11. Reconstruct problematic dry hydrant sites utilizing cross vanes to provide low maintenance facilities.

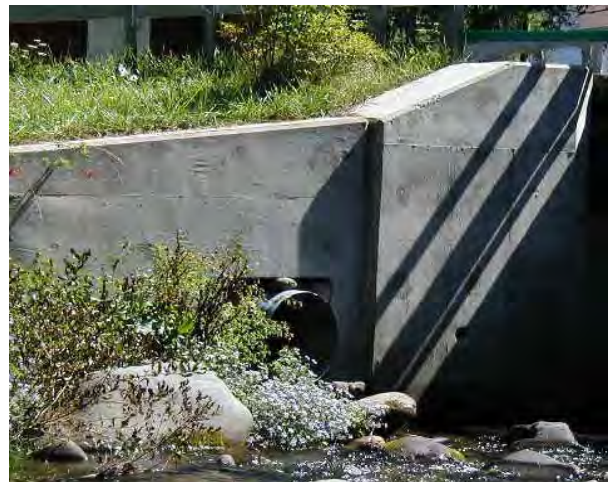
Photo 14. Culvert in left bank abutment on upstream side of River Road Bridge, view looking downstream from the center of the stream.

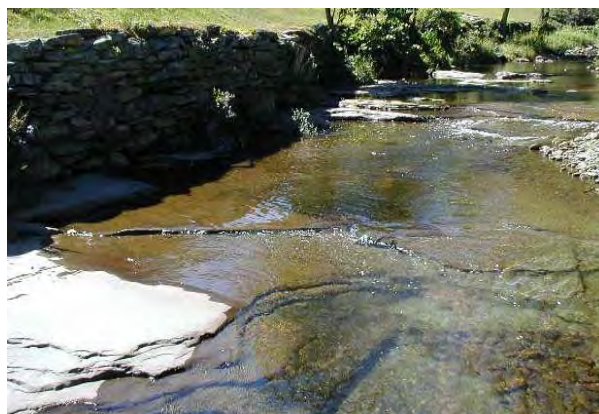
Photo 15. Bedrock streambed, starting approximately 200' upstream from Route 42 Bridge-view looking upstream from center of stream, stacked rock wall on left of photo.

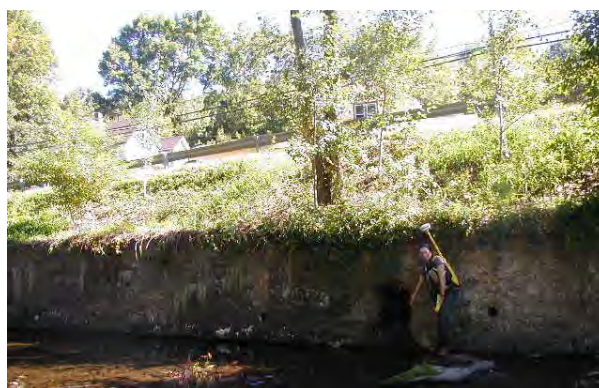
Photo 16. Concrete wall with box culvert along Route 55 between River Road and Fire House.

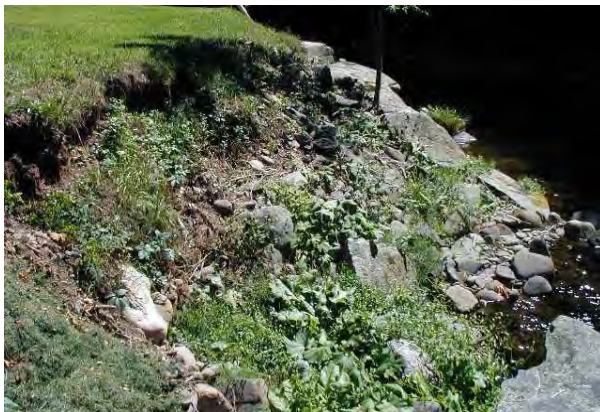
rip-rap, gabions, stacked rock, and concrete revetment. These protective measures appear to have been relatively successful in some areas, while less successful in other areas. For example, the banks along the rear of the Town Hall have been rip-rapped during previous maintenance attempts. Currently rip rap has been dislodged, fallen into the channel and is diverting storm flows (Photo 17). Residents have expressed concerns about the riprap revetment on the sharp bend upstream of the River Road Bridge. The riprap was installed in the 1970's to protect the road along the right floodplain. Some of the riprap has been dislodged and scattered along the channel by storm flows during the intervening years.

Photo 17. Dislodged riprap at left bank behind Town Hall parking lot-view looking downstream with dry hydrant partially visible in the background.

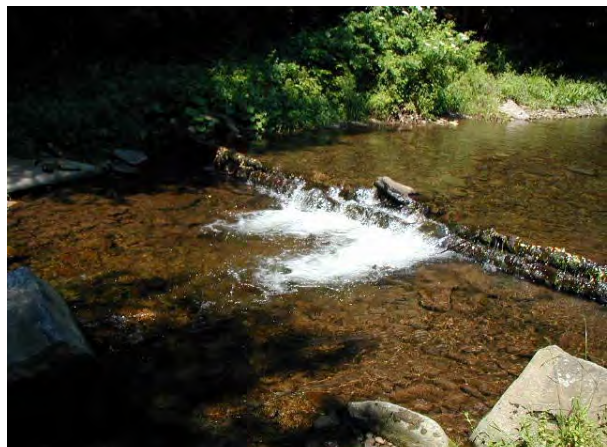
Photo 18. Wood weir behind Town Hall.
