H. Chestnut Creek Management Unit 8

Background

Chestnut Creek Stream Management Plan

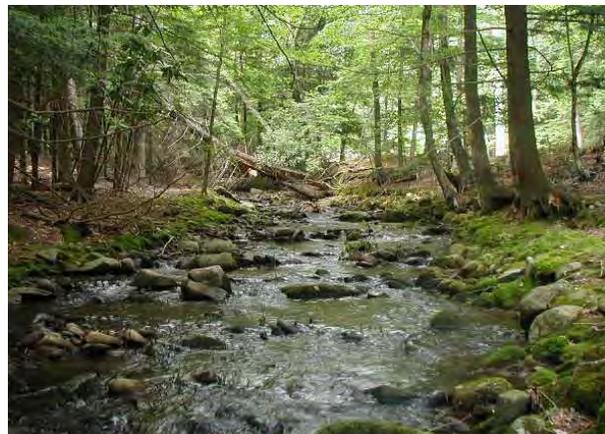
Photo 1. Reach view looking upstream.

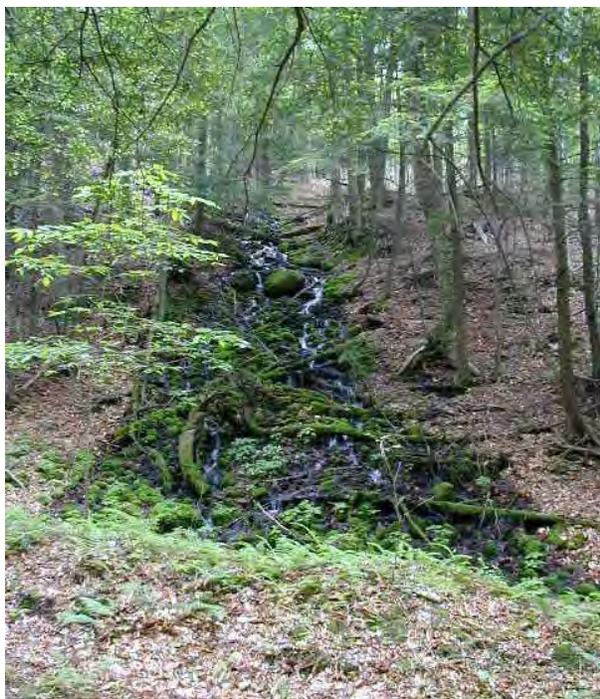
Photo 2. View looking up steep tributary on the side of a hill, which flows to the left bank of mainstem Pepacton Hollow along Camp Road.

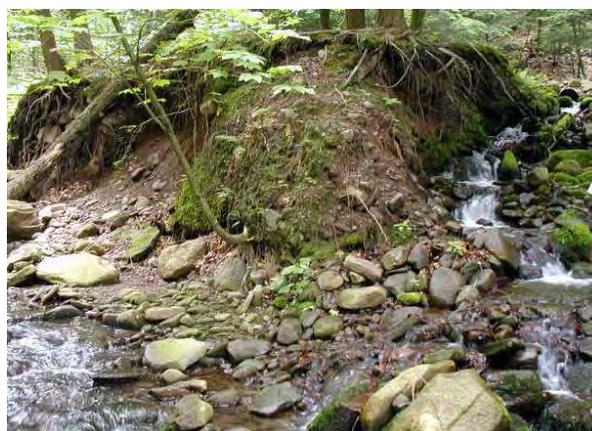
Photo 3. View looking upstream at left bank and confluence with another tributary downstream of Photo 2 (on right side of the photo) that flows under Camp Road. Significant erosion.

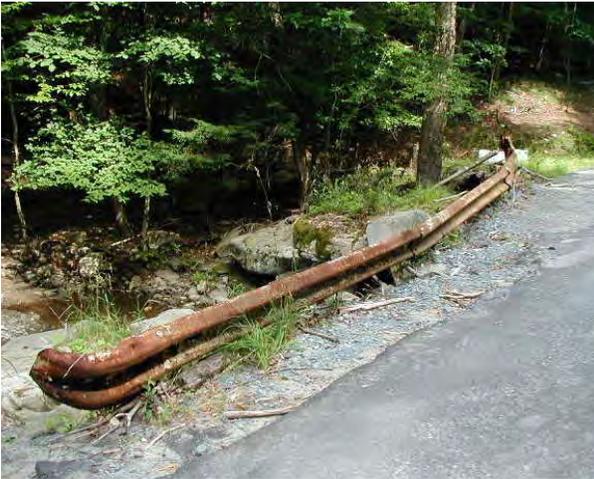
Photo 4. Recent storms have overtopped the road at this culvert, causing damage to the road. FEMA funding replaced guardrail seen in photo, 2002.

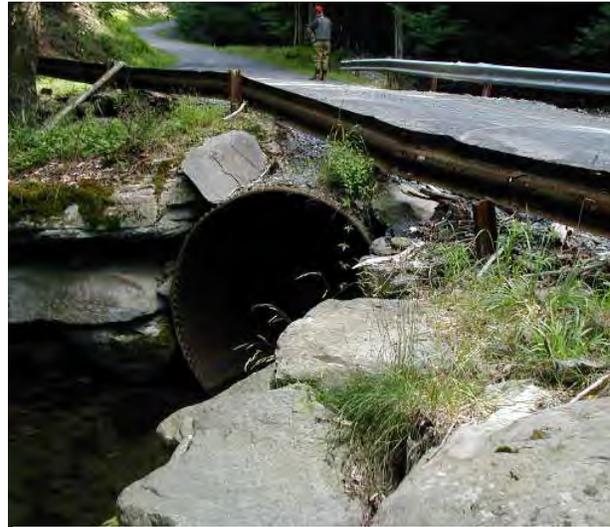
stakeholders regarding the existing 6.5-foot diameter culvert crossing under Pepacton Hollow Road (Photos 7 & 8). Local residents reported on several occasions floodwater crested the road and caused substantial damage throughout the area. Floodwaters kept landowners from their homes and/or landlocked from other access roads. Site inspections and the 2001 Stream Assessment Survey, noted the culvert pipe crossing under the roadway is of insufficient size to pass bankfull discharge. Several problems can directly result from an undersized culvert in this location. A backwater condition

Photo 7. Culvert crossing under Pepacton Hollow Road.

can occur when the culvert pipe is unable to carry the volume of water delivered to it during a storm event. This can cause floodwater to re-route around and over the culvert pipe causing damage to the roadway and erosion at its re-entrance point with the stream channel. Backwater conditions can also cause sedimentation upstream of the culvert and lead to streambank erosion as lateral forces on the bank are increased (Landowner Concerns and Interests, Volume I, Section IV.B.6).

Undersized culverts are more susceptible to upstream debris blockages, increasing potential for the stream to divert around the culvert during high flow events. Constriction that an undersized culvert can place on the stream channel can cause an increase in stream velocities through the culvert, causing stream bank erosion downstream of the culvert.

11. The culvert under Pepacton Hollow Road should be replaced with a suitable size crossing capable of providing adequate passage of base flow, bankfull flow and flood flow. Effort should be made to enhance the stability of the upstream and downstream reaches using adequate stabilization structure which will maintain and promote a naturally function stream channel.

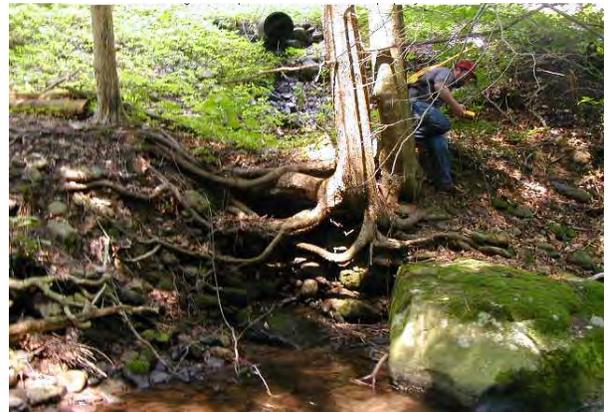
Photo 8. Looking at culvert (top of photo) under Pepacton Hollow Rd. right stream bank, stream flow right to left.

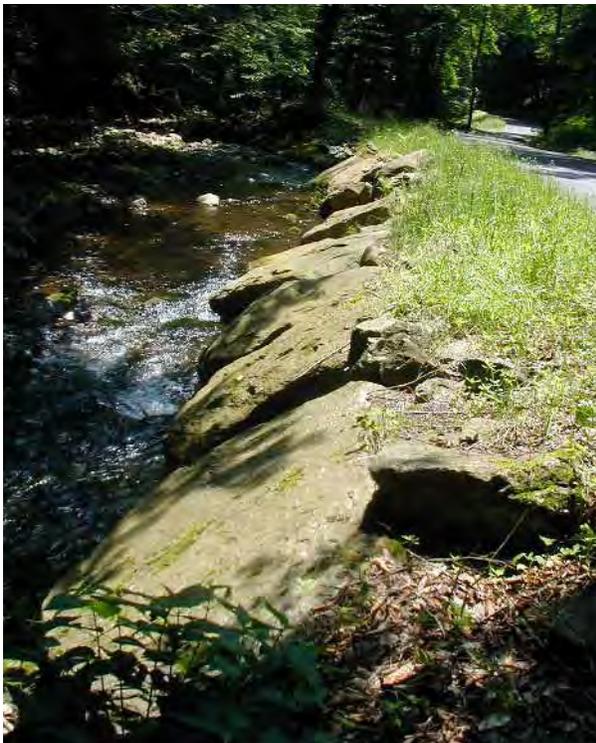
Three types of revetment were found in MU8. Riprap was found in two locations (Photo 9), totaling 90 feet, and a stacked rock wall measuring 160 feet was also inventoried. Berms made of side-cast channel material totaling 830 feet were found in five locations along Pepacton Hollow (Photo 10). The purpose of the berms was not determined, but seem to be a historic remnant of management for flooding. These berms have kept the stream from utilizing its natural floodplain.

Photo 9. View looking downstream at riprap on right bank.

4. Evaluate the existing revetment for replacement with an adequate stabilization structure which will maintain and promote a naturally function stream channel. Any stabilization technique should include bioengineering and/or re-vegetation.

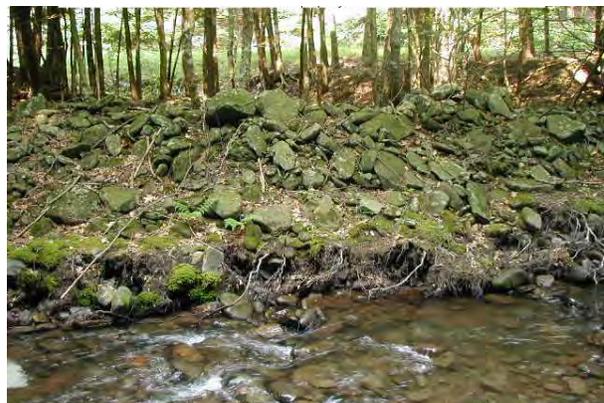
Floodplain berms such as these generally do not offer much, if any, protection from flooding, and can result in higher flood stages by preventing floodwaters from flowing over the floodplain. In situations where berms create higher flow velocities and channel stresses, channel erosion and down cutting can occur. Floodplains function to reduce flood velocity, increase absorption of floodwaters, encourage deposition of silt and fine sediments (keeping them from being washed further downstream) and decrease flood stage, in downstream areas.

Photo 10. Looking at undercut right bank and berm, stream flow left to right.

channel and evaluate quantify the benefits of removal or redesign.

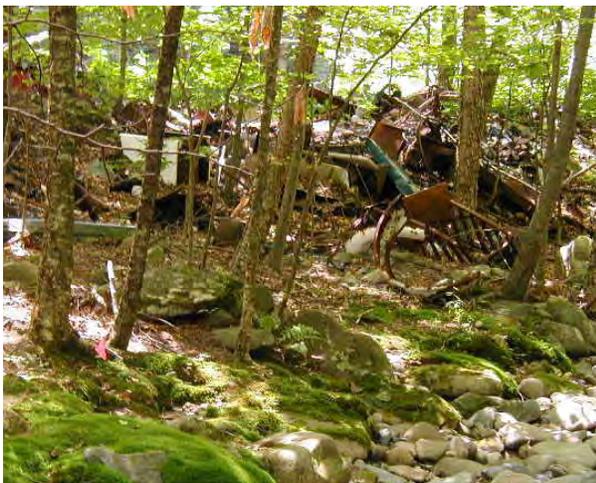
The Stream Assessment along Pepacton Hollow identified an area of floodplain which contains a 500-foot long section of dumped refuse and discarded litter. The area contains a mix of glass and metal waste and is located immediately adjacent to the active stream channel (Photo 11). There are large trees growing through the debris, indicating that it has remained relatively stable and has been present for some time. Several site inspections have been made by SCSWCD, the Town and NYC DEP, but have not revealed any contaminants leaching from the site. Although the area may not currently contribute to impaired water quality, it does remain an aesthetic concern.

Photo 11. View showing old dumping site along Pepacton Hollow stream bank. Stream flow is left to right.

8. Continue with evaluations in the floodplain area containing the dumped refuse. Consider removing the visible waste from the surface in order to prevent future entrainment of the waste and partially restore the aesthetic quality of the area.

9. Consider excavation and disposal of the waste material from the old dump site to improve both aesthetics of the area, stream stability and water quality.

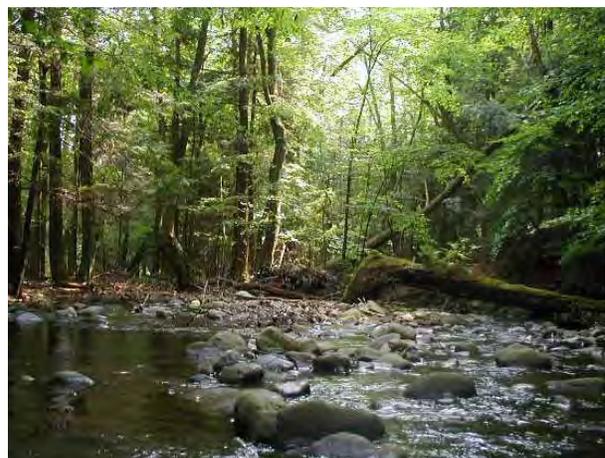
Photo 12. View looking downstream at aggradation.

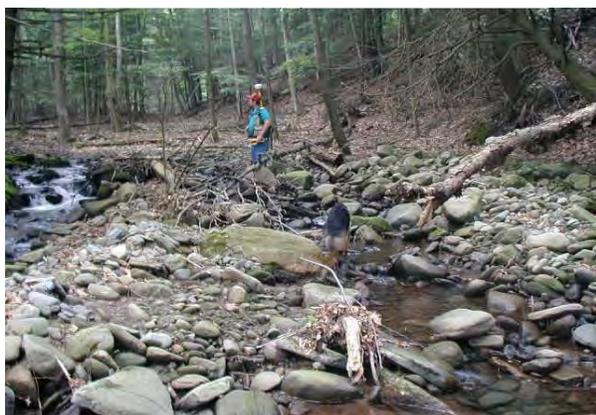
Channel materials such as large cobble and gravels were identified as the dominant sediment size, with isolated areas of bedrock totaling 240 feet. *Bar* formations were frequently noted and consisted of predominantly small side channel formations. Several sections containing recently deposited central bars indicated potential for localized channel aggradation (Photo 12 & 13). Aggradation is caused by the stream flow not having force to move the available sediment through the system, allowing it to deposit along the channel bottom. If total stream energy is less than the energy required to transport the sediment provided, the streambed will aggrade. Several areas were inventoried where the active channel had recently aggraded to nearly the elevation of the active floodplain, completely reducing channel capacity (Photo 13). Sand and fine gravel were

Photo 13. Looking upstream at mid-channel bar in left branch of split channel.

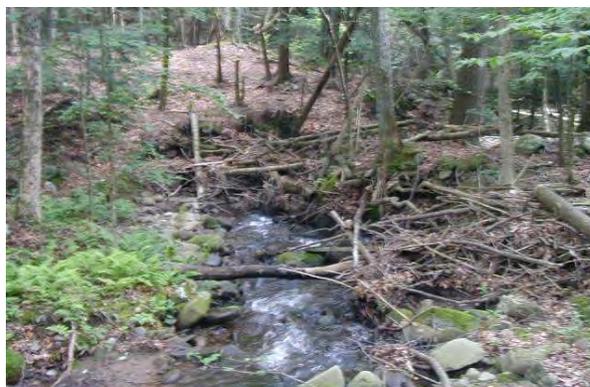
from 11 ft. to nearly 175 ft. in length. These occurrences seem to be random in distribution along the entire streams length and vary in type and scale. Many eroded areas included undercut banks causing large trees to fall into the stream (Photo 15).

Photo 15. Looking downstream at major debris jam on right branch of split channel.

16. Monitor the areas containing debris jams and channel blockages for changes in channel stability and threat to infrastructure. Initiate an assessment to document the source and magnitude of the large woody debris to include the effects from localized erosion. Treatment recommendations should target the reduction of debris at its source.

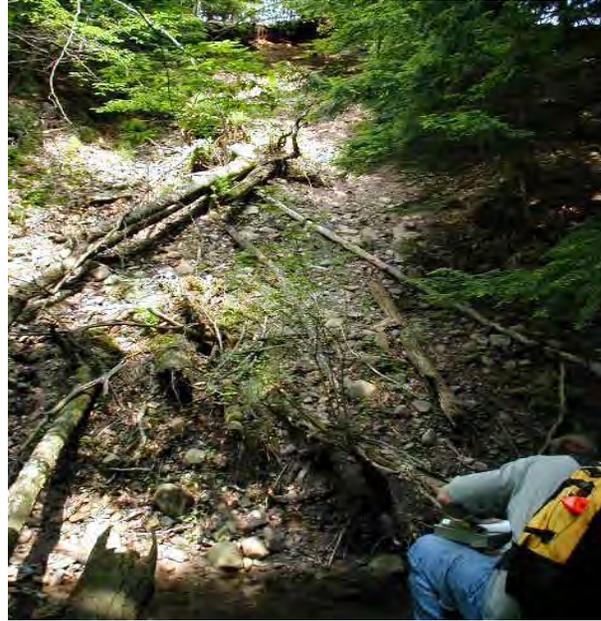
The upper reaches of MU 8 contain two primary areas of erosion totaling more than 1850 square feet. Streambank heights generally range between 10 ft. and 15 ft. through the area. One additional area along Camp Road contains a steep eroding bank approximately 70 ft. in height (Photo 16). Stream bank erosion is more extensive in areas where the stream channel impinges against steep, natural hill slopes. Erosion in these areas has caused larger bank failures and mass wasting from the displacement of material along the toe of these slopes.

Photo 16. Shows very steep eroding right bank along the upper reaches of Pepacton Hollow along Camp Road.

12. Conduct further morphological stability assessments through the areas containing potentially eroding streambanks. Determine the significance, rate, and magnitude of the disturbance and consider stabilization and/or restoration if deemed necessary.

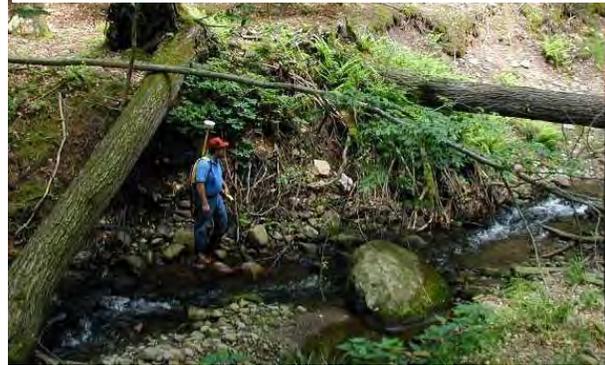
The lower reaches of Management Unit 8 contain five primary areas of erosion totaling 9,340 square feet of exposed streambank. Severe mass wasting was observed along a 40 ft. tall, 150 ft. long section of streambank. A number of smaller eroding banks were identified where undercutting of the banks have

caused large trees to fall into the stream channel (Photo 17).

Photo 17. Eroding right bank and fallen trees, incised section, along Camp Road.

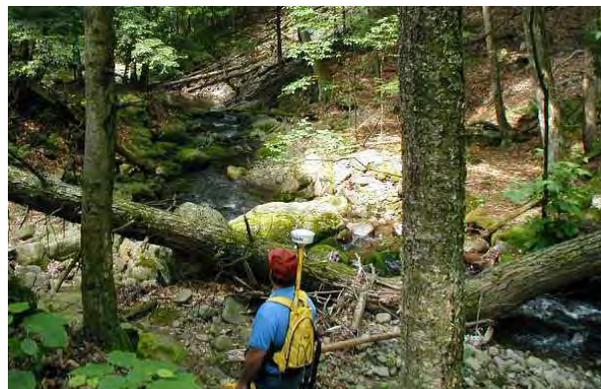
The 2002 Stream Assessment documented a number of areas containing debris jams and channel blockages. Although wood recruitment is a natural and necessary process for mountain stream stability, current volume likely exceeds natural rates. Some areas were documented with debris jams spanning the entire active channel. These blockages are seemingly affecting the capacity to move the water, sediment and smaller debris (Photo 18).

Debris jams and other channel obstructions may cause problems by trapping sediment, which initiates and/or accelerates development of gravel bars and further reduces channel capacity. Subsequent bed erosion and removal of the deposited gravels contributes sediment imbalance to downstream reaches. Alternately, small blockages can create and maintain beneficial physical habitat (Photo 18), as well as assist in controlling stream channel incision and degradation. Extent and effect of wood debris should be quantified and compared to indices that provide information on quantity and include stream types present. Further annual monitoring of the area for continued growth and potential impact would be an effective management strategy for woody debris, jams and channel impacts. Streambank erosion should be further measured and quantified and compared to other physically similar local streams. This could be further quantified for management purposes by evaluating stream types and natural sensitive areas within the corridor as well as assist in prioritizing enhancement opportunities.

Photo 18. View looking downstream from left bank at steam wide debris jam.
