I. Chestnut Creek Management Unit 9

In the summer of 2002, a stream inventory and assessment was conducted along Red Brook, MU9 by District staff. The inventory integrated photographic documentation throughout the management unit with the *GPS* (Global Positioning System) location of multiple physical attributes. The components were incorporated into a *GIS* (Geographic Information System) database and used in conjunction with various base maps to assess the corridor (MU 9 General maps Figures 1 & 2, Photo 1). The purpose of the assessment and the following

1. Summary Description

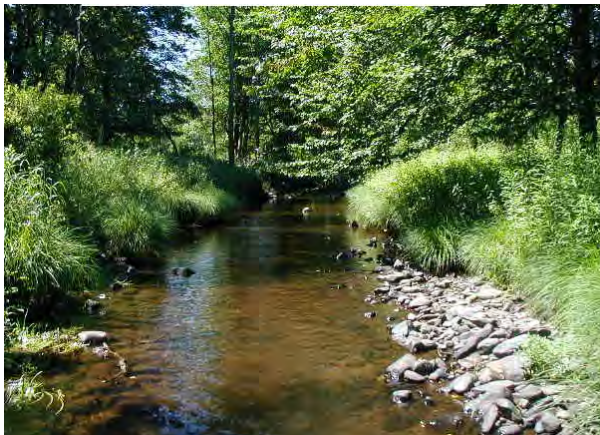
Photo 1. Reach view looking upstream from private bridge.

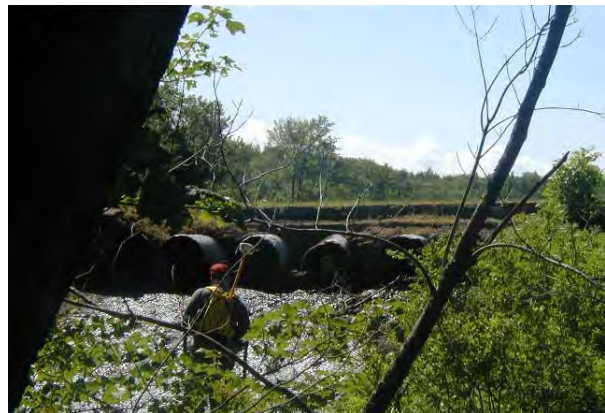
Photo 2. Beaver Dam Pond outfall. Six Culverts, looking upstream.

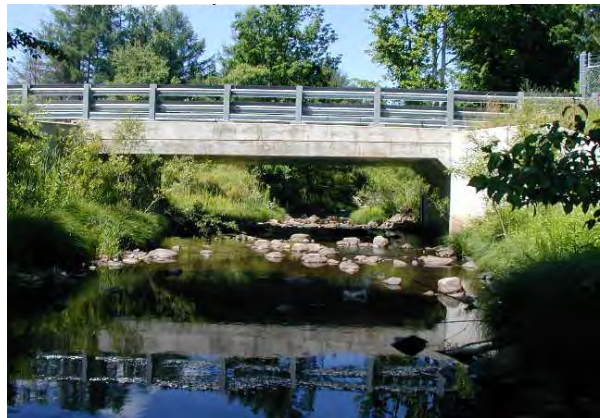
Photo 3. DEP bridge over Red Brook.

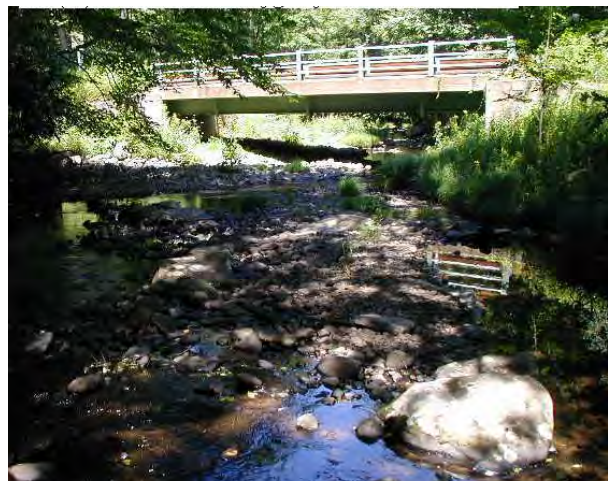
Photo 4. View looking at South Hill Road Bridge.

Hill Road bridge has settled over time, causing some cracking. Debris along the has blocked all of the right side and the deck exhibits longitudinal, transverse cracking and fatigue prone welds. The report also indicated that the waterway opening was undersized to pass higher *stream flows*.

9. Evaluate the existing bridge and culvert crossings for the ability to convey both *bankfull* and flood flow, as well as proper sediment transport. Additionally, any design modification should reduce scour and provide for fish passage.

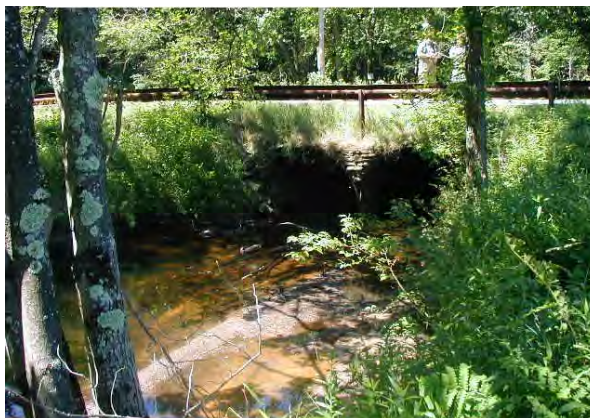
There is a private farm culvert crossing, two double culverts, one on Beaver Dam Road which appears to be having difficulty transporting sediment indicated by the presence of sand bars, however, no further studies have been conducted at this site (Photo 5). There is also another double culvert at a private crossing in which one of the culvert pipes is smaller and elevated to an overflow height seemingly to assist the larger culvert at higher flows (Photo 6). There is a six culvert outlet crossing at the mouth of the Beaver Dam pond (see Photo 2) and one small culvert that feeds an intermittent spring.

Photo 5. Looking upstream at twin culvert Beaver Dam Road crossing.

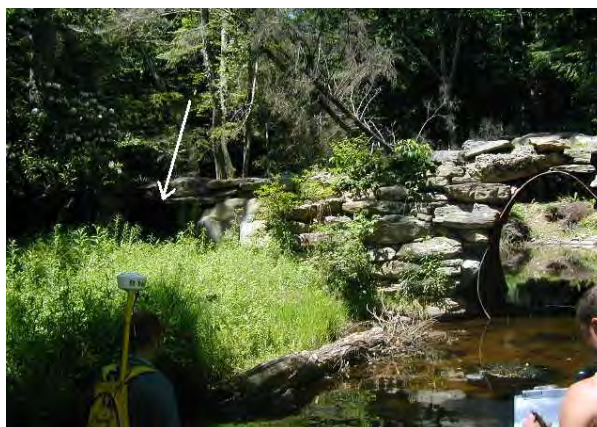
Photo 6. Looking downstream at double culvert Overflow culvert is indicated by white arrow.

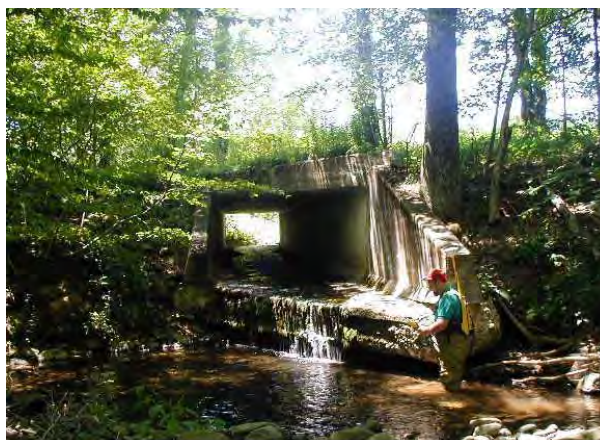
There is single “hanging” box culvert, located on an unnamed tributary crossing State Route 42, just upstream of the tributary’s confluence with Red Brook upstream of the South Hill Road Bridge (Figure 2). The base of the culvert is severely scoured and weathering, as the stream flow passing through its narrow confines has created a scour pool at the outlet (Photo 7). Project stakeholders voiced concern regarding the current condition of the channel at the outlet as well as the potential barrier to fish migration. Local anglers have expressed that Brown trout exist both upstream and downstream of the structure, though whether upstream fish are resident is unknown. The stream channel below the outlet has developed a large scour *pool* resulting in a three to four foot elevation

Photo 7. View from mid channel looking upstream. Scour pool at outlet of Route 42 box culvert. Eroding right bank 10' high.

difference in grade between the outlet invert and *base flow* of Red Brook. A potential cause for the elevation difference is excess channel scour produced by the *hydraulic* condition developed through the culvert. The steep slope of the culvert, lining and geometry are the suspected causes of this condition. Another potential cause of the grade difference is channel *incision* along the main stem of Red Brook leaving a perched condition, possibly a *headcut*, or downcutting, upstream migration, at the culvert. This scenario should be evaluated both for the immediate migration issue, as well as a possible indicator of local channel processes of Red Brook. The culvert bottom has begun to deteriorate revealing rebar supports along the bottom of the culvert and stress cracks in State Route 42 from culvert instability.

10. Evaluate the existing bridge and culvert crossings for the ability to facilitate fish passage during varying flow periods. Specific attention should be placed on the Route 42 box culvert, on the tributary to Red Brook, where it is recommended that fisheries biologists examine potential migration barrier and assist with project designers to recommend potential enhancements.

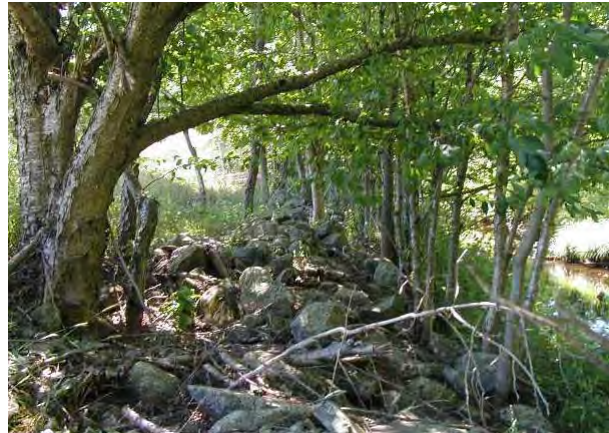
Photo 8. View looking upstream at dumped field stone on right bank.

feet. The purpose of the berm was not investigated, but it is suspected to be a historic remnant of land clearing for agricultural production and a protective measure from flooding (Community History and Current Conditions, Volume 1, Section IV.A). The berm is currently well vegetated with a large number of deciduous trees growing through the stones. The continuous makeup of the berm prevents flood flow from utilizing the undeveloped natural floodplain.

Floodplain berms such as these generally do not offer much, if any, protection from flooding, and can result in higher flood height (or stage) by preventing floodwaters from flowing over the floodplain. In situations where berms create higher flow *velocities* and channel stresses, channel erosion and down cutting can occur. Floodplains function to reduce flood velocity, increase absorption of floodwaters, encourage deposition of *silt* and fine sediments (keeping them from being washed further downstream) and decrease flood *stage*, in downstream areas.

Removal or restructuring of some of these

bermed areas should be considered to add floodplain function to this area and reduce potential erosion and instability problems. Setting berms back away from the active stream can provide a compromised solution, if flood protection is required. Further assessment should be performed in the area of the berm as well as upstream and downstream. The assessment should quantify the degree of disconnection of the stream from its floodplain, impacts of the berm to the channel and evaluate the benefits of removal or redesign.

8. Evaluate the existing floodplain berm to quantify the degree disconnection of from its floodplain, impacts of the berm to the channel and evaluate quantify the benefits of removal or redesign.

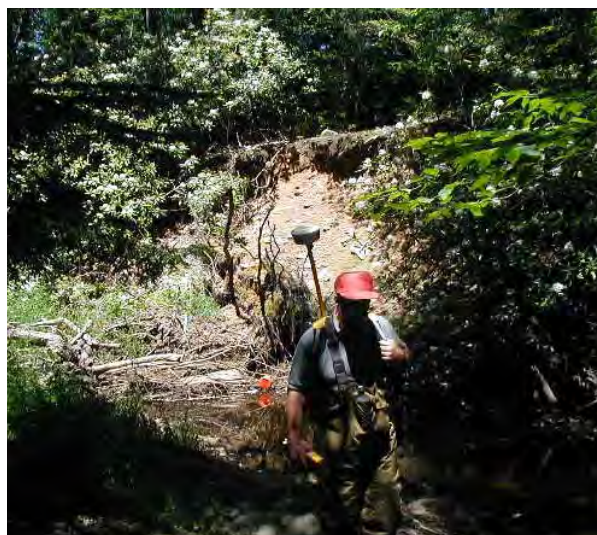
to 2% of the channel length. The erosion is located primarily in the upper watershed and occurs in four sections ranging from 85 ft. to nearly 200 ft in length (Photo 9). The exposures consist mainly of moderately undercut banks, located along areas with generally low bank heights. One bank, approximately 30 ft. - 40 ft. in height was inventoried, which potentially could be introducing a considerable volume of sediment to the stream system (Photo 10). Minimal information was collected along this bank. It is recommended that the relevant data be collected to determine the rate and magnitude of the failure as well as potential future impacts. In general, stream bank erosion in MU 9 seems to be less than other management units along Chestnut Creek.

Photo 9. View looking at 30'-60' eroded right bank. Lack of vegetation on top of cobble/gravel/sand. Fallen trees at base of bank.

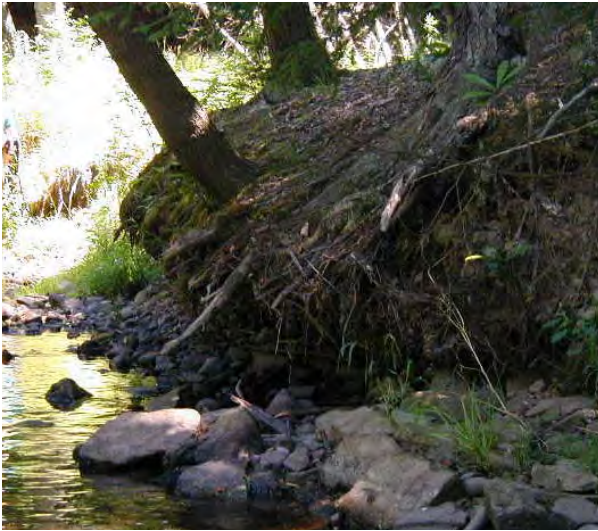
Photo 10. View looking at erosion and undercut trees on right bank.

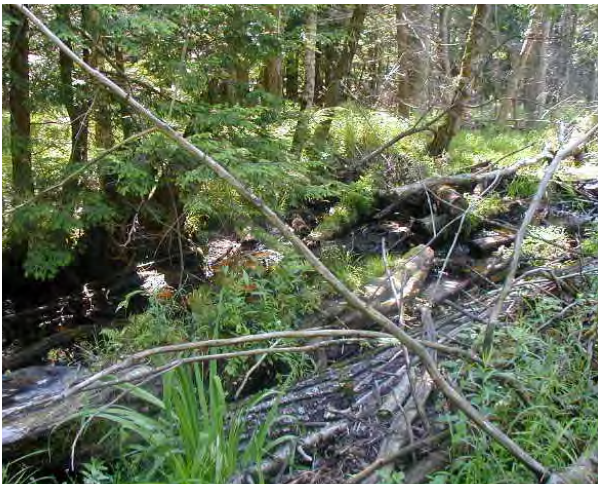
The 2002 Assessment documented a number of areas containing debris jams and channel blockages (Photo 11). The areas were located exclusively in the upper watershed below the Beaver Dam Pond

Photo 11. View looking upstream at river wide log jam on Red Brook, can cause stream instability.

outfall. These debris jams and other channel obstructions cause problems by trapping sediment, which initiates and/or accelerates the development of gravel bars and reduces channel capacity. Subsequent bed erosion and removal of the deposited gravels contributes sediment to downstream reaches. Alternately, small blockages can create and maintain beneficial physical habitat (Photo 12), as well as assist in controlling stream channel

14. Monitor the areas containing debris jams and channel blockages for changes in channel stability and threat to infrastructure. Initiate an assessment to document the source and magnitude of the large woody debris to include the effects from upstream pond and wetland areas. Treatment recommendations should target the reduction of debris at its source.

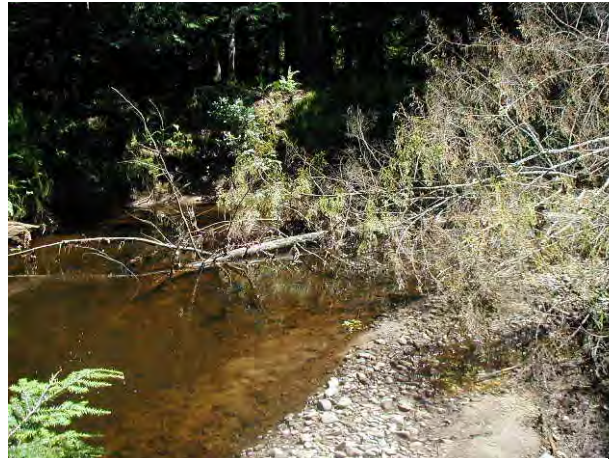
Photo 12. View looking at smaller debris jam on Red Brook, can add to habitat.

incision and *degradation*. Extent of wood debris should be quantified and compared to standards that provide information on quantity and include the association of the *stream types* present. Annual *monitoring* of the area for additional debris and potential impact would be effective management strategy woody debris, jams and channel impacts.

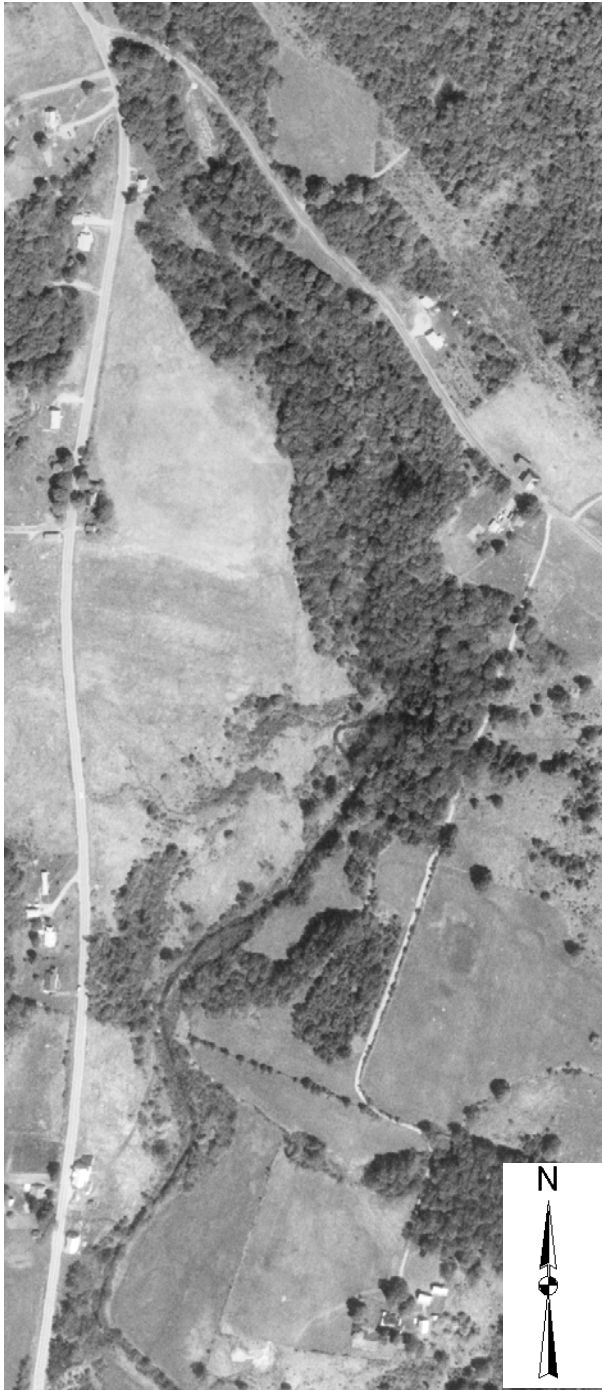
Photo 13. 1977 Aerial Photograph of MU 9.

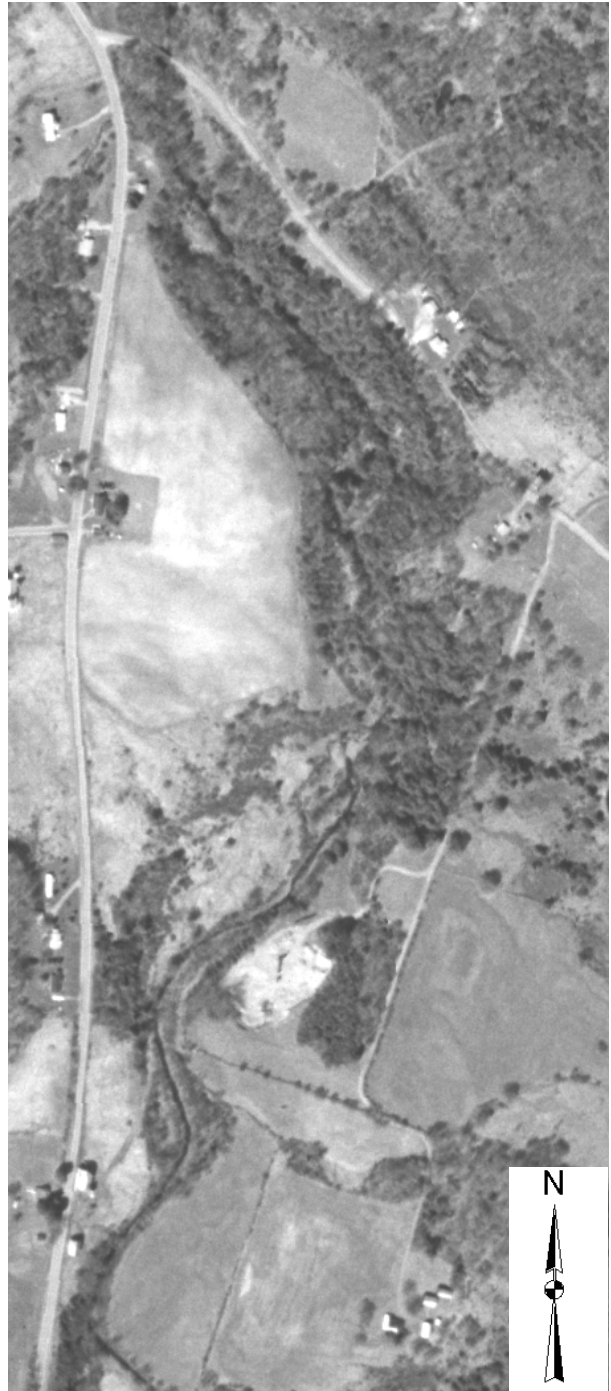
Photo 14. 1985 Aerial Photograph of MU 9.

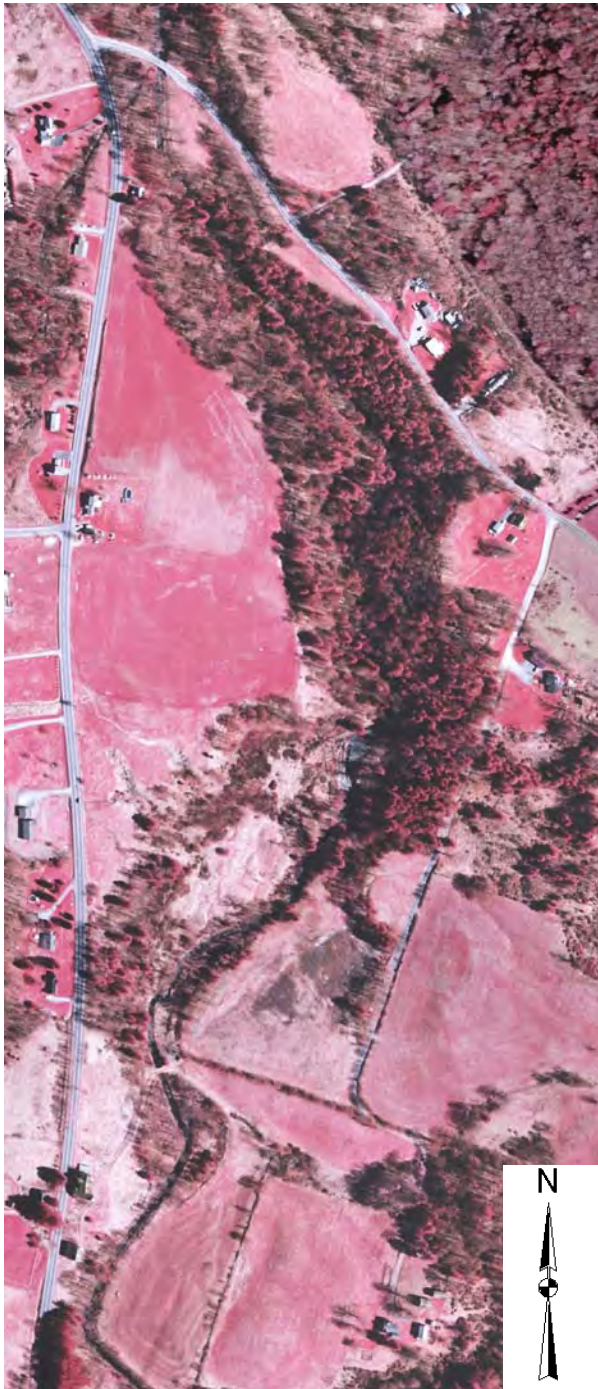
Aerial imagery shows land use and general riparian density has not changed significantly over the photographic series. Visual in the aerial series, the agricultural areas (seen on bottom left) have an extremely narrow riparian buffer in

Photo 15. 2001 Aerial Photograph of MU 9.

comparison to downstream areas (top center) which are wider and have increased density.

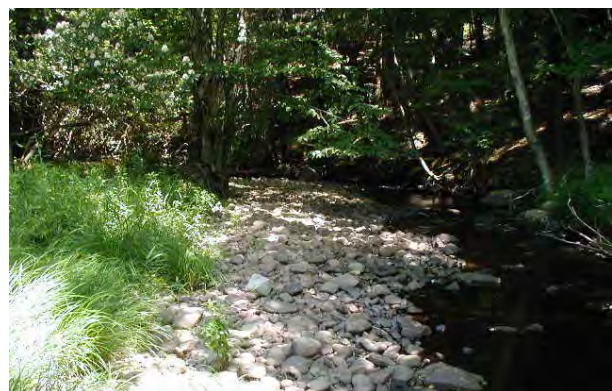
Photo 16. View shows diverse riparian buffer and larger cobble towards the end of a side bar.

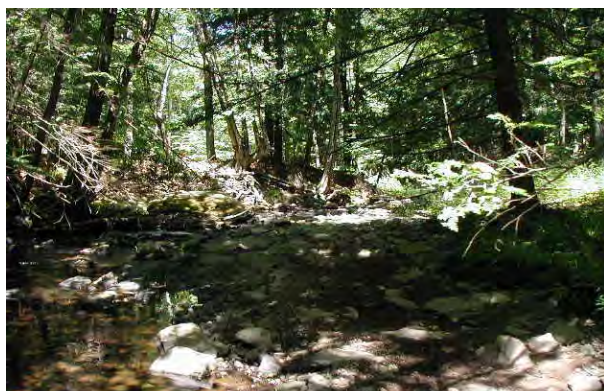
Photo 17. Forested buffer provides shade and habitat for the stream.
