# East Kill Management Unit 1

Town of Jewett – Station 84120 to Colgate Lake Dam (Station 73769)

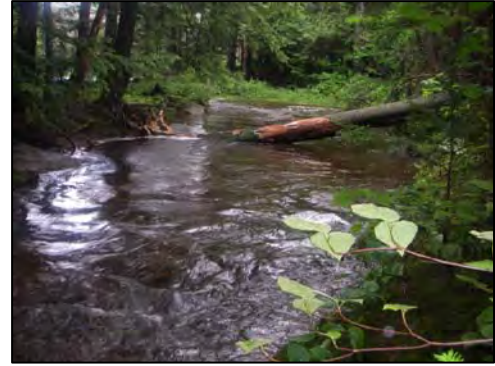
woody debris obstructions. The first obstruction (Station 84039), involving a tree lying across the stream channel, contributes to backwatering upstream of the tree and scour downstream of the tree, while the second obstruction appears to have a minimal impact on stream conditions causing minor erosion along the left bank just upstream of the debris.

*Woody debris at Station 84039  
looking upstream*

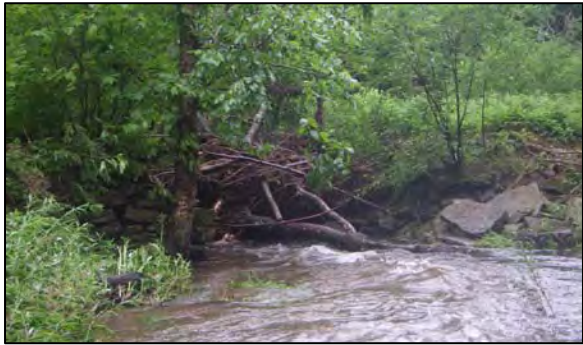
*Beaver dam and foot bridge at Station 83700*

As the stream channel turns sharply at the first meander bend, there is a beaver dam constructed along the left bank, followed by a small foot bridge (Station 83700). The beaver dam appeared to contribute to debris build up beneath the foot bridge.

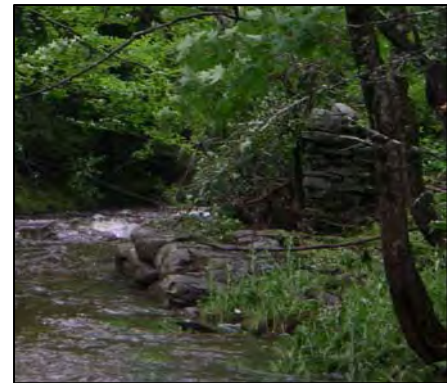
Downstream of the meander bend, there is a stacked rock (Station 83561) wall along the right stream bank; this is the only revetment in management unit #1. The rock wall provides some scour protection for the toe of the bank, but was only in fair condition overall.

*Stacked rock wall at Station 83561*

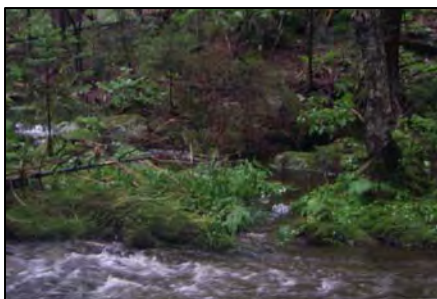
*Intermittent stream at Station 83240  
Looking across mainstem channel*

continuing downstream (Station 83400 to Station 81735), there was woody debris along the right bank, followed by several *intermittent* streams, including two spring seeps, entering from the left, one intermittent stream entering from the left (Station 83240), and one intermittent stream entering from the right. These tributaries tend to

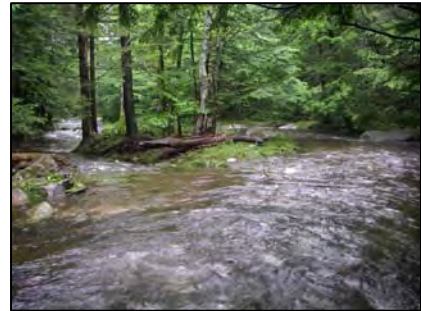
Downstream of the second meander bend, the stream channel diverges (Station 82959), or splits, forming a secondary channel at a well-vegetated center bar; the split channel converges, or merges, to form one stream channel approximately 116 feet downstream of the *divergence*. *Deposition*, or the accumulation of sediment, has occurred along the center bar.

*Channel divergence and center bar at Station 82959*

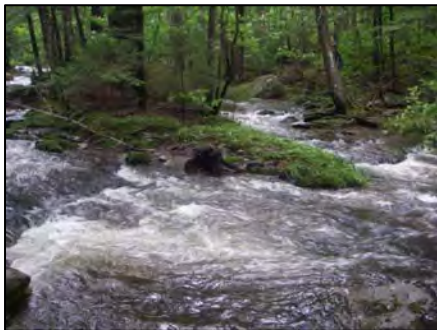
*Channel convergence at Station 82422*

Further downstream (Station 82534), the stream channel diverges to flow around a well established center bar that is vegetated with trees, grasses and sedges; the two channels merge (Station 82422) approximately 112 feet downstream, at the end of the center bar.

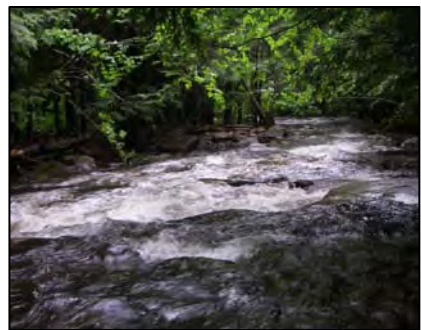
Continuing downstream, there is a very steep gradient with a *step pool sequence* (Station 81980), a series of short drops interspaced with pools. This type of morphology is a common feature of high gradient streams, the steps provide grade control and the pools dissipate energy.

*Step pool sequence at Station 81980*

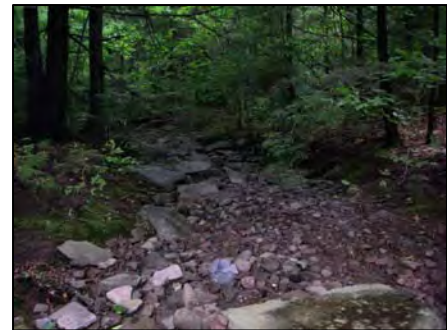
Further downstream on the right streambank, there is a channel divergence (Station 80700) at the start of a second flood chute. As high flows move through a flood chute, some of the sediment load deposits along the bed of the chute. The flood chute flows through the forested floodplain for approximately 306 feet until its confluence with the main channel (Station 80394), just upstream of Lake Capra.

*Flood chute at Station 80700*

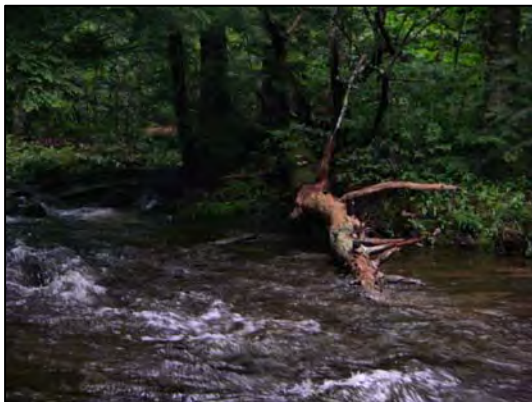
*Woody debris at Station 80622*

Continuing downstream, a fallen tree (Station 80622) was lodged along the left bank, causing a partial obstruction of the channel and minor scour just downstream of the debris. A small unnamed tributary (Station 80610) flows through the forested hillside and appears stable as it enters from the left streambank (Station 80610).

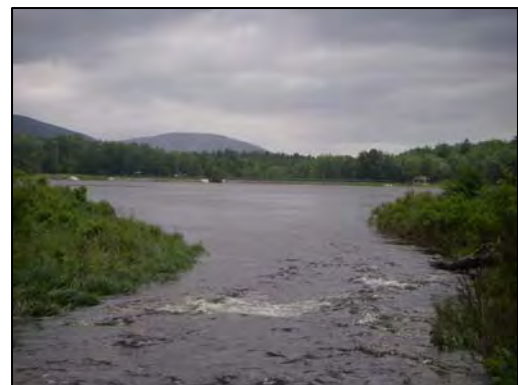
*East Kill confluence with Lake Capra  
at Station 80200*
