East Kill Management Unit 5

Town of Jewett – Scribner Hollow Road Bridge (Station 51119) to Station 40130

This management unit began at Scribner Hollow Road Bridge, and continued approximately 10,989 ft. to a private bridge on the Farber Farm in the Town of Jewett.

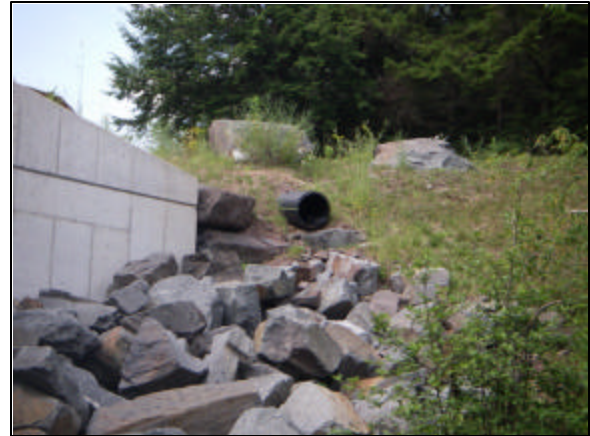
Piped outfall at Station 51070

a bridge. If this bridge is replaced in the future, it is recommended that a hydraulic analysis be conducted in order to determine the appropriate bridge width that will provide the capacity to convey flood flows through the opening. Near the bridge abutment, there was a 12 inch piped outfall (Station 51070), entering above the rip-rap along the left stream bank. This outfall provided drainage for Scribner Hollow Road.

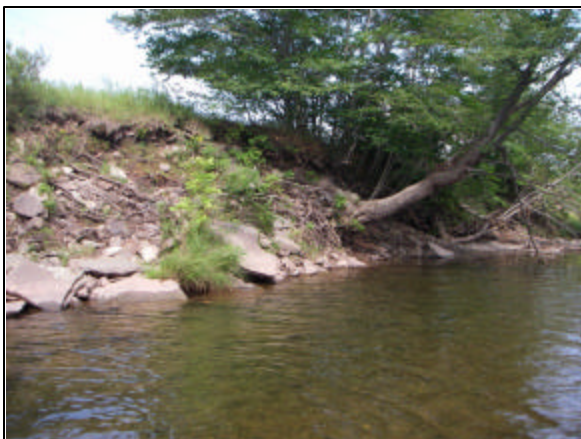
Erosion at Stations 50676 - 50471

slope failure associated with downcutting stream channels and undermined support of steep slopes. This resulted in an erosion area of approximately 4,052 ft² that had compromised woody vegetation along the bank. At the second location, approximately 2,149 ft² of the left bank was affected by hydraulic erosion (Stations 50676 – 50471). Although both areas were significant erosion

sites, they appeared to be slowly recovering, with herbaceous vegetation becoming established along portions of the face of the bank. However, without deep-rooted shrub and tree species, it is likely that the left bank will continue to erode during future high flows. At the top of the bank, there was a driveway, open field and mowed lawn. These erosion sites may be good candidates for remediation using vegetative toe and bank protection; during the field assessment, a riparian planting site was identified along the second erosion site. Both of these eroding sites on the left, should be included as part of the identified planting site (see details and planting recommendations below).

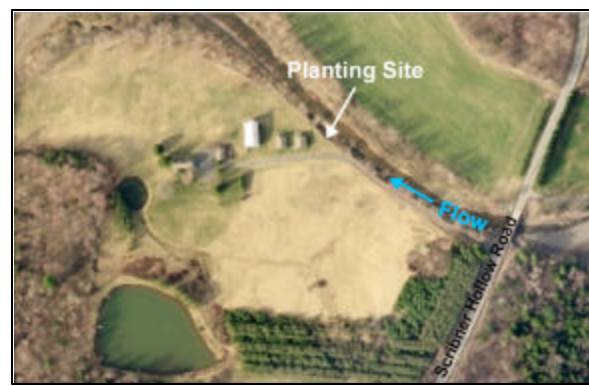
Downstream of the Scribner Hollow Road Bridge, there was a long private driveway that ran along the top of the eroding stream bank on the left. Beyond the driveway, the area was dominated by herbaceous vegetation including an open field and mowed lawn. This area is a recommended riparian planting site (Station 50589). A vigorous buffer with mature trees

Riparian planting site at Station 50589

is important at this site because it may also filter nutrients and pollutants, if any, from the adjacent agricultural fields. Recommendations for this site include establishing a riparian buffer with the planting of deep-rooted native trees and shrubs along the streambank and the upland area. Increasing the buffer width to at least 100 feet will help to stabilize the stream bank and protect water quality through this reach by improving buffer functionality. The location of the driveway and some of the on-site buildings pose limitations for establishing a buffer of an appropriate width; moving the driveway away from the stream should be considered. Due to the erosion and the driveway location, this site will require a more detailed assessment prior to proceeding with vegetative plantings.

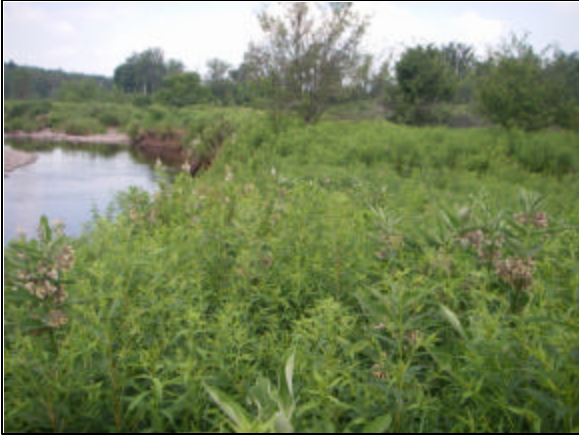
Riparian planting site at Stations 49900 - 49691

that the riparian zone be maintained along this bank and widened with native woody vegetation to achieve the critical 100-foot buffer in locations along the bank that have a narrow section of trees and shrubs. As the stream *meandered* downstream, the *thalweg*, or deepest part of the stream channel, flowed up against the right stream bank causing approximately 1,673 ft² of the bank to erode (Stations 49900 – 49691). The vegetation

along the top of this bank was herbaceous; during the assessment, this site was identified as a riparian planting site (Stations 49900 – 49691). Remediation of this site using vegetative toe and bank protection is recommended through plantings of native sedges along the stream's edge, and shrubs and trees in the upland area. Establishing a buffer width of at least 100 feet will provide the greatest benefit for stream bank stability and water quality; buffer width should be increased by the greatest amount agreeable to the landowners. Due to the close proximity of this eroding bank to the previous erosional area, and the recommendation to improve the buffer along both sites, it may be beneficial to coordinate planting efforts. As with all unstable banks, careful consideration should be given to the on-site conditions when determining the appropriate species and locations for plantings, to ensure that vegetative material is not washed away during subsequent periods of high water.

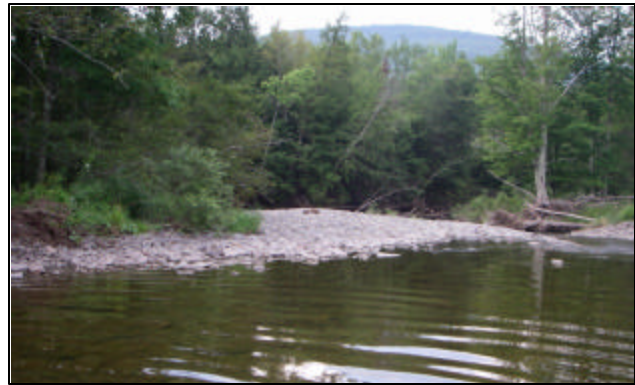
There was woody debris accumulation and excessive sediment deposition through the riverine wetland and continuing downstream including multiple point, side and transverse bars. Along the left stream bank there was a point bar (Stations 49151 – 48723) with a steeper slope at the top of the bar. Along the left side of the bar, there was evidence that showed a small secondary channel where water would flow along the back edge of the bar during periods of high water stage.

Point bar at Stations 49151 - 48723

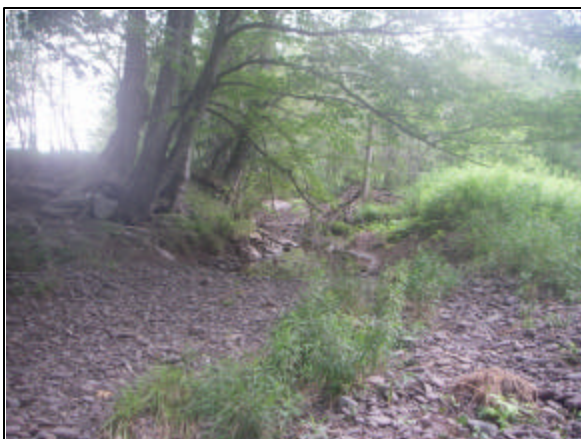
Along the right bank, there were two *divergences* (Stations 49127 and 48864) where a flood chute split off from the main channel. Flood chutes convey flow through a secondary channel during periods of high flows. The second divergence had abundant woody debris

Flood chute convergence at Station 48851

accumulation at the start of the channel. Only one channel convergence was observed during the assessment, it may be that both divergences provided channels for flow to the same flood chute. The flood chute converged (Station 48851) with the main channel approximately 276 feet downstream from the first channel divergence; there was woody debris accumulation at its confluence with the

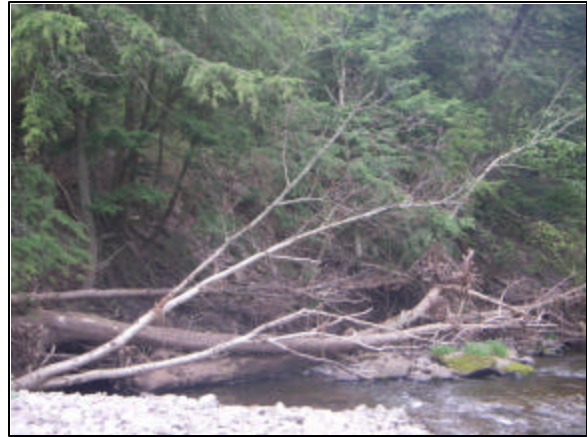
Just downstream of the tributary, there was a mass failure (Stations 48731 – 48643) along the left bank that caused 1,579 ft² of erosion and compromised mature woody vegetation. Multiple trees lined the toe of the bank and appeared to be contributing to localized scour, potentially exacerbating the erosion at this site. Aggradational conditions persisted through this stretch of the stream.

Mass failure at Stations 48731 - 48643

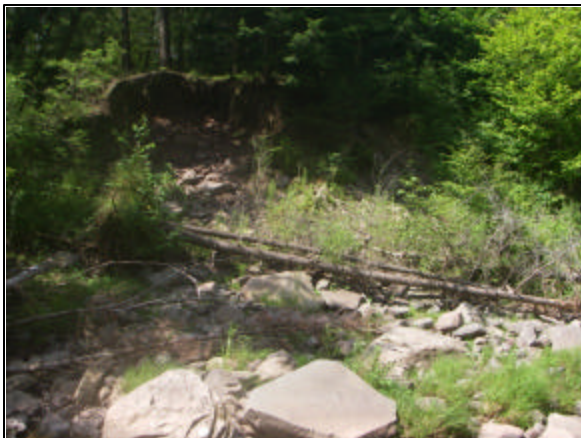
Continuing downstream, there was another mass failure (Stations 48400 – 48269) along 131 feet of the left stream bank that had resulted in approximately 3,004 ft² of erosion, exposing mixed till and compromising trees along the bank. At the time of the assessment, the bank appeared to be slowly recovering; there was a vegetated bench along the toe of the

Mass failure at Stations 48400 - 48269

bank and some young woody vegetation had been established along the face of the bank, which may help the bank to stabilize over time. This site may be appropriate for vegetative remediation with sedge plantings on the bench and along the toe of the bank to reinforce the vegetation that had begun to establish itself. Prior to proceeding with any work, this site may require a more detailed site assessment.

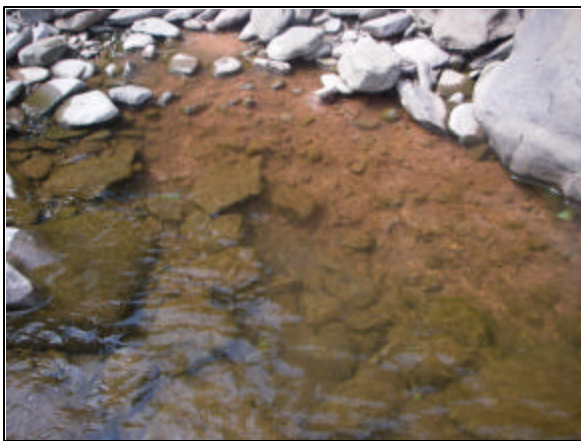
Continuing downstream, there was a 1.5 acre palustrine wetland (Stations 47457 - 46800) with scrub-shrub vegetation along the left stream bank. This wetland was classified as PSS1A (see Section 2.6 for detailed wetland type descriptions). Near the upstream portion of this wetland, there was a mass failure (Stations 47281 – 47126, Figure 5.5.1 Inset D) along the left bank. This mass failure had resulted in an erosion area of approximately 1,938 ft², exposing areas of mixed till and compromising mature trees along the bank. There were multiple exposures of lacustrine clay (Stations 47389 – 47189) along the stream bank and the channel bed throughout this erosion site, and just upstream of the erosion. Clay inputs into a stream are a serious water quality concern because they increase *turbidity*, degrade fish

Clay exposure at Stations 47389 - 47189

habitat, and can act as a carrier for other pollutants and pathogens. Excessive sediment deposition continued through this stretch of stream including side and point bars along the channel bed of both sides of the stream. Further downstream there was also a fallen tree (Station 46775) along the left bank that appeared to be causing localized scour upstream and downstream of the debris.

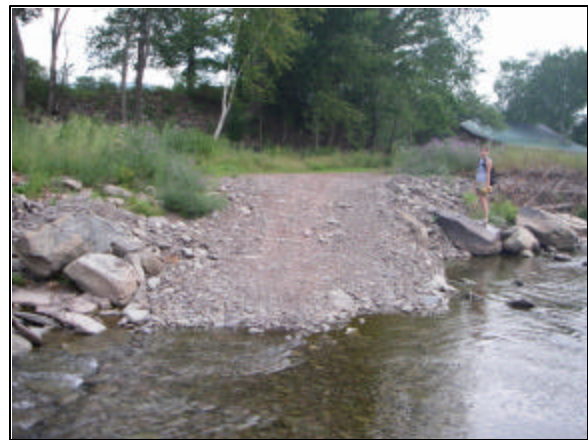
Stream crossing at Station 46726

installation was sparse, with herbaceous vegetation to the edge of the bank. There was a well established stream crossing (Station 46276) associated with the nearby agricultural lands that interrupted the rip-rap along the bank. This crossing appeared to contribute to the excessive sediment deposition along this stretch of stream and may contribute to the poor stability of the stream bank and failing rip-rap. There was also a 4-inch piped outfall (Station 46205), with no outfall protection, entering through the rip-rap on the right. Along the downstream portion of the rip-rap there was a flowing spring seep (Station 46124) that appeared to compromise the stream bank causing minor erosion along the rip-rap. Interplanting the rip-rap and reinforcing the toe of this stream bank with native shrub and sedge species is recommended. The risk to bank stability and water quality can be minimized by maintaining mature trees along the critical 100 foot buffer zone. There may be limitations to achieving the appropriate buffer width due to nearby residential and agricultural structures and pathways. However, a vigorous buffer with mature trees is important at this site because it may also filter nutrients and pollutants from the adjacent agricultural fields. The buffer width should be increased by the greatest amount agreeable to the landowners with plantings of native tree and shrub species. Following the 1996 flood, DEC issued an emergency stream disturbance permit (Station 46220) for flood repairs along 1,500 feet of stream channel including, woody debris removal and excavation of sand and gravel to restore stream flows to pre-flood conditions.

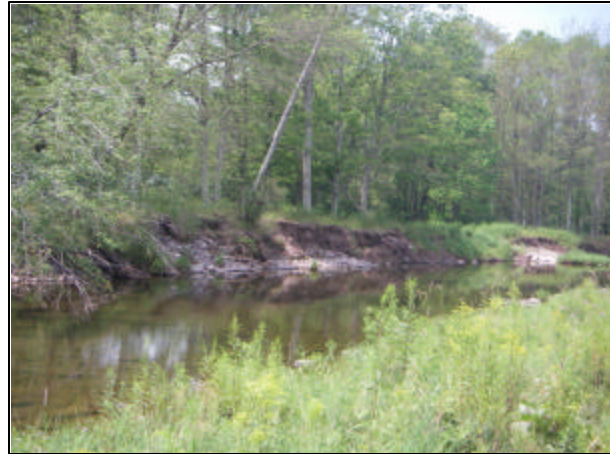
Erosion at Stations 45385 - 44945

45385 – 44945) along 440 feet of the left bank. The stream had caused approximately 2,200 ft² of the bank to erode, exposing mixed till and compromising some mature trees. Vegetation along the top of the bank was mixed; there was herbaceous vegetation that interrupted the continuity of the forest in some areas along the bank. Augmenting these areas with native trees and shrubs may help to improve bank stability. At the downstream portion of this eroding bank there were two fallen trees (Station 45039, Figure 5.5.1 Inset C) lying across the stream channel that provided an obstruction at all flows. At the time of the assessment, the debris did not appear to exacerbate the erosion at this site, however, during high flows the stream may flank this obstruction potentially contributing to increased erosion along this bank. There continued to be excessive sediment deposition through this reach of the stream including side, point and transverse bars.

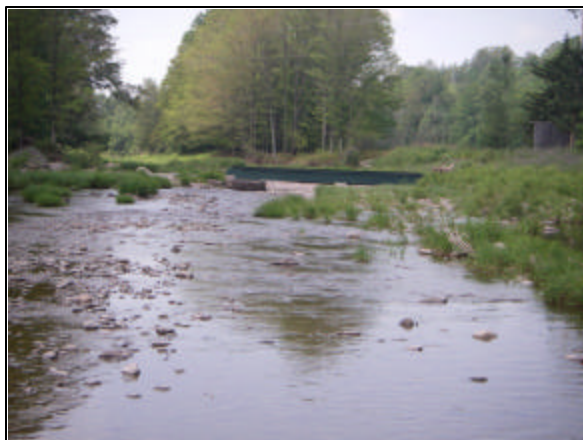
Bridge at Station 44190

sized bridge opening causes water to back up upstream of the bridge and reduces stream velocity. As stream velocity slows sediment drops out causing aggradation of the channel bed. The height and width of this bridge opening poses a constriction to flow. In high stage, the floodwater may seek conveyance through alternative paths, forming new channels around the bridge constriction, as appeared to have happened at this site. Following the 1996 flood, DEC issued an emergency stream disturbance permit (Station 43888) for flood repairs upstream and downstream of the bridge including, removal and excavation of sand and gravel to restore stream flows to pre-flood conditions. A second stream disturbance permit was issued in 2006 to remove sediment downstream of the bridge; this permit was also issued for the removal of the existing bridge and replacing it with a more appropriately sized bridge span that will convey flow during high-water. At the time of the assessment, work had not begun to replace this bridge. The permit allows in-stream or stream bank work between June 15th and September 30th of any year the permit is in effect; this permit expires on September 30, 2008.

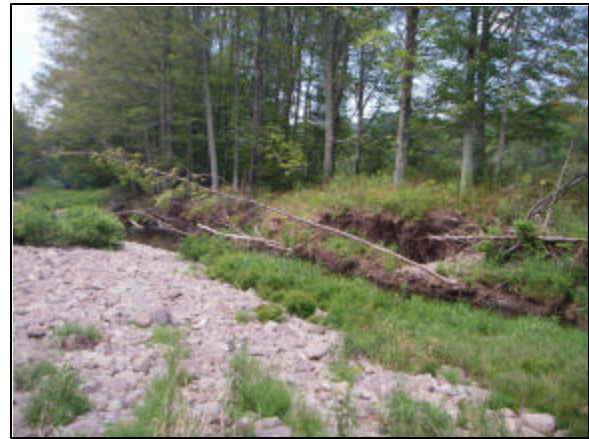
Erosion at Stations 43980 - 43791

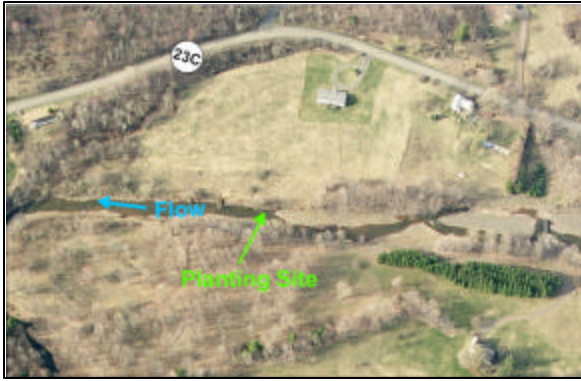
Riparian planting site at Station 43526

Opposite this erosion site, there was a riparian buffer planting site along the right stream bank (Station 43526) identified during the field assessment. There was 4,685 ft² of erosion (Stations 43500 – 42914) along 586 feet of the right stream bank compromising some small trees. Excessive sediment deposition continued through this stretch of the stream. There was some woody debris accumulated along the bank that appeared to be contributing to localized scour and upstream aggradation. Recommendations for this site include augmentation of the existing buffer with the planting of additional native trees and shrubs along the streambank and the upland area, and reinforcing the toe of the bank by planting sedges. Buffer width should be increased by the greatest amount agreeable to the landowners. Increasing the buffer width to at least 100 feet will increase the buffer functionality and protect the stream from nearby land uses.

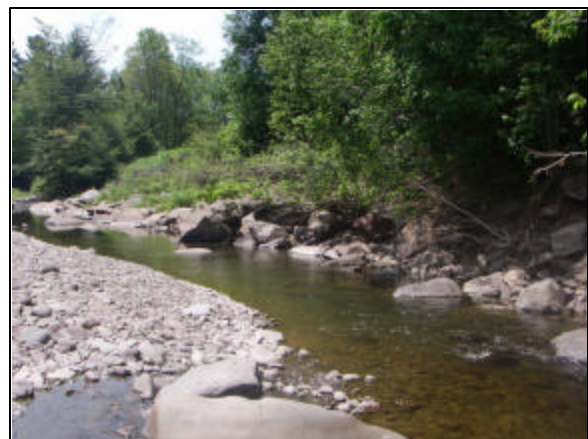
As the stream meandered to the left, the right bank was reinforced with rip-rap. The bank was high and steep with some mature woody vegetation to the top of the bank, beyond which there was mown lawn and a private residence. The rip-rap was in fair functional condition and poor structural condition. Interplanting the rip-rap and reinforcing the toe of this streambank with native shrub and sedge species is recommended. This planting will help to strengthen the revetment, while enhancing aquatic habitat. At the time of the field assessment, a recommended riparian

Rip-rap at Stations 42923 - 42713

planting site (Station 42758) was identified along the revetted bank due to the minimal riparian buffer between the stream and the mown lawn. As with previously mentioned riparian planting sites, recommendations for this planting site include enhancing the riparian buffer with native tree and shrub species and increasing the buffer width by the greatest amount agreeable to the landowners, with 100 feet being the optimal width for improving bank stability and protecting water quality.

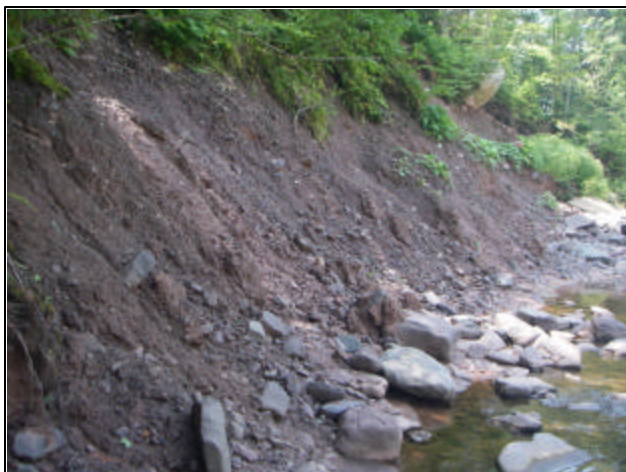
As the stream began to meander to the right, there was a mass failure (Stations 42407 – 42263) along the left bank. Streambank erosion often occurs on the outside of meander

Mass failure & clay exposure at Stations 42407 - 42263

bends where the stream velocity is greatest during high flows. Along this section of stream, during high water the toe of the bank was compromised and flow was undermining the steep slope, resulting in an erosion area of approximately 2,452 ft², exposing glacial till (Stations 42407 – 42263) throughout the bank and compromising mature trees. During high flows and times of active

erosion, a significant amount of clay may enter the stream from this bank; this poses a water quality threat due to the turbidity associated with clay exposures. Along the downstream portion of this eroding bank, there was a fallen tree that appeared to be contributing to localized scour and exacerbating the erosion at this site.

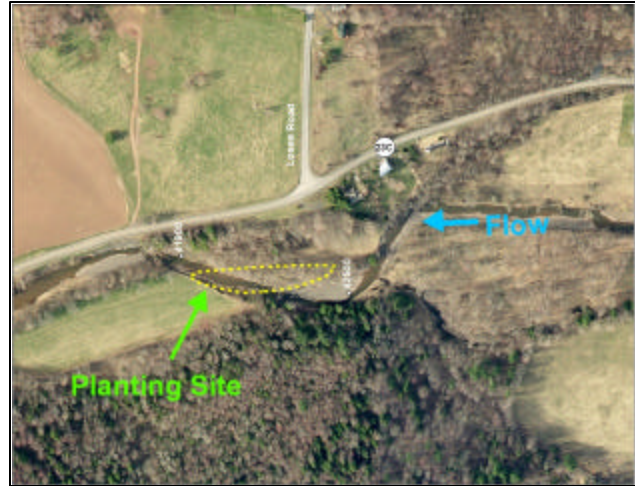
Downstream of the eroding bank, there was a recommended riparian planting site (Stations 42063 – 41900, Figure 5.5.1 Inset B) along the left bank. A natural riparian buffer was absent along this agricultural field, with herbaceous vegetation to the top of the bank and on the face of the relatively steep bank. Without deep-rooted shrub and tree species, this bank may be compromised during future high flows. Recommendations for this site include establishing a riparian buffer with the planting of native trees and shrubs along the streambank and the upland area. Buffer width should be increased by the greatest amount agreeable to the landowners. Increasing the buffer width to at least 100 feet will increase the buffer's functionality and protect the stream from nearby land uses. Starting along the downstream portion of this proposed riparian planting site there was a failing bank (Stations 41936 – 41787) resulting in an erosion area of approximately 1,640 ft² and exposing mixed till. The downstream portion of this erosion was along a thinly forested bank. Extending the planting area to include augmentation of the existing buffer may help to stabilize the eroding bank. Reinforcing the toe of the bank with native sedge species is also recommended.

*Wetland boundary approximately delineated by NWI
(Stations 42461 - 41944)
Planting site at Stations 42063 - 41900*

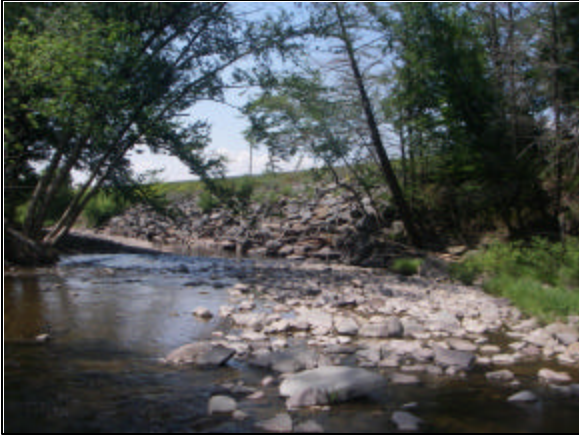
Rip-rap at Stations 41789 - 41587

rip-rap along the upstream portion (Stations 41789 – 41587) of the Route 23C road embankment was comprised of large rock and is in good structural and functional condition. The downstream portion of this revetted bank (Stations 41587 – 41323) was comprised of smaller rock with herbaceous vegetation throughout and some shrubby vegetation interspersed along the face of the embankment. This rip-rap was in fair

structural and functional condition. Interplanting the rip-rap and reinforcing the toe of this streambank with native shrub and sedge species is recommended. This planting will help to strengthen the revetment, while enhancing aquatic habitat. Excessive sediment deposition continued along this stretch of stream.

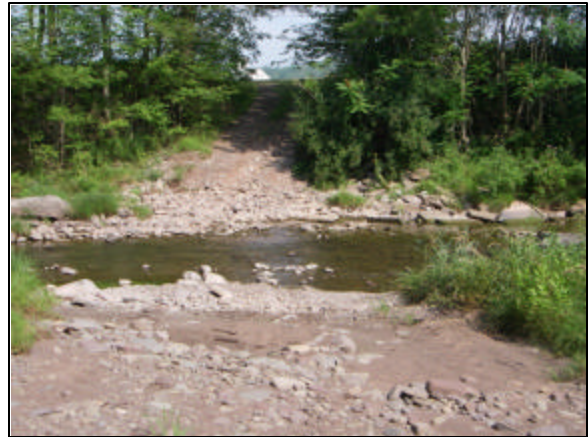
There was a well established stream crossing (Station 40923) associated with the nearby agricultural lands that interrupted the narrow riparian buffer along the bank. This crossing may be contributing to the excessive sediment deposition along this stretch of stream. Aggradational conditions including, side and point bars and full channel aggradation, persisted through this crossing area to the bridge at the end of this management unit.

Stream crossing at Station 40923

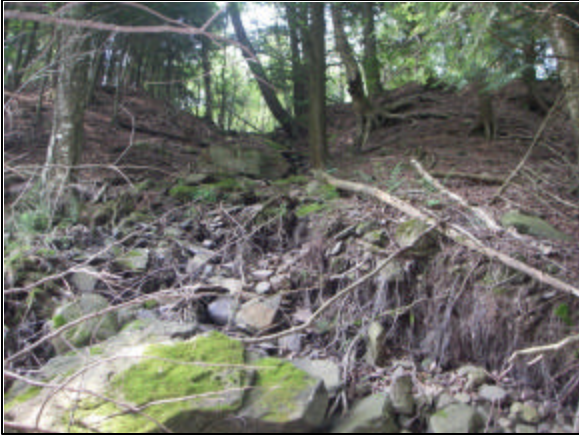
Tributary at Station 40453

40564 - 40413) along the bed and bank of this erosion site. During high flows and times of active erosion, a significant amount of clay may enter the stream from this bank, contributing to increased turbidity and impaired water quality. Entering along the left, there was an unnamed intermittent tributary (Station 40453) that drained the hill slope. At the time of the assessment there was no flow through this tributary. However,

it appeared to have been contributing to the erosion at this site; the channel created by the tributary flow had exposed many roots, and some trees were compromised and had started to fall along the intermittent channel. Further downstream, another tributary (Station 40154) entered along the left bank of the East Kill. It was a small intermittent unnamed tributary that had little flow at the time of the assessment.

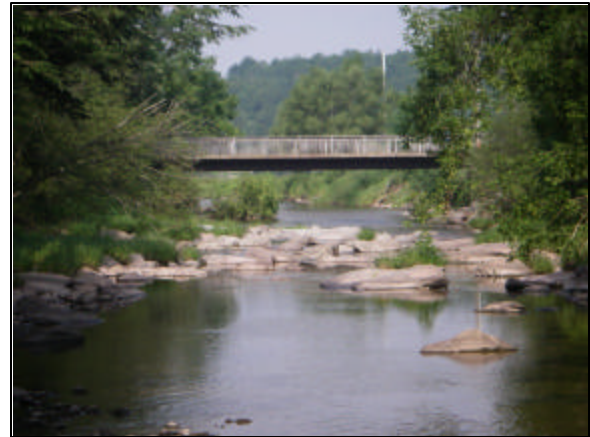
This management unit ended at a private bridge (Station 40130) that provided access to agricultural land. There was rip-rap along both stream banks upstream and downstream of the bridge. Excessive sediment deposition upstream of the bridge was observed at the time of the assessment.

Bridge at Station 40131

Deposits such as these are commonly caused by inadequate sizing of the bridge opening. An undersized bridge opening causes water to back up upstream of the bridge, reducing stream velocity, which results in sediment deposition. While bankfull flows and may flow freely through this bridge, higher flows may backwater, resulting in the upstream aggradation. If this bridge is replaced in the future, it is recommended that a hydraulic analysis be conducted in order to determine the appropriate bridge width that will provide the capacity to convey flood flows through the opening.
