East Kill Management Unit 8

Town of Jewett – Route 296 Bridge (Station 26386) to Station 15760

This management unit began at the Route 296 Bridge (#1045150), and continued approximately 10,626 ft. to Station 15760.

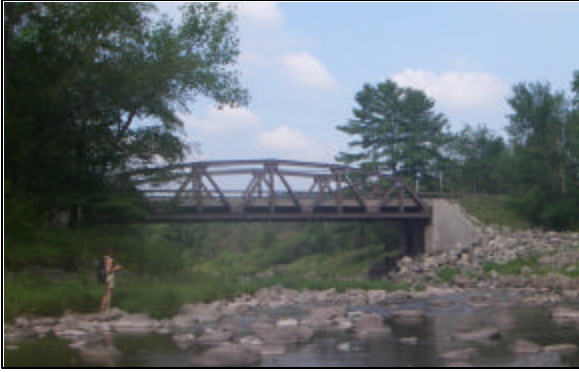
This management unit began as the stream flowed under the Route 296 bridge (Station 26386, Bridge # 1045150). There were aggradational conditions upstream and downstream of the bridge, which is commonly caused by inadequate sizing of the bridge opening. An undersized bridge opening causes water to back up upstream of the bridge, reducing stream velocity, which results in sediment deposition. While bankfull flows may

Route 296 Bridge at Station 26386

flow freely through this bridge, higher flows may backwater, resulting in upstream aggradation. If this bridge is replaced in the future, it is recommended that a hydraulic analysis be conducted in order to determine the appropriate bridge width that will provide the capacity to convey flood flows through the opening. Rip-rap (Stations 26386 – 26124) continued from management unit #7

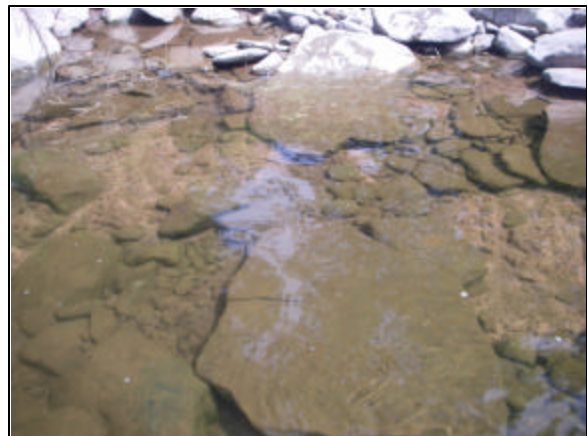
Along the right channel bed, there was a clay exposure (Station 25739). Clay inputs into a stream are a serious water quality concern because they increase *turbidity*,

Clay exposure at Station 25739

degrade fish habitat, and can act as a carrier for other pollutants and pathogens.

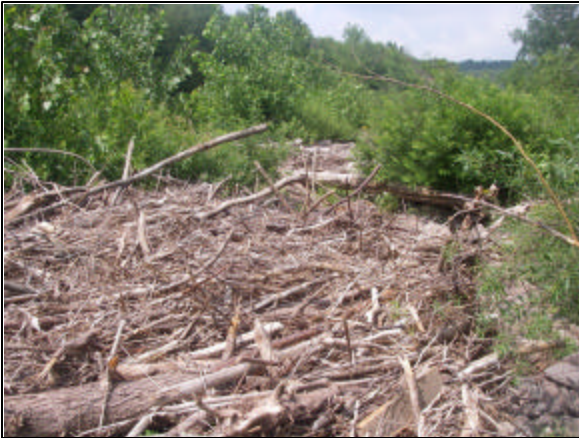
Woody debris at Station 25423

Continuing downstream, there was a flood chute along approximately 797 feet of the right stream bank (Stations 25618 – 24821); the flood chute channel was comprised of cobble and there was herbaceous vegetation and willows at the divergence and at its' confluence with the East Kill. Large amounts of woody debris (Station 25423) had accumulated along the flood chute.

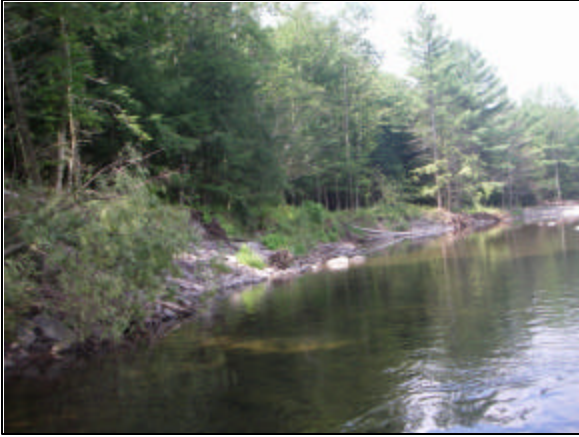
Erosion at Stations 25219 - 24929

caused approximately 1,742 ft² of erosion (Stations 25219 - 24929) along 290 feet of the left stream bank. Along the eroded bank there were exposed roots and some small trees had been compromised. The land use along the top of the left bank and the adjacent upland area was forested, providing a well vegetated riparian buffer. This erosion site appeared to be slowly recovering with herbaceous vegetation becoming established on the face

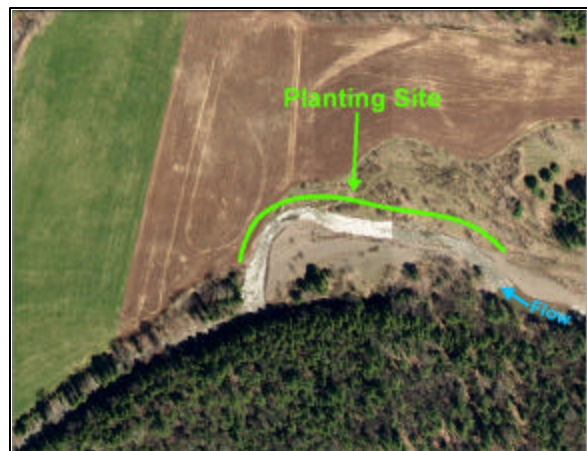
Along the meander bend downstream of the erosion site, a proposed riparian planting site (Stations 24813 – 24113) was identified on the right. The riparian zone had herbaceous vegetation with some shrubs and small trees interspersed along the top of the stream bank. A vigorous buffer with mature trees is important at this site because it may filter nutrients and pollutants, if any, from the adjacent agricultural fields. Recommendations for this site include augmentation of the existing buffer with the planting of additional native trees and shrubs along the streambank and the upland area. Increasing the buffer width to at least 100 feet will help to stabilize the stream bank and protect water quality through this reach by slowing stormwater runoff and filtering pollutants associated with nearby

Riparian planting site at Stations 24813 - 24113

land use. While riparian planting activities are appropriate along the majority of this site, careful consideration should be given to planting activities along the eroding portion (discussed below) of the site. Prior to proceeding with any work along the erosion, this site would require a more detailed assessment.

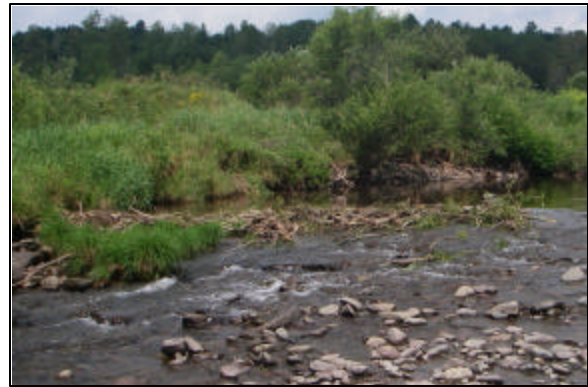
Along the proposed planting site there was a beaver dam across most of the channel that provided a partial obstruction to flow, causing water to back-up upstream of the dam. While beaver impoundments can sometimes be a nuisance, beavers have historically played a beneficial and ecologically important role in the stream system. Beaver activity adds organic debris (trees, leaves, etc. which provide the base of the food chain), reduces water velocities and flood-related hazards downstream, and creates wetland areas that filter sediment and release water to the stream and groundwater slowly throughout the year.

*Beaver dam at Station 24274
photo orientation – looking upstream*

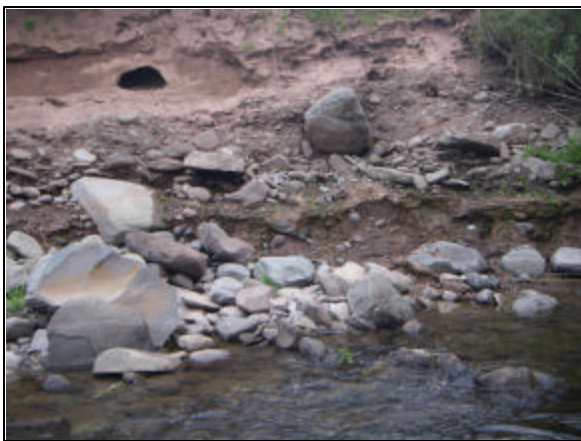
Along the downstream portion of the proposed riparian planting site, the right stream bank had eroded (Stations 24278 – 24045, Figure 4.8.1 Inset D) along approximately 233 feet of the bank. The top of the bank had herbaceous vegetation and there were two clay exposures (Stations 24235 and 24115) along the toe of the bank and the right channel bed. During the field assessment, this bank was identified as a proposed Bank Erosion Monitoring

*Clay exposure at Station 24235
photo orientation – looking at*

Site (BEMS) to study erosion along this reach. To monitor BEMS, a cross-section and long profile may be conducted to collect baseline data. Once the baseline data has been collected, this cross-section can be resurveyed in the future to calculate the bank's erosion rate. Improving the riparian buffer along this site is important however, other stream bank stabilization techniques

may be required to reinforce the bank and to minimize any loss of planted vegetation.

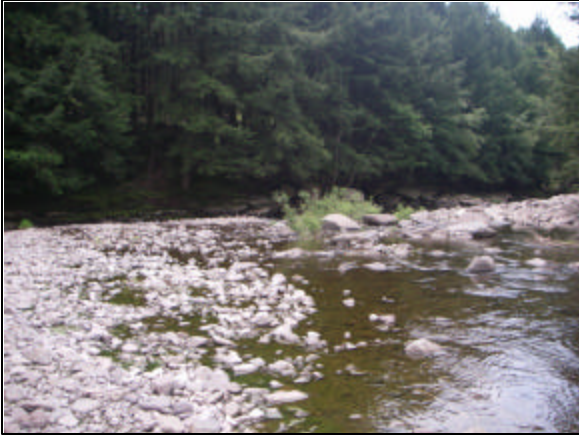
Full channel aggradation at Station 24050

Along the meander bend with the planting site and wetland complex, there was excessive sediment deposition (Stations 24949 – 24050) throughout the reach including, side, *point*, and *transverse bars*, as well as full channel aggradation. Continuing downstream, there was bedrock (Stations

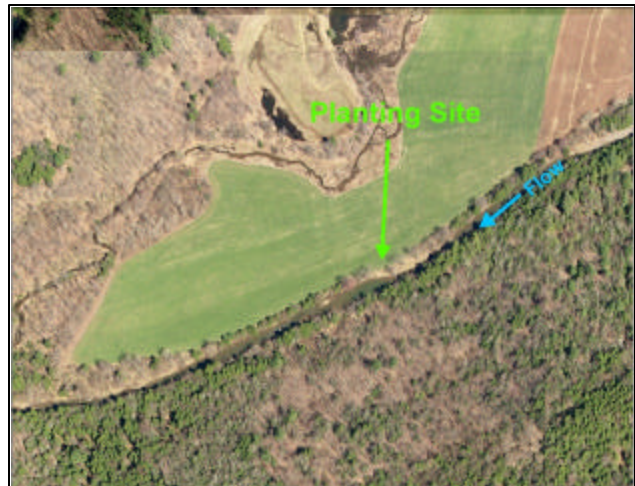
Continuing downstream along the agricultural fields on the right, a second proposed riparian planting site (Stations 23116 – 22800) was identified. The riparian zone along this site had herbaceous vegetation with a few small trees interspersed along the bank and a maintained field along the top of the bank. Upstream and downstream of the site (as seen in the aerial photo) the riparian zone had mature woody vegetation but the buffer was narrow. Recommendations for this site are similar to the recommendations for the first planting site and include enhancing the buffer width by planting native trees and shrubs along the bank and upland area. Buffer width should be increased by the greatest amount agreeable to the landowners. Increasing the buffer width to at least 100 feet will increase the buffer functionality, such as filtering nutrients and pollutants, if present, from the nearby agricultural fields.

Riparian planting site at Stations 23116 - 22800

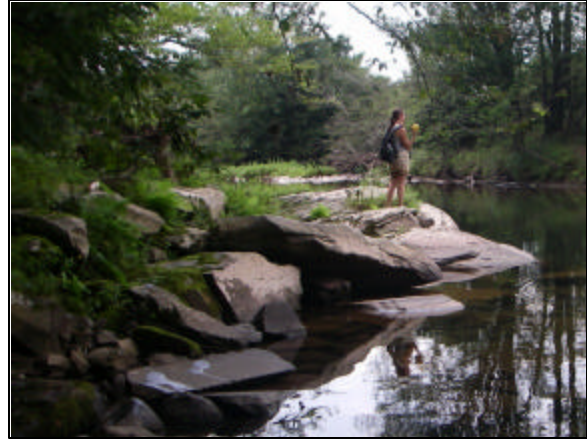
Opposite the planting site, there was bedrock (Stations 22985 – 22887) along approximately 98 feet of the left bank and channel bed. The bedrock provided lateral control along the left, and provided grade control for the channel by preventing *degradation* or *downcutting* of the stream, the process by which streambeds and floodplains are lowered in elevation by eroding downward into the stream bed over time.

Bedrock at Stations 22985 - 22887

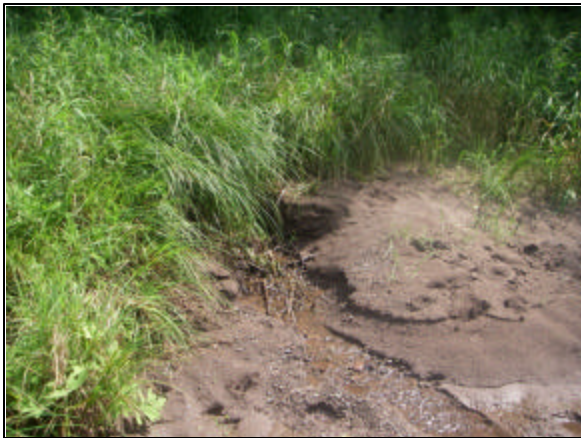
Further downstream there were two small unnamed intermittent tributaries (Station 22468 and 22412) that entered along the left bank. An *intermittent stream* flows periodically or seasonally, and is dry for part of the year; both tributaries were flowing at the time of the assessment. Along approximately 27 feet of the right stream bank, there was a minor erosion site (Station 22371). There was a thin line of trees at the top of the bank, many of their roots had become exposed and the face of the bank had bare soil. This erosion site was along the agricultural field that had previously been identified for streamside planting upstream. Although it is a minor erosion site, and may self-recover over time, enhancing the buffer width may help to stabilize the bank and protect water quality.

Tributary at Station 22412

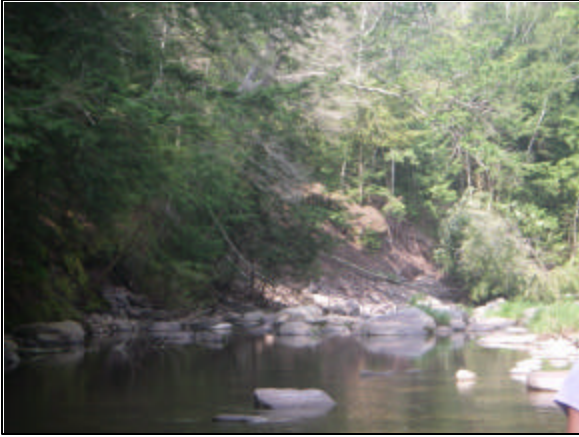
As the stream meandered to the right, excessive sediment deposition continued including a point bar (Stations 21411 – 21087) along the right channel bed. Point bars are commonly located on the inside of a meander bend and are caused by a decrease in the stream's capacity to transport sediment. Opposite the point bar, there was a *mass failure* (Stations 21427 – 21251) along 176 feet of the left stream bank. A mass failure is a large slope failure associated with downcutting stream channels and undermined support of steep

Mass failure at Stations 21427 - 21251

slopes. Streambank erosion often occurs on the outside of meander bends where the stream velocity is greatest during high flows. This site had an erosion area of approximately 5,261 ft² and mature trees had been compromised along the bank. Along the downstream portion of this erosion site, some of the trees along the toe of the bank had fallen into the stream channel. This woody debris (Station 21287) caused a minor

obstruction at low flows and appeared to exacerbate the erosion upstream and downstream of the debris.

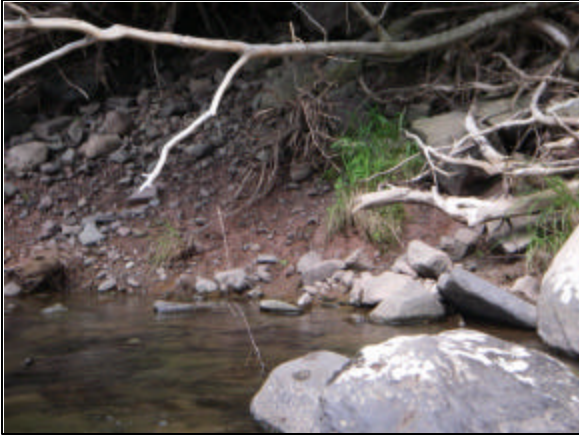
Clay exposure at Stations 20700 - 20669

As the stream meandered to the left, there was a clay exposure along the bank and channel bed along approximately 31 feet of the right stream bank. As mentioned previously, clay exposures are of concern due to the negative impact fine sediment has on water quality and aquatic habitat.

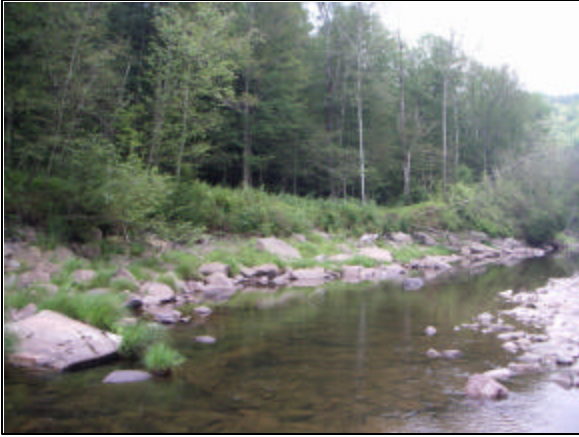
Erosion at Stations 19282 - 19040

As the stream meandered to the right, there was erosion (Stations 19282 – 19040) on the outside of the meander bend along approximately 242 feet of the left stream bank. There was some herbaceous vegetation along the face of the stream bank, with some exposed roots and fallen trees. The top of the bank was forested. This erosion site may be a good candidate for remediation using vegetative toe and bank protection, but may self recover with time. Recommendations include reinforcing the toe of the stream bank with sedge species and planting native shrubs and trees along the bank. Prior to proceeding with any vegetative plantings, the erosional conditions should be given careful consideration when identifying the appropriate species and locations for plantings.

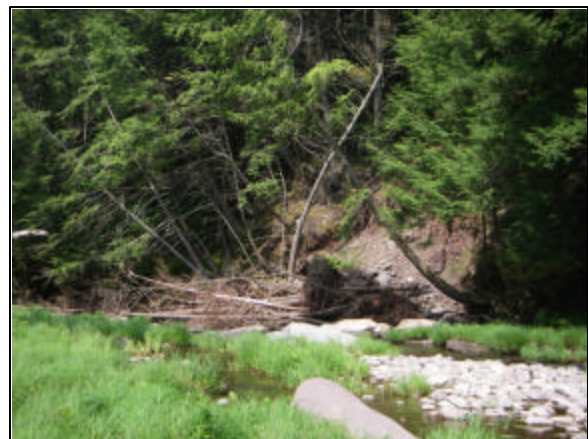
As the stream meandered to the left, there was a mass failure (Stations 18856 – 18642) along the right stream bank. This mass failure had resulted in an erosion area of approximately 3,215 ft², exposing areas of mixed till and compromising mature trees along the bank. The fallen trees that have accumulated along the toe of the bank appeared to be exacerbating the erosion upstream and downstream of the debris. Along the upstream portion of this eroding bank, there was a lacustrine clay exposure (Stations 18854 – 18789, Figure 4.8.1 Inset B)

Mass failure at Stations 18856 - 18642

for approximately 65 feet. During high flows and times of active erosion, a significant amount of clay may enter the stream from this bank; this poses a water quality threat due to the turbidity associated with clay exposures. Excessive sediment deposition continued along this stretch of the stream.

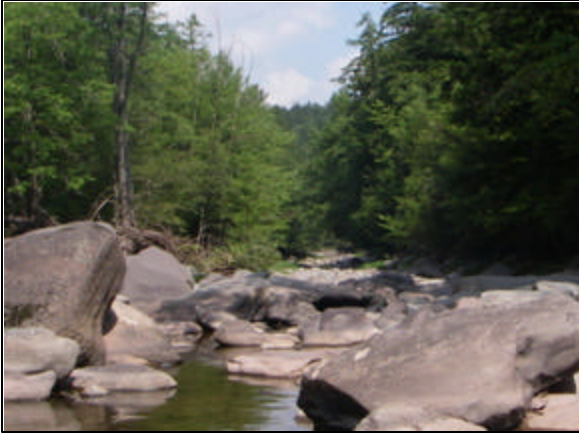
Channel divergence at Station 18284

As the stream meandered to the right, there was a channel divergence (Station 18284), forming a split channel, for approximately 410 feet that flowed around a well vegetated center bar with trees, shrubs and herbaceous vegetation. Flow through the secondary channel on the right side of the center bar was intermittent; at the time of the assessment, flow appeared to be subsurface at the divergence and through most of the channel until further downstream when there was a small amount of flow through the secondary channel as it converged (Station 17874, Figure 4.8.1 Inset A, photo orientation looking upstream) with the main channel. The secondary channel appeared to exacerbate the aggradational conditions at the confluence and further downstream; there was excessive sediment deposition including, point and center bars and full channel aggradation.

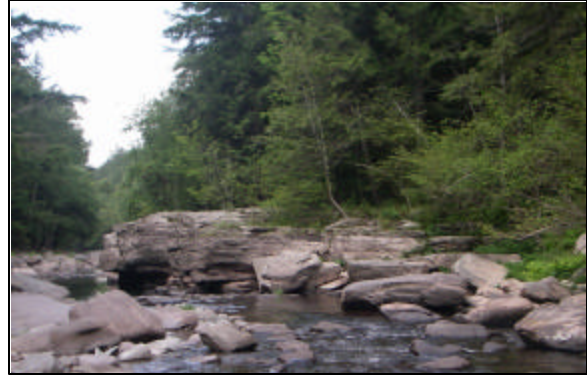
As the stream meandered to the left, there was bedrock (Stations 17118 - 16898) along approximately 220 feet of the right stream bank and bed, gradually covering the full bed of the stream channel. The bedrock provided lateral control by limiting stream bank erosion and provided grade control by preventing *degradation* or *downcutting* of the stream. There was seepage along most of the bedrock including a small intermittent tributary (Station 16875) that entered along the right stream bank. Aggradational conditions persisted along this stretch of stream and continued downstream.

Bedrock at Stations 17118 - 16898

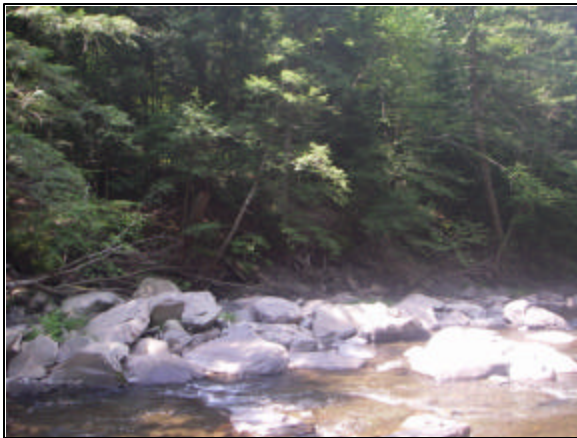
Further downstream, there was erosion (Stations 16572 – 16332) along approximately 240 feet of the left stream bank. The erosion was compromising trees and shrubs along the bank, many roots were exposed and some of the woody vegetation was slumping or had

Erosion at Stations 16572 - 16332

fallen along the bank. The erosion had also caused a 215 feet clay exposure (Stations 16546 – 16331) along the bank and right channel bed. The stream banks and the upland area were forested along this stretch of stream. This erosion site may be a good candidate for remediation using vegetative toe and bank protection, but may self recover with time. Management unit #8 ended downstream at Station 15760.

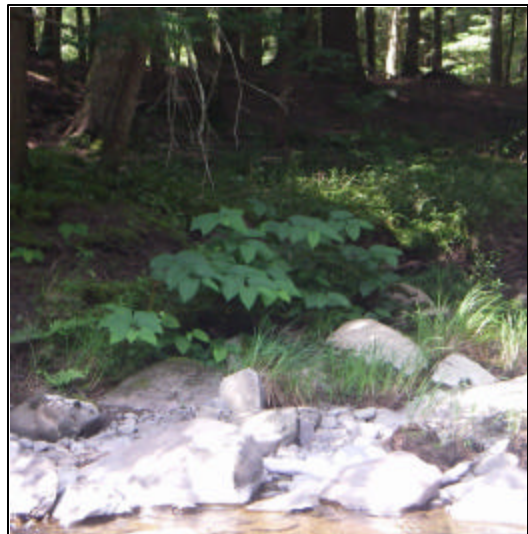
Some plant species that are not native can create difficulties for stream management, particularly if they are invasive. Japanese knotweed (*Fallopia japonica*), for example, has become a widespread problem in recent years. Knotweed shades out other species with its dense canopy structure (many large, overlapping leaves), but stands are sparse at ground level, with much bare space between narrow stems, and without adequate root structure to hold the soil of stream banks. The result can include rapid stream bank erosion and increased surface runoff leading to a loss of valuable topsoil. Japanese knotweed locations were documented as part of the stream feature inventory conducted during the summer of 2006 (Riparian Vegetation Mapping, Appendix B). The first appearance of Japanese knotweed on the East Kill occurred in management unit #7, although there are some significant stands of knotweed in management unit #7, the knotweed occurrences in management unit #8 were primarily small patches. In total, nine Japanese knotweed occurrences along an estimated length of 97 feet were documented in this management unit during the stream feature inventory.

Japanese knotweed at Station 17560

The best means for controlling knotweed is prevention of its spread. Therefore, efforts should be made to ensure that all fill brought into the area is clean and does not have fragments of knotweed or other invasive plants. If Japanese knotweed sprouts or small stands are observed, they should be eradicated immediately to avoid further spread. The Japanese knotweed patches that were observed in this unit may be removed to prevent further spread, see appendix B for more information on knotweed removal methods.
