East Kill Management Unit 9

Town of Jewett –Station 15760 to Mill Hollow Road Bridge (Station 11254)

Stream Channel Conditions (2006)

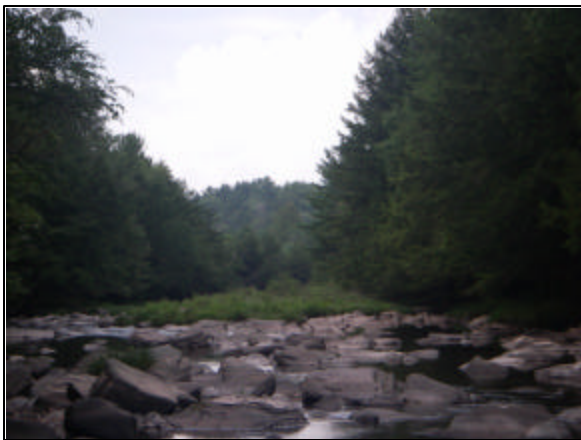
Sidebar at Stations 15431 - 14222

valley with forested vegetation along both sides of the stream. Downstream of the start of the unit, there was a side bar (Station 15431) along approximately 1,209 feet of the right channel bed. The side bar was well vegetated with grasses, sedges and willows. Side bars result from *aggradation*, or the deposition of material that has eroded and transported from other areas.

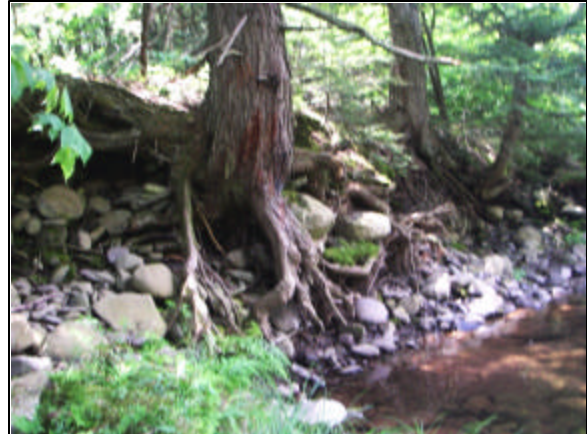
Erosion at Stations 15360 - 15319

Continuing downstream there was erosion (Stations 15360 – 15319) along approximately 41 feet of the left stream bank. There was a narrow line of trees with exposed roots along the stream bank. Along the top of the bank there was a hiking/all-terrain vehicle trail on the terrace, beyond the trail, the hillside was forested. Although this erosion site did not appear to pose a significant threat to water quality, if it continues to erode, the trail may be compromised. This erosion site may be a good candidate for remediation using vegetative toe and bank protection. Reinforcing the toe of this streambank with native shrub and sedge species is recommended.

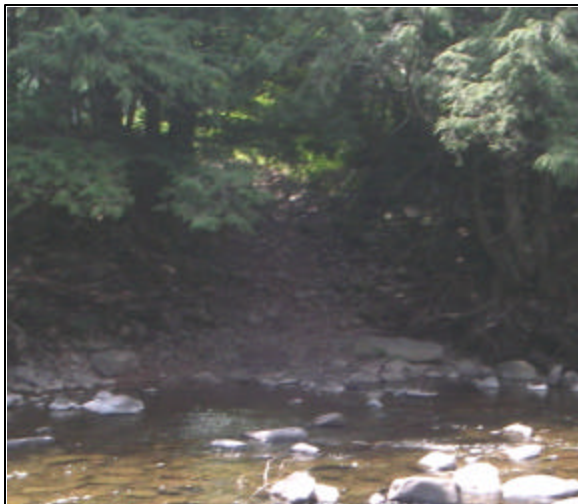
*Channel crossing at Station 14675
Photo orientation – looking at*

Further downstream, there was a channel crossing (Station 14675) that disrupted the forested riparian buffer on the right and left stream banks. The land cover along both sides of the stream was primarily forested with some areas of open field with woody vegetation. The crossing appeared to be used for recreational purposes to access a field beyond a relatively narrow buffer along the left bank.

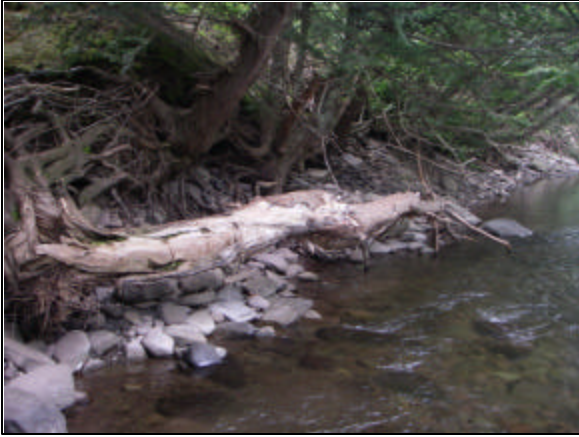
*Woody debris at Station 14281
Erosion at Stations 14656 - 14093*

Continuing downstream, there was a more significant erosion site (Stations 14656 – 14093) along approximately 563 feet of the left stream bank. The stream had caused an erosion area of approximately 3,938 ft² along

this low bank, and resulted in exposed roots, slumping trees, and multiple lacustrine clay exposures (Station 14593, Figure 4.9.1 Inset D, and Stations 14251 – 14094). Both clay exposures were along the stream bank and channel bed of this erosion site, with the first affecting approximately 18 feet of the stream along the upstream portion of the erosion and the second affecting approximately 157 feet of the stream channel further downstream.

Clay inputs into a stream are a serious water quality concern because they increase *turbidity*, degrade fish habitat, and can act as a transport mechanism for other pollutants and pathogens. There was a fallen tree along the eroding bank (Station 14281) that appeared to contribute to scour upstream of the debris and caused a minor obstruction at low flows.

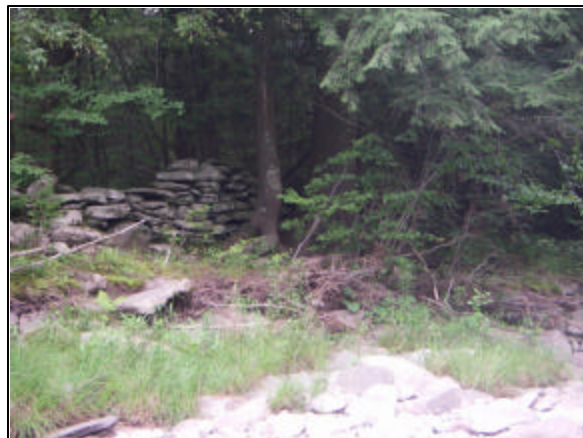
Rockwall at Stations 14083 - 13809

Just downstream of the erosion site, the left stream bank was reinforced with a rock wall (Station 14083 – 13809) for approximately 274 feet. The rock wall was in fair structural and functional condition.

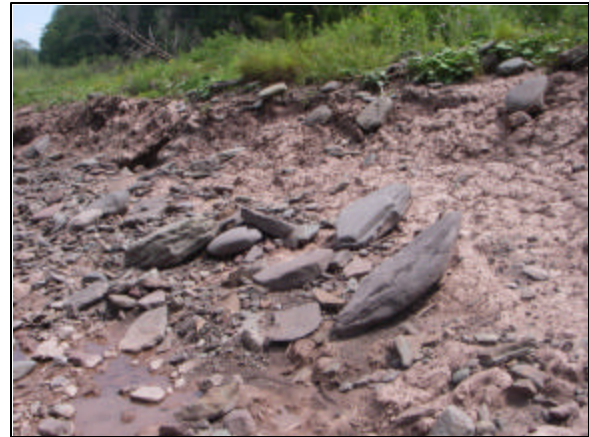
*Clay deposited along Stations 14088 - 12959
photo orientation – looking at*

typically caused by a decrease in sediment transport capacity. There were willows and herbaceous vegetation, including grasses and sedges, interspersed along the bar. There was also a significant amount of clay along the bar that appeared to be deposited from the failing stream bank on the right.

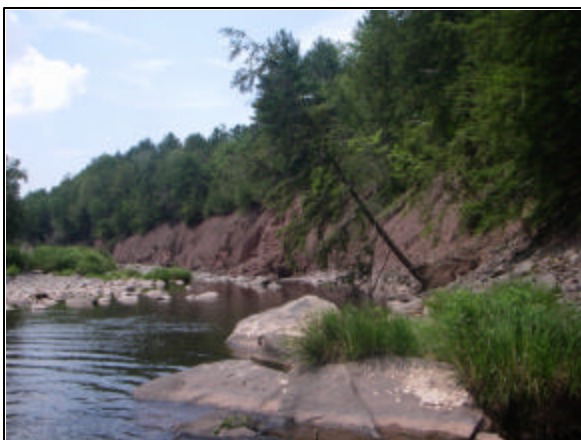
*Mass failure and clay exposure
at Stations 13961 – 13005*

Along this meander bend, there was a *mass failure* (Stations 13961 – 13005) along the right stream bank. Stream bank erosion often occurs on the outside of meander bends where the stream velocity is greatest during high flows. Along this section of stream, the *thalweg*, or deepest part of the stream channel, flowed up against the right stream bank undermining the vertical slope, resulting in an erosion area of approximately 28,673 ft², exposing mixed till and compromising mature trees at the top of the bank. There were two woody debris accumulations (Stations 13700 and 13536) within the stream channel along this eroding bank, they posed minor obstructions at low flows and one (Station 13536) of them appeared to contribute to localized aggradation. There was a continuous lacustrine clay exposure (Stations 13961 – 13005) along the eroding bank and across the entire channel bed. During high flows and times of active erosion, a significant amount of clay enters the stream from this bank; this poses a water quality threat due to the turbidity associated with clay exposures. Further exacerbating the erosion and

mass failure at this site, were the multiple small seeps along this bank, including an unnamed intermittent tributary (Station 13727) and an unnamed perennial tributary (Station 13480, Figure 4.9.1 Inset C). To study erosion along this reach, it is recommended that this site be considered for a potential Bank Erosion Monitoring Site (BEMS). To monitor BEMS, a cross-section and long profile may be conducted to collect

This stream bank may cause a considerable amount of turbidity during high flow, if conditions persist, with the stream bed continuing to incise and the bank continuing to erode, water quality will continue to

be impaired due to clay inputs. Full restoration at this site may be necessary to minimize these potential impacts. Restoration techniques may include the installation of *rock vanes*, which protect the stream bank by redirecting the thalweg away from the stream bank and towards the center of the channel; these structures tend to improve in-stream habitat through scour, oxygenation, and cover. To restore this site, it may be necessary to move the channel away from the vertical stream bank along the right by utilizing the wide floodplain area along the left. Full restoration would also involve *bioengineering* techniques that utilize live vegetation, either alone or in combination with harder materials such as rock or (dead) wood, to stabilize soils associated with stream banks or hill-slopes. Roots stabilize the soil, while stems, branches and foliage slow high velocity water, reducing erosion and encouraging

deposition of fine sediment. If this site is to be considered for full restoration, an in-depth survey, a thorough morphological assessment and a project design would be required.

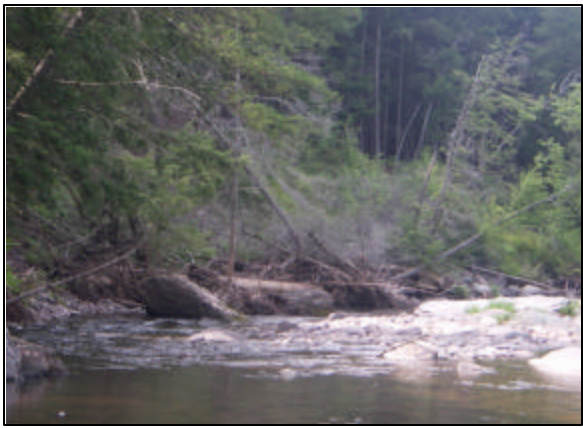
*Mass failure along Stations 12416 – 11845
Woody debris Station 12123*

As the stream meandered to the right, there was a mass failure (Stations 12416 – 11845, Figure 4.9.1 Inset B) along approximately 571 feet of the left stream bank. This mass failure resulted in an erosion area of approximately 22,860 ft², exposing lacustrine clay (Stations 12349 – 11833) and compromising mature trees along the bank. The height of this bank is variable; it starts low and then increases going downstream,

until it tapers off at the end of the erosion site. There was a significant amount of woody debris (Station 12123) along the erosion site that appeared to contribute to upstream aggradational conditions and localized scour, exacerbating the erosion of the bank. Opposite the eroding bank, there was excessive sediment deposition that formed a side bar (Stations 12454 – 12249) and point bar (Stations 12238 – 11800) along the right channel bed.

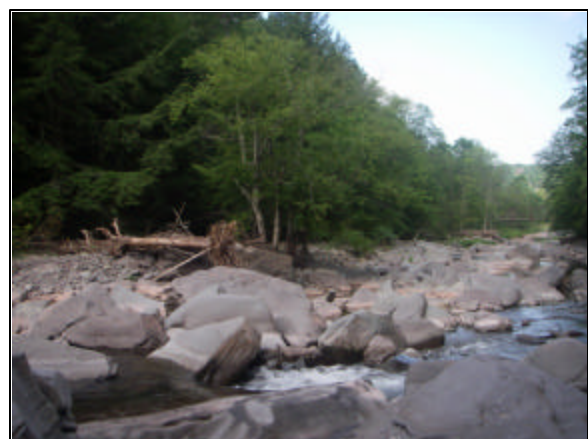
*Point bar at Stations 11736 – 11264
Woody Debris at Station 11700*

Continuing downstream, a small unnamed intermittent spring seep entered along the right bank through herbaceous vegetation including grasses and sedges; there was flow at the time of the assessment. As the stream meandered to the left, there was a point bar (Stations 11736 – 11264) that stretched for approximately 472 feet along the left channel bed and ended just upstream of the Mill Hollow Road Bridge. There was abundant woody debris accumulated in multiple

locations along the point bar, none of these caused an obstruction at low flow. The woody debris (Station 11700) along the upstream portion of the point bar did not appear to have a significant impact on stream channel conditions while the two debris accumulations (Stations 11493 and 11364) further downstream did appear to contribute to minor localized scour.

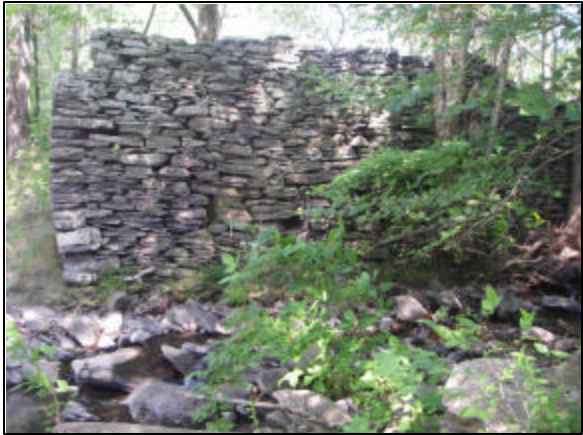
Rock wall and Roaring Brook at Station 11312

Continuing downstream, Roaring Brook (Station 11312, Figure 4.9.1 Inset A, photo orientation – looking at) entered along the right stream bank. This tributary drains the slopes of Cave Mountain before it reaches the flatter topography of the valley floor where it enters the East Kill. As a result of this stream slope change, the tributary lost its ability to transport sediment gathered from the mountain slopes, and began to deposit

sediment at its mouth and into the more gently sloped East Kill. This is a common feature of confluence areas, which often contain extensive sediment bars, function as important sediment storage areas, and are typically among the most dynamic and changeable areas in the stream system. The New York State Department of Environmental Conservation classifies streams and rivers based on their “best use” (NYSDEC, 1994). Roaring Brook was classified C(t) by the NYS DEC, indicating that the best uses for this stream were the support of fisheries, including trout fisheries, and other non-contact activities. There was a rock wall installed perpendicular to the East Kill, reinforcing the right stream bank of Roaring Brook; it was in fair structural and functional condition. The rock wall was part of the remains of an old Mill.

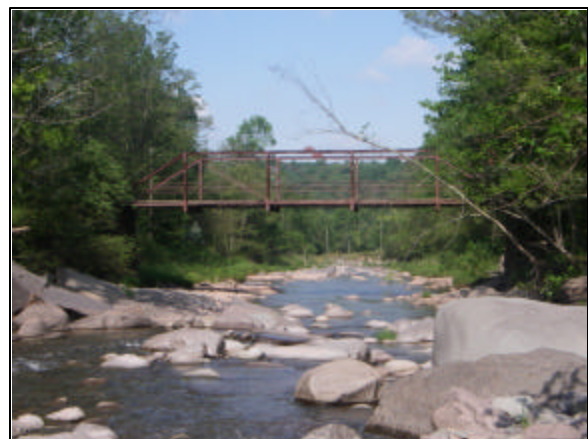
Mill Hollow Road Bridge at Station 11254

The management unit ended as the stream flowed under the Mill Hollow Road Bridge (Station 11254, Bridge # 3201140). At the time of the assessment, excessive

sediment deposition was observed upstream of the bridge. Such aggradation conditions are commonly caused by inadequate sizing of the bridge opening. An undersized bridge opening causes water to back up upstream of the bridge, reducing stream velocity, which results in sediment deposition. While bankfull flows may flow freely through this bridge, higher flows may backwater, resulting in the upstream aggradation. If this bridge is replaced in the future, it is recommended that a hydraulic analysis be conducted in order to determine the appropriate bridge width that will provide the capacity to convey flood flows through the opening.

The ability of the channel to convey sediment was also affected by the Mill Hollow Road Bridge that appeared to be contributing to backwater conditions and upstream channel aggradation. Installation of floodplain drainage under bridge approaches may reduce the backwater conditions and improve sediment transport continuity.

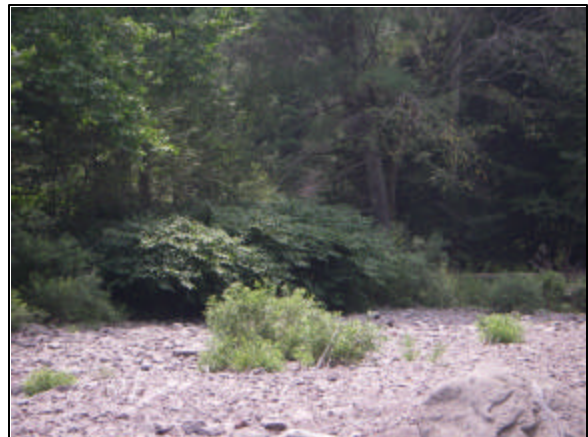
Japanese knotweed at Station 13045

Some plant species that are not native can create difficulties for stream management, particularly if they are invasive. Japanese knotweed (*Fallopia japonica*), for example, has become a widespread problem in recent years. Knotweed shades out other species with its dense canopy structure (many large, overlapping leaves), but stands are sparse at ground level, with much bare space between narrow stems, and without adequate root structure to hold the soil of stream banks. The

result can include rapid stream bank erosion and increased surface runoff leading to a loss of valuable topsoil. Japanese knotweed locations were documented as part of the stream feature inventory conducted during the summer of 2006 (Riparian Vegetation Mapping, Appendix B). The first appearance of Japanese knotweed on the East Kill occurred in management unit #7, although there are some significant stands of knotweed in management unit #7, the knotweed occurrences in management unit #9 were primarily small patches. In total, 2

Japanese knotweed occurrences along an estimated length of 23 feet were documented in this management unit during the stream feature inventory. The best means for controlling knotweed is prevention of its spread, therefore, efforts should be made to ensure that all fill brought into the area is clean and does not have fragments of knotweed or other invasive plants. If Japanese knotweed sprouts or small stands are observed, they should be eradicated immediately to avoid further spread within this unit and downstream management units. The Japanese knotweed patches that were observed in this unit may be removed to prevent further spread, see appendix B for more information on knotweed removal methods.
