East Kill Management Unit 10

Town of Jewett – Mill Hollow Road Bridge # 3201140 (Station 11254) to Mill Hollow Road Bridge # 3201130 at County Route 17 (Station 6699)

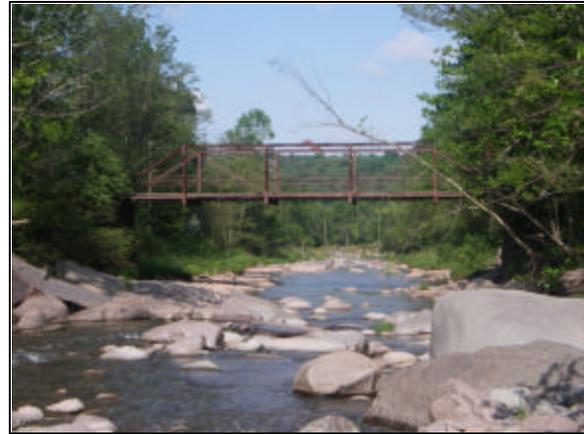
continued downstream, there was a mix of forested vegetation and residential and agricultural land use with herbaceous vegetation. At the time of the assessment, sediment deposits upstream and downstream of the bridge were noted. Deposits such as these are commonly caused by inadequate sizing of the bridge opening. An undersized bridge opening causes water to back up upstream of the bridge, reducing stream velocity, which results in sediment deposition. While bankfull flows may flow freely through this bridge, higher flows may backwater, resulting in stream channel aggradation. If this bridge is replaced in the future, it is recommended that a hydraulic analysis be conducted in order to determine the appropriate bridge width that will provide the capacity to convey flood flows through the opening.

Mill Hollow Road Bridge at Station 11254

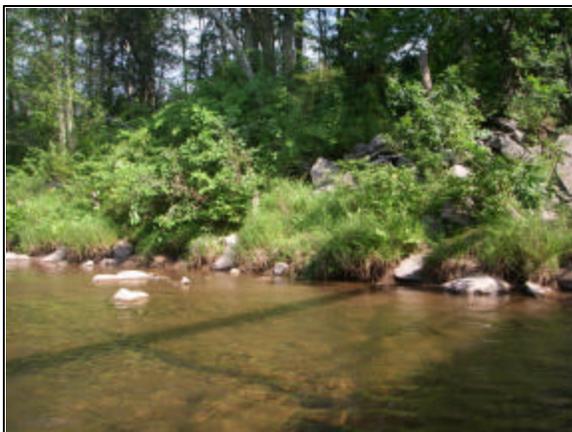
Rock wall at Stations 11231 - 11144

stream bank, just downstream from the bridge, was reinforced with a stacked rock wall (Stations 11231 – 11144). The rock wall was in poor functional condition and had failed structurally. Some herbaceous and shrubby vegetation had become established intermittently along the rock wall. Interplanting the rock wall and reinforcing the toe of this stream bank with additional native shrub and sedge species is recommended. This planting will help to strengthen the revetment, while enhancing aquatic habitat.

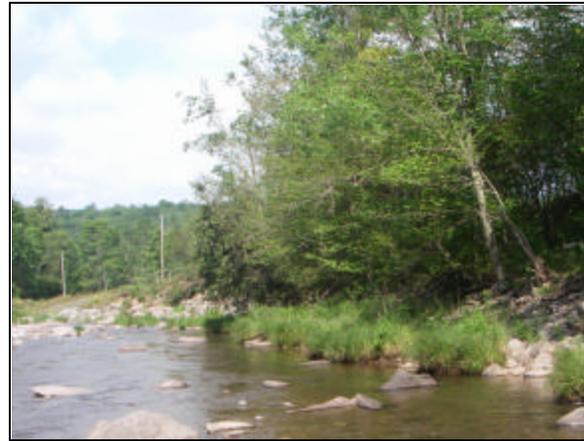
Continuing downstream, there was an erosion site (Stations 10888 – 10200, Figure 4.10.1 Inset A) along approximately 688 feet of the right stream bank. Along the upstream and downstream portions of the erosion site, there was a narrow buffer of trees on the top of the bank. Along a significant portion of the erosion site there was an open field of herbaceous vegetation on the top of the bank, and the face of the bank had minimal

Erosion at Stations 10888 - 10200

The erosion site may need to be

reinforced using a combination of stabilization techniques including *bioengineering* to minimize loss of planted materials. Bioengineering involves the use of live vegetation, either alone or in combination with harder materials such as rock or (dead) wood, to stabilize soils associated with stream banks or hillslopes. Roots stabilize the soil, while stems, branches and foliage slow high *velocity* water, reducing erosion and encouraging deposition of fine sediment. Prior to proceeding with any vegetative plantings this site may require a more detailed site assessment and erosional conditions should be given careful consideration when identifying the appropriate species and locations for plantings. Along the downstream portion of this erosion site, small young trees have been compromised, with one fallen tree (Station 10218) causing a minor obstruction at low flow.

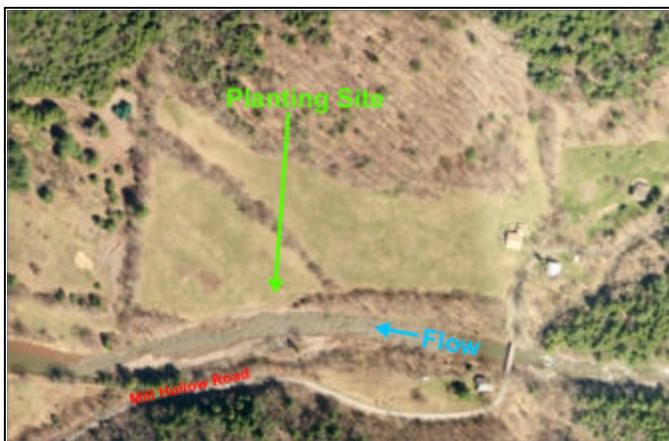
vegetation. During the field assessment, a proposed riparian planting site (Station 10637, Figure 4.10.1 Inset A) was identified along this eroding stream bank. A vigorous buffer with mature trees is important at this site because it may also filter nutrients and pollutants, if any, from the adjacent fields. Recommendations for this site include augmentation of existing buffer and establishing a wooded buffer where herbaceous vegetation is maintained to the top of the stream bank. Buffer width should be

Riparian planting site at Station 10637

increased by the greatest amount agreeable to the landowners.

Increasing the buffer width to at least 100 feet will increase the buffer functionality. To improve the riparian zone, native trees and shrubs should be planted along stable portions of the stream bank and the upland area.

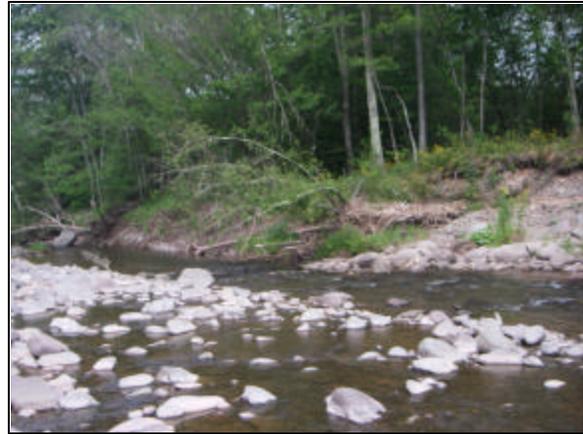
Woody debris at Station 10218

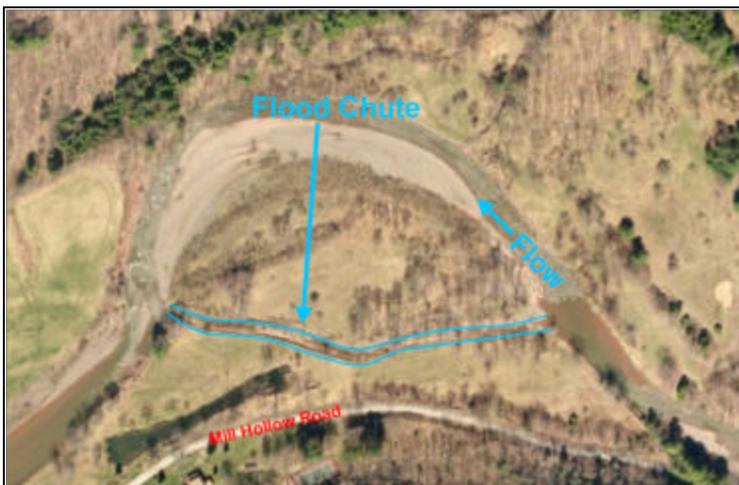
Flood chute at Stations 9815 - 8467

split off from the main channel. Flood chutes convey flow through a secondary channel during periods of high flows; this flood chute converges (Station 8467) with the main channel approximately 892 feet downstream. At the time of the assessment, flow was subsurface at the divergence; further downstream along the flood

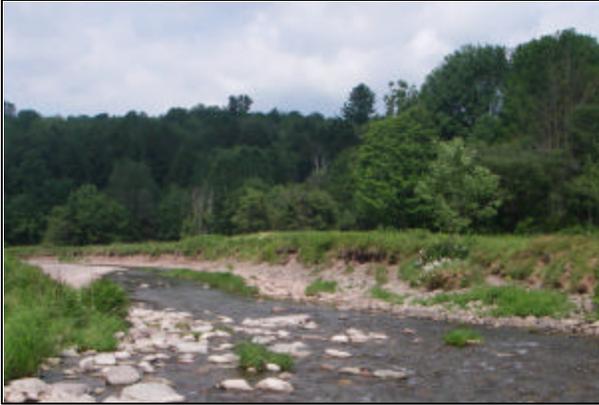
Erosion at Stations 9800 - 9059

As the stream meandered to the left, there was erosion (Station 9800 – 9059) along approximately 741 feet of the right stream bank. Stream bank erosion often occurs on the outside of meander bends where the stream velocity is greatest during

high flows. The face of the stream bank had little to no herbaceous vegetation and there was a maintained field at the top of the bank with some woody vegetation interspersed. Along the erosion site there were young trees (Stations 9269 and 9128) that had been compromised and fallen along the bank in two locations, causing only minor obstructions at low flow. This erosion site may be a good candidate for remediation using vegetative toe and bank protection. Prior to proceeding with any work, this site may require a more detailed site assessment. To help stabilize the bank, recommendations for this site include establishing a woody buffer with the planting of native trees and shrubs along the stream bank and the upland area. Buffer width should be established for the greatest amount agreeable to the landowners. Increasing the buffer width to at least 100 feet will increase the buffer functionality, help to improve stream bank stability and protect water quality by filtering pollutants associated with the nearby land use.

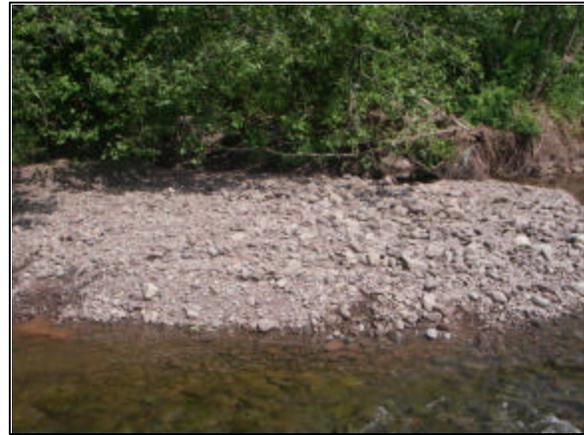
Continuing along this meander bend, an unnamed tributary entered from the right stream bank (Station 9065). At the time of the assessment, flow was subsurface. This tributary drains the slopes of Tower Mountain before it reaches the flatter topography of the valley floor where it enters the East Kill. As a result of this stream slope change, the tributary lost its ability to transport sediment

*Aggradation at tributary confluence
Station 9065*

gathered from the mountain slopes, and began to deposit sediment at its mouth and into the more gently sloped East Kill. This is a common feature of confluence areas, which often contain extensive sediment bars, function as important sediment storage areas, and are typically among the most dynamic and changeable areas in the stream system. Aggradational conditions persisted along this meander bend. The New York State Department of Environmental Conservation classifies streams and rivers based on their “best use” (NYSDEC, 1994). This tributary was classified C(ts) by the NYS DEC, indicating that the

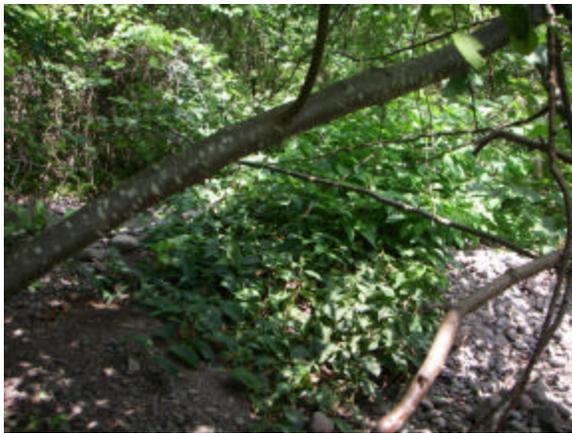
Japanese knotweed at Station 9070

Near the confluence of this tributary, there was a patch of Japanese knotweed (Station 9070) on the right bank. Japanese knotweed is an invasive non-native species which does not provide adequate erosion protection due to its very shallow rooting

Removal of this Japanese Knotweed stand is recommended to prevent the spread of this invasive species (See Section 2.7 Riparian Vegetation).

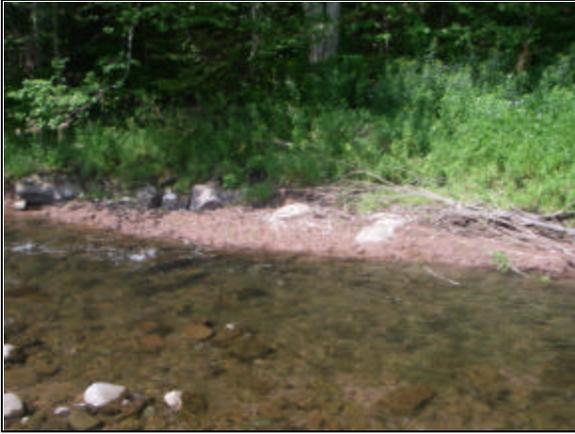
Clay exposure at Stations 9000 - 8794

Further downstream, along the same meander bend, there was a lacustrine clay exposure (Stations 9000 – 8794) along the right stream bank and channel bed. Clay

inputs into a stream are a serious water quality concern because they increase *turbidity*, degrade fish habitat, and can act as a carrier for other pollutants and pathogens.

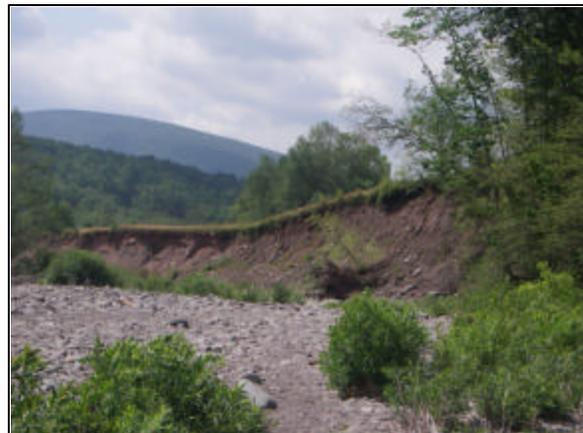
The clay exposure was followed by a significant erosion site (Stations 8794 – 8505) that had an erosional area of approximately 5,772 ft², and had compromised some woody vegetation causing it to fall along the stream bank. The woody debris appeared to contribute to some localized scour exacerbating the erosion along this bank. The face of the stream bank was bare and lacustrine clay (Stations 8794 – 8505) had been exposed along the length of the eroded bank. During high flows and times of active erosion, a significant amount of clay may enter the stream from this bank; this poses a water quality threat due to the turbidity associated with clay exposures. There was mown lawn to top of the stream bank. The risk to bank stability can be minimized by maintaining mature trees along the critical 100 foot buffer zone. However, due to the active erosion along this high and steeply sloping stream bank, establishing and maintaining a deep-rooted wooded buffer may not be feasible. Improving the riparian buffer along this site is important, however, other stream bank stabilization techniques may be required to reinforce the bank prior to establishing a buffer planted with native shrubs and trees.

Erosion at Stations 8794 - 8505

During the field assessment, this bank was identified as a proposed Bank Erosion Monitoring Site (BEMS) to study erosion along this reach. To monitor the BEMS, a cross-section and long profile may be conducted for the collection of baseline data. Once the baseline data has been collected, this cross-section can be resurveyed in the future to calculate the bank's erosion rate.

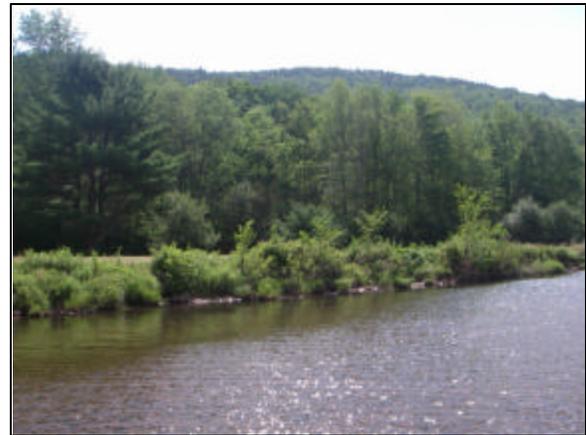
Downstream of the first wetland, there was a proposed riparian planting site on the left stream bank (Station 8037) that was identified at the time of the assessment. There was mowed lawn to the top of the bank, while the face of the bank was vegetated with herbaceous and shrubby vegetation.

Riparian planting site at Station 8037

Recommendations for this site include augmentation of existing buffer with the planting of additional native trees and shrubs along the stream bank and the upland area. Buffer width should be increased by the greatest

amount agreeable to the landowners. Increasing the buffer width to at least 100 feet will increase the buffer functionality.

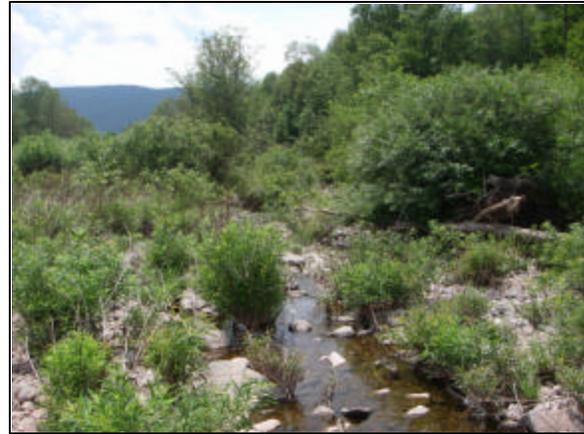
Continuing downstream, there was a channel divergence (7926) along the right, forming a secondary channel around an island that had herbaceous and shrubby vegetation and an accumulation of gravel deposits and woody debris. Further downstream, there was erosion along approximately 191 feet of the right bank of the secondary channel (Stations 7770 – 7579, Figure 4.10.1 Inset B). The erosion had exposed the roots of woody vegetation and caused some trees to fall along the bank. The fallen woody debris appeared to cause localized scour upstream and downstream of the debris, exacerbating the erosion along this bank.

Channel divergence at Station 7926

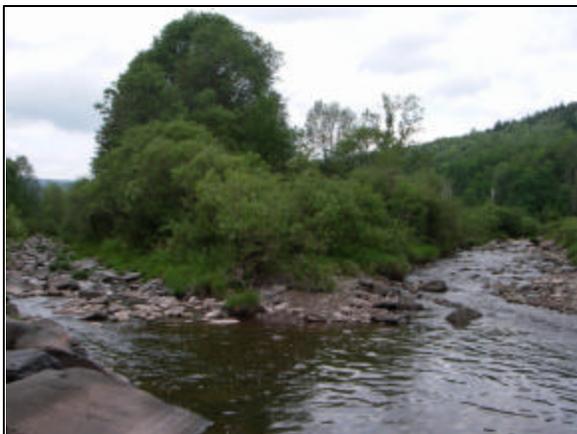
Channel convergence at Station 6747

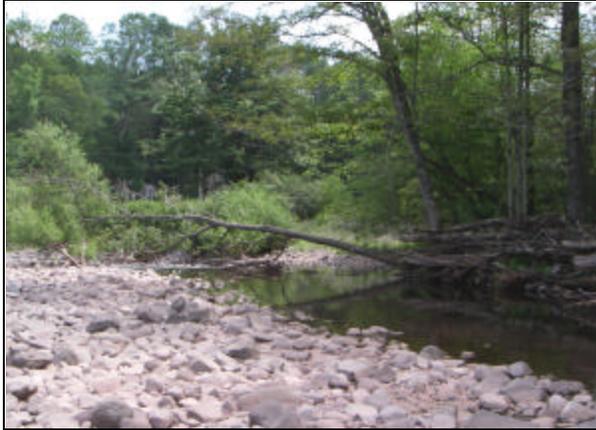
Woody debris at Station 7320

island. Both accumulations of woody debris caused minor obstructions at low flow, the first obstruction appeared to contribute to deposition upstream and localized scour downstream of the debris, while the second appeared to contribute to aggradational conditions.

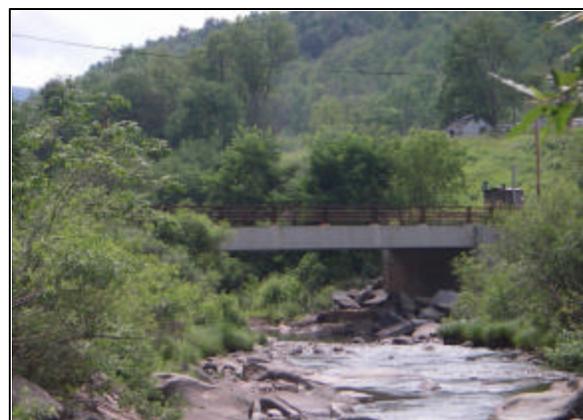
This management unit ended at the Mill Hollow Road Bridge at County Route 17 (Station 6699, Bridge # 3201130). At the time of the assessment excessive aggradational conditions were observed upstream of the bridge. While the bridge opening seemed to provide an adequate span for low flows, higher flows appear to backwater, reducing stream velocity, which

Mill Hollow Road Bridge at Station 6699

results in upstream aggradation. If this bridge is replaced in the future, it is recommended that a hydraulic analysis be conducted in order to determine the appropriate bridge width that will provide the capacity to convey flood flows through the opening.

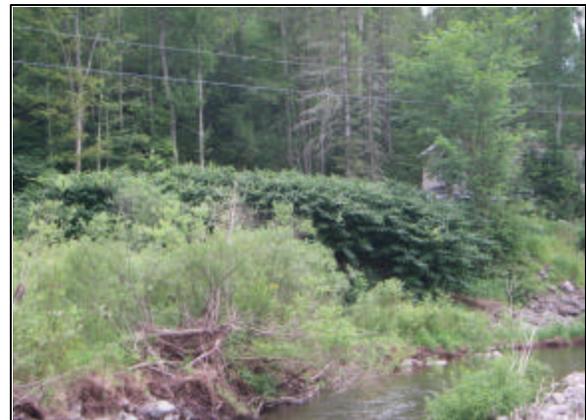
Japanese knotweed at Station 7142

The best means for controlling knotweed is prevention of its spread, therefore, efforts should be made to ensure that all fill brought into the area is clean and does not have fragments of knotweed or other invasive plants. If Japanese knotweed sprouts or small stands are observed, they should be eradicated immediately to avoid further spread within this unit and downstream management units. The Japanese knotweed patches that were

observed in this unit may be removed to prevent further spread, see Section 2.7 Riparian Vegetation for more information on knotweed removal methods.
