# Manor Kill Management Unit 10

Town of Conesville –Station 1775 to Station 0

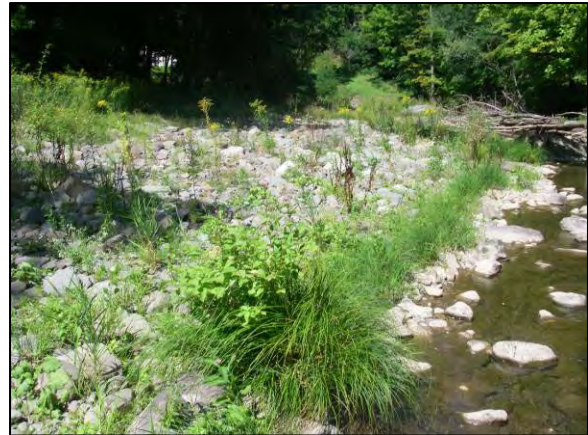
As the stream meandered to the left, a point bar had formed along the left streambank (Station 1758). Point bars commonly form on the inside of meander bends, where stream velocity is slower during high flows, allowing sediment to drop out of the water column and settle along the stream bed. This point bar extended approximately 174 feet and was mainly comprised of cobble and gravel and some vegetation.

*Point Bar at Station 1758*

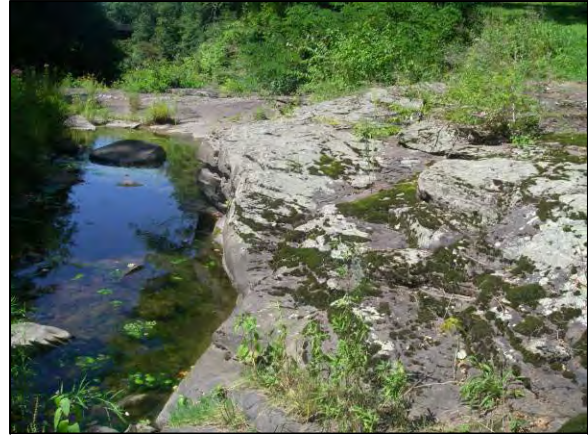
Continuing downstream, the slope of the streambed began to steepen. The stream channel became confined as bedrock lined the banks and bed of the channel (Figure 4.10.1, Inset D, Stations 1437-0). The stream approached a series of breaks in the elevation of the bedrock resulting in a multi-tiered waterfall; steep vertical banks were on both sides of the stream, with a mature forest along the top of the left bank and a mixture of forest and buildings along the right. The bedrock provides lateral control by limiting stream bank erosion; it provides grade control for the channel by preventing degradation or downcutting of the stream, the process by which streambeds and floodplains are lowered in elevation by eroding downward into the stream bed over time. This bedrock began at Station 1437 and continued beyond Manor Kill's confluence with the Schoharie Reservoir.

*Bedrock Beginning at Station 1437*

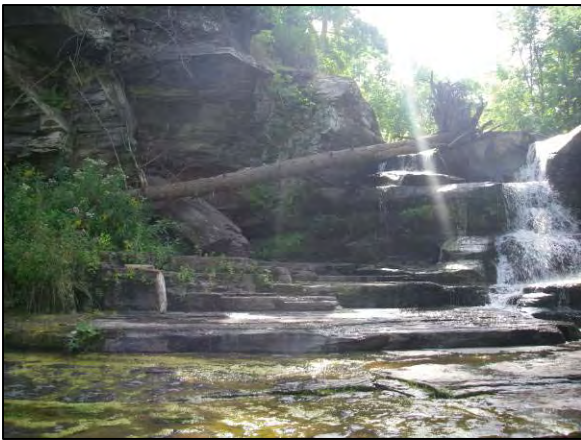
*Tree at Station 1248*

and woody debris that had been deposited along the left streambank (Station 1328). The remains of an old stacked rock foundation was also observed along the left bank at Station 1305. Along the right bank there was an additional woody debris obstruction. A large tree with its root wad extended from the top of the waterfalls to the lower tier.

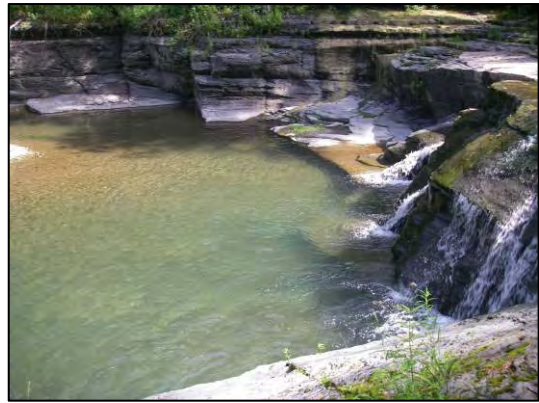
At Station 1154 the stream flowed over a second tier dropping approximately 10 feet into a large, deep pool.

*Pool at Station 1154*

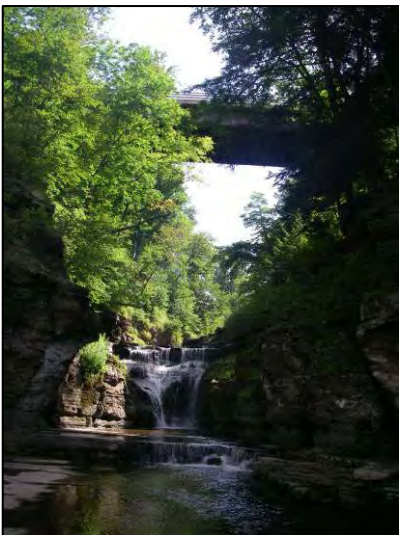
*Waterfall & Bridge at Station 800*

Continuing downstream, the stream flowed over a fourth tier; cascading over a series of rock steps and dropping approximately 43 feet into a large, deep pool.

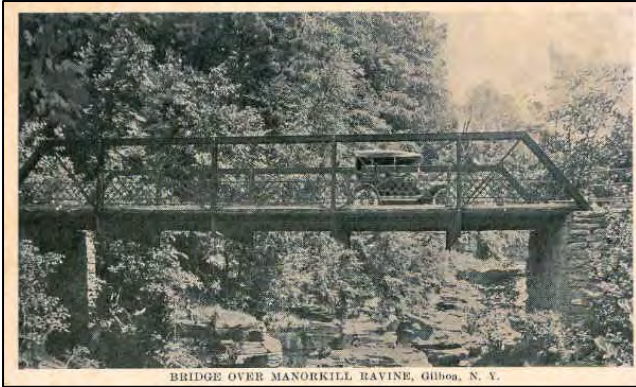
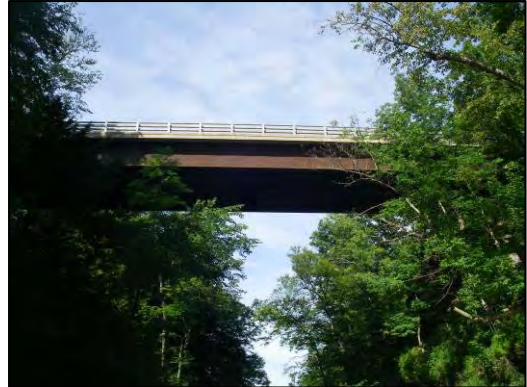
County Route 39/Prattsville Road Bridge (ID 00000002264080) spanned approximately 160 feet across the Manor Kill at Station 800. This bridge, orginally built in 1930, was replaced by NYCDEP in 2003. It appeared to be in good functional and structural condition; the abutments

*Postcard of Original Bridge (ca .1930) & Picture of Current Bridge (2008)  
Postcard Photo Credit: The Catskill Vintage Views*

showed no signs of scour and the bridge appeared to pass stream flows effectively. Under the bridge, a seep entered the stream over vegetated bedrock along the left bank. Management Unit 10 ended as the stream exited the pool downstream of the fourth tier and flowed into the Schoharie Reservoir. (Figure 4.10.1, Inset A, Station 0). The Schoharie Reservoir contributes approximately 15% of NYC water annually (Joint Venture, 2004).

| Summary of Recommendations<br>Management Unit 10 | |
|--|---|
| Infrastructure | When bridges are replaced, construct with the appropriate height and width to allow conveyance of flood flows. Inspect the stormwater infrastructure to ensure some level of treatment prior to emptying into the stream. |

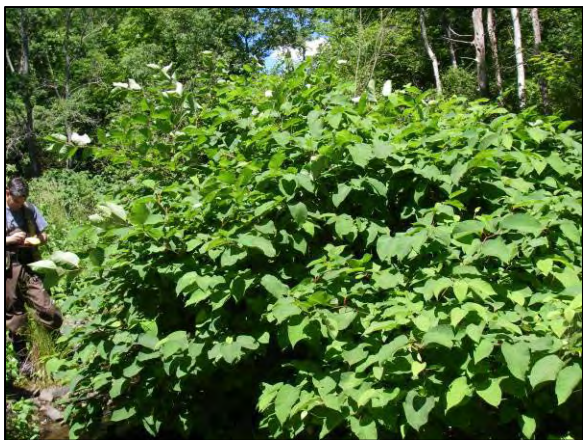
*Japanese knotweed at Station 42469*

years. Knotweed shades out other species with its dense canopy structure (many large, overlapping leaves), but stands are sparse at ground level, with much bare space between narrow stems, and without adequate root structure to hold the soil of streambanks. The result can include rapid streambank erosion and increased surface runoff leading to a loss of valuable topsoil. Japanese knotweed locations were documented as part of the stream feature inventory conducted during the summer of 2008 (Riparian Vegetation Mapping, Section 2.7). There were no Japanese knotweed occurrences documented during the stream feature inventory. The best means for controlling knotweed is prevention of its spread, therefore, efforts should be taken to ensure that all fill brought into the area is clean and does not have fragments of knotweed or other invasive plants. If Japanese knotweed sprouts or small stands are observed, they should be eradicated immediately to avoid further spread within this unit.

| Summary of Recommendations<br>Management Unit 10 | |
|--|---|
| Riparian Vegetation | Treat, remove and prevent the spread of Japanese knotweed where feasible. Plant a buffer of trees and shrubs along proposed planting sites and increase width of riparian buffer in appropriate locations. |
