Manor Kill Management Unit 2

Town of Conesville – Manor Creek Rd. (Station 45598) to Beaver Hill Rd. (Station 38909)

Figure 4.2.1 Management Unit 2 - 2006 aerial photography with 2008 stream feature inventory.

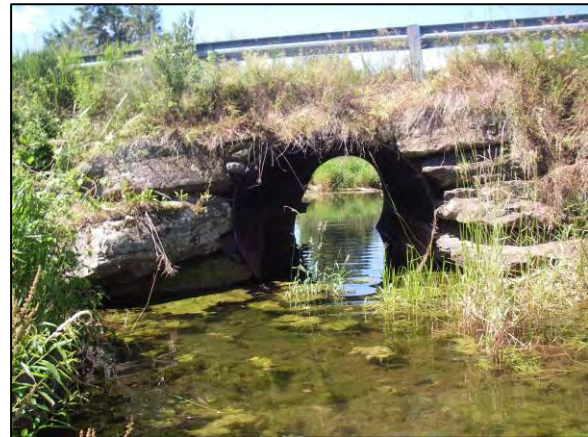
Culvert and Bridge at Station 45598

This management unit began at the Manor Creek Road bridge (Station 45598). One large culvert conveyed flow under the private bridge; it was supported by boulder sized stacked rock abutments. There was water ponding upstream and downstream of the bridge at the time of the assessment, with no flow beyond the downstream pond. The pond downstream of the bridge appeared to have been dredged and maintained. While most flows may pass freely through this bridge, flood flows may be constricted, potentially contributing to backwater. If this bridge is replaced in the future, it is recommended that it be constructed with the appropriate bridge width that will provide the capacity to convey flood flows.

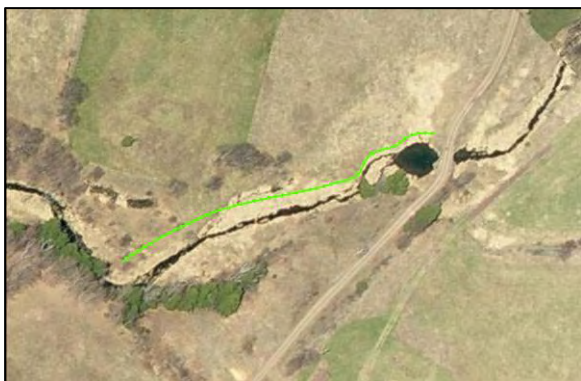
Riparian Planting Site at Stations 45580-45072

Also downstream of the bridge, there was a proposed riparian planting site (Stations 45580 - 45072) along approximately 510 feet of the right streambank. This site had herbaceous vegetation to the edge of the stream, and appears to be maintained as a hay field. At the time of the assessment, subsurface flow became surface flow along the upstream portion of this planting site. A vigorous buffer with mature trees is important

at this site because it may also filter nutrients from the adjacent fields. Nutrient inputs appear to be a threat to water quality along this stretch of stream as evidenced by the significant algal growth (Station 45348) within the stream channel. Recommendations for this site include planting native trees and shrubs along the streambank and the upland area. Buffer width should be increased by the greatest amount agreeable to the landowners. Increasing the buffer width to at least 100 feet will increase the buffer functionality and protect water quality through this reach by slowing stormwater runoff and filtering pollutants associated with nearby land uses. Along this planting site, a small unnamed intermittent tributary (Station 45217) entered along the right streambank providing drainage for the adjacent agricultural field.

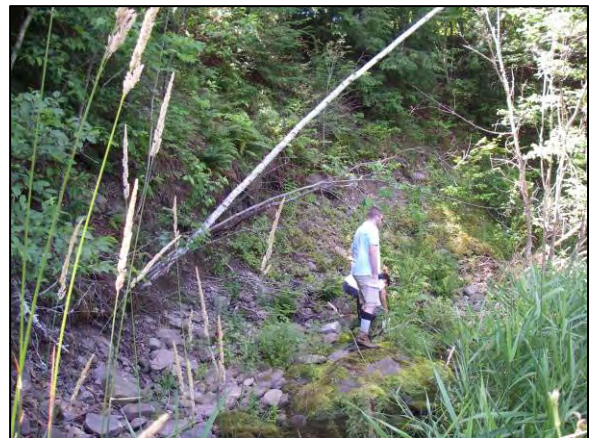
Erosion at Stations 45083 - 44941

As the stream meandered to the right, there was erosion (Stations 45083 - 44941) on the left bank. Streambank erosion often occurs on the outside of meander bends where the stream velocity is greatest during high flows. Along this section of stream, during high flows the toe of the bank is undermined, which has compromised the steep slope and resulted in an erosion area of approximately 3,525 ft². There are several mature trees that have been compromised or have fallen along this erosion site. At the top of the bank, there was an open field with a narrow wooded

buffer. Although this bank was a significant erosion site, it appeared to be slowly recovering, with herbaceous vegetation, including grasses and ferns, becoming established on the face of the bank. However, without deep-rooted shrub and tree species, it is likely that this bank will continue to erode during future high flows. This erosion site may be a good candidate for remediation

using vegetative toe and bank protection. Prior to proceeding with any work, this site would require a more detailed site assessment.

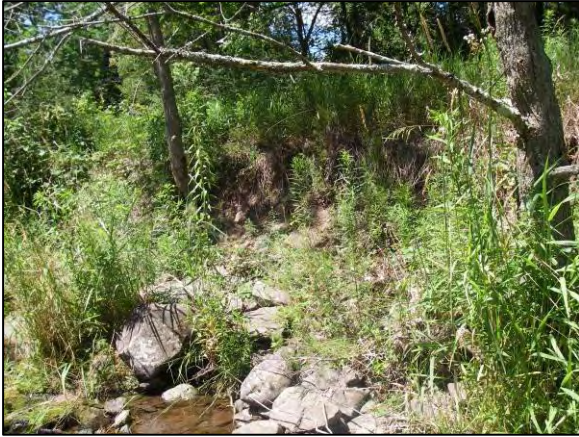
Erosion at Stations 44794 - 44741

As the stream meandered to the left, there was minor hydraulic erosion (Stations 44794 - 44741) along the right streambank. The streambank had a mixture of herbaceous and woody vegetation along the face of the bank, and a mature forested buffer at the top of the bank. This site may self-recover over time. Downstream of the eroding bank there was a center *bar*: a location within the stream channel in which sediment accumulates and occupies a significant portion of the channel. The center bar, with well-established herbaceous vegetation, stretched for approximately 25 feet within the stream channel.

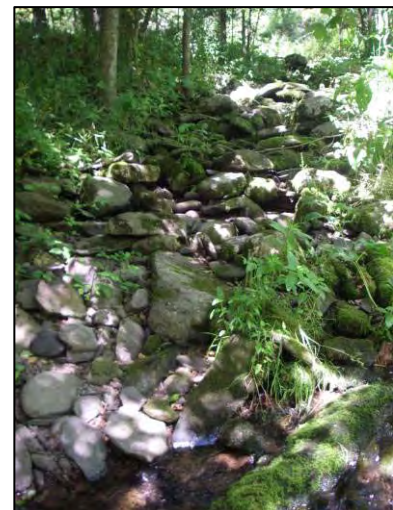
Tributary at Station 44143

an unnamed intermittent tributary (Station 44143) entered from the left streambank. The New York State Department of Environmental Conservation classifies streams and rivers based on their “best use” (NYSDEC, 1994). This tributary was classified C by the NYS DEC, indicating that the best uses for this stream are supporting fisheries and for other recreational activities.

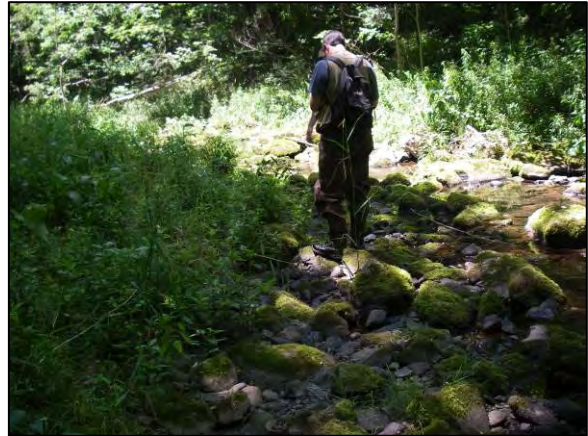
Point bar at Station 43862

As the stream meandered to the left, there was a point bar (Station 43862) with established herbaceous vegetation along the left stream bed. Point bars commonly form on the inside of meander bends, where stream velocity is slower during high flows, allowing sediment to drop out of the water column and settle along the stream bed. Also along the left streambank, there was a channel

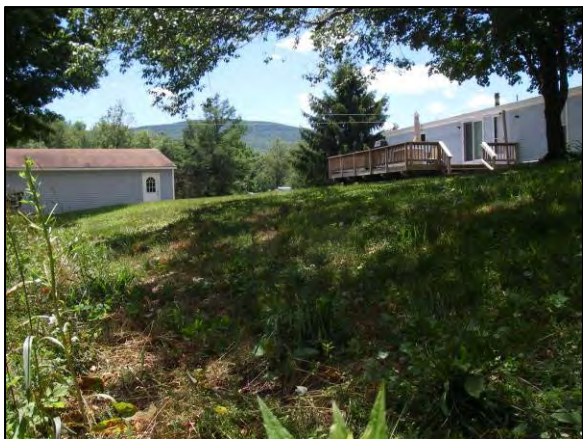
Riparian Planting Site at Stations 43623 - 43479

Continuing downstream, there was a proposed riparian planting site along the right streambank. Along the upstream portion of the planting site (Stations 43623 - 43479), there was minor erosion (Station 43586) for approximately 20 feet, where herbaceous vegetation is mowed to the edge of the stream. Along the downstream end of the site, there was a small

dam (Station 43539), constructed of cobble. The dam appeared to be maintained in order to create a shallow pool adjacent to the yard, and was contributing to upstream scour of the streambank. Recommendations for this site include discontinued mowing to the stream’s edge, planting native sedges along the toe of the bank, and planting native trees and shrubs along the streambank and the upland area. Buffer width should be increased by the

greatest amount agreeable to the landowners.

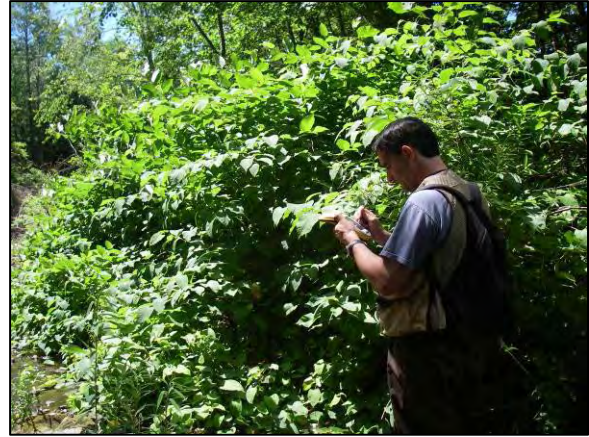
Japanese knotweed at Station 43195

Further downstream, the first occurrence of Japanese knotweed (Station 43291) on the Manor Kill was observed. Continuing downstream there were additional stands of Japanese knotweed along approximately 46 feet of the right stream bank (Stations 43195 - 43149) and approximately 76 feet of the left streambank (Stations 43112

- 43036). Japanese knotweed is an invasive non-native species which does not provide adequate erosion protection due to its very shallow rooting system; knotweed also grows rapidly and tends to crowd out more beneficial streamside vegetation. The best means for controlling knotweed is prevention of its spread. Therefore, effort should be made to ensure that existing stands are not fragmented via unnatural processes (i.e. mowing without removal of all mowed material) and transported into downstream areas. Small stands should be eradicated immediately to avoid further spread within this unit and downstream management units. There are removal methods that may be used for larger stands (Section 2.7), these methods should be used with caution and carefully executed to avoid further spread of Japanese knotweed.

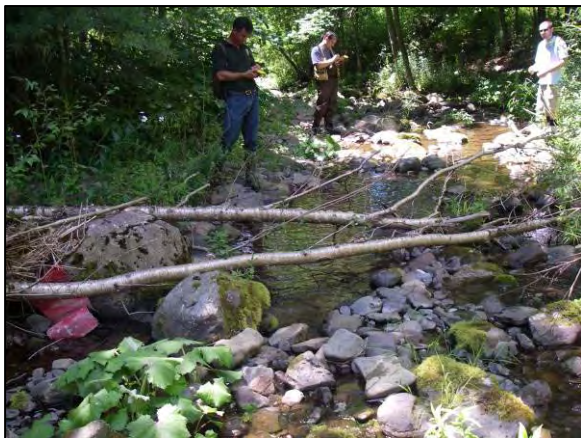
Woody Debris at Station 43016

Along this section of stream, the *thalweg* flows up against the toe of the bank undermining the steep slope, resulting in an erosion area of approximately 6,786 ft², exposing mixed till and compromising mature trees along the bank. Along the downstream portion of the mass failure, a young tree had fallen across the stream channel causing a minor obstruction (Station 43016) at low

flows. During higher flows, it likely poses a more significant obstruction contributing to backwater and upstream *aggradation*, or excess sediment deposition.

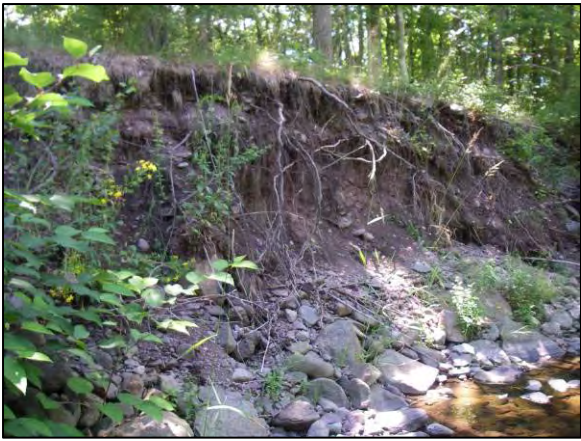
Erosion at Stations 42815 - 42692

Further downstream, there was erosion (Stations 42815 - 42692) along approximately 123 feet of the left streambank. Along the upstream portion of the erosion there was a successional old field along the top of the bank; continuing downstream the top of the bank was forested. The toe of the bank was undermined causing the top of the bank to slump over, exposing roots and compromising trees. Along the downstream portion of the erosion site there was a fallen tree across the channel, which was not causing an obstruction at low flow, but may pose a more significant obstruction during higher flows. There were multiple stands of knotweed along the left and right banks along this stretch of stream.

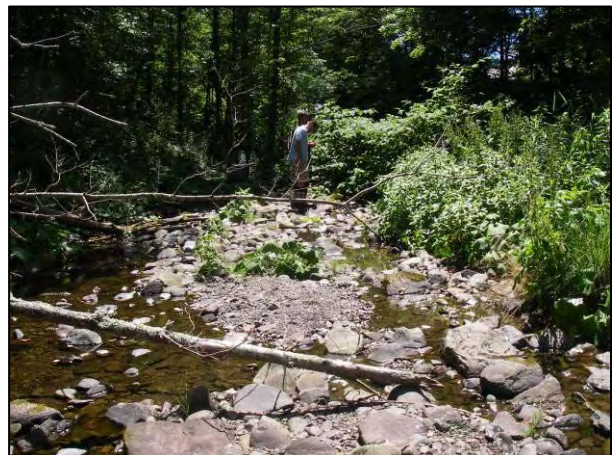
Center Bar at Stations 42347 - 42300

Continuing downstream, the stream was experiencing *aggradation*, the process by which streams are raised in elevation by the deposition of material eroded and

transported from other areas, and a center bar (Station 42347 to 42300) had formed within the stream channel. Just downstream of the center bar, an intermittent tributary (Station 42237) entered along the right bank. This tributary was classified C by the NYS DEC, indicating that the best uses for this stream are supporting fisheries and other non-contact activities. The tributary confluence with the Manor Kill was

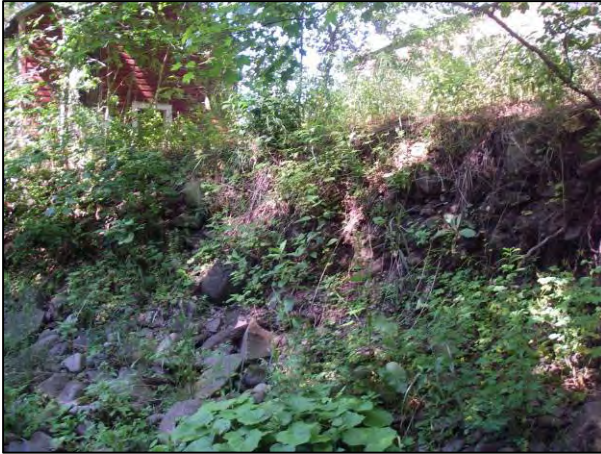
Erosion at Stations 42216 - 42164

relatively steep and appeared to contribute to downstream erosion (Stations 42216 - 42164) along approximately 52 feet of the right streambank. There was herbaceous vegetation on the face of the bank and a few young trees at the top of the bank, beyond which there was mown lawn and a barn. Although this site was not identified as a proposed planting site, recommendations for this site include the discontinuation of mowing to the stream's edge and planting native trees and shrubs along the upland area to augment the existing buffer. Prior to proceeding with any vegetative plantings, the condition of the eroding bank should be given careful consideration when identifying the appropriate species and locations for plantings.

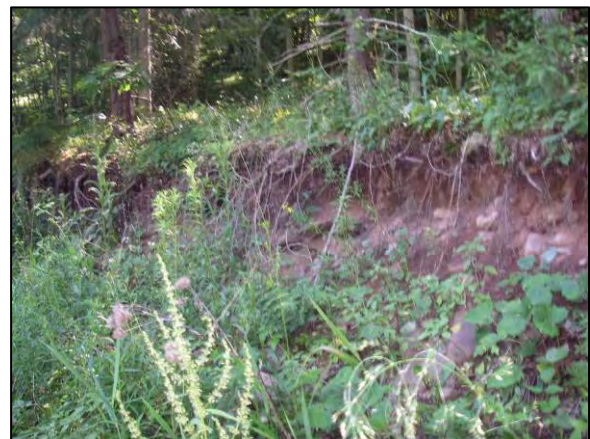
Erosion at Stations 41805 - 41651

Just downstream, there was more significant erosion (Station 41805 – 41651) of

the left streambank for approximately 154 feet. Along the upstream portion of the erosion site, the bank was undercut, roots were exposed and some young trees had fallen; it was forested at the top of the bank. There was herbaceous vegetation at the toe of the bank and some on the face of the bank. Japanese knotweed persisted through this stretch of stream, and there were aggradational conditions (center bar) within the stream channel.

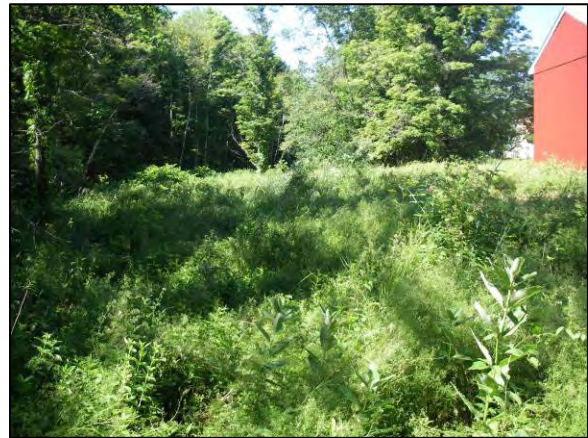
Riparian Planting Site at Stations 42094 - 41763

Opposite the erosion sites, there was a proposed riparian planting site (Stations 42094 - 41763); a successional old field with a thin line of trees providing a narrow buffer between the field and the stream's edge.

Recommendations for this site include augmentation of existing buffer with the planting of additional native trees and shrubs along the streambank and the upland area. Buffer width should be increased by the greatest amount agreeable to the landowners.

Increasing the buffer width to at least 100 feet will increase the buffer functionality and protect the stream from nearby land uses. Just downstream, along approximately 170 feet of the right streambank, there was an erosion site (Stations 41705 - 41534) with mowed lawn to the top of the bank; some areas had a thin line of trees and shrubs. There was also a small rock wall at the top of the bank for approximately seven feet.

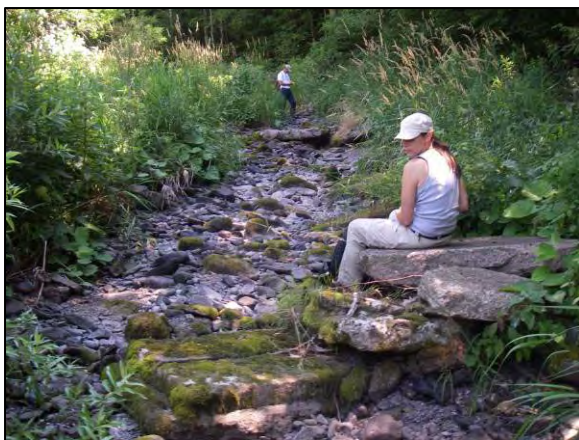
Concrete obstruction at Stations 41233 - 41178

Along the left streambank, there were large concrete pieces dumped along the toe of the streambank, with herbaceous vegetation established throughout. Downstream of this revetment (Stations 41239 - 41184), concrete remnants had washed into the channel; these concrete blocks appeared to contribute to upstream aggradation causing stream flow to go subsurface. Water reappeared further downstream where the stream bed consisted primarily of natural material.

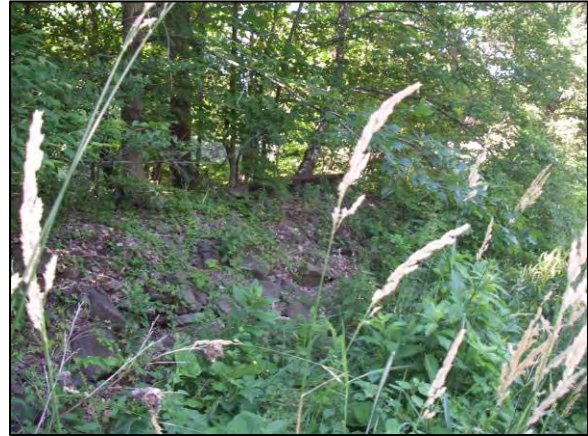
Berm at Stations 41184 - 41040

As the stream meandered to the right, there was a berm (Stations 41184 - 41040) along approximately 144 feet of the left streambank. Generally, it is recommended that berms be evaluated for their influence on floodplain connectivity and stream entrenchment. Removal should be considered where there is significant negative impact. This berm appears to be relatively old with trees and shrubs established along the length of the berm, therefore removal is not recommended.

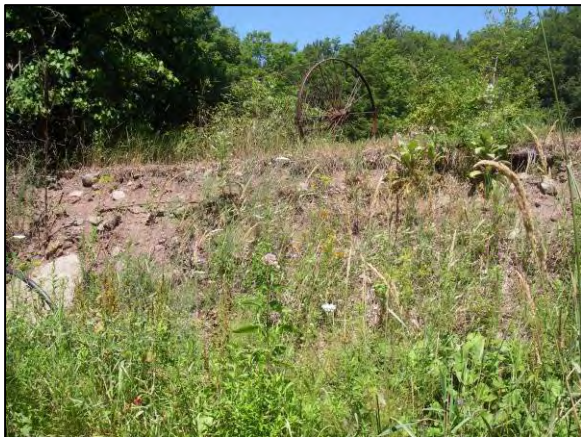
Erosion at Stations 40950 - 40787

Continuing downstream, there was erosion (Station 40950 to Station 40787) along approximately 163 feet of the right streambank. There was herbaceous vegetation along the eroding bank with a parking lot at the top of the streambank beyond a narrow herbaceous buffer. There was also a utility crossing (Station 40898) along the eroding bank.

Recommendations for this site include discontinued mowing to the top of the streambank and

planting of native trees and shrubs along the upland area to create a deep-rooted wooded buffer to filter runoff from the parking lot and provide increased stability to the streambank. Prior to proceeding with any vegetative plantings, the condition of the eroding bank should be given careful consideration when identifying the appropriate species and locations for plantings.

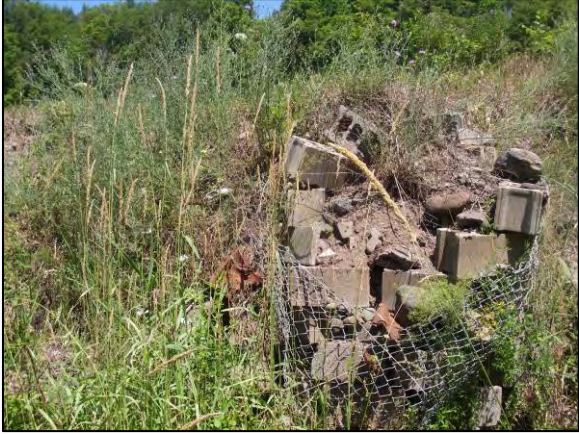
Dump Site at Station 40863

Along this eroding bank, concrete was dumped in the stream channel (Station 40861) and a mixture of concrete, metal and other debris was dumped along the streambank (Station 40863). The concrete within the stream channel posed an obstruction to flow and caused upstream aggradation.

Discontinuing to actively dump material along the bank and within the stream channel is

recommended. Recommendations also include removal of all hazardous material and any material along the streambank that may be mobilized during a flood.

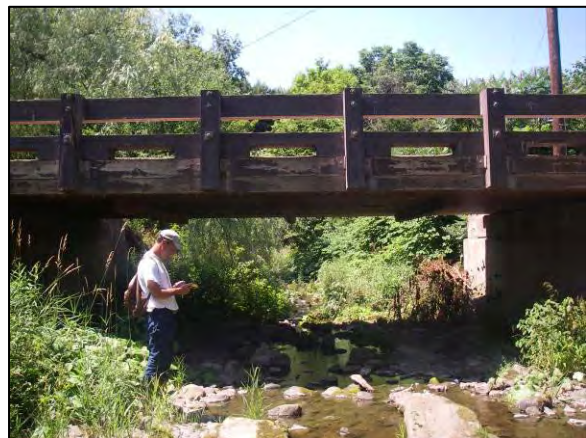
Bridge at Station 40631

Further downstream, there was a bridge (Station 40631), with excess sediment deposition upstream of the bridge. Aggradation such as this is commonly caused by inadequate sizing of the bridge opening. An undersized bridge opening causes water to back-up upstream of the bridge, reducing stream velocity, which results in sediment deposition. While bankfull flows may flow freely through this bridge, higher flows may backwater, resulting in the upstream aggradation. If this bridge is replaced in the future, it is recommended that a hydraulic analysis be conducted in order to determine the appropriate bridge width that will

provide the capacity to convey flood flows through the opening.

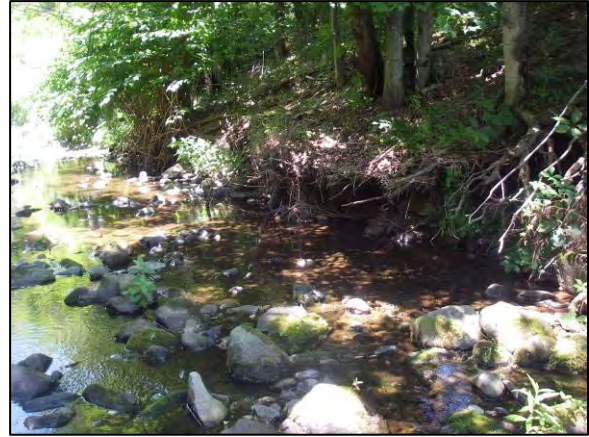
Erosion at Stations 40494 - 40454

Downstream of the bridge there was erosion (Stations 40494 - 40454) along the right streambank. Flow through here had caused undercut banks, exposing roots and compromising mature trees. Opposite this erosion site, there was minor erosion (Stations 40493 - 40388) along the left streambank.

Both of these streambanks had a narrow wooded buffer between the adjacent mown lawn and residential trailers.

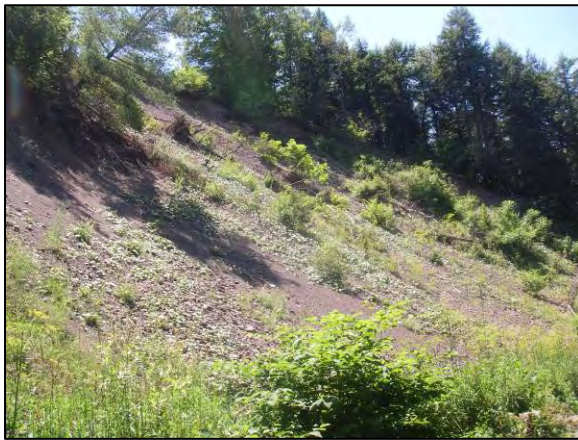
Mass Failure at Stations 40414 - 40265

As the stream meandered to the right, the minor hydraulic erosion on the left streambank was followed by a *mass failure* (Stations 40414 - 40265). Streambank erosion often occurs on the outside of meander bends where the stream velocity is greatest during high flows; along this section of stream, the thalweg flows up against the toe of the bank undermining the steep slope, resulting in an erosion area of approximately 7,431 ft², exposing

mixed till and compromising mature trees along the bank. At the top of the bank, there was a gravel mine. Along the upstream and downstream portions of the erosion site, there was a narrow wooded buffer between the gravel mine and the eroding bank; however, the majority of the eroding bank has no buffer or a thin line of trees. Continued mining activity may contribute to the streambank instability along this site.

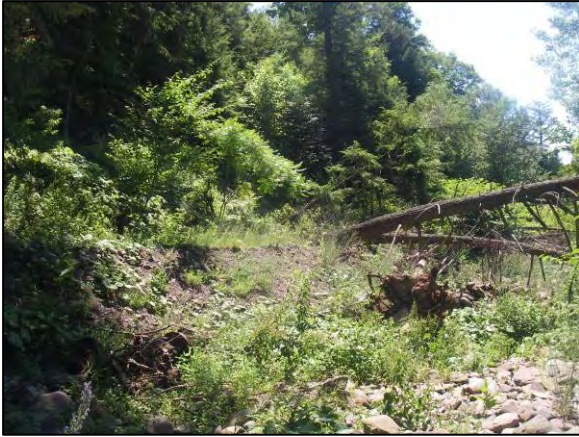
Erosion near Station 39900

Downstream of the mass failure, there was a channel *divergence* (Station 40207) where a secondary channel (Figure 4.2.1, Inset B) split off from the main channel; it converges (Station 39662) with the main channel approximately 545 feet downstream. There was Japanese knotweed along both banks of the secondary channel. Along the left streambank of the secondary channel, there was erosion (near Station 39900) that had

compromised mature trees causing them to fall across the channel. These trees would pose a significant obstruction during high flows. At the time of the assessment, there was subsurface flow along the upstream portion of the secondary channel; surface flow began at the woody debris obstruction. Flow in the main channel was also subsurface downstream of the mass failure. Along this erosion site, a low terrace with herbaceous and shrubby vegetation had formed, evidence that the bank may be starting to self-recover. However, above the terrace, the streambank continued to slump. There is a forested buffer, approximately 150 – 200 feet wide, between the gravel mine and the eroding streambank. Loss of this buffer and continued mining activity may contribute to further instabilities along this stretch of stream.

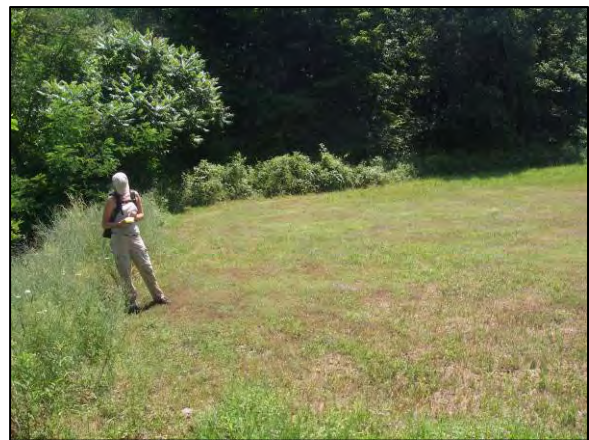
Riparian Planting Site at Stations 39867 - 39790

As the main channel meandered to the left, there was erosion (Stations 39970 - 39812) along approximately 158 feet of the right streambank, causing exposed roots, an undercut bank, and compromising small trees. Along the upstream portion of the erosion site, there was a young forest; continuing downstream, there was herbaceous vegetation mowed to the edge of the bank. This area was identified as a potential riparian planting site (Station 39867 – 39790). Recommendations for this site include planting native trees and shrubs along the streambank and the upland area, and reinforcing the toe of the bank by planting sedge species. Buffer width should be increased by the greatest amount agreeable to the landowners. Increasing the buffer width to at least 100 feet will increase the buffer functionality and protect the stream from nearby land uses. Due to the erosion along this site and the potential need for bank grading, a more detailed site assessment may

be necessary prior to proceeding with any plantings.

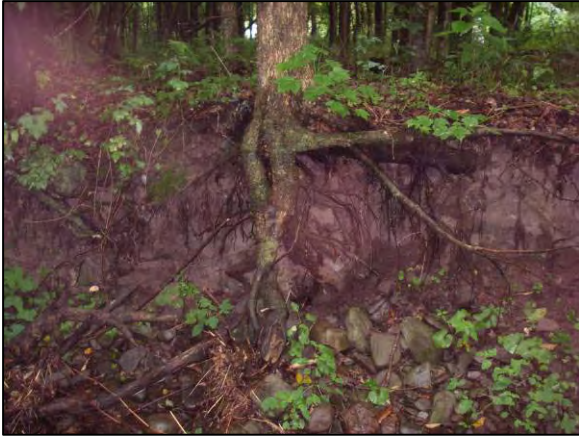
Erosion at Stations 39838 to 39801

Just downstream, there was another erosion site (Stations 39838 - 39801) along approximately 37 feet of the right streambank, exposing roots and compromising trees. It appeared as though the channel along this erosion site had been historically managed through dredging of the streambed material and deposition of the dredged material along

both sides of the stream channel. Japanese knotweed persisted along this stretch of the stream. Downstream of the eroding bank, flow returned to the channel at the time of the assessment.

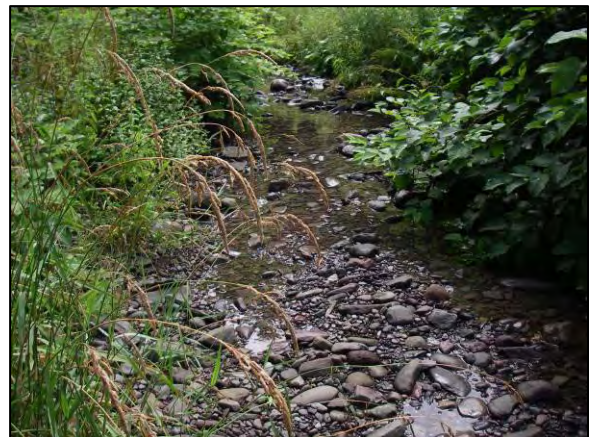
Convergence at Station 39395

Continuing downstream, there was a channel divergence (Station 39568) along the left, where a flood chute split off from the main channel. Flow was subsurface for much of the channel length; along the downstream portion of the flood chute flow returned to the surface. This secondary channel converged (Station 39395) with the main channel approximately 173 feet downstream from the channel divergence. At this location, the flood chute continued with a second divergence from the main channel that converged (Station 39174) approximately 221 feet downstream. Along the left bank of the secondary channel there was a mass failure (Figure 4.2.1, Inset A, Stations 39532 - 39316). This resulted in an erosion area of approximately 6,490 ft² that had compromised mature trees along the bank.

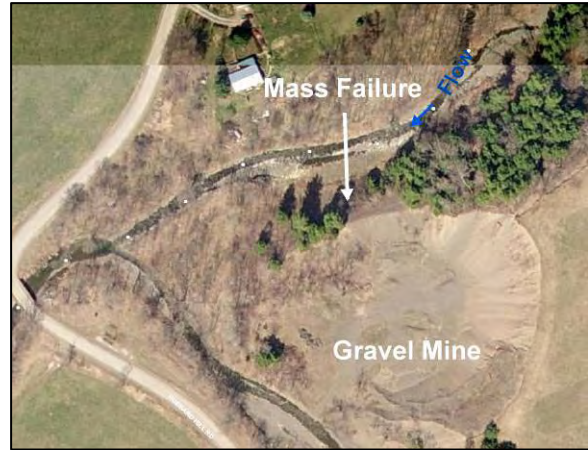
Mass Failure at Stations 39532 - 39316

Although this bank was a significant erosion site, it appeared to be slowly recovering, with herbaceous vegetation, shrubs and young trees becoming established on the face of the bank. However, if this secondary channel became the main channel or carried significant flow during high flood events, it would further compromise the mass failure. The instability along this stretch of stream was also

influenced by the adjacent gravel mine. It is recommended that mining of gravel close to the stream's edge be discontinued, allowing a vegetated buffer to regenerate naturally. Opposite the mass failure and continuing downstream, the right streambank was experiencing hydraulic erosion in three locations totaling approximately 388 feet.

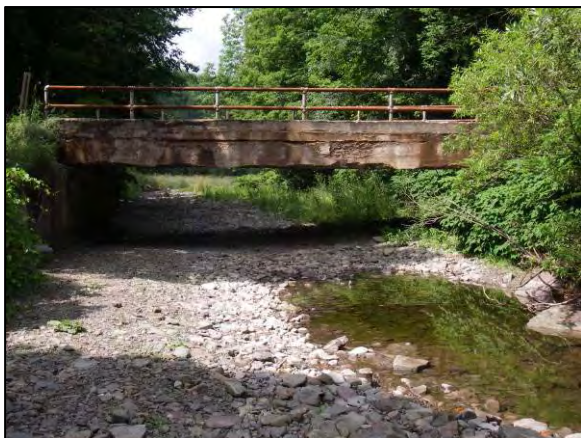
Bridge and Aggradation at Stations 38909 & 39020

Management Unit 2 ended at the Beaver Hill Road bridge (Station 38909). Downstream of the tributary and upstream of the bridge, full channel aggradation (Station 39020) was observed. While the bridge opening seemed to provide an adequate span for low flows, higher flows appear to backwater, reducing stream velocity, which results in upstream

aggradation. If this bridge is replaced in the future, it is recommended that it be constructed with the appropriate bridge width that will provide the capacity to convey flood flows through the opening. Hydraulic analysis should be conducted in order to determine the appropriate bridge width that will provide the capacity to convey water and sediment flow through the opening.

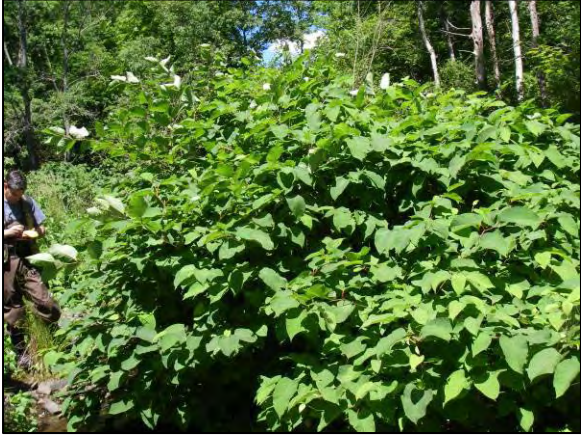
Japanese knotweed at Station 42469

Some plant species that are not native can create difficulties for stream management, particularly if they are invasive. Japanese knotweed (*Fallopia japonica*), for example, has become a widespread problem in recent years. Knotweed shades out other species with its dense canopy structure (many large, overlapping leaves), but stands are sparse at ground level, with much bare space between

narrow stems, and without adequate root structure to hold the soil of streambanks. The results can include rapid streambank erosion and increased surface runoff leading to a loss of valuable topsoil. Japanese knotweed locations were documented as part of the stream feature inventory conducted during the summer of 2008 (Riparian Vegetation Mapping, Section 2.7). In total, 54 Japanese knotweed occurrences, along an estimated length of 2,816.50 feet, were documented during the stream feature inventory. The best means for controlling knotweed is prevention of its spread, therefore, effort should be made to ensure that all fill brought into the area is clean and does not have fragments of knotweed or other invasive plants. If Japanese knotweed sprouts or small stands are observed, they should be eradicated immediately to avoid further spread within this unit and downstream management units.
