Manor Kill Management Unit 3

Town of Conesville – Beaver Hill Rd. (Station 38909) to Station 26995

This management unit begins at Beaver Hill Road, continuing approximately 11,914 ft to Station 26995 in the Town of Conesville.

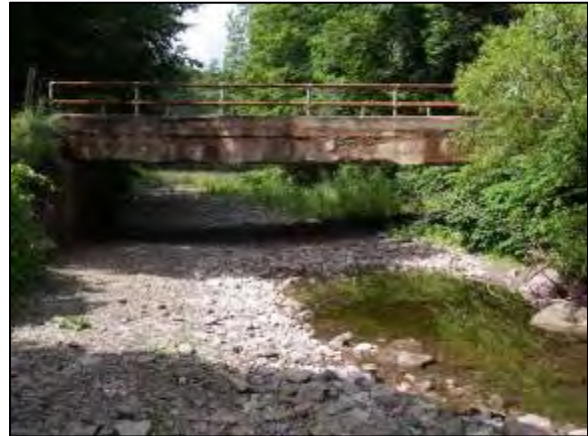
Bridge and Aggradation at Stations 38909 & 39020

Management Unit 3 began at the Beaver Hill Road bridge (Station 38909). Upstream of the bridge, full channel aggradation (Station 39020) was observed. While the bridge opening seemed to provide an adequate span for low flows, higher flows appear to backwater, reducing stream velocity, resulting in upstream aggradation. If this bridge is replaced in the future, it is

recommended that a hydraulic analysis be conducted in order to determine the appropriate bridge width capable of conveying the available water and sediment. At the time of the assessment flow was subsurface downstream of the bridge.

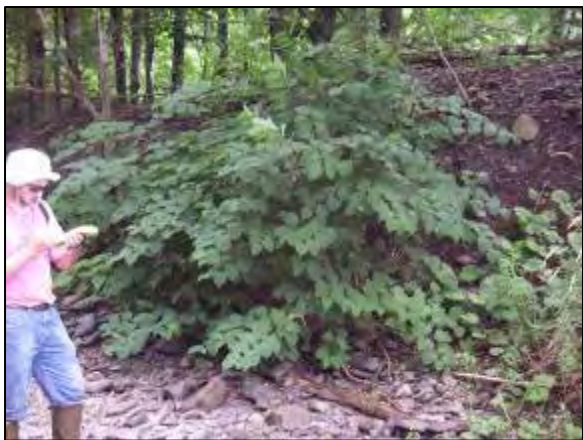
Japanese knotweed along Berm at Station 38796

Just downstream of the bridge, there was a well-vegetated berm (Stations 38884 – 38677), with shrubs and young trees, along approximately 207 feet of the left streambank. Berms such as this, while created with the best of intentions, tend to raise flood elevations and increase the erosive power of the stream. It is recommended that berms be evaluated for

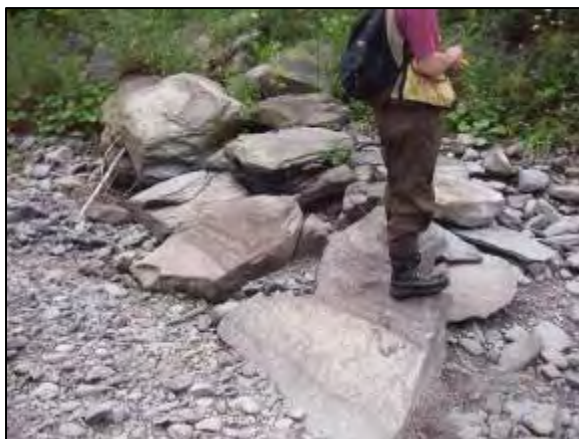
Rock vane at Station 38660

structure. However, this rock vane had failed structurally and was no longer functional.

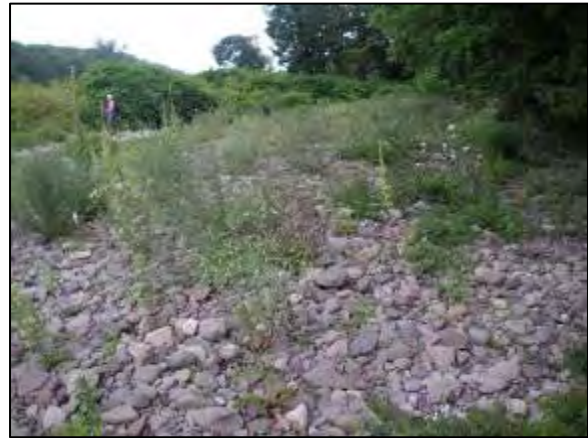
Center Bar at Stations 38564 - 38341

Through this section of stream, there was channel *aggradation*, the process by which streams are raised in elevation by the deposition of material eroded and transported from other areas. The main channel appeared to be along the left of a vegetated center bar (Stations 38564 – 38341).

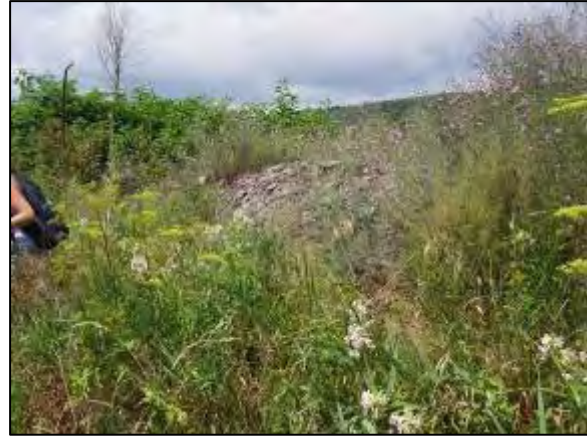
Berm at Stations 37622 -37536

On the right streambank, along the first planting site, just before the stream meandered to the left, there was a channel divergence (Station 37900) where a flood chute split off from the main channel. Flood chutes convey flow through a secondary channel during periods of high flows. This flood chute converges (Station 37416) with the main channel approximately 484 feet downstream. There were multiple stands of

Japanese knotweed along both sides of this secondary channel. At the time of the assessment there was no flow in the secondary or main channel. Along the right bank of the secondary channel, there was erosion (Stations 37711 - 37631) for approximately 80 feet, followed by an earthen berm (Stations 37622 – 37536) for approximately 86 feet. There were also multiple locations of large woody debris that contributed to aggradational conditions and localized scour.

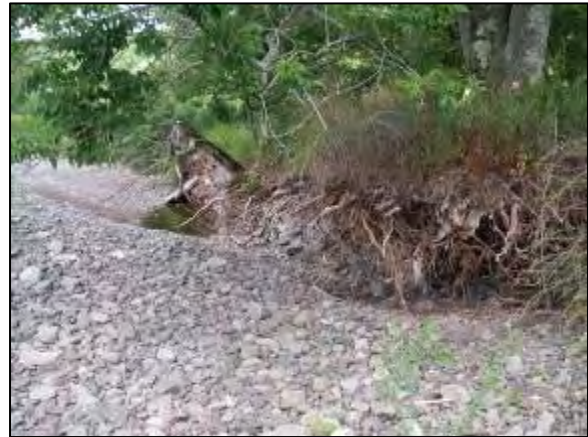
Erosion at Stations 36800 - 36580

As the stream gently meandered to the left, there was erosion (Stations 36800 – 36580) along the right streambank and a proposed planting site for approximately 220 feet. With the exception of a thin wooded buffer along the upstream portion of the erosion site, there was herbaceous vegetation to the edge of the stream. The woody vegetation had been compromised along the undercut banks, with exposed roots and one tree that had fallen along the erosion site.

which included a fallen tree, appeared to contribute to localized aggradational conditions and rerouting of the stream. There were also multiple stands of Japanese knotweed.

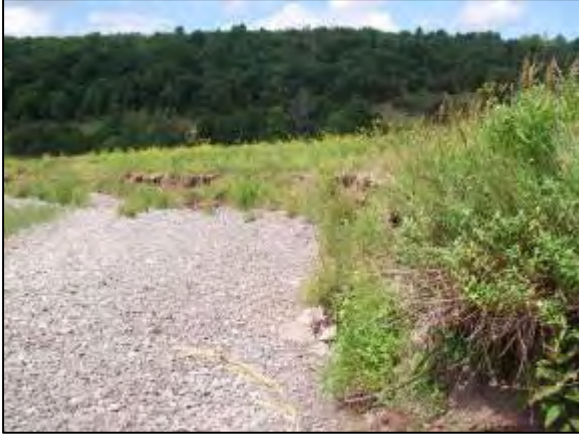
Erosion at Stations 36183 - 34909

As the stream meandered to the left, there was a third proposed riparian planting site (Stations 36190 – 34170) along

mentioned planting sites, recommendations for these sites include establishing a buffer where none exists and augmentation of the existing buffered areas by planting native trees and shrubs along the streambank and the upland area. Buffer width should be increased to 100 feet or by the greatest amount agreeable to the landowners. Portions of both proposed planting sites are experiencing erosion in multiple locations along the streambank. Therefore, prior to proceeding with any vegetative plantings, these conditions should be given careful consideration, and additional assessment may be necessary.

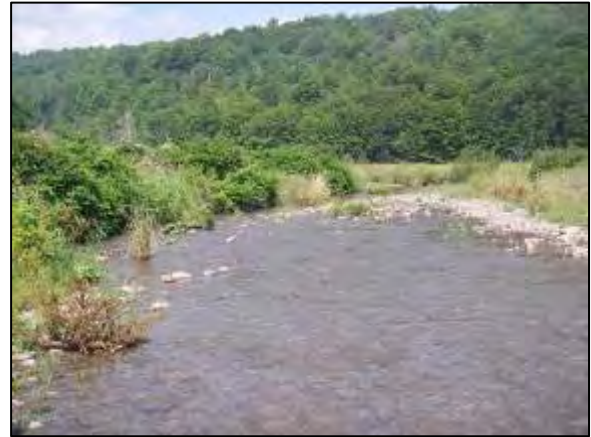
Transverse Bar at Stations 35415 - 35175

Continuing along the riverine wetland and proposed planting sites, there was erosion (Stations 35374 – 35173) along approximately 201 feet of the left streambank. Starting just upstream of the eroding bank there was a transverse bar (Stations 35415 – 35175) that directed flow at the toe of the left bank, contributing to the erosion at this site.

Japanese knotweed persisted along this stretch of stream. This erosion site may be a good candidate for remediation using vegetative toe and bank protection. In addition to the planting recommendations for the proposed riparian planting site, planting native sedge species along the toe of the bank is recommended to reinforce and help stabilize the streambank. As mentioned previously, additional site assessment may be necessary prior to proceeding with any work along this stretch of stream.

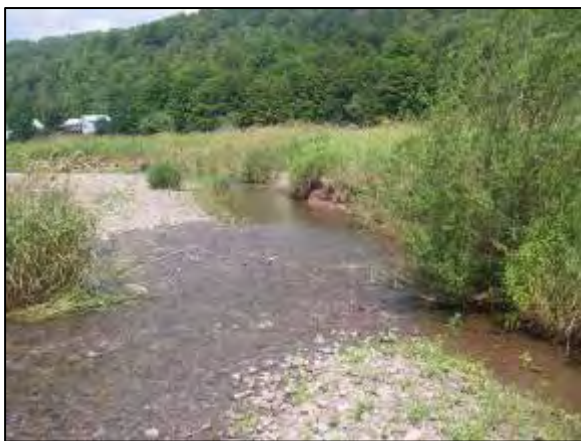
*Erosion at Stations 35202 – 34891
and Transverse Bar at Stations 35150 - 35125*

As the stream meandered to the left, aggradational conditions persisted, including point, side and transverse bars. A transverse bar (Stations 35150 – 35125) directed flow at

the toe of the right streambank, contributing to approximately 1,245 square feet of erosion (Stations 35202 – 34891) along 311 feet of the streambank. With only herbaceous vegetation to the edge, and without deep-rooted shrub and tree species, it is likely that this bank will continue to erode during future high flows. The hydraulic erosion had caused the first significant clay exposure (Station 35120) within this management unit; clay was

exposed along the streambank and channel bed for approximately 12 feet. Clay inputs into a stream are a serious water quality concern because they increase *turbidity*, degrade fish habitat, and can act as transport for other pollutants and pathogens.

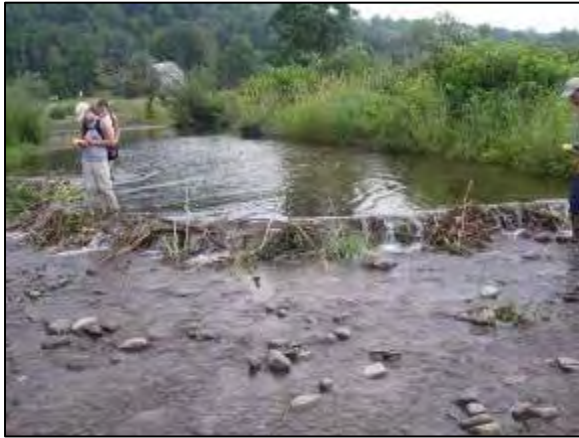
Beaver Dam at Station 34903

Continuing downstream of the erosion site, there was a beaver dam across the stream channel. The dam appeared to be actively maintained and contributed to backwater and downstream aggradational conditions. While beaver impoundments can sometimes be a nuisance, beavers have historically played a beneficial and ecologically important role in the stream system. Beaver activity adds organic debris (trees, leaves, etc. which

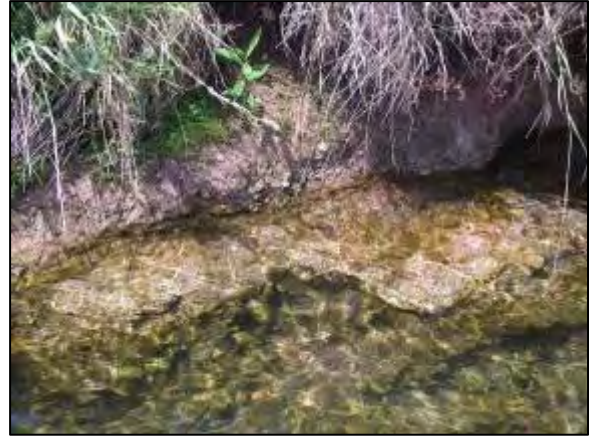
Clay Exposure at Station 33554

gently meandered to the left, there was erosion (Stations 33670 – 33398) along approximately 272 feet of the right streambank. Portions of the eroding bank were overhanging and slumping into the stream channel and portions of an old wire fence were compromised. There were two lacustrine clay exposures (Stations 33554 and 33486) stretching approximately 10 and 12 feet respectively, along the eroding

streambank. Herbaceous vegetation was maintained to the stream's edge. Although this section of the stream channel was not identified as a proposed planting site during the assessment, a wooded buffer with deep rooted vegetation is critical for providing streambank stabilization and protecting water quality from potential nutrient and pollutant inputs associated with the agricultural activity on the adjacent lands. Recommendations for this site include discontinue mowing to the stream's edge, allowing succession to proceed with natural regeneration of shrub and early successional tree species. Buffer width should be increased by the greatest amount agreeable to the landowners. The erosion and clay along this site may need to be addressed prior to proceeding with any riparian plantings of native sedge, shrub and tree species.

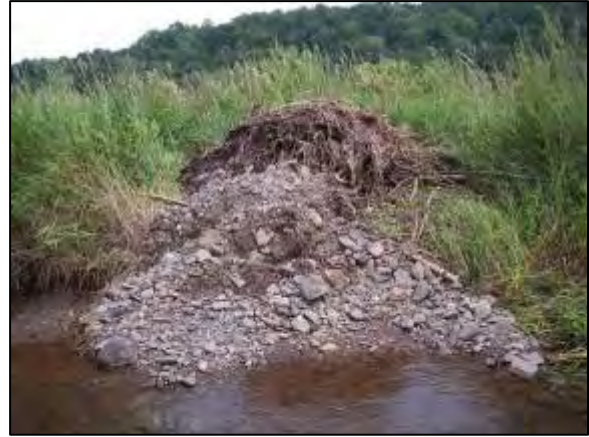
Dredged material from Tributary at Station 32604

This tributary was classified C(TS) by the NYS DEC, indicating that the best uses for this stream are supporting fisheries and other recreational activities, including trout spawning. The channel of the tributary, and the Manor Kill at the tributary confluence, had been dredged. The dredged material was deposited along the Manor Kill on the right streambank downstream of the tributary and on the left streambank, opposite the confluence.

This type of channel modification requires a NYSDEC issued permit, and is not recommended, especially due to the trout spawning activity that may take place in this tributary and along the Manor Kill. Further downstream, another unnamed tributary that drains the adjacent fields (Figure 4.3.1b, Inset D, Station 32487) entered along the left streambank. This tributary was not classified by NY DEC.

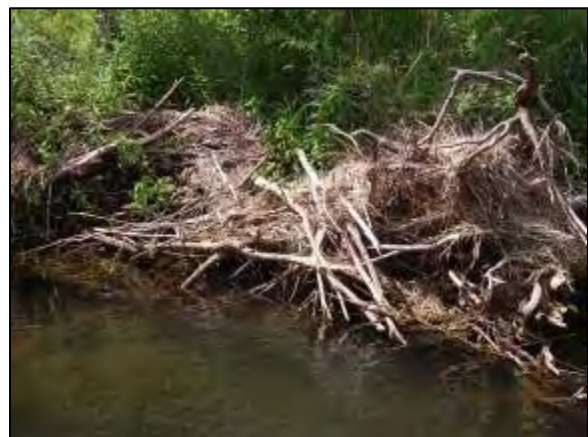
Woody Debris at Station 30619

There were multiple woody debris obstructions (Station 30619) along the left and right streambanks downstream. The woody debris obstructions were caused by the removal of a beaver dam from the main channel and placement of the dam materials along each side of the stream. The remaining debris appeared to contribute to upstream sediment deposition and rerouting of the stream. Along this stretch of stream, and continuing downstream aggradational conditions persisted and there were multiple stands of Japanese knotweed. There were also three additional clay exposures (Stations 30541, 30427 and 30405) totaling approximately 33 feet. A fallen tree from the left bank was partially buried along

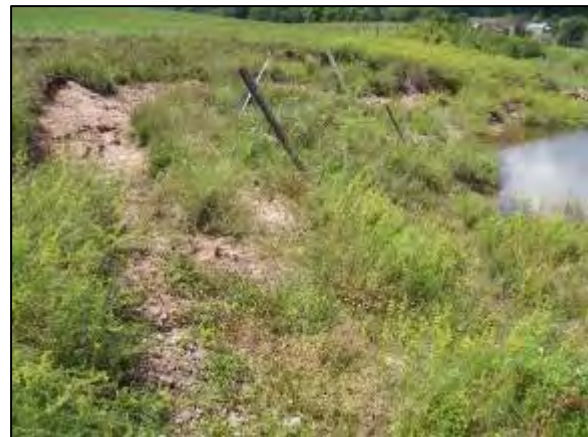
Mass Failure at Stations 29682 - 29664

As the stream gently meandered to the right, hydraulic erosion (Stations 29682 – 29664) on the left streambank was followed by the first *mass failure* in this management unit. Streambank erosion often occurs on the outside of meander bends where the stream velocity is greatest during high flows; along this section of stream, the thalweg flows up against the toe, undermining the streambank. This resulted in an erosion area of approximately 1,724 ft², exposing lacustrine clay along the bed and banks and compromising a wire fence along the adjacent pasture. Although future high flows may continue to erode this bank, it did appear to be self-recovering and may be a good candidate for remediation using vegetative toe and bank protection including willow staking and planting sedges along the toe of the streambank. Prior to proceeding with any work, this site would require a more detailed site assessment.

Consideration should also be given to the abundant beaver activity along this stretch of stream; vegetative plantings may require protection, such as tree tubes, to maximize survival rates. Along this stretch of stream, there was a 2.9 acre palustrine wetland (Stations 33133 - 31936) along the stream corridor. This wetland was classified as PEM1A, *palustrine, emergent, persistent, temporarily flooded*. The Army Corps of Engineers regulates federal wetlands; therefore, if the planting sites require streambank grading or modifications, these wetlands will need to be considered and the appropriate permits should be obtained.

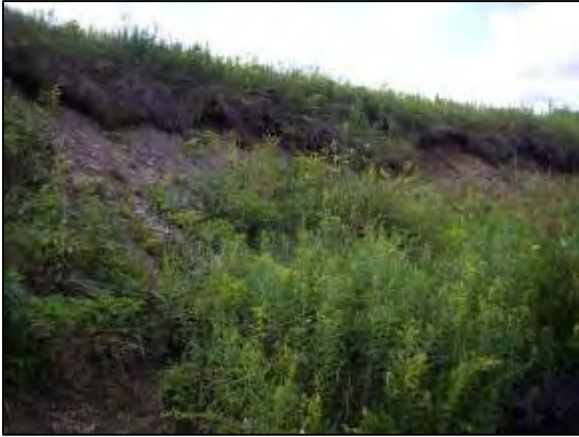
Erosion at Stations 29319 - 29201

Further downstream, there was another eroding bank (Stations 29319 – 29201) along the left streambank for approximately 118 feet. This erosion site had herbaceous vegetation to the edge of the stream and along the toe of the streambank. Along the downstream portion of this site, there was a lacustrine clay

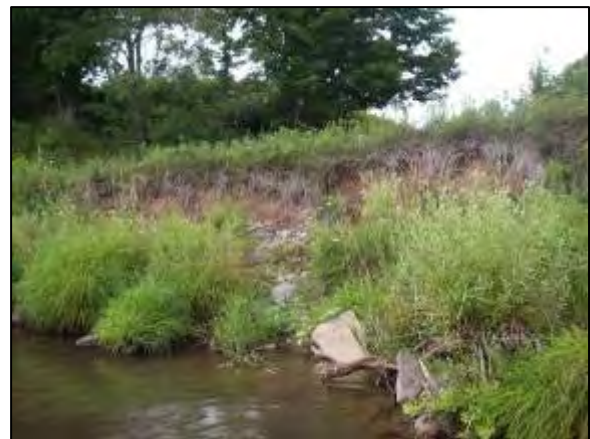
Erosion at Stations 28011 - 27857

As the stream gently meandered to the left, the right streambank was reinforced with rip rap (Stations 28068 – 27939) for approximately 129 feet. At the time of the assessment, the rip rap had failed and was providing little to no streambank protection. Beginning behind the rip rap and continuing downstream, there was erosion (Stations 28011 – 27857) along approximately 154 feet of the right bank. During the field assessment, this bank was identified as a proposed Bank Erosion Monitoring Site

(BEMS) to study erosion along this reach. To monitor bank erosion, a cross-section and longitudinal profile may be completed to collect baseline data. Once the baseline data has been collected, this cross-section can be resurveyed in the future to calculate the bank's erosion rate. Improving the riparian buffer along this site is important and has been recommended; however, other stream bank stabilization techniques may be required to reinforce the bank and to minimize any loss of planted vegetation. Opposite this erosion site, the left streambank was eroding (Stations 28006 -27778) for approximately 228 feet. A

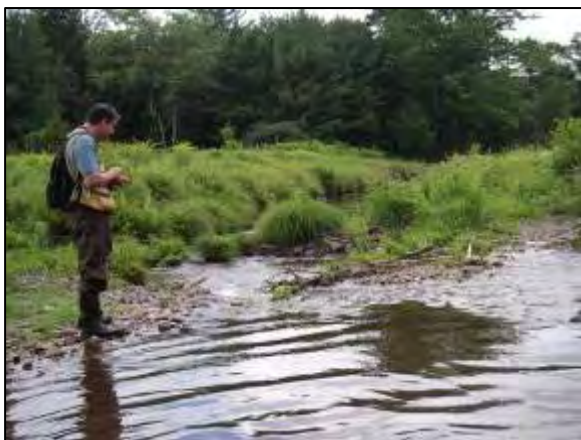
*Beaver Dam Remnants at Station 27600
Transverse Bar at Stations 27622 - 27581*

no longer being maintained, or had been partially removed in an attempt to restore channel flow. It appeared as though this dam had contributed to the erosion along the right streambank. The remnants of the beaver dam contributed to aggradational conditions that persisted through this stretch of stream, including a transverse bar (Stations 27622 – 27581), that was causing backwater along the right.

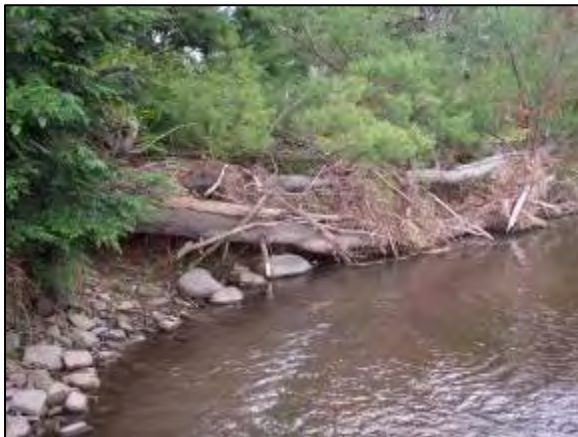
Woody Debris at Station 27290

As the stream meandered to the right, there was erosion (Stations 27424 – 27154) along approximately 270 feet of the left streambank. Along the much of this erosion, the CREP site continued with herbaceous vegetation to the top of the bank, followed by shrubs and young trees. As land use changed from agricultural to forested, the erosion continued

causing exposed roots and compromising mature trees that had fallen along the streambank. There were two woody debris obstructions resulting from the erosion (Station 27290 and Figure 4.3.1b, Inset A, Station 27261). Both obstructions contributed to localized scour of the toe of the left streambank and the channel bed, and caused upstream aggradational conditions across the

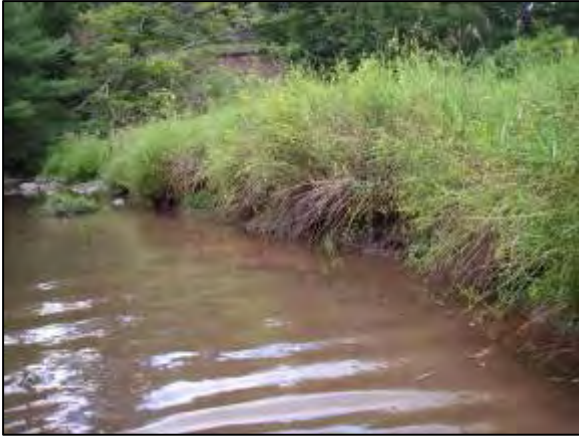
Erosion at Stations 27246 - 27183

full channel. Opposite this erosion the right streambank was eroding for approximately 63 feet. This minor erosion site (Stations 27246 – 27183) may be a good candidate for remediation using vegetative toe and bank protection. Reinforcing the toe of the streambank with native sedge species is recommended. A CREP site and proposed riparian planting site (Stations 27246 – 27183) continued along this erosion site.

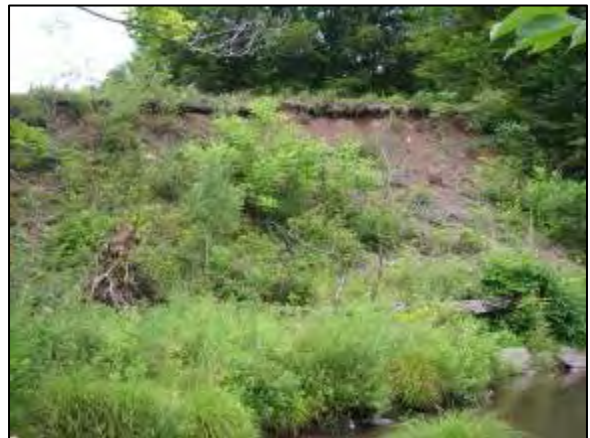
Mass Failure at Stations 27163 - 26938

The depositional features and dam remnants all appeared to contribute to upstream backwater conditions. Also along this meander bend, there was a mass failure (Stations 27163 – 26938) on the left bank for approximately 161 feet in management unit 3 and then continued into management unit 4 for an additional 64 feet.

There was a mixture of herbaceous vegetation and open forest along this mass failure; mature trees were compromised and had fallen along the streambank. The erosion appeared to be self-recovering, with sedges along the toe of the bank and herbaceous vegetation, shrubs and willows establishing along the face of the bank; although future high flows may result in continued erosion along this meander bend. There were multiple small patches of Japanese knotweed along this stretch of stream. Management Unit 3 ended at Station 26995.
