# Manor Kill Management Unit 4

Town of Conesville – Station 26995 to Station 24315

This management unit begins at Station 26995, continuing approximately 2,680 ft to Station 24315 in the Town of Conesville.

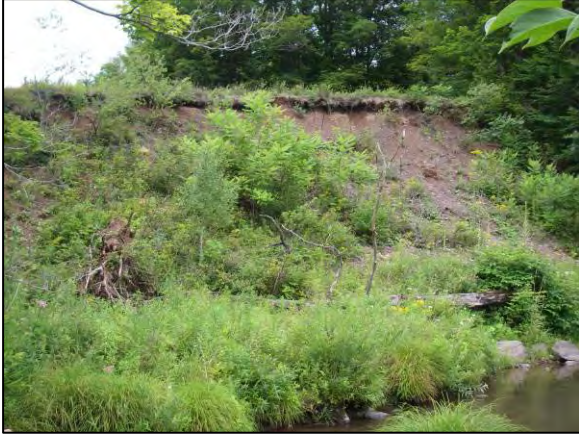
*Mass Failure at Stations 27163 - 26938*

Management unit 4 began as the stream valley narrowed and the adjacent vegetation along the left streambank changed from herbaceous to forested. As the stream meandered to the right, a *mass failure* (Stations 27163 – 26938) began in management unit 3 and continued downstream into this management unit. Streambank erosion often occurs on the outside of meander bends where the stream velocity is greatest during high flows. Along this section of stream, the *thalweg*, or deepest part of the stream channel, flows up against the toe of the bank undermining the steep slope, resulting in erosion along 64 feet in management unit 4 (161 feet of erosion in management unit 3). There was a mixture of herbaceous vegetation and open forest along this mass failure; mature trees were compromised and had fallen along the streambank. At the downstream portion of the mass failure the erosion had caused a lacustrine clay exposure (Station 26951) along the left channel bed. Clay inputs into a stream are a serious water quality concern because they increase *turbidity*, degrade fish habitat, and can act as a carrier for other pollutants and pathogens. The erosion site appeared to be self-recovering, with sedges along the toe of the bank and herbaceous vegetation, shrubs and willows establishing along the face of the bank. Although, future high flows may result in continued erosion along this meander bend.

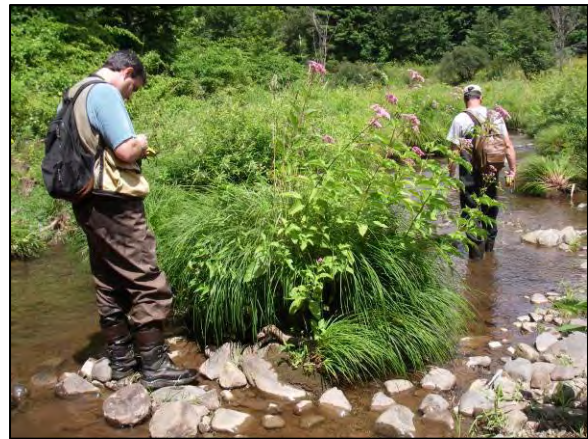
Continuing downstream, there was excess sediment deposition including, a small well-vegetated center bar (Station 26959), with sedges and other herbaceous species, and a side bar (Stations 26897 - 26867) stretching along approximately 30 feet of the left channel bed.

*Center Bar at Station 26959*

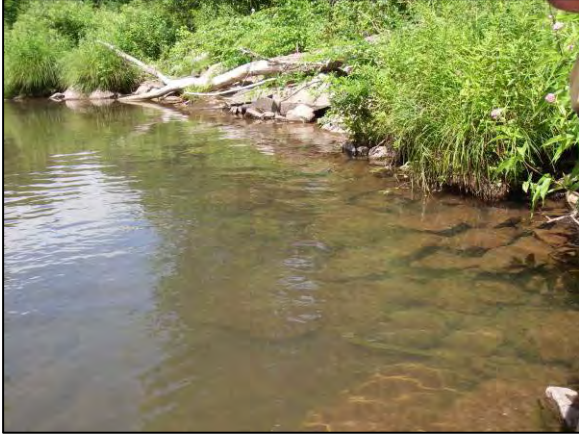
*Revetment at Stations 26750 - 26712*

structurally and was in poor functional condition.

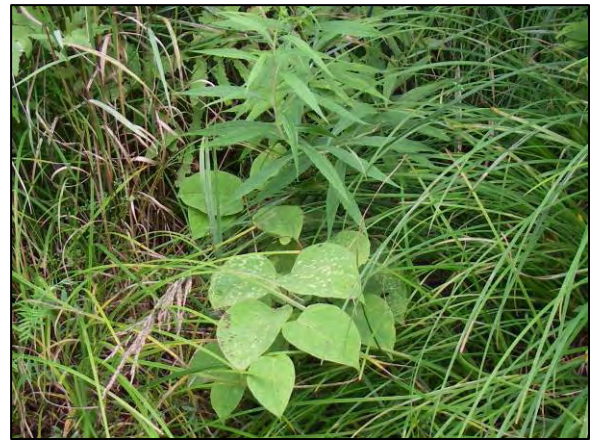
Continuing downstream, the first occurrence of Japanese knotweed (Station 26626) in this management unit was documented; this was a very small patch. Japanese knotweed is a non-native invasive species which does not provide adequate erosion protection due to its very shallow rooting system; knotweed also grows rapidly

*Japanese knotweed at Station 26626*

and tends to crowd out more beneficial streamside vegetation. The best means for controlling knotweed is prevention of its spread. Therefore, efforts should be made to ensure that existing stands are not fragmented via unnatural processes (i.e. mowing without removal

of all mowed material) and transported into downstream areas. Small stands should be eradicated immediately to avoid further spread within this unit and downstream management units. There are removal methods that may be used for larger stands (see Section 2.7), these methods should be used with caution and carefully executed to avoid further spread of Japanese knotweed.

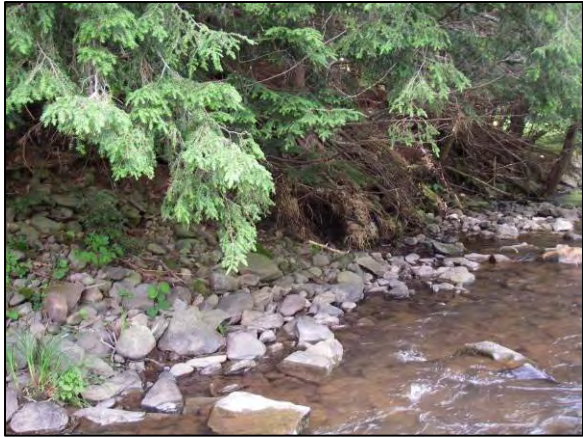
*Erosion at Stations 26588 - 26432*

Further downstream, the left streambank was eroding (Stations 26588 – 26432) for approximately 156 feet. The streambank and upland area were forested; the erosion caused undercut banks, exposing roots and compromising mature trees. Starting along the lower portion of the eroding bank and continuing downstream, there was a side bar (Station 26541) for approximately 40 feet along the left channel bed.

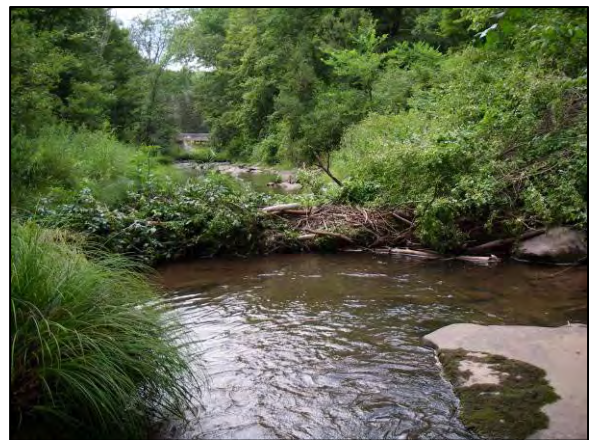
Downstream of the side bar, there was a beaver dam (Station 26343). While beaver impoundments can sometimes be a nuisance, beavers have historically played a beneficial and ecologically important role in the stream system. Beaver activity adds organic debris (trees, leaves, etc. which provide the base of the food chain), reduces water velocities and flood-related hazards downstream, and creates wetland areas that filter sediment and release water to the stream and groundwater slowly throughout the year. Although the dam is across the entire channel, water is able to flow underneath the dam. During higher flows, the dam poses a more significant obstruction to

*Beaver Dam at Station 26343*

flow; it appeared that higher water levels flowed along both sides of the beaver dam.

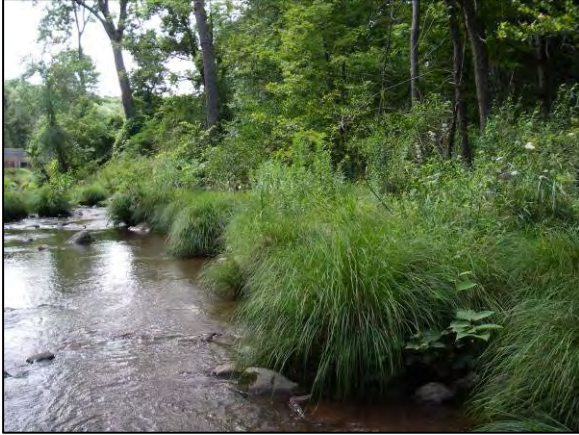
*Side Bar at Stations 26149 - 26070*

Further downstream, there were several more patches of Japanese knotweed (between Stations 26200 and 25900) along the left and right streambanks. There were also well-vegetated side bars along approximately 79 feet of the right channel bed (Stations 26149 – 26070) and 101 feet along the left channel bed (Stations 26080 - 25979). At the time of the assessment, there was flow through the sedges along and behind the side bar along the right streambank.

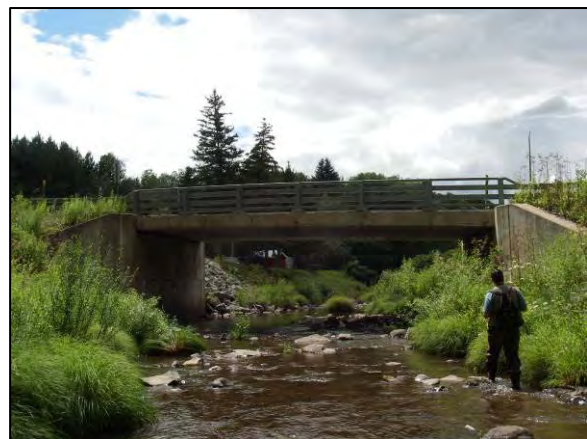
Downstream, the Manor Kill flowed under South Mountain Road Bridge (Bridge # 3354990, Station 25880, also known as Haner Road). This bridge, which was replaced in 2000, was in good structural and functional condition, and appeared to have adequate height and width to convey most flows. There was rip rap along the bridge abutments upstream and downstream of the bridge.

*Bridge at Station 25880*

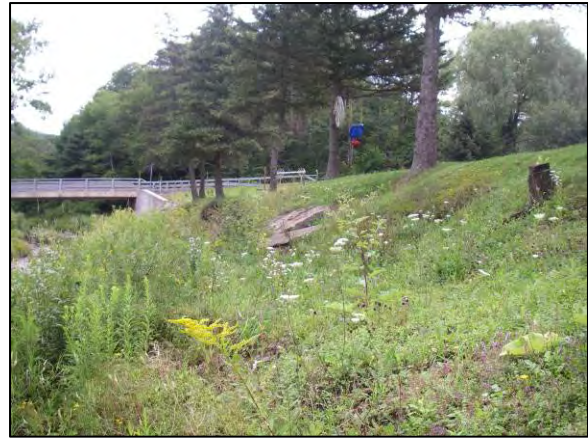
Along the left streambank, rip rap (Figure 4.4.1, Inset C, Stations 25833 – 25797) began at the bridge abutment and continued downstream for approximately 36 feet. The revetment was in good structural and functional condition and provided scour protection at the toe of the bank. Interplanting the rip-rap and reinforcing the toe of this streambank with native shrub and sedge species is

*Riparian Planting Site at Stations 25833 - 25673*

recommended. This planting will help to strengthen the revetment, while enhancing aquatic habitat. The riparian buffer beyond the rip-rap installation was sparse, with some mature trees and mown grass to the edge of the bank. The risk to bank stability can be minimized by maintaining mature trees along the critical 100 foot buffer zone. The buffer width should be increased by the greatest

amount agreeable to the landowners. In addition to interplanting the rip rap, recommendations for this proposed riparian planting site (Stations 25833 – 25673, photograph orientation looking upstream) include planting native trees and shrubs along the streambank and the upland area. Downstream of the revetment, and continuing along the proposed riparian planting site, the left streambank was eroding (Stations 25785 – 25632) for approximately 153 feet. At the downstream end of the erosion, there was a fallen tree (Stations 25632) with accumulated woody debris; it appeared to contribute to localized scour of the channel bed and the toe of the streambank. Prior to proceeding with any vegetative

plantings, a more detailed site assessment may be necessary. The conditions at this site should be given careful consideration when identifying the appropriate species and locations for plantings.

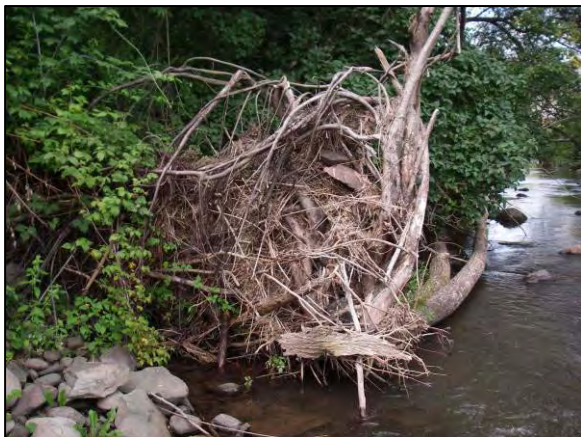
*Woody Debris at Station 25632*

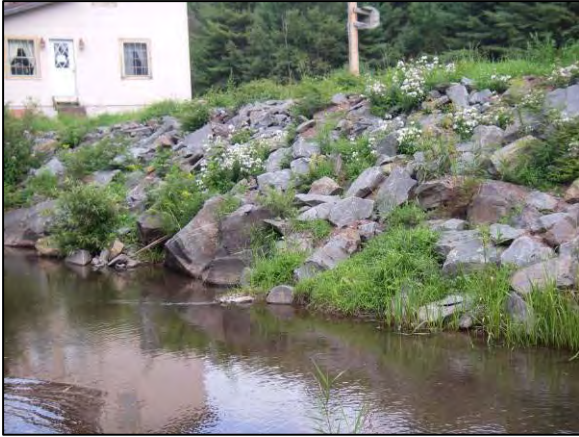
*Rip rap at Stations 25485 - 25301*

sediment deposition, including full channel aggradation (Station 25503) and a transverse bar (Stations 25337 – 25285). A small unnamed tributary (Station 25438) entered from the left streambank; there was a relatively large patch of Japanese knotweed just downstream of the tributary. Along this stretch of stream, the right streambank was reinforced with rip rap (Figure 4.4.1, Inset B, Stations 25485 – 25301) for approximately

184 feet. The rip rap was in good structural and functional condition and provided scour protection along the toe of the streambank. Along the upstream portion of the rip rap there was mowed lawn to the edge of the bank. Interplanting the rip-rap and reinforcing the toe of this streambank with native shrub and sedge species is recommended. Although this site was not identified as a proposed riparian planting site, planting native shrub and tree species along the upland area is recommended. As mentioned previously, a permit was issued for 100 feet of streambank rip rap repair, installation of new rip rap, and minor fill and grading in pre-disturbed lawn areas, in order to prevent the stream from undermining the adjacent home. This permit expires on September 30, 2009.

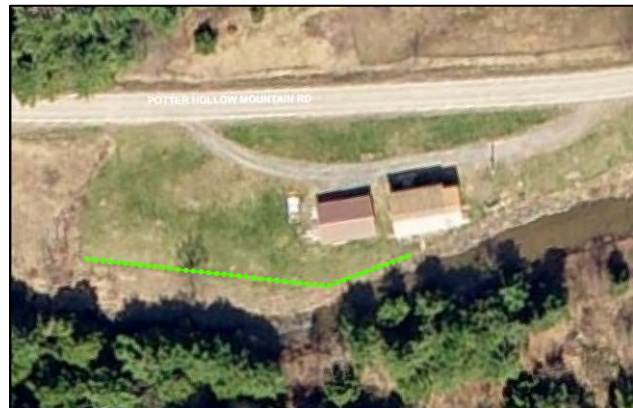
Beginning along the downstream portion of the revetment and continuing downstream, there was a proposed riparian planting site (Stations 25345 – 25104) for approximately 241 feet of the right streambank. Herbaceous vegetation was maintained to the edge of the stream for a portion of the site length; there were some areas with a few shrubs and trees that provided a thin wooded buffer. Recommendations for this site include discontinued mowing to the stream's edge, establishing a buffer where none exists, and augmentation of the existing buffered areas by planting native trees and shrubs along the streambank and

*Riparian Planting Site at Stations 25345 - 25104*

the upland area. Buffer width should be increased by the greatest amount agreeable to the landowners. Increasing the buffer width to at least 100 feet, where feasible, will increase buffer functionality and protect water quality by slowing stormwater runoff and pollutants associated with nearby land use.

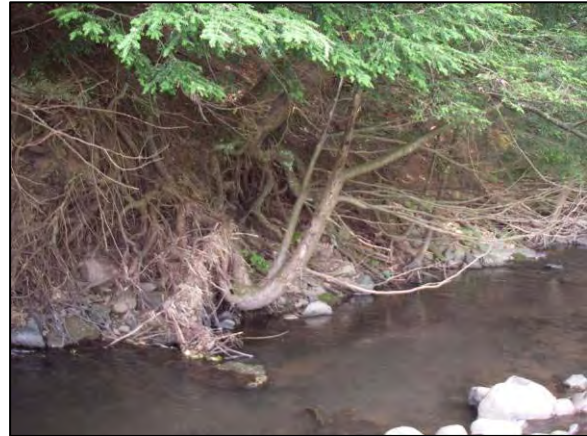
Continuing downstream, there was erosion (Stations 25098 – 24981) along the left streambank for approximately 117 feet.

*Erosion at Stations 25098 - 24981*

The streambank and upland areas were

forested; the erosion exposed roots, compromising mature trees and caused a fallen tree along the downstream portion of the erosion. There was a large boulder in the stream channel that directed flow toward the left bank, exacerbating the erosion at this site. There was also a side bar (Stations 25069 – 25004) along the right streambank for approximately 65 feet. Three small patches of Japanese knotweed (Stations 25072, 25047 and 24900) also grew along the right, and one on the left (Station 24900).

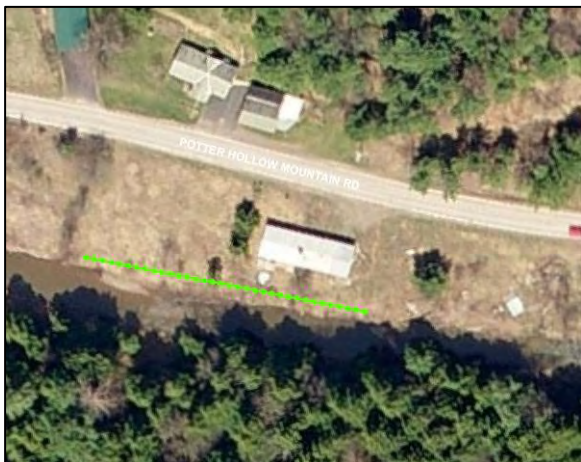
Further downstream, excess sediment deposition continued, including full channel aggradation (Station 24720), a transverse bar (24713 – 24662) and a point bar (Stations 24562 – 24393). The channel was over-wide starting where there was full channel aggradation and continuing downstream until it began to narrow along the point bar. Along the right streambank, there was a proposed riparian planting site (Stations 24639 – 24407) for

*Riparian Planting Site at Stations 24639 - 24407*

approximately 232 feet. There was mowed lawn to the top of the bank, and a mixture of herbaceous vegetation and shrubs along the face of the streambank. As with the previous planting site, recommendations for this site include discontinued mowing to the top of the bank, establishing a buffer where none exists, and augmentation of the existing buffered areas providing a buffer width of the greatest

amount agreeable to the landowner. There were two significant stands of Japanese knotweed (Station 24586, Figure 4.4.1, Inset D, and Station 24500) along this planting site. Prior to beginning planting efforts, these stands should be removed if feasible, or effort should be made to avoid spreading this invasive plant.

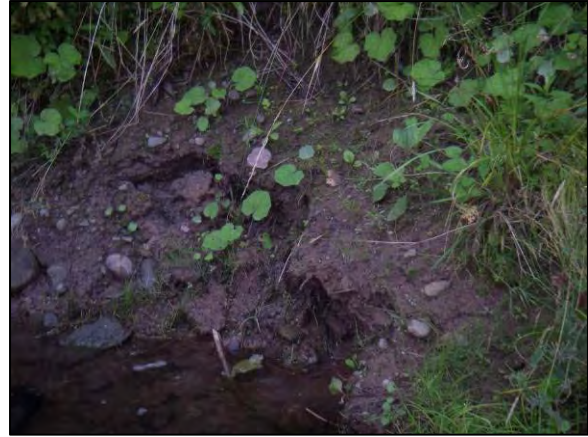
Opposite the proposed planting site, there was erosion along the left streambank that appeared to be self-recovering. This area was vegetated with a mature closed evergreen forest and herbaceous vegetation had reestablished along the face of the bank. However, there was a relatively small clay exposure (Station 24520) along the left channel bed and toe of the streambank for approximately three feet. This management unit ended just downstream at Station 24315.

*Clay Exposure at Station 24520*

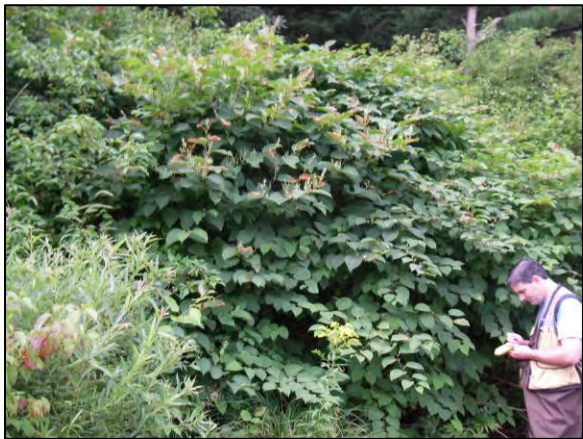
*Japanese knotweed at Station 25434*

Some plant species that are not native can create difficulties for stream management, particularly if they are invasive. Japanese knotweed (*Fallopia japonica*), for example, has become a widespread problem in recent years. Knotweed shades out other species with its dense canopy structure (many large, overlapping leaves), but stands are sparse at ground level, with much bare space between narrow stems, and without adequate root structure to hold the soil of streambanks. The result can include rapid streambank erosion and increased surface runoff leading to a loss of valuable topsoil. Japanese knotweed locations were documented as part of the stream feature inventory conducted during the summer of 2008 (Riparian Vegetation Mapping, Section 2.7). In total, 18 Japanese knotweed occurrences along an estimated length of 122.50 feet were documented during the stream feature inventory. The best means for controlling knotweed is prevention of its spread, therefore, effort should be made to ensure that all fill brought into the area is clean and does not have fragments of knotweed or other invasive plants. If Japanese knotweed sprouts or

small stands are observed, they should be eradicated immediately to avoid further spread within this unit and to downstream management units.
