# Manor Kill Management Unit 5

Town of Conesville – Station 24315 to Station 19795

Figure 4.5.1 Management Unit 5 - 2006 aerial photography with 2008 stream feature inventory.

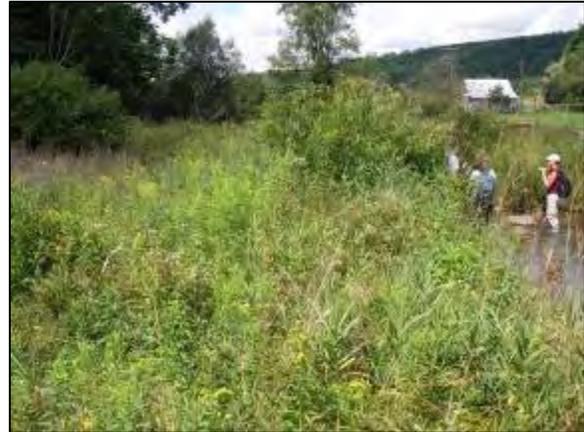
Management unit 5 began as the stream valley broadened and gently meandered to the left. There was a proposed riparian planting site (Stations 24315 – 23905) along the left streambank for approximately 410 feet. This site was the first of seven proposed planting sites within this unit, with successional old field to the edge of the stream. Recommendations for this site

*Riparian Planting Site at Stations 24315-23905*

include planting native trees and shrubs along the streambank and the upland area. Buffer width should be increased by the greatest amount agreeable to the landowners. At this site, there was a narrow forested buffer beyond the successional old field, followed by maintained herbaceous agricultural fields. By planting this site from the stream's edge to the forested area, a 100 foot buffer would be created. Increasing the buffer width to at least 100 feet will increase the buffer functionality and protect the stream from nearby land uses. Along this planting site, there was a stream channel crossing (Figure 4.5.1, Inset D, photograph orientation looking at, Station 24253) that appeared to be used for recreational purposes.

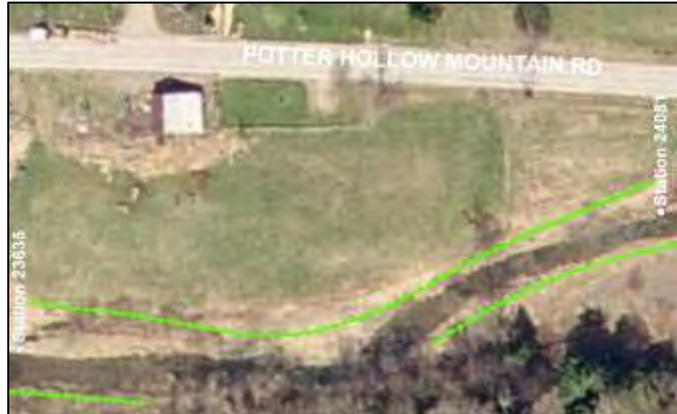
Continuing downstream, there was a proposed riparian planting site (Stations 24081 – 23835) along the right streambank. There was mowed lawn to the top of the bank and herbaceous vegetation with a few shrubs and young trees along the

*Riparian Planting Site at Stations 24081 - 23835*

streambank. Recommendations for this site include discontinued mowing to the top of the bank, allowing succession to proceed with natural regeneration of shrub and early successional tree species, and augmentation of the existing buffer with the planting of additional native trees and shrubs along the streambank and the upland area. As with the previous planting site, buffer width should be increased to 100 feet or by the greatest amount agreeable to the landowners.

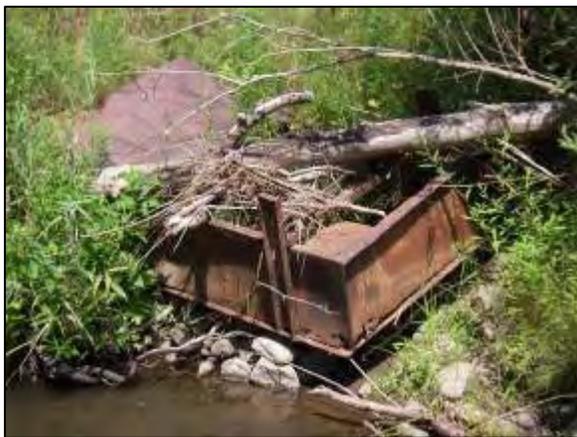
*Dump Site at Station 24025*

Along this planting site, there was a dump site (Station 24025) with old farm equipment and metal scraps, with some woody debris that had accumulated on the equipment. This dump site did not appear to be active or to pose an immediate threat to people or the environment. However, this material was along the stream's edge and could be mobilized during future high flows, posing a potential threat to downstream areas.

Removal of this dumped material is recommended.

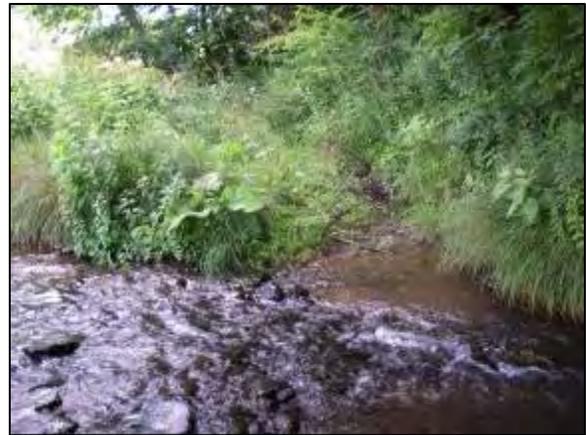
Continuing downstream, there was a *convergence* (Station 23828) where a flood chute joins the main channel. The location of the channel *divergence*, where the flood chute split from the main channel was not observed or recorded at the time of the assessment.

Flood chutes convey flow through a secondary channel during periods of high flows. Just downstream of the secondary channel's confluence with the main channel, there was a *transverse bar* (Stations 23827 – 23808), a location within the stream channel in which sediment accumulates diagonally, occupying much of the channel. This bar directed flow towards the left, and contributed to minor erosion (Stations 23811 – 23733) of the left streambank for approximately 78 feet. There was a narrow wooded buffer between the stream channel and the adjacent agricultural fields. A few shrubs and young trees were compromised due to exposed roots along the face of the streambank. The source of the transverse bar should be identified and remedied if a long-term solution is desired for this relatively minor erosion.

*Convergence at Station 23828*

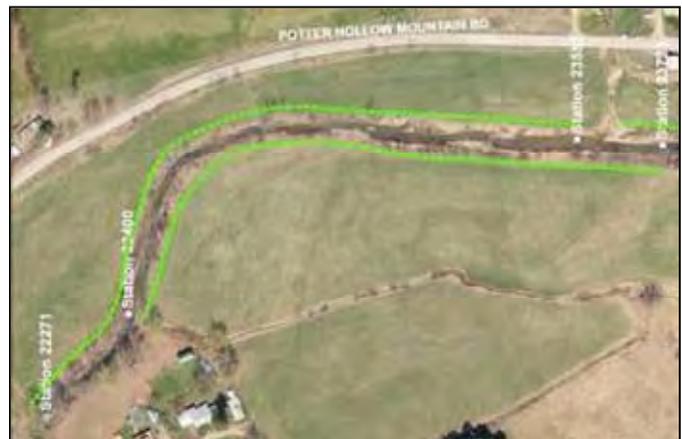
Further downstream, there were two proposed riparian planting sites, one that stretched for approximately 1,293 feet along the left streambank (Stations 23723 – 22400), and one that stretched for approximately 1,436 feet along the right streambank (Stations 23552 – 22271). Along portions of both streambanks, there was a narrow buffer of shrubs, willows and a few trees between the stream

*Riparian Planting Sites at Stations 23723 – 22400 and 23552 - 22271*

channel and the adjacent agricultural fields. A vigorous buffer with mature trees is important at this site to protect water quality by slowing stormwater runoff and filtering nutrients and pollutants caused by the nearby land use. Recommendations for this site include augmentation of the existing buffer with the planting of additional native trees and shrubs along the streambank and the upland area, increasing the buffer width to 100 feet or the greatest amount agreeable to the landowners. Along the upstream portion of these planting sites, there was approximately 30 feet of full channel *aggradation* (Station 23494), the

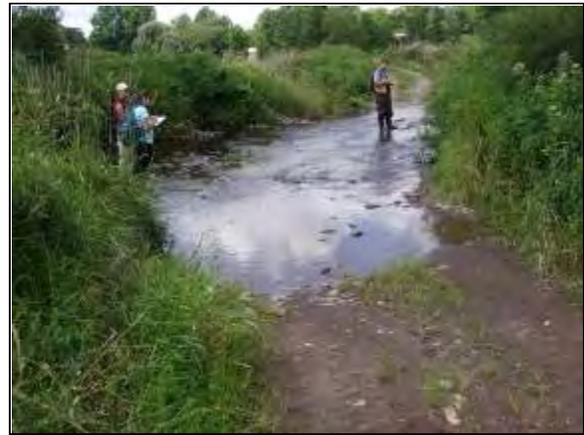
Continuing downstream along the proposed planting sites, there was a well maintained channel crossing (Station 23177) that provided access to the agricultural fields on both sides of the streams. Due to maintenance of the crossing, there was full channel aggradation for approximately 35 feet of the stream channel.

*Channel Crossing at Station 23177*

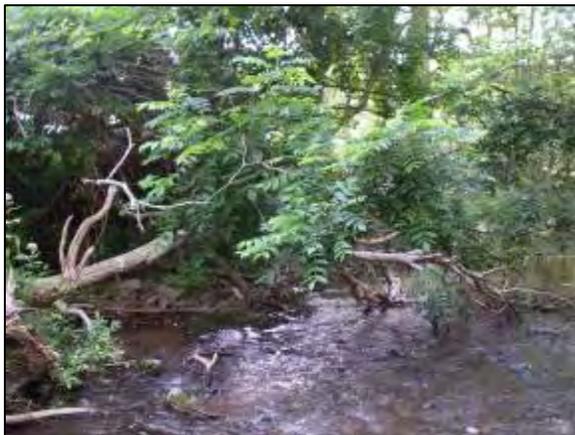
*Woody Debris at Station 22356*

Further downstream, there was a fallen tree (Station 22356) from the left streambank that caused a minor obstruction to flow. At higher flows, it may pose a more significant obstruction. However, woody debris is beneficial to a stream system, it provides critical habitat for fish and insects, and adds essential organic matter that will benefit organisms downstream.

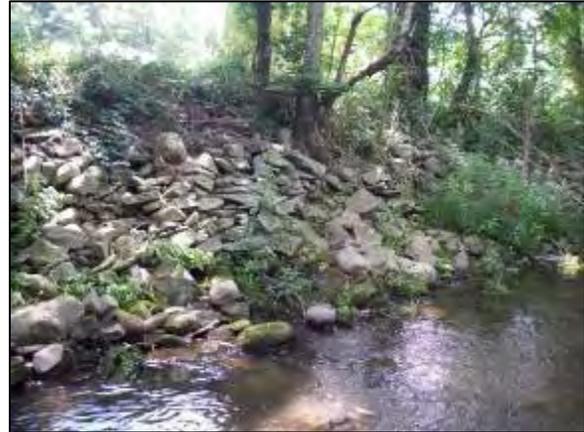
As the stream gently meandered to the right, approximately 104 feet of the left streambank was stabilized with *revetment* (Stations 22333 – 22229). Although the revetement was in poor structural condition, it was in good functional condition. It appeared as though the revetement began as a stacked rock wall, portions of which had collapsed, and were now functioning as rip rap.

*Revetment at Stations 22333*

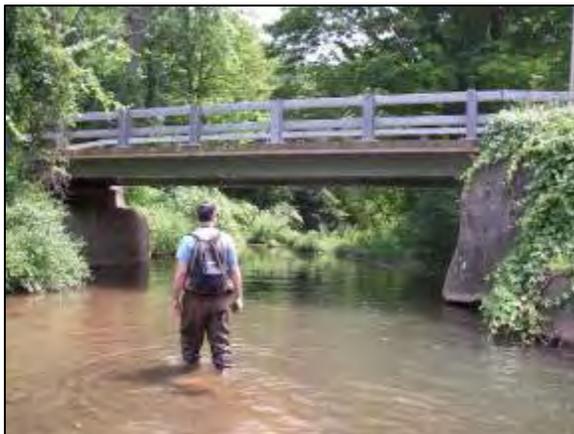
Continuing downstream, the Manor Kill flowed under the Champlin Road Bridge (Station 21930, Bridge # 2228540). This bridge may constrict the floodplain at very high flows but appeared to pass most flows effectively. There have been multiple permits issued for repair of the bridge abutments; flood damage to bridges is typically caused by inadequate hydraulic capacity of the bridge, misaligned piers and/or abutments, or accumulation of

*Champlin Road Bridge at Station 21930*

debris. As bridges are replaced over time, these issues should be evaluated and adjusted if necessary to lessen the probability of flood damage by providing a more effective conveyance channel for water and sediment. The bridge appeared to contribute to downstream aggradation, with a side bar along approximately 84 feet of the right stream bed (Stations 21906 – 21822).

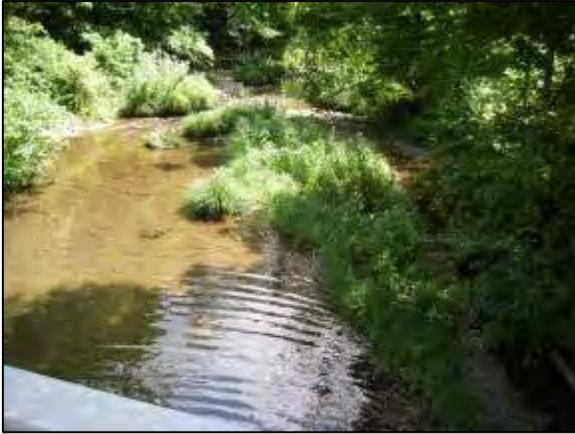
*Side Bar at Stations 21906 - 21822*

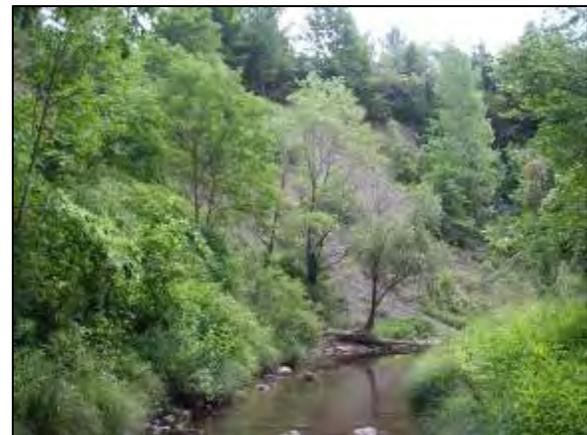
As the stream meandered to the right, there was a mass failure (Stations 21660 – 21519) along the left streambank for approximately 141 feet. Streambank erosion often occurs on the outside of meander bends where the stream velocity is greatest during high flows. Along this section of stream, the *thalweg*, or deepest part of the stream channel, flows up against the toe of the bank undermining the steep slope, resulting in an erosion area of approximately 8,439 ft<sup>2</sup> and compromising mature trees along the bank. The fallen trees caused localized scour, thereby contributing to erosion along this site. At the top of the streambank, there was a thin line of trees followed by agricultural fields; the face of the bank was exposed with some herbaceous vegetation and shrubs re-establishing along portions of the bank. There was also a small dry channel carved down the face of the bank. During heavy precipitation this channel drains the adjacent fields; it appeared to exacerbate the erosion along this mass failure.

*Mass Failure at Stations 21660 - 21519*

Recommendations for this site include allowing succession to proceed with natural regeneration of shrub and early successional

tree species to provide a wider buffer at the top of the bank. The site should be monitored to determine if additional measures are required, but it appeared to be stabilizing over time.

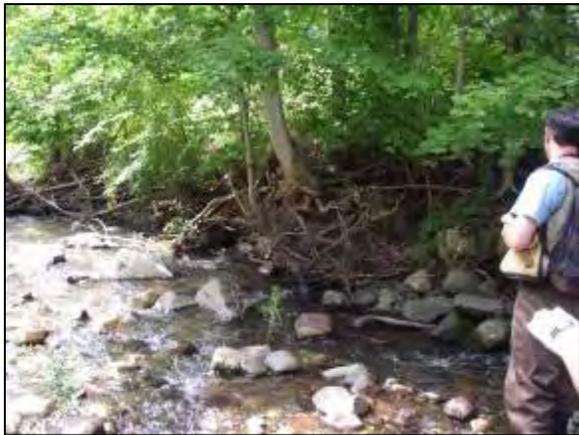
*Erosion at Stations 21520 - 21386*

Continuing downstream, there was erosion (Stations 21520 – 21386) along the right streambank for approximately 134 feet. There was a narrow wooded buffer at the top of the bank, followed by a mowed field. Along this stretch of stream, a proposed riparian planting site (Stations 21561 – 21351) was identified. Recommendations for this site include augmentation of existing buffer with the planting of additional native trees and

shrubs along the streambank and the upland area. Buffer width should be increased by the greatest amount agreeable to the landowners. Increasing the buffer width to at least 100 feet will increase the buffer’s functionality. Prior to proceeding with any work, this site may require a more detailed site assessment; and the eroding conditions should be given careful consideration when identifying the appropriate species and locations for plantings. Also along this stretch of stream, and continuing downstream, there were multiple aggradational areas and small patches of Japanese knotweed.

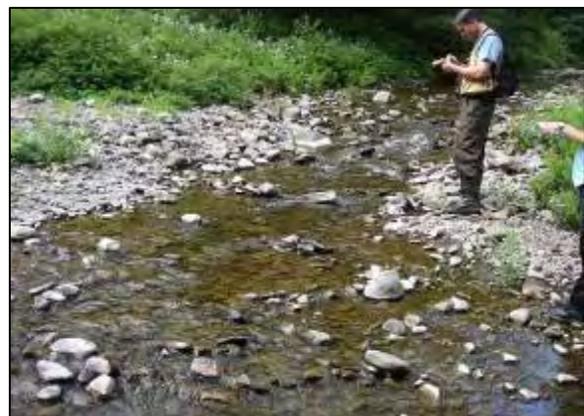
Downstream, the Bear Kill entered from the right streambank (Station 21024).

*Tributary at Station 21024*

This tributary drains the slopes of High Knob and Hubbard Hill Mountains before it reaches the flatter topography of the valley floor where it enters the Manor Kill. As a result of this stream slope change, the tributary loses its ability to transport sediment gathered from the mountain slopes, and began to deposit sediment at its mouth and into the more gently sloped Manor Kill forming a delta (Station

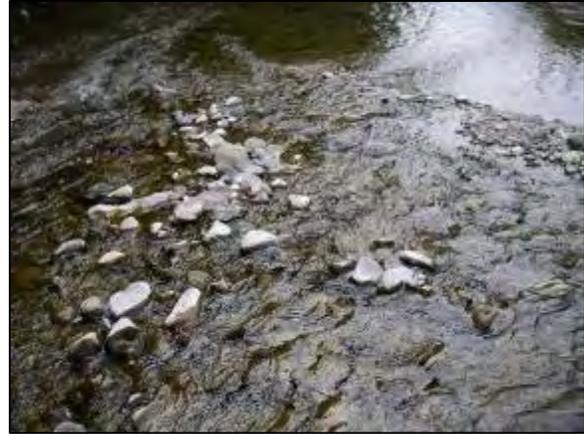
*Delta Deposition at Station 21024*

21024) at its confluence. There was also a significant side bar (Figure 4.5.1, Inset B, Stations 21022 – 20748) along approximately 274 feet of the right channel bed, just downstream of the tributary. Sediment deposition is a common feature of confluence areas, which often contain extensive sediment bars, function as important sediment storage areas, and are typically among the most dynamic and changeable areas in the stream system. This tributary was classified C(ts) by the NYS DEC, indicating that the best uses for this stream are supporting fisheries, including trout spawning, and other recreational activities.

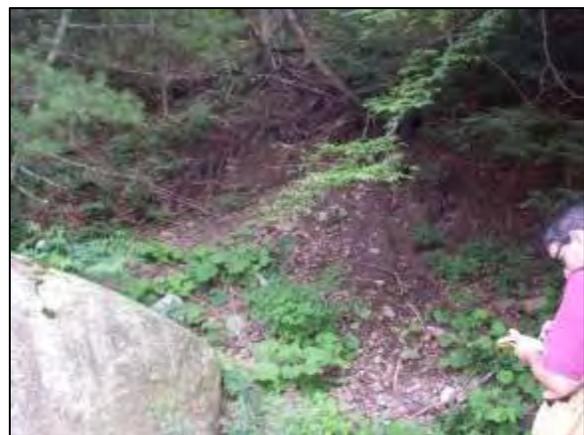
*Erosion at Stations 20809 - 20763*

Further downstream, the left streambank was eroding (Stations 20809 – 20763) for approximately 46 feet, with

exposed roots, compromising mature trees. Opposite the eroding streambank there was a proposed riparian planting site (Stations 20755 – 19826) along the right streambank for approximately 929 feet; this planting site is on the Town of Conesville’s property.

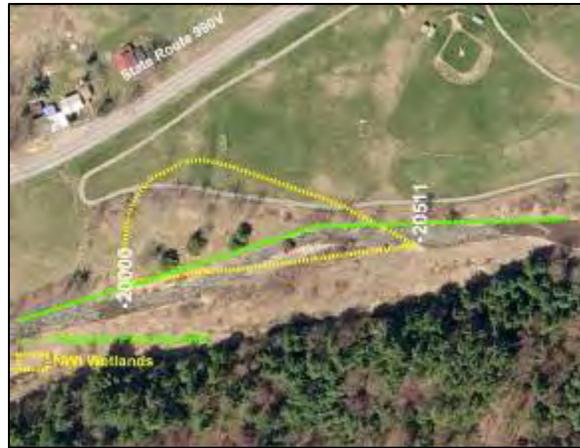
Along this proposed planting site, there was a 1.4 acre federally designated wetland (Stations 20511 – 20000). Wetlands are important features in the landscape that provide numerous beneficial functions

*Riparian Planting Site at Stations 20755 – 19826  
Wetland boundary approximately delineated by NWI  
Stations 20511 - 20000*

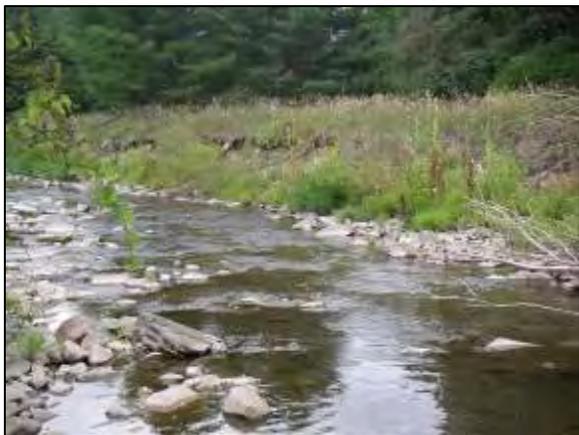
Along the middle portion of this planting site, there were two areas of erosion. The first erosion site (Figure 4.5.1, Inset A, Stations 20484 – 20374) stretched along approximately 110 feet of the right bank and resulted in an erosion area of 1,318 ft<sup>2</sup> with exposed roots, fallen trees and overhanging bank material. Some of the fallen trees and associated woody debris contributed to localized scour of the channel bed and toe of the streambank. The second erosion site (Stations 20335 – 20124), was less significant, although

*Erosion at Stations 20335 - 20124*

it stretched along approximately 211 feet of the right bank. There was herbaceous vegetation to the stream’s edge and along the lower terrace of the streambank. In the fall 2008, a portion of this proposed riparian planting site, including the terrace along the length of this erosion site, was planted with native shrubs and trees by the New York City Department of Environmental Protection (NYCDEP), Schoharie County Soil and Water

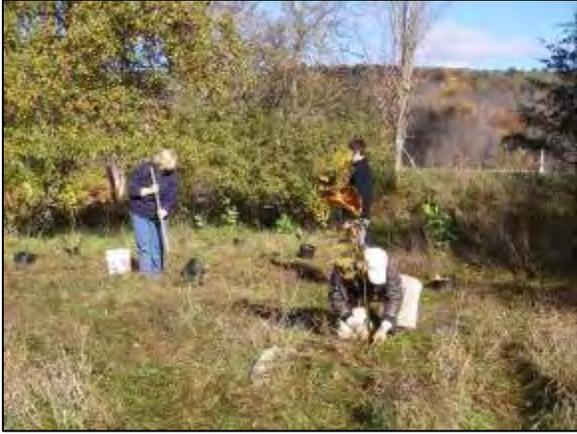
*Planting efforts along  
Riparian Planting Site at Stations 20755 - 19826*

Conservation District (SCSWCD), and students from the Gilboa School District. The planting project covered approximately 0.32 acres along 235 feet of streambank length, and it included the planting of 87 trees and 170 willow stakes. Recommendations for the unplanted portions of this site are consistent with the recommendations for previously mentioned planting sites. Prior to proceeding with any additional plantings, the conditions along the first erosion site (Stations 20484 –

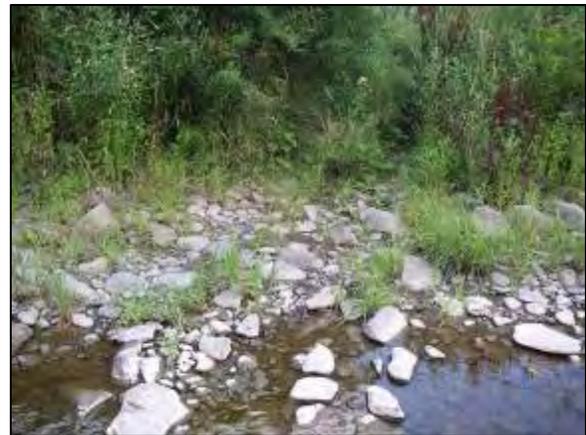
Just before this management unit ended, there was a stream channel crossing (Station 19975) that appeared to be used for recreational purposes including, all terrain vehicle (ATV) usage. This management unit ended at Station 19795.

*Channel Crossing at Station 19975*

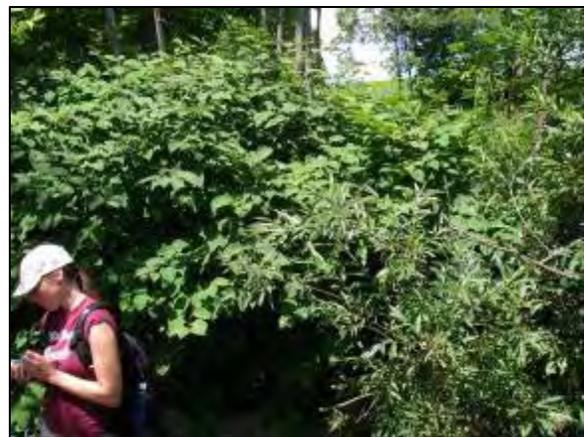
Some plant species that are not native can create difficulties for stream management, particularly if they are invasive. Japanese knotweed (*Fallopia japonica*), for example, has become a widespread problem in recent years. Knotweed shades out other species

*Japanese Knotweed at Station 22925*

with its dense canopy structure (many large, overlapping leaves), but stands are sparse at ground level, with much bare space between narrow stems, and without adequate root structure to hold the soil of streambanks. The results can include rapid streambank erosion and increased surface runoff leading to a loss of valuable topsoil. Japanese knotweed locations were documented as part of the stream feature inventory conducted during the summer of 2008 (Riparian Vegetation Mapping, Section 2.7). In total, 17 Japanese knotweed occurrences, covering an estimated length of 80 feet, were documented during the stream feature inventory. The best means for controlling knotweed is prevention of its spread, therefore, efforts should be made to ensure that all fill brought into the area is clean and does not have fragments of knotweed or other invasive plants. If Japanese knotweed sprouts or small stands are observed, they should be eradicated immediately to avoid further spread within this unit and to downstream management units.
