Manor Kill Management Unit 6

Town of Conesville – Station 19795 to Station 15492

Figure 4.6.1 Management Unit 6 - 2006 aerial photography with 2008 stream feature inventory.

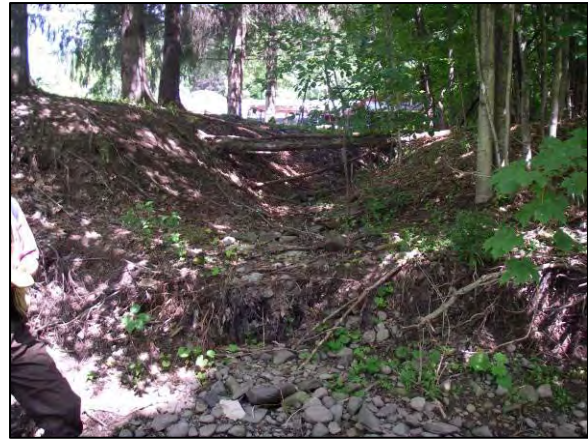
Tributary at Station 19752

Just downstream of the start of Management Unit 6 an unnamed tributary (Station 19752) entered along the right streambank. The tributary may have originated at a culvert near State Route 990V, providing stormwater drainage. At the time of the assessment, there was no flow; there was minor scour of the right streambank at its confluence with the Manor Kill.

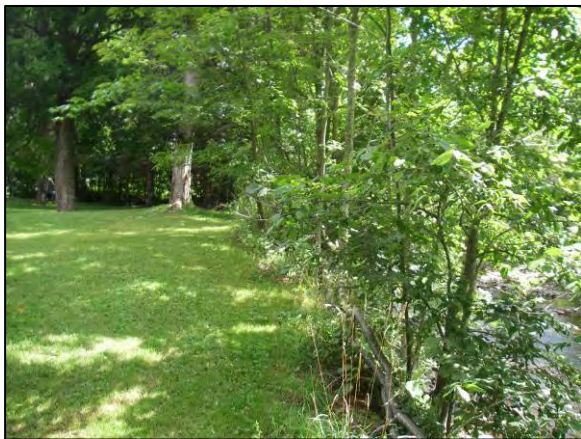
Riparian Planting Site at Stations 19719 - 19622

Downstream of the tributary, there was a proposed riparian planting site (Stations 19719 – 19622) covering approximately 97 feet of the right streambank. There was minor erosion along this bank; at the top of the bank there is a thin line of young trees and shrubs followed by mowed lawn. Enhancing the quality of the buffer and increasing the buffer width to at least 100 feet will help to stabilize the stream bank and protect water quality through this reach by slowing stormwater runoff and filtering pollutants associated with the nearby land use. Recommendations for this site include discontinued mowing to the top of

the bank, allowing succession to proceed with natural regeneration of shrub and early successional tree species, and augmentation of the existing buffer by planting additional native trees and shrubs along the streambank and the upland area. Buffer width should be increased by the greatest amount agreeable to the landowners. Although the erosion at this site was relatively minor, this site may require

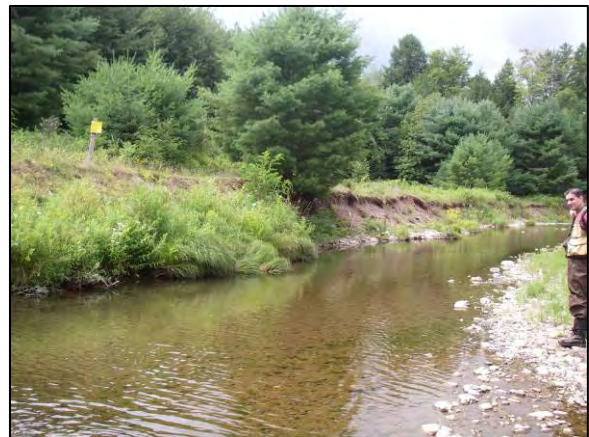
Erosion at Stations 19405 - 19009

Along the meander bend, there was erosion (Stations 19405 – 19009) for approximately 397 feet of the left streambank. Streambank erosion often occurs on the outside of meander bends where the stream velocity is greatest during high flows. There was herbaceous vegetation with few trees along this bank. Along the upstream portion of the erosion, there were fallen and compromised trees that appeared to contribute to upstream aggradational conditions and localized scour. Portions of this erosion site appeared to be self-recovering with herbaceous vegetation becoming re-established on the face of the bank. Recommendations for this site include discontinued mowing to the stream's edge,

allowing natural regeneration of shrub and early successional tree species.

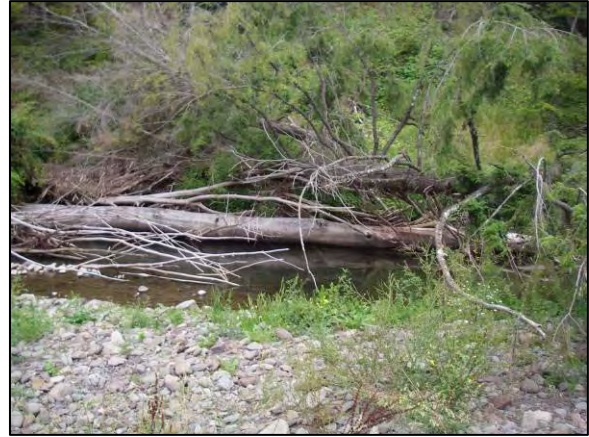
Woody Debris at Station 19000

Continuing along this meander bend, the *thalweg*, or deepest part of the stream channel, flowed up against the left streambank causing the first mass failure (Figure 4.6.1, Inset D, Stations 19015 – 18872). This mass failure resulted in an erosion area of approximately 7,174 ft², exposing roots and compromising mature trees along the bank. During the field assessment, this bank was identified as a proposed Bank Erosion Monitoring Site (BEMS) to study erosion along this reach. To monitor BEMS, a cross-section and long profile may be conducted to collect baseline data. Once the baseline data has been collected, this cross-section can be resurveyed in the future to calculate the bank's erosion rate. Along this erosion site, multiple large trees (Stations 19000 and 18918) had fallen across the stream channel contributing to upstream aggradation and localized scour of the channel bed and toe of the streambank. The first woody debris obstruction contributed to scour that created large, deep pools. Woody debris such as this, is beneficial to a stream system, it provides critical habitat for fish and insects, and adds essential organic matter that will benefit organisms downstream.

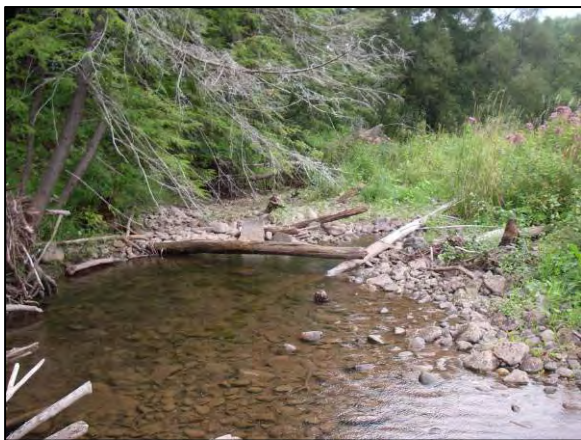
Channel Divergence at Station 18897

As the stream gently meandered to the left, there was a channel *divergence* (Station 18897) along the left, where a flood chute split off from the main channel. Flood chutes

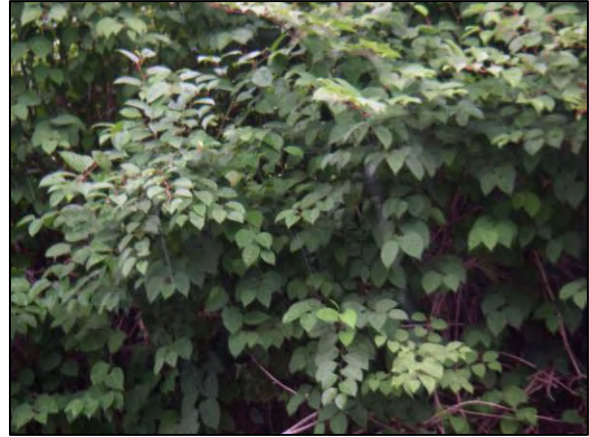
Japanese Knotweed at Station 18760

Further downstream, there was the first significant stand of Japanese knotweed in this unit (Station 18760, there were smaller patches further upstream in this unit).

Japanese knotweed is an invasive non-native species which does not provide adequate erosion protection due to its very shallow rooting system; knotweed also grows rapidly

and tends to crowd out more beneficial streamside vegetation. The best means for controlling knotweed is prevention of its spread. Therefore, effort should be made to ensure that existing stands are not fragmented via unnatural processes (i.e. mowing without removal of all mowed material) and transported into downstream areas. Small stands should be eradicated immediately to avoid further spread within this unit and downstream management units. There are removal methods that may be used for larger stands (see Section 2.7); these methods should be used with caution and carefully executed to avoid further spread of Japanese knotweed.

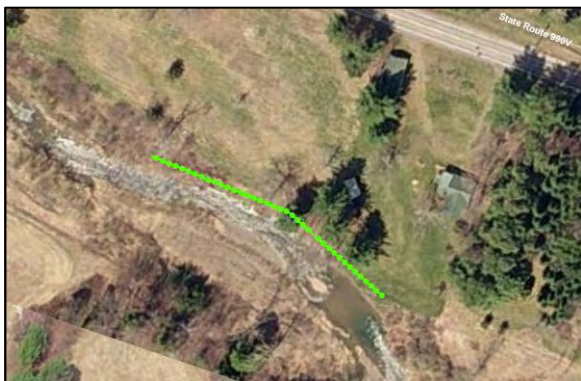
Riparian Planting Site at Stations 18713 - 18413

Continuing downstream, there was erosion (Stations 18771 – 18410) along the right streambank for approximately 361 feet. Along the upstream portion of the erosion site, lacustrine clay was exposed (Stations 18718 - 18607) in the channel bed and toe of the streambank. Clay inputs into a stream are a serious water quality concern because they increase *turbidity*, degrade fish habitat, and can act as transport for, or mask the presence of,

other pollutants and pathogens. There was little to no riparian buffer along much of this erosion site, and it was located along a proposed riparian planting site (Stations 18713 – 18413). Recommendations for this site include discontinued mowing to the stream's edge to allow succession to proceed, and establishing and enhancing the buffer

through the planting of native shrub and tree species. Reinforcing the toe of the streambank with native sedge species is also recommended. Buffer width should be increased by at least 100 feet or the greatest amount agreeable to the landowners. Prior to proceeding with any vegetative plantings, a more detailed assessment may be necessary and the eroding conditions should be given careful consideration when identifying the

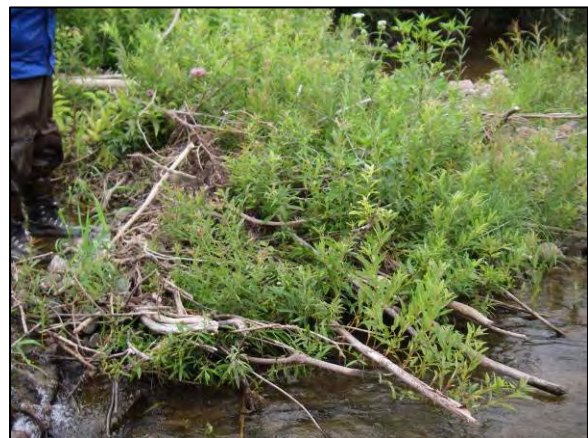
Beaver Dam at Station 18281

Continuing downstream, there was an old beaver dam (Station 18281) causing a partial obstruction of the left portion of the stream channel. This beaver dam appeared to contribute to upstream and downstream aggradational conditions. There was a second old beaver dam (Station 18168) further downstream across the full channel that also posed a partial obstruction to stream flow and contributed to localized aggradational conditions.

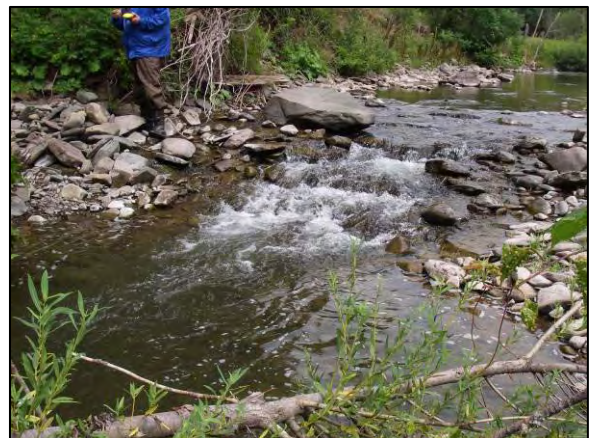
Head Cut at Station 17788

Just upstream of the tributary confluence, there was a *head cut* (Station 17788). A head cut is a marked change in stream bed slope, as in a step or waterfall, which is unprotected or of greater height than the stream can maintain. The stream was actively eroding the streambed downward to a new base level; there was a drop in channel elevation of approximately six feet.

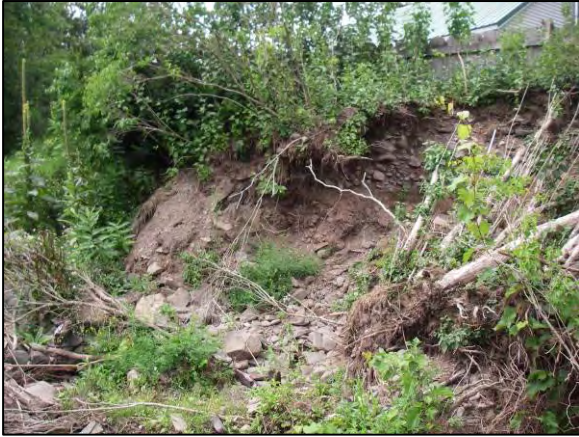
Erosion at Stations 17782 - 17690

Continuing downstream, there was erosion (Stations 17782 – 17690) along the right streambank for approximately 92 feet. The erosion had compromised several young trees and caused a large tree to fall across the stream channel; the fallen woody debris was posing an obstruction to flow that appeared to contribute to upstream aggradational conditions and localized scour of the channel bed and toe of the streambank. At the top of the bank, a fence was undercut, beyond which there was a house. If this bank continues to actively erode, both the fence and home may be in danger.

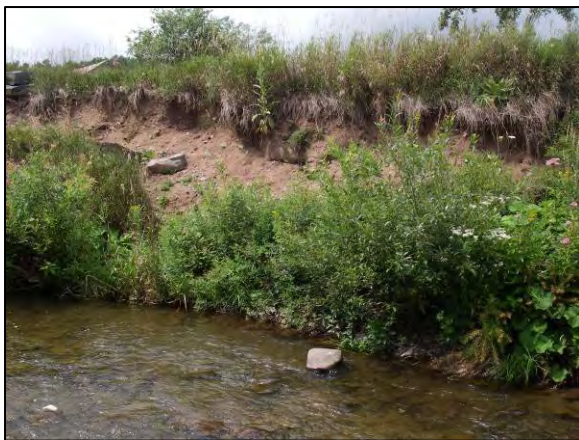
Erosion at Stations 17200 - 17010

establishing a wooded buffer with native vegetation at least 100 feet wide or the greatest width agreeable to the landowner. There were areas of erosion along this site. One of the erosion sites (Stations 17200 – 17010) had resulted in an erosion area of approximately 2,094 ft² along approximately 190 feet of the right streambank. This bank was nearly vertical and had some herbaceous

vegetation and willows at the toe of the bank. Prior to proceeding with any vegetative plantings, the eroding conditions should be given careful consideration when identifying the appropriate species and locations for plantings; a more detailed site assessment and bank grading may be necessary.

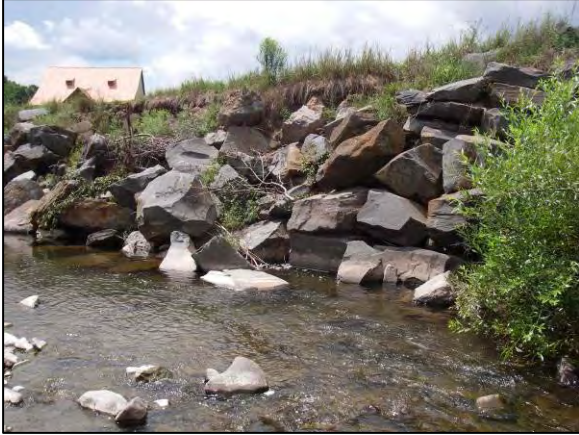
Revetment at Stations 17146 - 16971

Along portions of this erosion site, the right streambank was reinforced with rip rap (Stations 17146 – 16971) comprised of large rocks, stacked nearly vertical, for approximately 175 feet. Sections of the revetment had failed structurally; it was in poor functional condition and did not provide adequate scour protection. It is likely that the revetment will continue to fail during future high flows. The bank may need to be graded to lessen the slope of the revetment; interplanting the rip rap and reinforcing the toe of this streambank with native shrub and sedge species is recommended. Such plantings may help to strengthen the revetment, while enhancing aquatic habitat. The risk to bank stability can be minimized by maintaining mature trees along the critical 100 foot buffer zone. Aggradational conditions persisted through this stretch of stream including, multiple side bars, a point bar and a transverse bar.

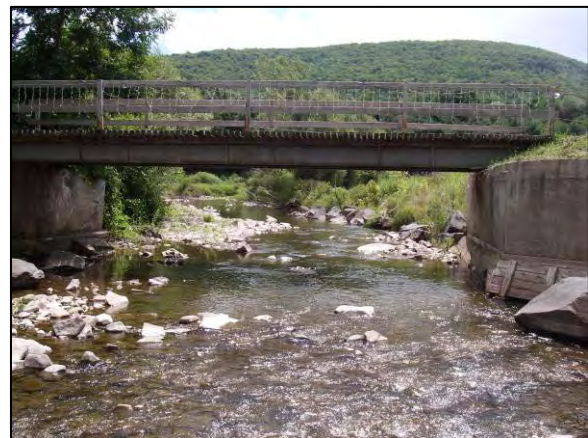
Bridge at Station 16957

Continuing downstream, the Manor Kill flowed under a private bridge (Station 16957). Gravel deposits upstream and downstream of the bridge were noted. Deposits such as these are commonly caused by inadequate sizing of the bridge opening. An undersized bridge opening causes water to back up upstream of the bridge, reducing stream velocity, which results in sediment deposition. There has been damage to the abutment on both sides of the bridge; in 1998 a streambank disturbance permit was issued to repair the damage. Flood damage to bridges is typically caused by inadequate hydraulic capacity of the bridge, misaligned piers and/or abutments,

or accumulation of debris. As bridges are replaced over time, these issues should be evaluated and adjusted if necessary to lessen the probability of flood damage by providing a more effective conveyance channel that promotes water and sediment flow through the bridge opening.

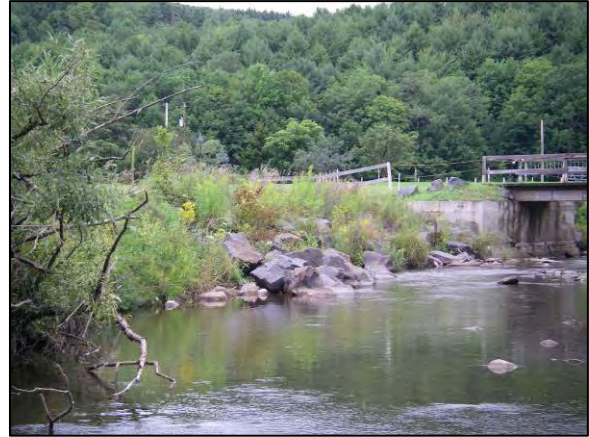
Revetment at Stations 16944 - 16874

Downstream of the bridge, the right streambank was reinforced with rip rap (stations 16944 – 16874) for approximately 70 feet. It was in fair structural and functional condition and didn't appear to provide adequate scour protection. As with the rip rap upstream of the bridge, a planting site continues along here and interplanting the revetment and reinforcing the toe of this streambank with native shrub and sedge species is recommended.

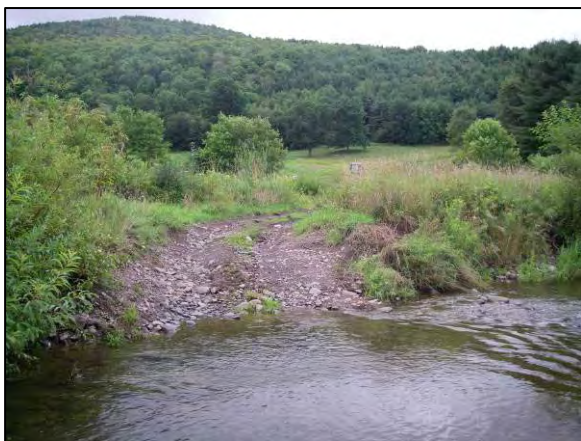
Channel Crossing at Station 16693

Continuing downstream, there was a channel crossing (Station 16693) to provide access to the agricultural fields along the left side of the stream. Maintenance of the crossing

appeared to contribute to upstream and downstream aggradational conditions. Along the left streambank, there was minor erosion (Stations 16710 – 16695) just upstream of the crossing for approximately 15 feet. Erosion (Stations 16677 – 16296) continued downstream of the crossing for approximately 381 feet along the left. Both of these erosion sites had herbaceous vegetation to the top of

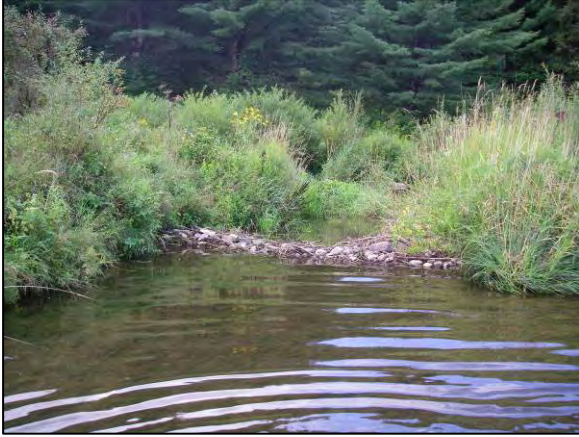
Beaver Dam at Station 16432

Along the downstream portion of this erosion site, there was a beaver dam (Station 16432) occupying the left portion of the stream channel, from the left streambank to a well vegetated center bar (Stations 16432 – 16293). The stream channel was over wide through this stretch of stream. The beaver dam appeared to contribute to upstream and localized aggradational conditions. Just downstream of the beaver dam, an unnamed tributary (Station 16407) entered along the left streambank. The flow through this tributary appeared to be affected by beaver activity, with multiple deep pools, including one at its confluence with the Manor Kill. Further downstream, there was a more substantial beaver dam (Figure 4.6.1, Inset B, Station 16370) also stretching from the left streambank to the center bar (Stations 16432 – 16293), occupying the left portion of the stream channel. This dam caused backwater upstream of the dam and appeared to contribute to excess sediment deposition upstream and downstream of the dam. Through this section of the stream, the channel was over wide and there were multiple areas and types of aggradational conditions including, center, side, point and transverse bars. These conditions seem to be maintained by abundant beaver activity.

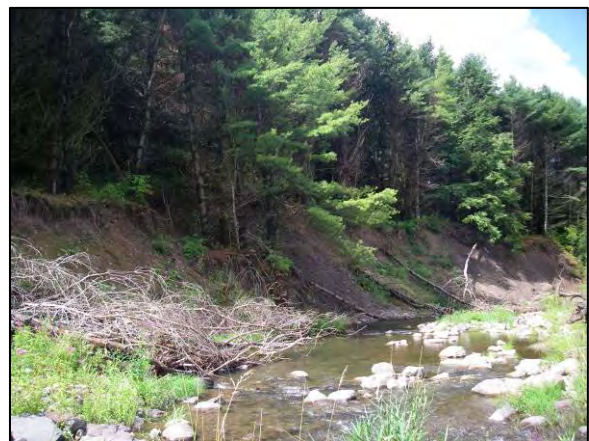
Mass Failure at Stations 16317 - 16052

As the stream meandered downstream, the *thalweg* flowed up against the toe of the left bank, undermining the steep slope and causing a mass failure (Stations 16317 – 16052). During the field assessment, this

bank was identified as a proposed Bank Erosion Monitoring Site (BEMS) to study erosion along this reach. Collection of baseline data, including a cross-section and long profile, is recommended. Once the baseline data has been collected, this cross-section can be resurveyed in the future to calculate the bank's erosion rate. At the time of the assessment, this mass failure had resulted in an erosion area of approximately 6,621 ft², exposing areas of lacustrine clay (Station 16315) and compromising mature trees. The fallen trees were in multiple locations along the streambank (Stations 16283, 16153 and 16052) and were contributing to upstream aggradation and localized scour of the channel bed and toe of the streambank, including scour of a deep pool along the downstream end of the erosion site. Excess sediment deposition resulted in the formation of side, point, transverse and center bars along this meander bend. There were also multiple small patches of Japanese knotweed through this stretch of stream.

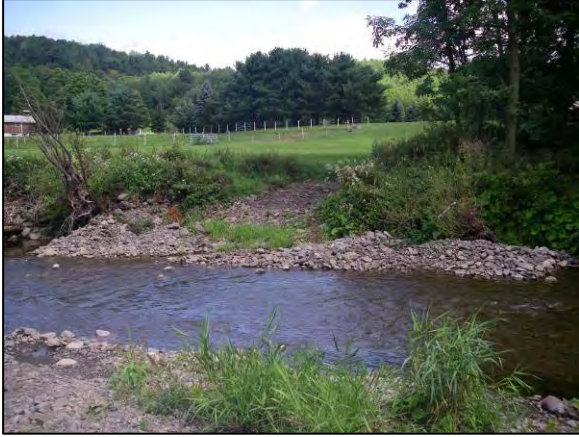
Channel Crossing at Station 15966

Continuing along this meander bend, there was a stream channel crossing (Station 15966) that appeared to serve primarily as a stream access point. It appeared as though channel material was placed upstream and

downstream of the access point to help maintain the crossing and to protect the streambank. The channel material used for bank protection is not likely to withstand significant stream velocities. During future high flows, this material will likely be mobilized and carried to downstream locations. This type of channel modification is not recommended. The NYS DEC Protection of Waters Program requires a permit for stream bed or bank disturbance including excavating gravel material and placing fill along streambanks.

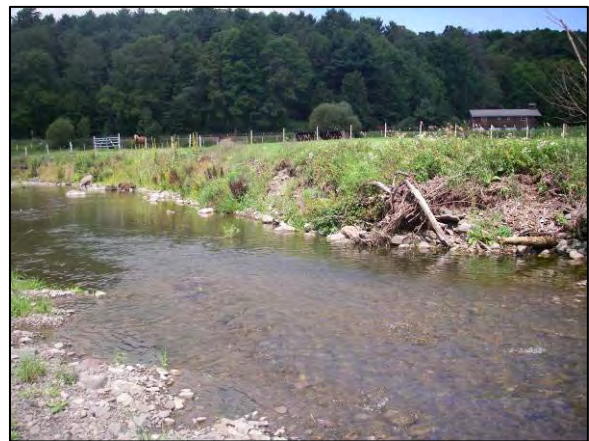
Riparian Planting Site at Stations 15969 - 15716

Downstream of the channel crossing, there was a proposed riparian planting site (Stations 15969 – 15716) along the right streambank for approximately 254 feet. Recommendations for this site include discontinued mowing to the stream's edge, allowing succession to proceed with natural regeneration of shrub and early successional tree species, and establishing a wooded buffer with plantings of native shrub and tree species.

The risk to bank stability can be minimized by maintaining mature trees along the critical 100 foot buffer zone. Buffer width should be increased by the greatest amount agreeable to the landowners. A vigorous riparian zone with deep-rooted native trees and shrubs would increase buffer functionality such as filtering nutrients and pollutants, if present, from the nearby land use. This site will

require a more detailed site assessment, and the erosion would need to be addressed prior to proceeding with any riparian plantings.

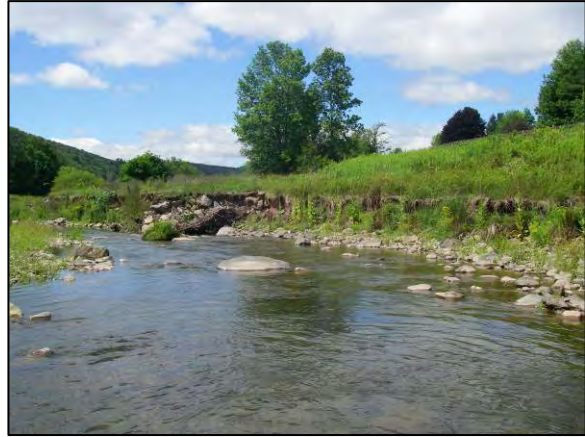
*Erosion at Stations 15962 -15500
(downstream portion)*

Along the planting site, and continuing downstream, the right streambank was eroding (Stations 15962 – 15463) for approximately 499 feet. There was mown lawn to the top of the bank along the upstream portion of the erosion site, beyond which there was a fence surrounding a horse pasture.

Continued erosion along this bank may compromise a portion of the fence. The erosion continues downstream of the pasture; this portion of the erosion site has old field or periodically maintained herbaceous vegetation to the top of the bank. The bank height and severity of the erosion also appeared to worsen moving downstream. Along the downstream end of the erosion site, there were remains of an old foundation that appeared to contribute to localized scour of the channel bed and toe of the streambank, and caused upstream backwater and aggradational conditions. The channel was over wide along this stretch of the stream. This site may benefit from the installation of *bioengineering* techniques that utilize live vegetation, either alone or in combination with harder materials such as rock or (dead) wood, to stabilize soils associated with stream banks or hillslopes. Roots stabilize the soil, while stems, branches and foliage slow high velocity water, reducing erosion and encourage deposition of fine sediment. If bioengineering techniques are going to be considered for streambank stabilization through this reach, an in-depth survey, a thorough morphological assessment and a project design may be required. Management unit 6 ended just downstream of this erosion site.
