Manor Kill Management Unit 7

Town of Conesville – Station 15492 to Station 9805

This management unit begins at Station 15492, continuing approximately 5,687 ft to Station 9805 in the Town of Conesville.

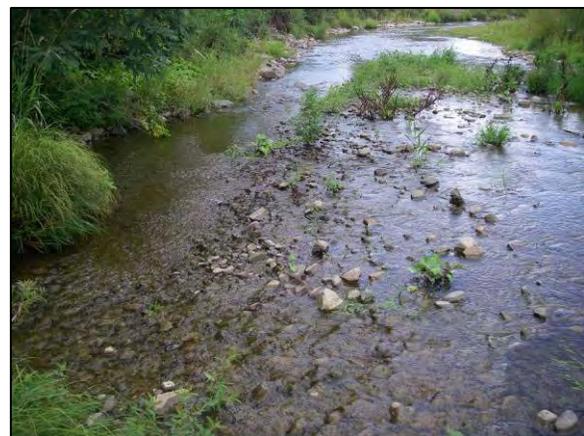
Transverse Bar at Stations 15294 - 15262

Along the right streambank, there was a piped outfall (Station 15368) that appeared to receive intermittent flow. This drainage pipe did not have outfall protection. Continuing downstream, there were multiple areas of channel *aggradation*, the process by which streams are raised in elevation by the deposition of material eroded and transported from other areas. These areas included transverse, point and center bars. During low flows, the transverse, or diagonal, bar (Station 15294 – 15262) directs flow toward the left streambank.

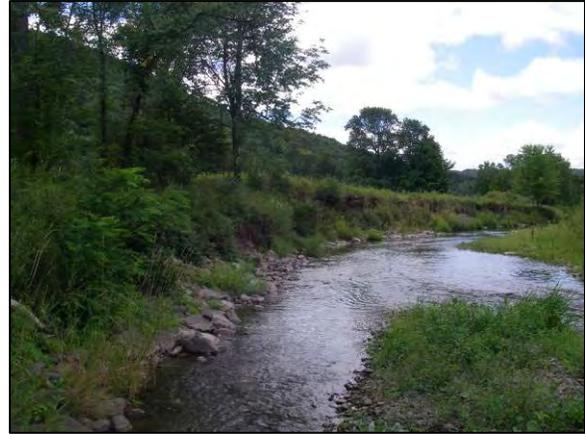
Erosion at Stations 15274 - 14944

As the stream meandered to the right, there was erosion (Stations 15274 – 14944) along the left streambank for approximately 330 feet. Streambank erosion often occurs on the outside of meander bends where the stream velocity is greatest during high flows. Along the upstream portion of the erosion, there was a thin line of trees at the top of the bank; along the remainder of the eroding bank, there was a successional old field to the edge of the stream. This area was identified as a proposed riparian planting site (Stations 15127 – 14683). Recommendations for this site include the planting native trees and shrubs along the streambank and the upland area. Enhancing the quality of the buffer with woody vegetation, and increasing the overall buffer width, will help to protect water quality through this reach by slowing stormwater runoff and filtering pollutants associated with nearby land uses. Buffer width should be increased by the greatest amount agreeable to the landowners.

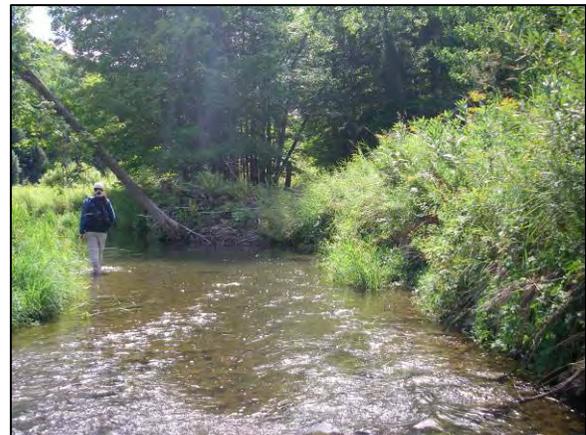
Erosion at Stations 14431 - 14271

Along the first wetland, there was erosion (Stations 14431 - 14271) on the right streambank for approximately 160 feet. The upstream portion of the erosion had herbaceous vegetation to the edge of the

stream; this vegetation was primarily successional old field with a few willows. Allowing natural succession to proceed along this bank is recommended in order to gain a woody vegetative buffer that may help to improve streambank stability. Also along this eroding bank, there was a compromised tree and a beaver lodge (Station 14366) with abundant woody debris accumulated behind the lodge; this beaver lodge did not appear to be active. Continuing downstream along the erosion, there was a young forest that provided a wooded buffer from the adjacent agricultural fields.

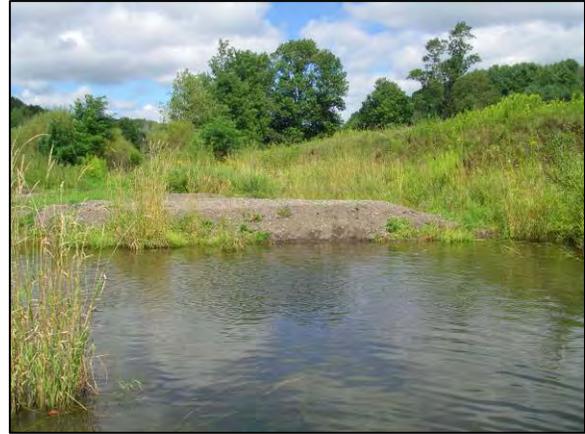
Point Bar at Stations 14491 - 14251

Opposite the erosion site, there was a point bar that stretched for approximately 240 feet along the left stream bed. There was an overflow channel along the backside of the point bar. The overflow channel contributed to the excess sediment deposition, particularly along the downstream end of the point bar, which had a steep drop off into a deep pool in the main channel. Just downstream, there was a stream channel crossing or access point (Station 14250) that appeared to be used for recreational purposes, and was only maintained along the right streambank.

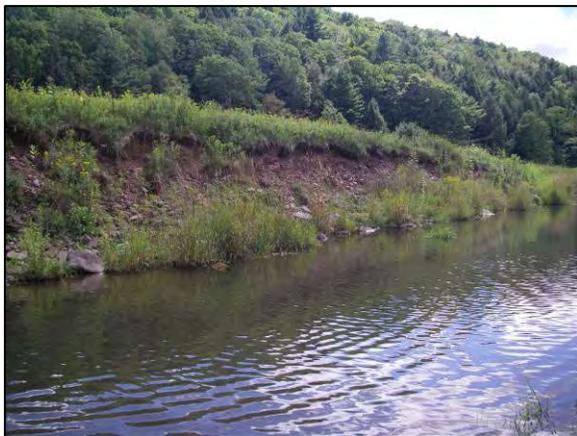
Erosion at Stations 14180 - 14043

Continuing downstream, there was erosion (Stations 14180 – 14043) along the left streambank for approximately 137 feet. There was a successional old field to the top of the

streambank; the face of the bank was exposed with herbaceous vegetation becoming established along the toe of the bank. Recommendations for this site include refraining from periodic mowing or maintenance of the field, allowing succession to proceed with natural regeneration of shrub and early successional tree species. Over time this site may self-recover.

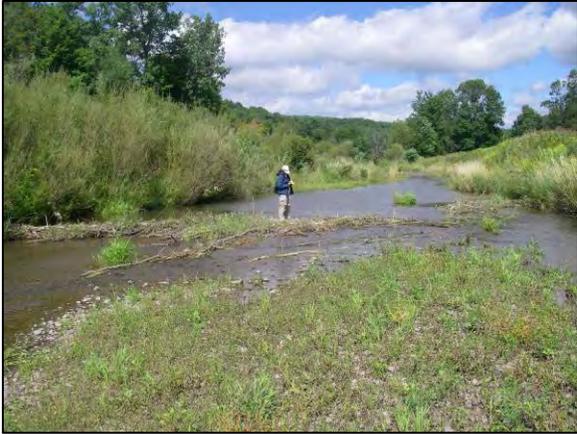
Beaver Dam at Station 14007

Further downstream, there was a beaver dam (Station 14007) that was actively being constructed or maintained, with evidence of fresh beaver damage to the willows upstream and downstream of the dam along the right streambank. This dam contributed to upstream backwater and downstream aggradational conditions, including a center bar followed by a transverse bar. Behind the willow vegetated

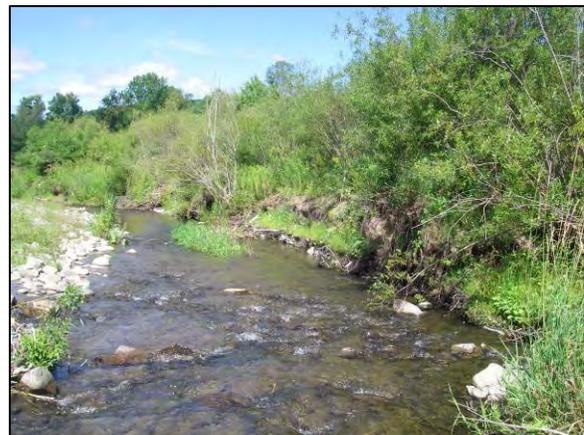
Erosion at Station 13464

Further downstream, there was erosion (Station 13464) along the right streambank that started at the confluence of the back water channel and continued for approximately 293 feet. The erosion along this bank was relatively minor, with exposed roots and a mix of herbaceous and shrubby vegetation to the stream's edge. Along this stretch of stream, there was a channel *divergence* (Station 13393), where a flood chute split off from the

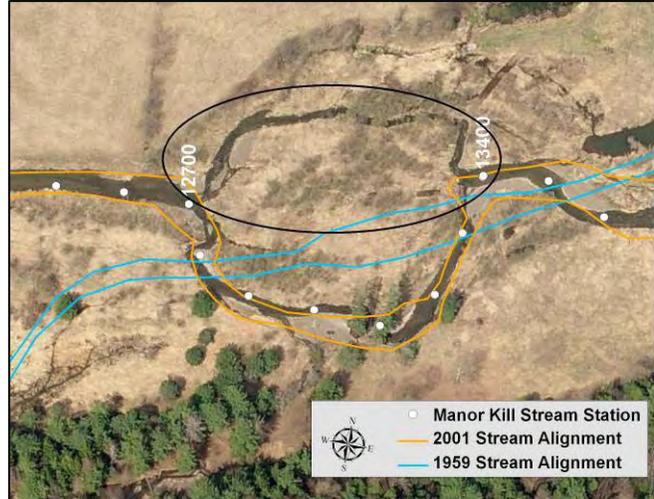
Lateral Migration between Stations 13400 - 12700

main channel. Flood chutes convey flow through a secondary channel during periods of high flows; this flood chute converged (Station 12665) with the main channel approximately 728 feet downstream. Based on a review of the historic and recent aerial photographs, this area has experienced significant lateral migration. Sometime between 1980 and 2001, the relatively straight channel observed in the 1959, 1967 and

1980 aerial imagery, meandered to the left, creating a new more sinuous channel. This new channel appeared to function as the main channel through 2006 (stream stationing based on 2006 aerials), and a less significant channel meandered to the right (see area indicated with black oval). Between 2006 and the 2008 assessment, the existing secondary channel (right (black oval)) became the main channel, while the left channel (previously mentioned, Stations 13393 – 12665) appeared to be cut off from the main channel due to abundant woody debris and aggradation. This channel may function as an overflow channel during very high flood flows.

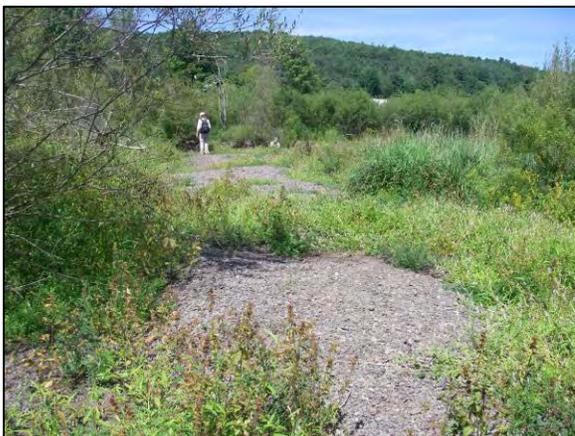
*Full Channel Aggradation at Stations 13380-13225, Secondary Channel
Photograph Orientation, Looking Upstream*

At the time of the assessment, there was no surface flow along the upstream portion of the secondary channel. There was excess sediment deposition beginning at the channel divergence and continuing for much of the secondary channel. This included full channel aggradation (Stations 13380 – 13225) for approximately 155 feet, followed by multiple point bars.

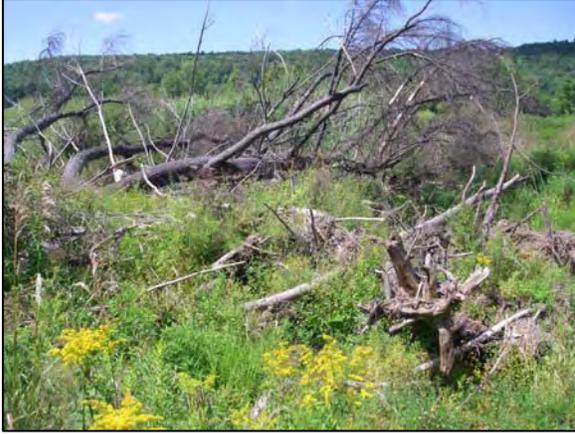
*Woody Debris at Station 13050
Secondary Channel*

the secondary channel, it appeared as though much of this excess sediment deposition was caused by a large fallen tree and accumulated woody debris (Station 13050) that posed a significant obstruction to channel flow. Downstream of the fallen tree, there was surface flow, additional woody debris, and the aggradational conditions persisted.

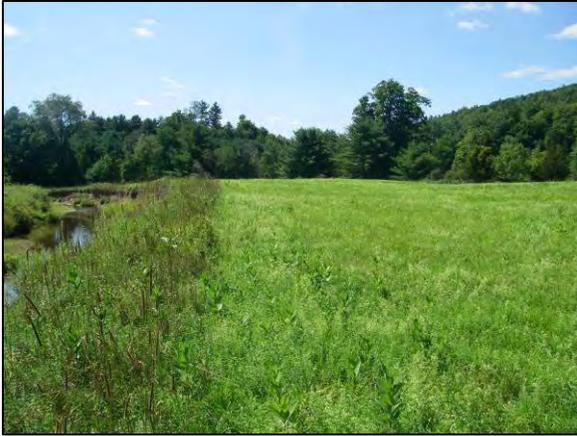
Proposed Planting Site Stations 12627-12201

Continuing along the stream, two proposed planting sites (Stations 12927-12652

and 12627-12201) were identified along the right bank. These planting sites were separated by a thin row of trees that ran perpendicular to the stream.

Recommendations for these sites include planting native trees and shrubs along the streambank and the upland area. Buffer width should be increased by the greatest amount agreeable to the landowners. Increasing the buffer width to at least 100 feet will increase

the buffer's functionality. Portions of both proposed planting sites are experiencing erosion; therefore, prior to proceeding with any vegetative plantings careful consideration should be given to identifying the appropriate species and locations for plantings. A more detailed site assessment may be necessary to determine whether stream bank grading will be required.

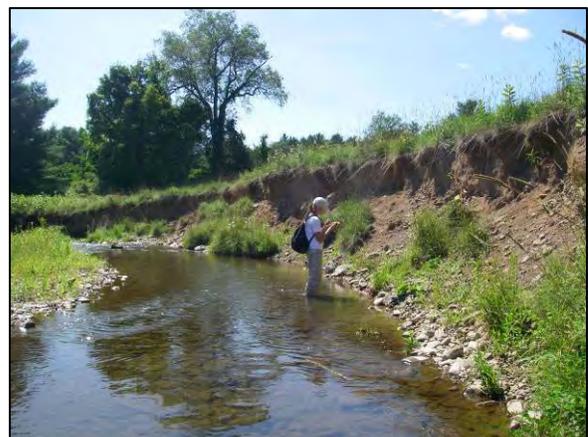
BEMS at Stations 12637-12169

During the field assessment, the right bank along the second planting site was identified as a proposed Bank Erosion Monitoring Site (BEMS) to study erosion along this reach. To monitor BEMS, a cross-section and long profile may be conducted to collect baseline data. Once the baseline data has been collected, this cross-section can be resurveyed in the future to calculate the bank's erosion rate. Improving the riparian buffer along this site is important however, other stream bank stabilization techniques may be required to reinforce the bank and to minimize any loss of planted vegetation. Toward the end of this erosion site, clay was exposed (Figure 4.7.1, Inset B, Stations 12300-12172) along the streambank and channel bed for approximately 166 feet. Clay inputs into a stream are a serious water quality concern because they increase turbidity, degrade fish habitat, and can act as a carrier for other pollutants and pathogens.

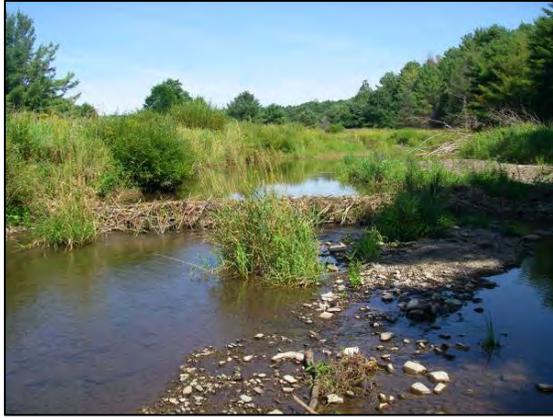
Beaver Dam at Station 11769

downstream a beaver dam (Station 11769) had been constructed across the stream channel. The dam appeared to be actively maintained and contributed to backwater and downstream aggradational conditions as well as scour along both banks downstream of the dam. While beaver impoundments can sometimes be a nuisance, beavers have historically played a beneficial and ecologically important role in the

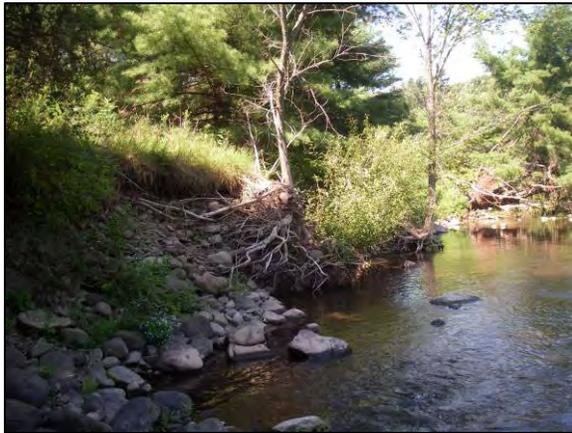
Erosion at Stations 10630-10266

Continuing downstream there was erosion (Stations 10630-10266) along the left streambank for 365 feet. Along this erosion, vegetation was a mix of grasses, shrubs and trees. The woody vegetation had been compromised along the undercut banks, with exposed roots and one tree that had fallen along the downstream portion of the erosion site (Figure 4.7.1 Inset A, Station 10505).

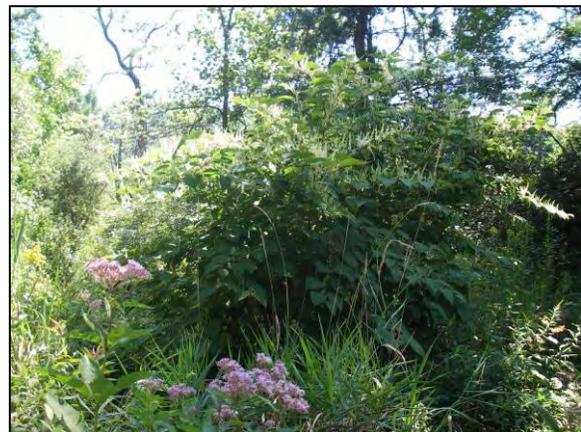
Japanese Knotweed at Station 10056

As the stream meandered to the left, Japanese knotweed (Station 10056) was observed on the left bank. This was the first and only observation of knotweed in this management unit. Japanese knotweed is an invasive non-native species which does not provide adequate erosion protection due to its very shallow rooting system, and also grows rapidly to crowd out more beneficial streamside vegetation. The best means for controlling knotweed is prevention of its spread. Therefore, effort should be made to ensure that existing stands are not fragmented via unnatural processes (i.e. mowing without removal of all mowed material) and transported into downstream areas. Small stands should be eradicated immediately to avoid further spread within this unit and to

downstream management units. There are removal methods that may be used for larger stands (see Section 2.7), these methods should be used with caution, and carefully executed to avoid further spread of Japanese knotweed.

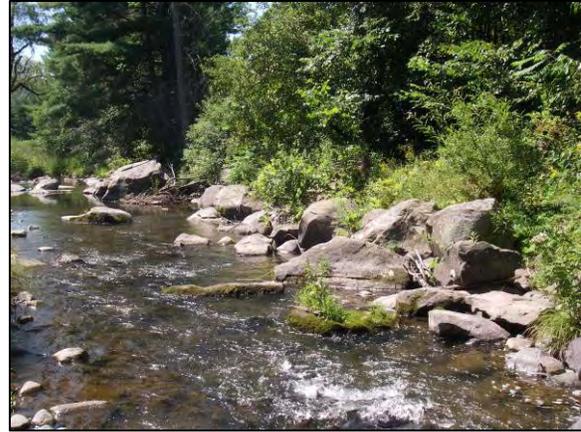
Revetment at Stations 9900-9779

As the stream meandered toward State Route 990V, the right streambank had been reinforced with rock rip-rap (Stations 9900-9779) along the toe of the bank for approximately 90 feet in Management Unit 7 and continued into Management Unit 8 for an additional 40 feet. The rip-rap appeared to be old and consisted of natural large boulders, was in fair functional condition and poor structural condition; however it appeared to provide adequate scour protection. Vegetation along the revetment was a mixture of grasses, shrubs and trees. Management Unit 7 ended at Station 9805.
