Manor Kill Management Unit 9

Town of Conesville – Station 4523 to Station 1775

Figure 4.9.1 Management Unit 9 - 2006 aerial photography with 2008 stream feature inventory.

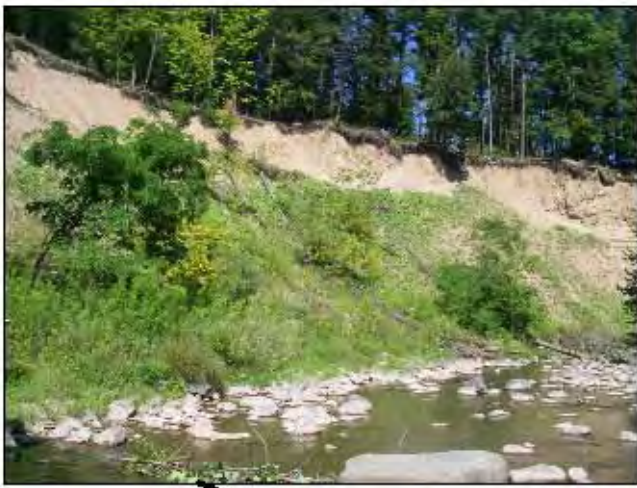
A

As the stream meandered to the right, the thalweg, or deepest part of the stream channel, flowed up against the left streambank causing a second mass failure (Figure 4.9.1, Inset A, Stations 2289 – 1906). This mass failure resulted in an erosion area of approximately 12,547 ft², exposing roots and compromising mature trees. Land was forested from the top of the erosion to Prattsville Road – a distance of approximately 300 feet. Along the erosion, multiple trees had fallen into the stream contributing to localized scour and aggradation.

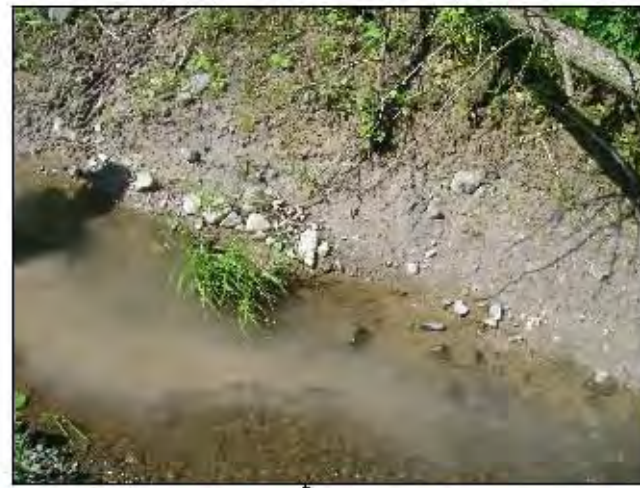
B

Along the erosion there were multiple obstructions including woody debris and beaver dams that contributed to scouring and aggradation. At Station 2630 large fallen trees had accumulated additional woody debris causing a deep scour pool adjacent to the debris (Figure 4.9.1, Inset B, Station 2630). These trees also appeared to contribute to localized upstream and downstream aggradation as well as multiple smaller scour pools. Additional beaver dams and woody debris contributed to aggradational conditions along a large center bar (Station 2602) which had multiple channels flowing through. Beaver dams in the stream

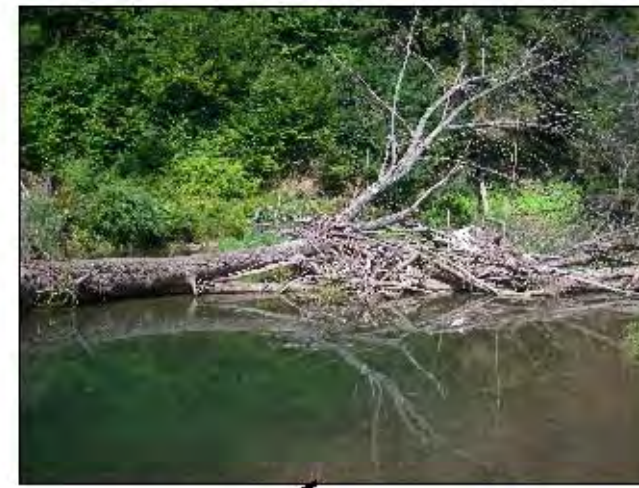
C

Following the hydraulic erosion along the left bank, there was a mass failure (Stations 2552-2411) resulting in an erosion area of approximately 6,662 ft², exposing areas of lacustrine clay (Figure 4.9.1, Inset C, Stations 2497-2420) and compromising mature trees along the bank. Fallen trees were in multiple locations along the streambank. The mass failure was forested at the top of the bank with herbaceous vegetation on the face of the upstream portion of the bank.

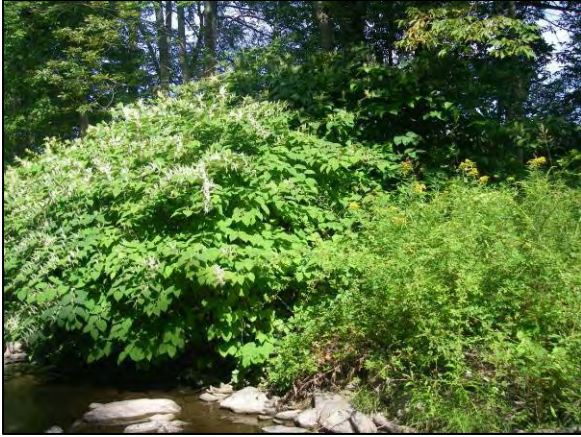
Management Unit 9 began just downstream of a tributary confluence. Along the right bank, two stands of Japanese knotweed were observed. Japanese knotweed is an invasive non-native species which does not provide adequate erosion protection due to its very shallow rooting system; knotweed also grows rapidly and tends to crowd out more beneficial

Japanese Knotweed at Station 4304

streamside vegetation. The best means for controlling knotweed is prevention of its spread. Therefore, efforts should be taken to ensure that existing stands are not fragmented via unnatural processes (i.e. mowing without removal of all mowed material) and transported into downstream areas. Small stands should be eradicated immediately to avoid further spread within this unit and to downstream management units. There are removal methods that may be used for larger stands (see Section 2.7); these methods should be used with caution and carefully executed to avoid further spread of Japanese knotweed.

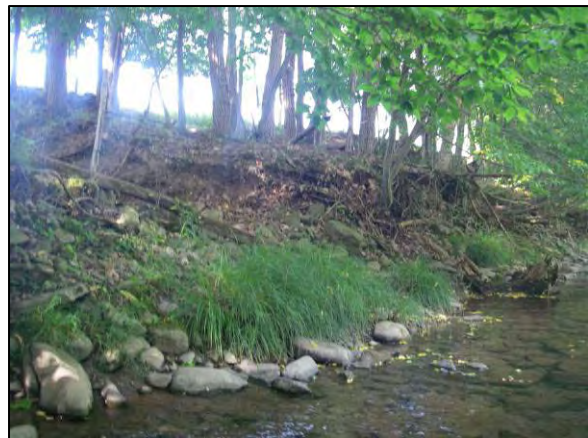
Downstream of the convergence the left bank was experiencing hydraulic erosion (Station 4081-3781) for approximately 682 feet. There was a thin buffer of young trees at the top of the bank that separated the stream from an agricultural field. A portion of the bank had

Erosion at Station 4304

high overhanging material with exposed roots, compromised trees and a failing wire fence. At Station 3746 a tributary entered from the left. This tributary drains the adjacent agricultural fields and appears to contribute to the upstream and downstream erosion.

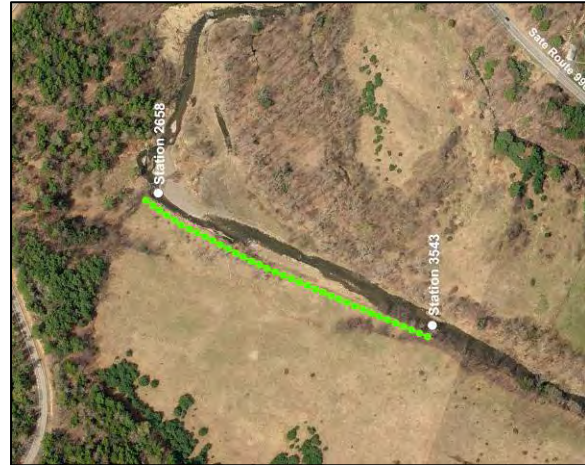
Continuing downstream, a riparian planting site (Station 3543) was proposed for approximately 885 feet along the left streambank. This site was a successional old field with herbaceous vegetation to the edge of the stream. Recommendations include continuing to allow succession to occur with natural regeneration of shrub and early successional tree species. This would be accomplished by not mowing, as well as planting native trees and shrubs along the

Planting Site at Stations 3543-2658

streambank and the upland area. Buffer width should be increased by the greatest amount agreeable to the landowners. Increasing the buffer width to at least 100 feet will help to stabilize the stream bank and protect water quality through this reach by slowing stormwater runoff and filtering pollutants associated with nearby land use. Portions of the streambank along the planting site were experiencing erosion; therefore prior to proceeding with any vegetative plantings, a more detailed assessment may be necessary. The eroding conditions should be given careful consideration when identifying the appropriate species and locations for plantings.

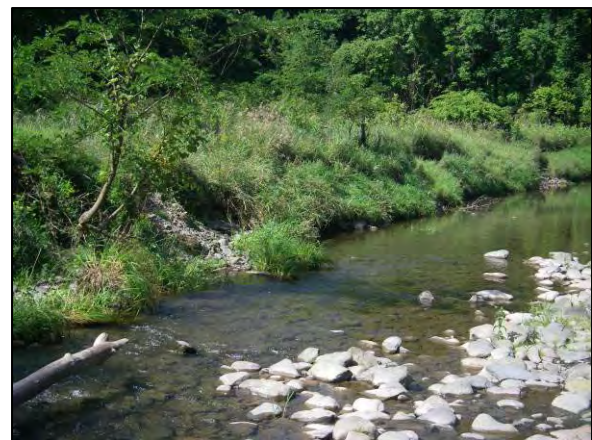
As the stream meandered to the right, hydraulic erosion began along the downstream portion of the proposed planting site and extended 374 feet (Stations 2888-2552). The erosion was approximately 6 feet in height; much of the bank material had slumped over the face of the bank, exposing roots. Opposite the erosion, a point bar had

Erosion at Stations 2888-2552

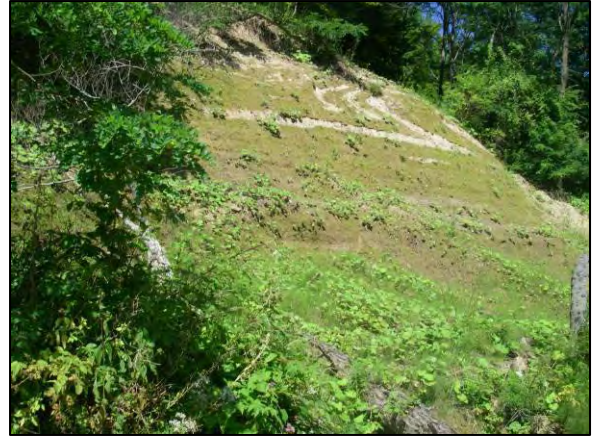
Mass Failure at Stations 2552-2411

Summary of Recommendations Management Unit 9	
Intervention Level	Assisted Self-Recovery
Stream Morphology	No recommendations at this time.
Riparian Vegetation	Treat, remove and prevent the spread of Japanese knotweed, where feasible. Plant a buffer of trees and shrubs along proposed planting sites and increase width of riparian buffer in appropriate locations.
Infrastructure	No recommendations at this time.
Aquatic Habitat	Watershed Aquatic Habitat Study
Flood Related Threats	No structures in 100-year floodplain – protect floodplain from development.
Water Quality	Encourage homeowners to participate in the CWC septic program, if eligible.
Further Assessment	Establish bank erosion monitoring sites at the two mass failures - Stations 2552-2411 and Stations 2289 – 1906.

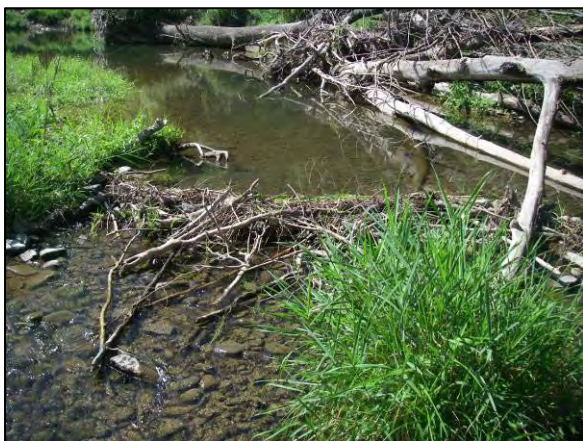
Beaver Dam at Station 2600

extended from center bar to center bar (Station 2600), and from center bar to the right bank, (Station 2579) also contributing to aggradation and backwatering. While beaver impoundments can sometimes be a nuisance, beavers have historically played a beneficial and ecologically important role in the stream system. Beaver activity adds organic debris (trees, leaves, etc. which provide the base of

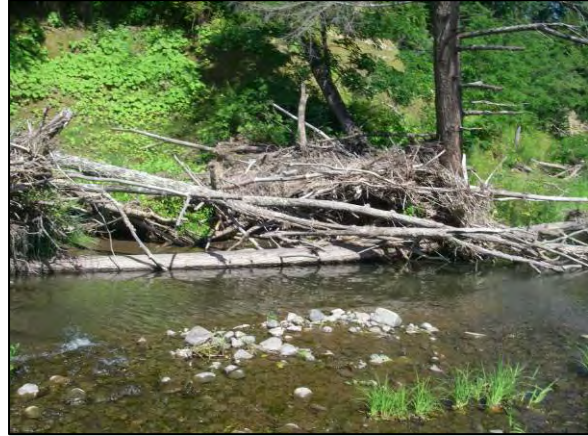
Further downstream trees that had fallen from the mass failure caused an additional obstruction accumulating woody debris and contributing to a localized scour pool as well as upstream and downstream aggradation (Station 2462). Woody debris is beneficial to a stream system as it provides critical habitat for fish and insects, and adds essential organic matter that will benefit organisms downstream. However, if the debris becomes a hazard it may need to be cut or removed.

Woody Debris at Station 2462

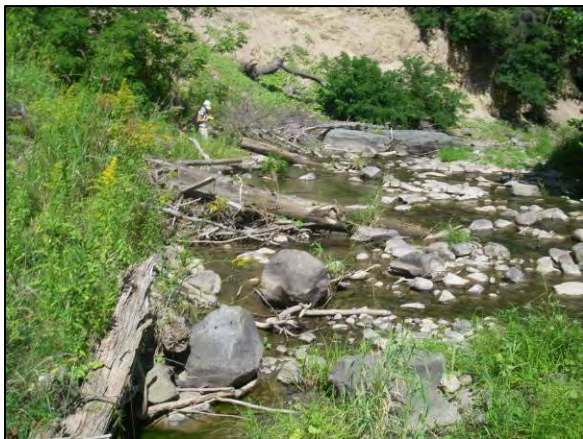
Woody Debris at Station 2134

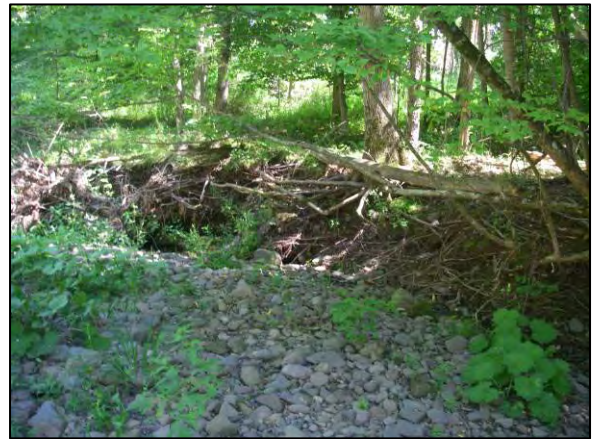
Continuing downstream, there was a channel divergence (Station 2056) along the right streambank where an additional secondary channel split off from the main channel and flowed behind a side bar for approximately 165 feet. At the time of the assessment flow was subsurface. The convergence of this channel appeared to contribute to hydraulic erosion (Stations 1961-1891) along the right bank. This erosion exposed roots and compromised trees of a young forest. At Station 1890 a tributary entered from the right bank which also appeared to contribute to downstream erosion.

Erosion at Stations 1961-1891

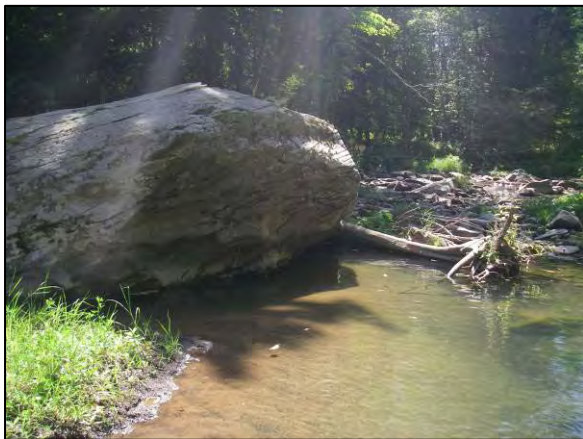
Woody debris obstructions continued further downstream at Stations 1847 and 1787 where trees had fallen into the stream and contributed to localized scouring and deposition. At Station 1812 a large boulder in the center of the stream caused additional woody debris to

Boulder at Station 1812

accumulate; the boulder appeared to contribute to upstream and downstream aggradation as well as localized scouring of the bed along its sides. Just downstream of the boulder, a center bar extended from Station 1812 into Management Unit 10, Station 1714. This center bar was composed of cobble and gravel with some herbaceous vegetation. Management Unit 9 ended at Station 1775.

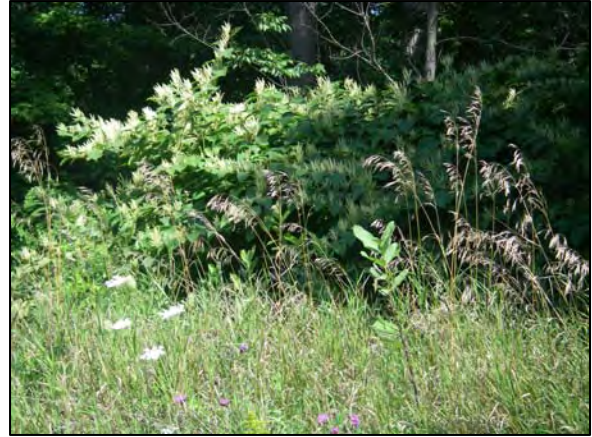
Some plant species that are not native can create difficulties for stream management, particularly if they are invasive. Japanese knotweed (*Fallopia japonica*), for example, has become a widespread problem in recent years. Knotweed shades out other species with its dense canopy structure (many large, overlapping leaves), but stands are sparse at ground level, with much bare space between narrow stems, and without adequate root

Knotweed at Station 3074

structure to hold the soil of streambanks. The results can include rapid streambank erosion and increased surface runoff leading to a loss of valuable topsoil. Japanese knotweed locations were documented as part of the stream feature inventory conducted during the summer of 2008 (Riparian Vegetation Mapping, Section 2.7). In total, three Japanese knotweed occurrences, covering an estimated length of 55 feet, were documented during the stream feature inventory. The best means for controlling knotweed is prevention of its spread, therefore, effort should be made to ensure that all fill brought into the area is clean and does not have fragments of knotweed or other invasive plants. If Japanese knotweed sprouts or small stands are observed, they should be eradicated immediately to avoid further spread within this unit and downstream management units.
