Rondout Creek Management Unit 3

Management Unit 3
Between Station 7100 and Station 4700

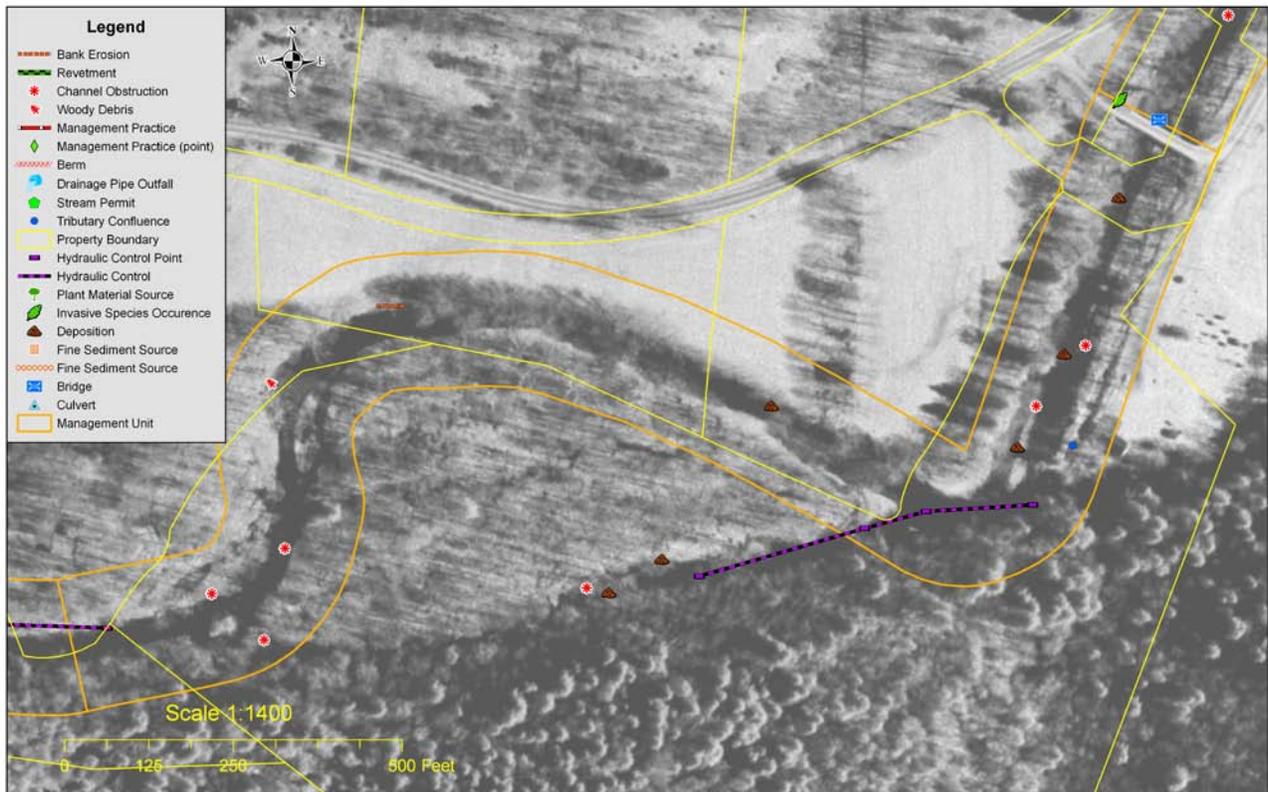
Figure 1 Stream feature inventory, MU3

The 2009 stream feature inventory revealed that 1% (41 ft.) of the stream length exhibited signs of active erosion along 2,386 ft. of total channel length (Fig. 1). No revetment is present in this management unit. No berms were identified in this management unit at the time of the stream feature inventory.

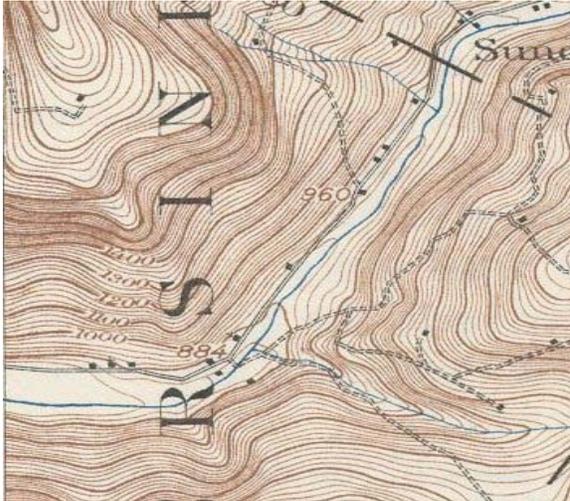
Figure 2 Excerpt of 1905 USGS topographic MU3

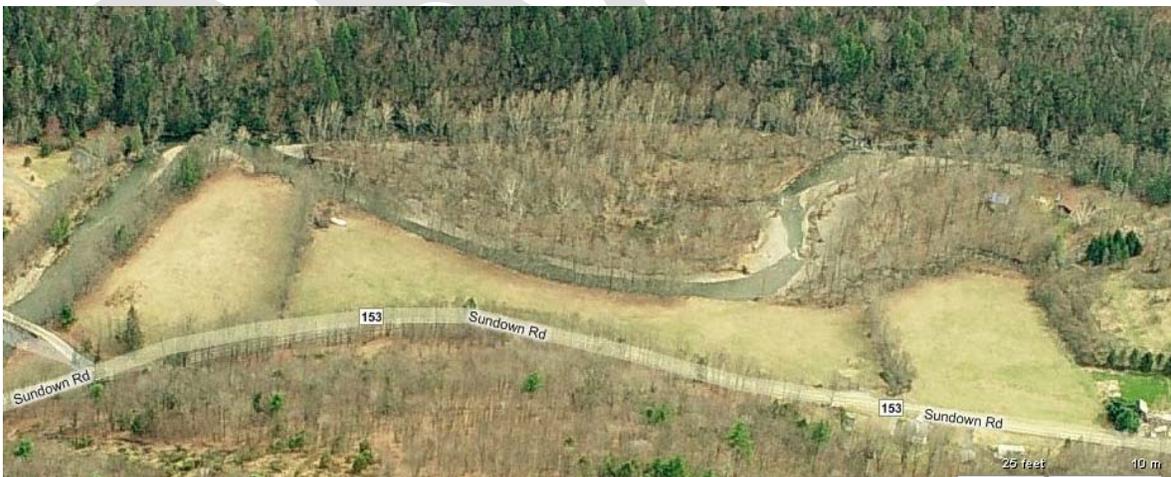
At the southern extent of the alluvial fan, the valley floor bends to the right, turned by the valley wall, and begins to broaden as it approaches the Rondout Reservoir a mile down valley. In the roughly one hundred and twenty centuries since the retreat of the glaciers, the position of Rondout Creek has moved back and forth across this narrow valley floor floodplain numerous times. Until recently, the channel has been shown as a single thread, although the 1905 USGS topo map (Fig. 2) shows the channel hugging the left valley wall, while the later USGS maps show the channel looping counterclockwise around the Sycamore floodplain forest from Stations 6400 to 5000 (Fig. 3). The channel currently splits at the hard right turn, taking both courses.

Figure 3 Management Unit 3

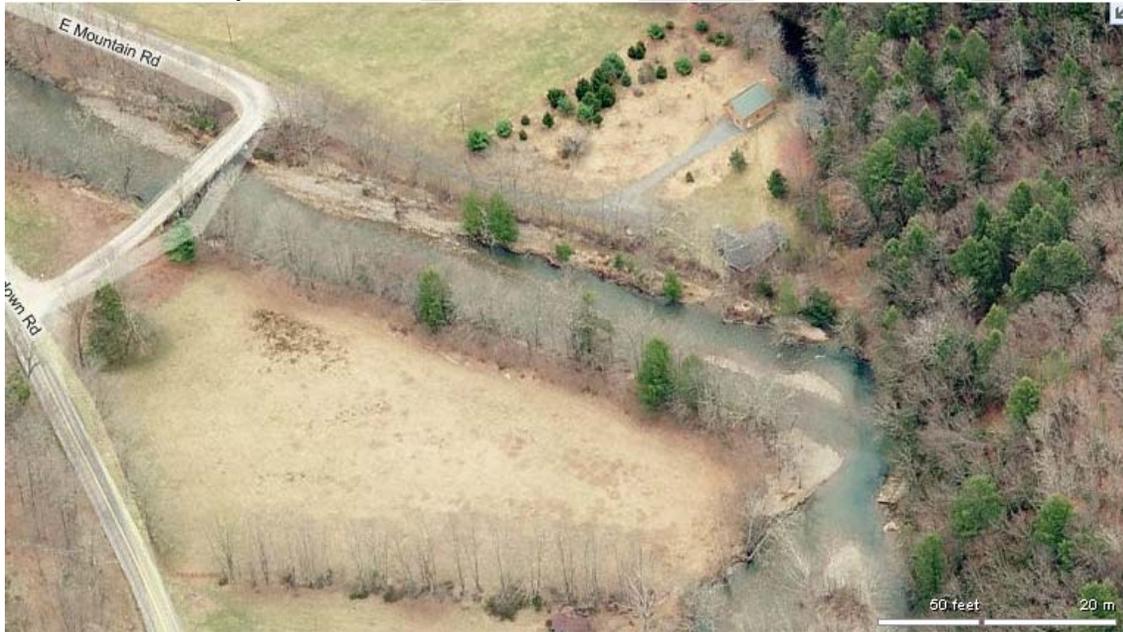
Figure 4 90 degree right turn in stream channel

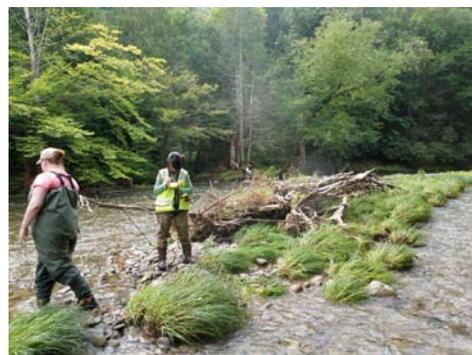
Figure 5 Woody debris collected on center bar

6600 it becomes a center bar, evidence of bed *aggradation* resulting from backwater effects created by the hard right turn forced as the channel hits the valley wall. The center bar has collected woody debris (Fig. 5). A perennial spring (Fig. 6) enters the channel from the left at Station 6600 near the residence, and some back eddy scour was evident associated with this confluence, which the homeowner appears to be trying to mitigate with dumped block. It is recommended that potential bioengineering treatments be investigated to address the scour problems.

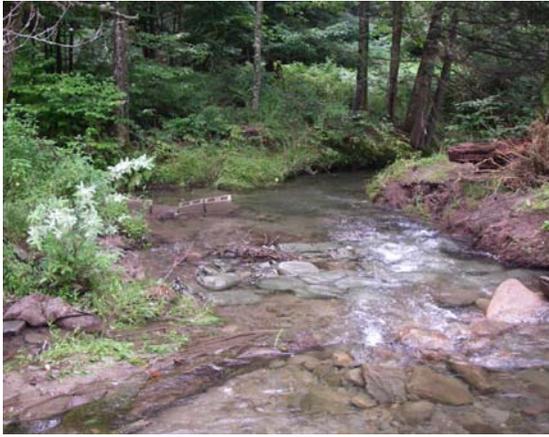
Figure 6 Perennial spring, unnamed. left

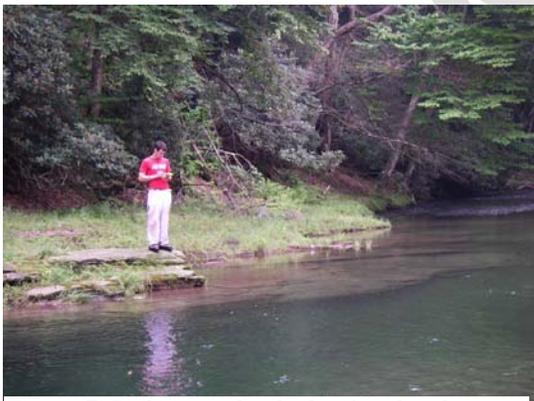
As the channel approaches the valley wall, the bed is scoured to bedrock on the left beginning at a deep pool around Station 6500 (Fig. 7). The channel splits here, with the left channel continuing over bedrock bed for 500 ft. along the base of the valley wall, and the right channel continuing around a low-elevation floodplain forest largely comprising mature Sycamore (Fig.8).

Figure 7 Bed scoured to bedrock at bend

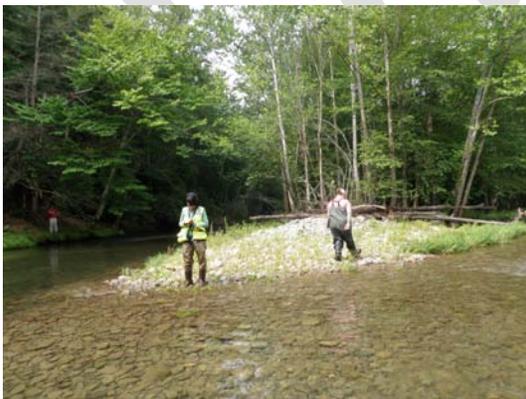
Figure 8 Channel divergence, Stn 6500

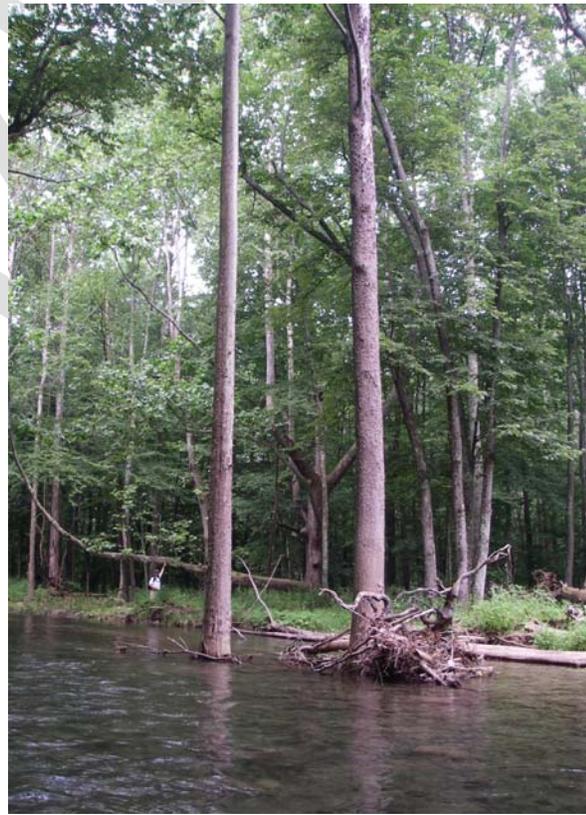
Figure 9 Mature Sycamore floodplain forest, note person for scale

This floodplain forest appears to be fairly unique in terms of its structure, disturbance regime and biodiversity; it is recommended that the vegetation community be assessed and, if warranted, steps be taken to ensure its protection.

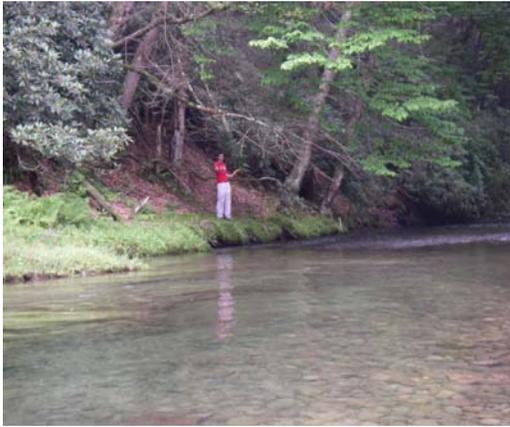
Figure 10 Bedrock hydraulic control, left

Continuing down the left thread, the channel runs along base of the valley wall, controlled for much of its length by bedrock in the bank and left edge of bed (Fig. 10). The mature canopy nearly encloses the channel (Fig. 11).

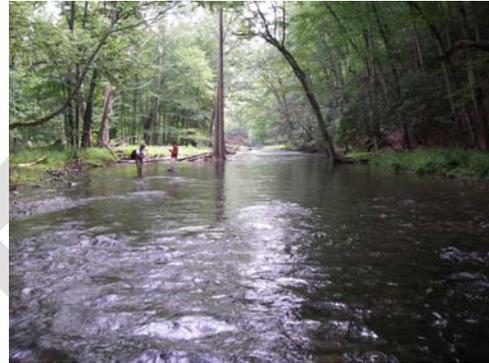
Figure 11 Mature tree canopy shading channel

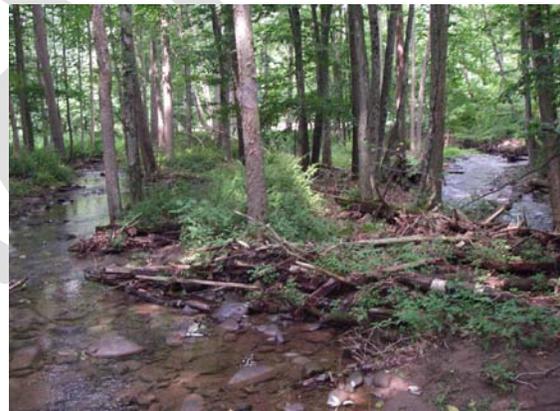
On the island to the right of this channel, multiple channel threads course through the forested floodplain and the extensive collection of woody debris caught among the trees (Fig. 12).

Figure 12 Multiple channels on island created by extensive woody debris obstructions

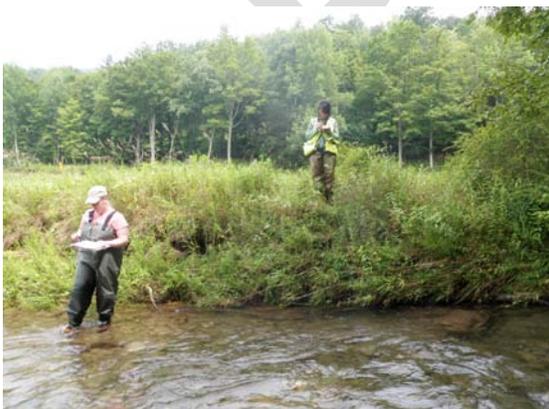
Figure 13 Erosion of the right bank, right channel

aggradation is also evident, and a short stretch of bank erosion (approximately 44 ft.) was observed at Station 5500, creating a break in the single line of trees protecting the right bank. It is recommended that bioengineering practices be installed at this location, and the possibility of reestablishing a wider woody buffer along the outside of this meander be explored, to increase bank resistance to erosion in the future.

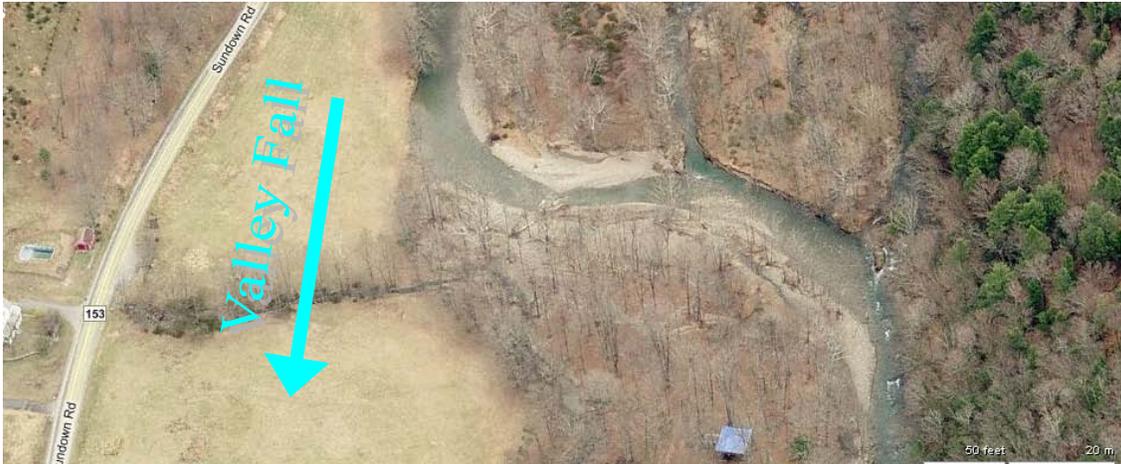
Figure 14 Lower end of island, channels converge

The direction of channel flow is nearly perpendicular to the valley fall here (Fig. 14); consequently, the floodplain and grounds of the residence down-valley of these tight bends show evidence of frequent overbank flows.

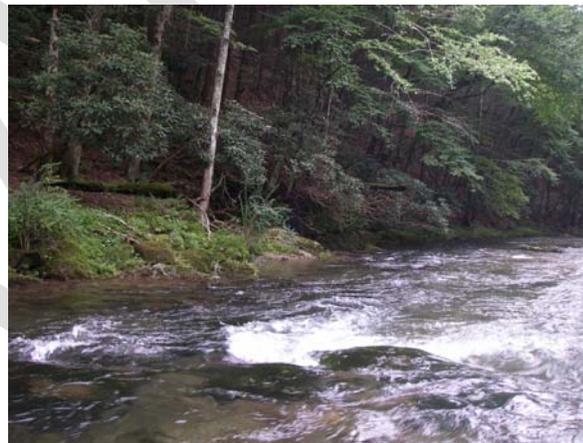
Around Station 4900 the left and right channels converge as a single thread channel, again running along the base of the left valley wall, and at Station 4700, the left bank is again controlled by rock ledge (Fig. 15) as Management Unit 3 ends.

Figure 15 Bedrock hydraulic control, left bank
