# Rondout Creek Management Unit 7

Management Unit 7  
Between Station 16,300 and Station 18,500

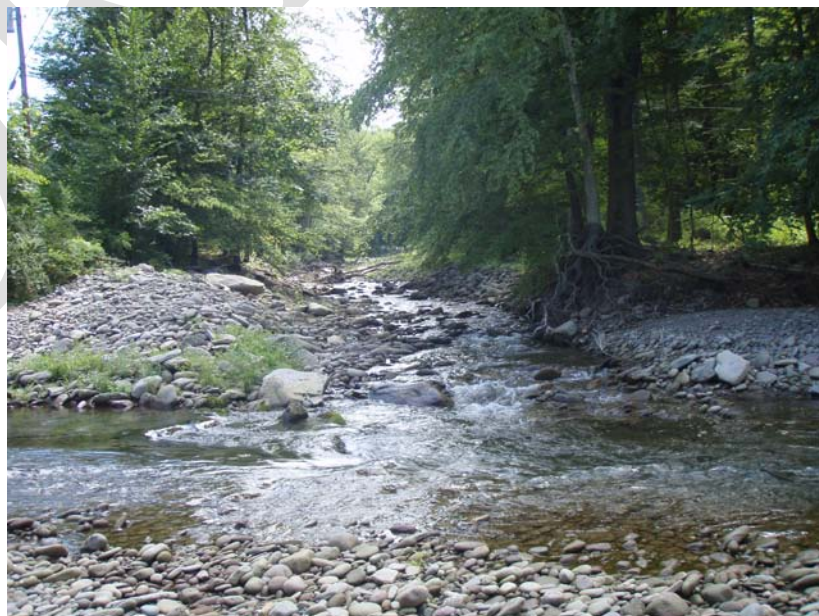
As the Rondout Creek exits from under the Ulster County Route 42 Bridge, the channel is fairly entrenched, and is turned to the right as it approaches the confluence of Sundown Creek on the left (Fig. 5). Sundown Creek is described Sections 4.18 through 4.20. Historically the confluence may have been 1000 ft. further downstream, where the channel meets the left valley wall. A house

Figure 5 The confluence of Sundown Creek (East Branch of the Rondout)

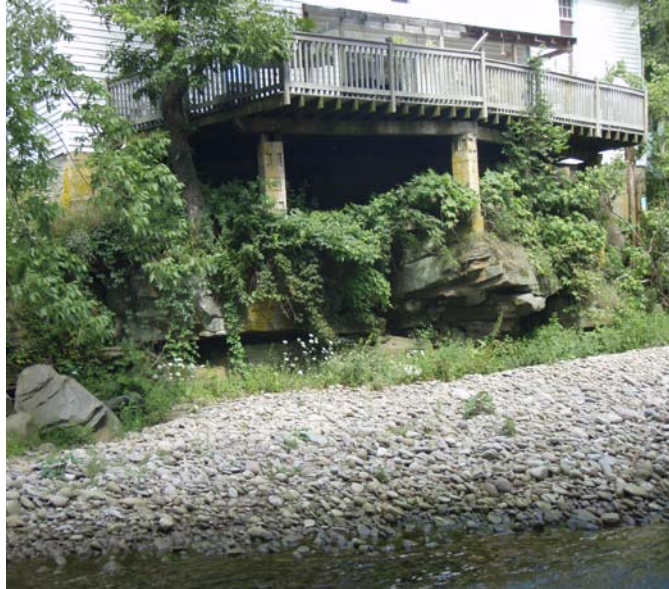
Figure 6 House on ledge

sits on the right immediately opposite the confluence, on ledge that receives the direct force of high flows from Sundown Creek. Sundown Creek is flashy, but delivers only moderate sediment loads due to the bedrock channel bed and extensive bank revetment along much of its length, except during exceptionally large floods.

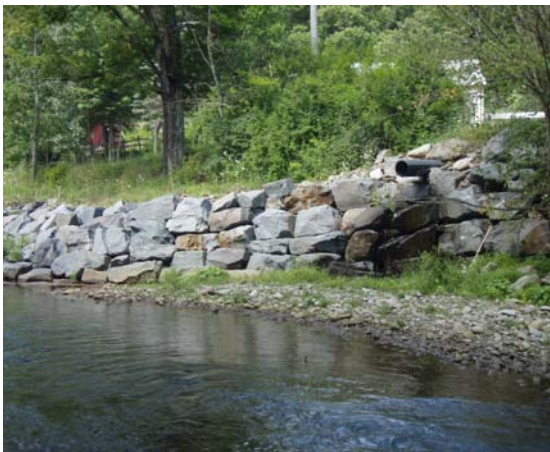
Downstream of the ledge, however, the right bank is subject to erosion, and has been a chronic location for high flows to jump the channel and use the adjacent lawns and highway.

This bank was recently armored from between Stations 17850 and 18350 as part of an *Emergency Watershed Protection* project, with a mixture of stacked, tiled and dumped rip-rap, and *stream barbs* were installed to slow velocities immediately adjacent to the bank, and to direct the force of the combined flows of Sundown Creek and the Rondout away from the bank. The stream barbs are only a few years old, and seem to be functioning as intended, protecting the bank. Scour holes have developed downstream and sediment is accumulating upstream of each barb, and

Figure 7 Revetment on right bank, with piped outfall from Ulster Rte 42 road drainage vegetation is establishing near the waters edge. These rock structures should be monitored for several years, in conjunction with the conditions of the bed and banks downstream, as part of a hydraulics and sediment transport study of Management Units 7-10. Piles of cobble and gravel remain in the floodplain on the right around Station 18000. Their effect on floodplain flows should be assessed as part of the hydraulics study.

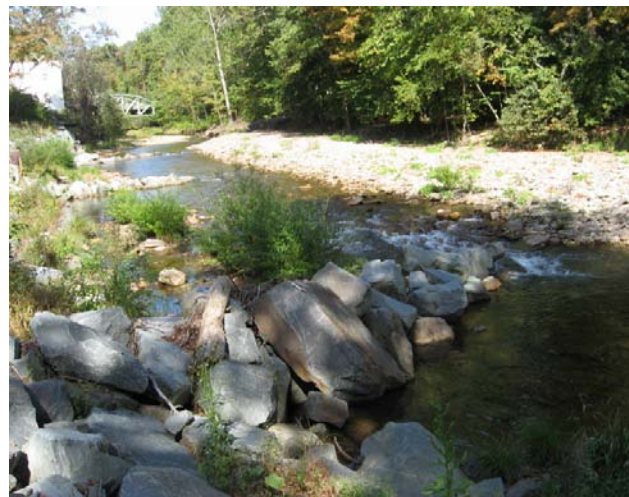
Figure 8 Looking upstream. Barbs installed to deflect flows away from the right bank

18 % (412 ft.) of the stream length in this management unit has been treated with some form of stabilization, including the logs piled around Station 18000. The revetment is in varying states of repair and functionality. Flow-deflecting stream barbs around Station 18000 should be monitored for ongoing effectiveness. Rubble piles in the floodplain at this site should be evaluated for their effect on future overbank flows, as part of the hydraulics study mentioned above.

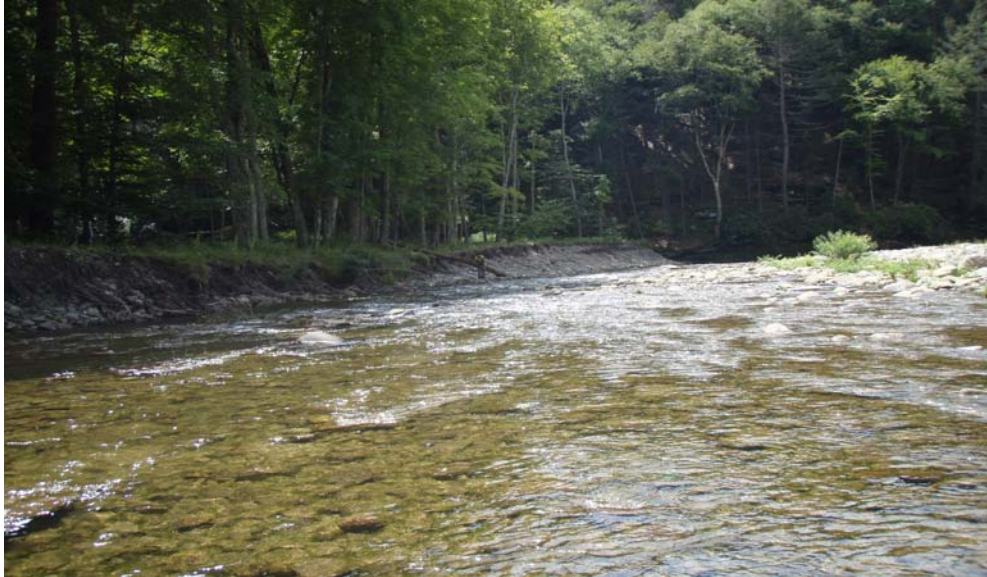
*Figure 9 Bank erosion and loss of woody buffer*

channel, the left bank has eroded into a stand of mature pines from Stations 18000 to 17400, entraining a great deal of large wood (some of which has deposited in downstream management units) and a lateral bar has formed on the right bank (See Figure 11, with person standing next to downed tree in center of photo for scale). As the channel widens due to the erosion, it no longer can transport the bedload supplied from upstream, and so the bed is aggrading here; this is exacerbated by the hard 90-degree turn in the channel alignment at Station 17400, as the channel hits the rock ledge of the valley wall, which produces backwatering at higher flows.

The landowner has piled rocks and downed tree trunks along the back of the bar on the upstream end of the eroded bank to provide some protection against further erosion. *Assisted restoration* is recommended for this site, stabilizing the eroding left bank with bioengineering practices, and narrowing the channel with plantings on the right bank/bar.

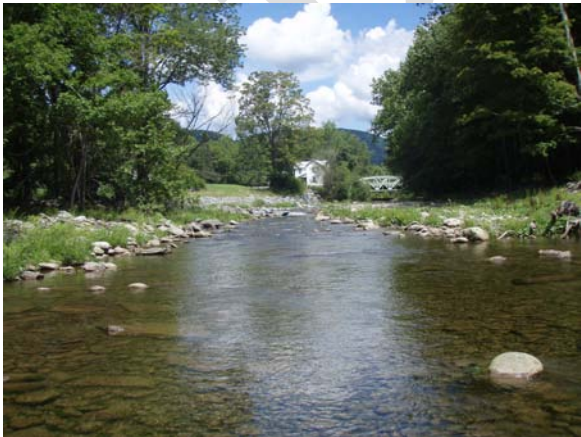
*Figure 11 Looking upstream, aggradation*

Over time this should reverse the aggradation in the channel which is increasing pressure on the eroding bank.

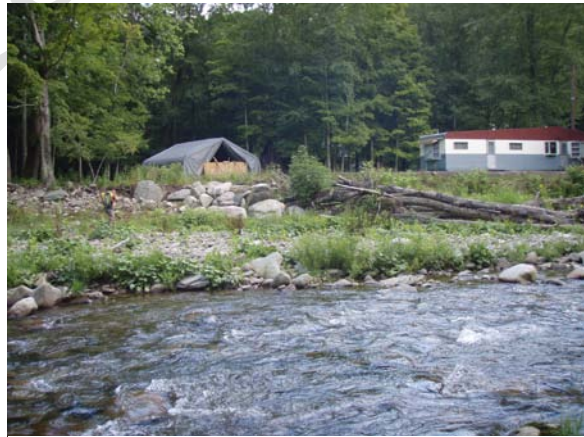
*Figure 11 Logs placed to protect eroding bank*

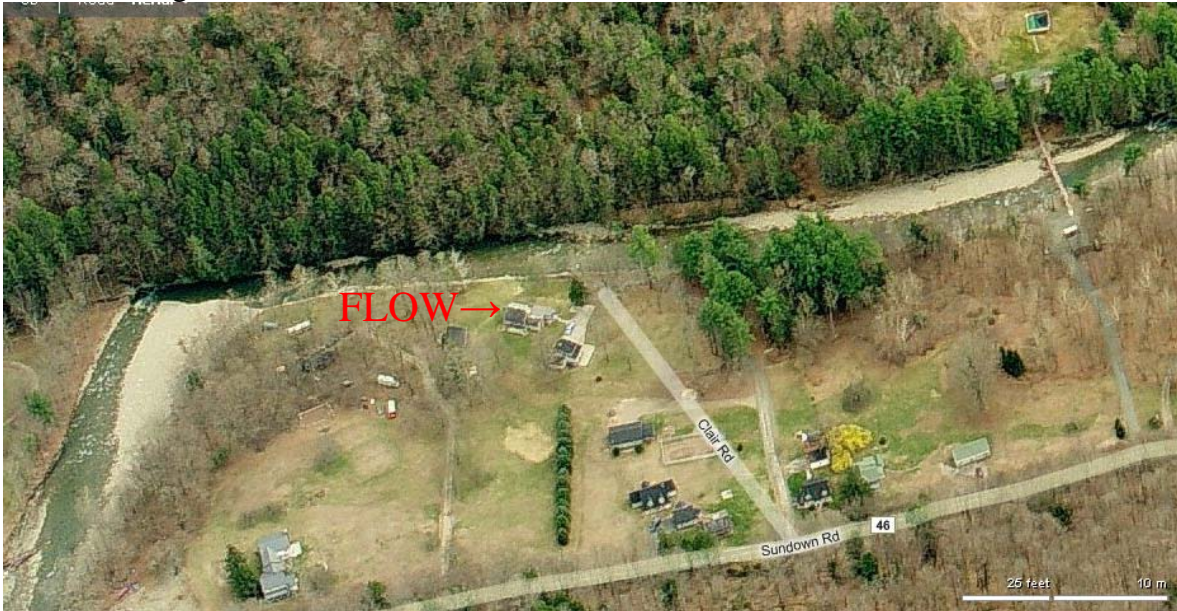
Figure 123 Ninety-degree turn in channel

At the downstream end of the erosion site (Station 17400), the channel is turned hard to the right by the left valley wall that frames the Sundown Creek delta. A small unnamed tributary enters from the left at the turn. A large point bar has developed on the inside of the turn, following the bank retreat on the left.

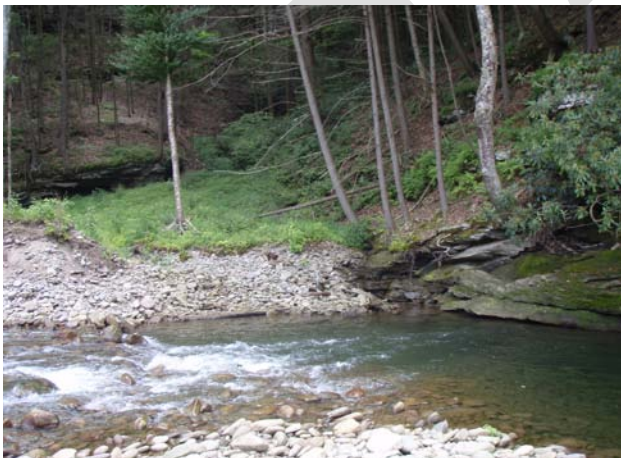
Figure 13 Channel turned to the right by the left valley wall, tributary confluence and point bar

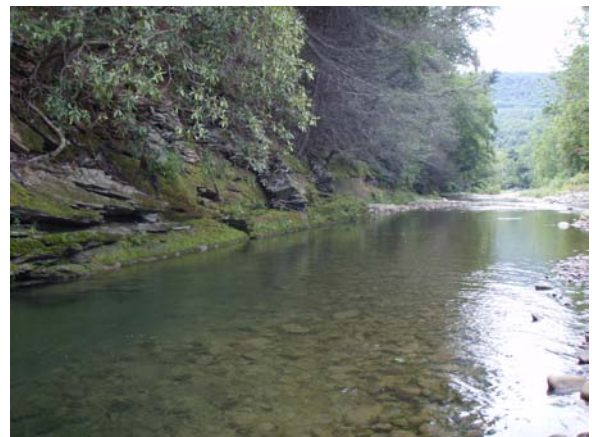
Throughout this reach, the channel is controlled laterally on the left by bedrock, and rip-rap revetment has been installed in two locations on the right bank. The first is between Stations

Figure 14 Bedrock control on left

16750 and 17100, and is in poor shape, but is still functional.

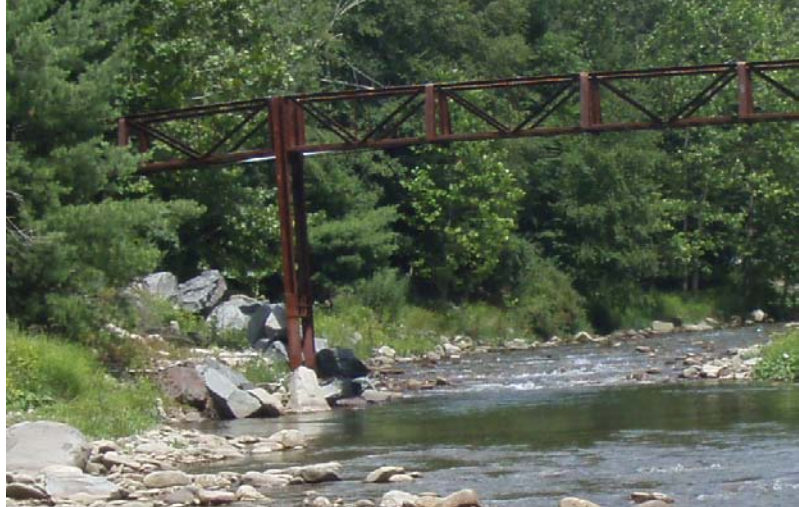
The second rip-rap has been placed fairly recently along the right abutment of the footbridge, at Station 16300, the end of Management Unit 7.

This bank has experienced chronic erosion, as the channel tries to recover some sinuosity. This site should be monitored for continued threat of erosion.

*Figure 15 Rip-rap and erosion at right pier of footbridge*

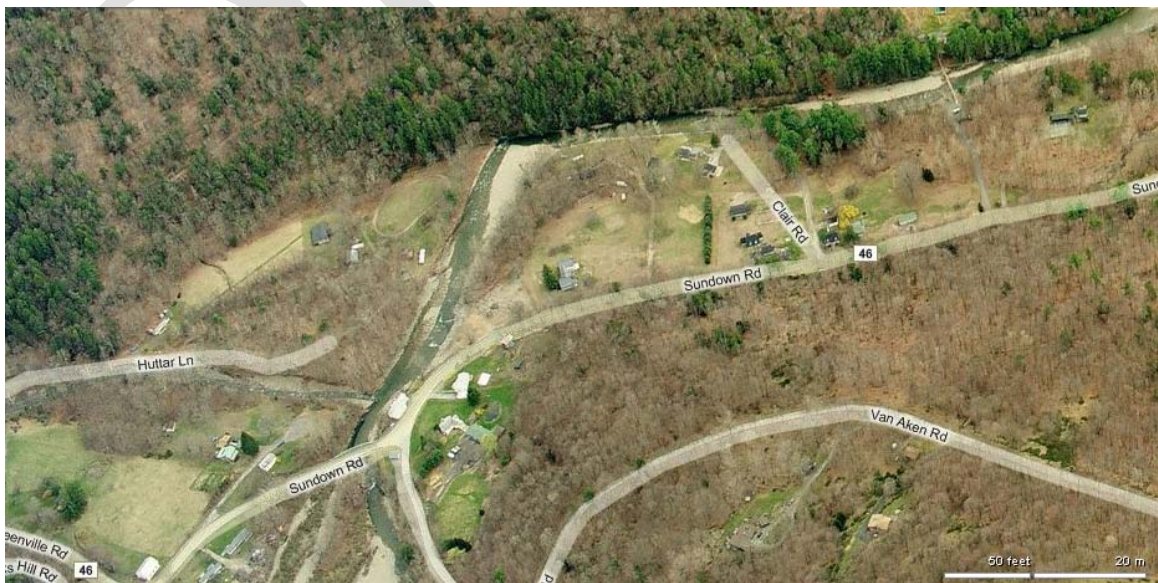
*Figure 167 Looking downstream. Complex sediment transport dynamics in MU7*

Sediment transport in Management Unit 7 is fairly complicated. Significant bed sediment is stored in braided reaches of Rondout Creek upstream of the Sundown Road Bridge. When this is mobilized by high flows, some of it is transported through the constriction posed by the bridge and enters MU7, where it immediately encounters the confluence of the Sundown Creek, which adds additional streamflow, sediment discharge and turbulence. The effect of the turbulence created by the confluence is that velocities on the mainstem upstream of the confluence are likely slowed, adding to the backwatering effect of the constriction created by the bridge. Just downstream of the confluence, a different story is going on; Sundown Creek does not appear to discharge an exceptionally large sediment supply, despite its steep gradient, because much of the bed of the stream has been scoured to bedrock, and because the banks for most of its length are stabilized by a healthy forest buffer. Discharging proportionately more water than sediment, Sundown Creek likely increases sediment conveyance downstream. The stream barbs installed a few years ago on the right bank directly opposite the confluence probably also accelerate sediment transport through this area by concentrating flows toward the middle of the channel, increasing the channel depth ---and therefore velocities-- there.

These increased velocities however, probably account in part for the erosion of the left bank just downstream. This bank erosion has resulted in an overly wide channel, lowering velocities significantly, and resulting in aggradation of the streambed. This situation is compounded by the evolving alignment of the channel, which as it moves to the left into the eroding bank, results in a harder right hand turn at the valley wall, creating a backwater effect upstream. This section of the management unit is under-competent and will require an intervention to narrow the channel, increase bankfull depths and restore sediment transport conveyance capacity.
