Rondout Creek Management Unit 10

Management Unit 10
Between Station 25,300 and Station 27,200

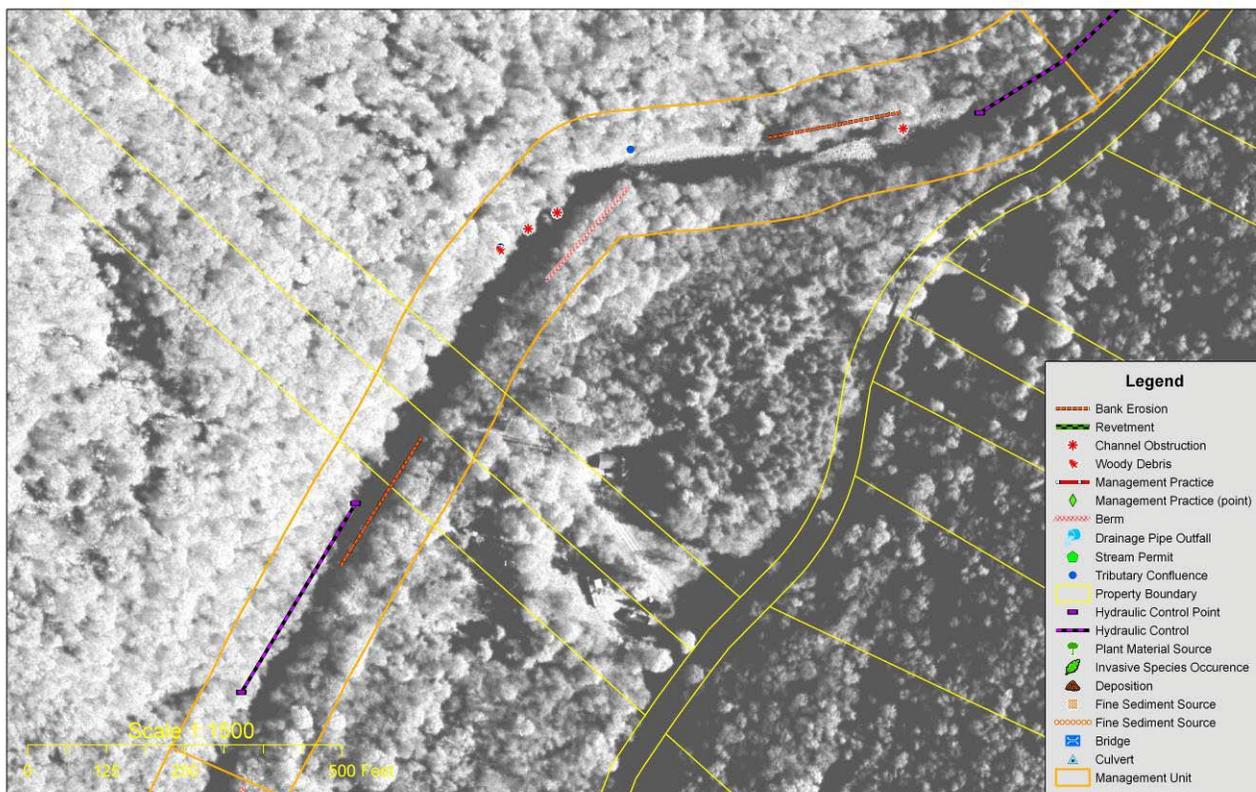
Figure 1 Management Unit 10 Stream feature inventory

The 2009 stream feature inventory revealed that 12% (455 ft.) of the stream length exhibited signs of active erosion along 1,892 ft. of total channel length (Fig.1). Revetment has been installed on 0% (0 ft.) of the stream length. 5% (95 ft.) of the stream banks had been bermed in this management unit at the time of the stream feature inventory.

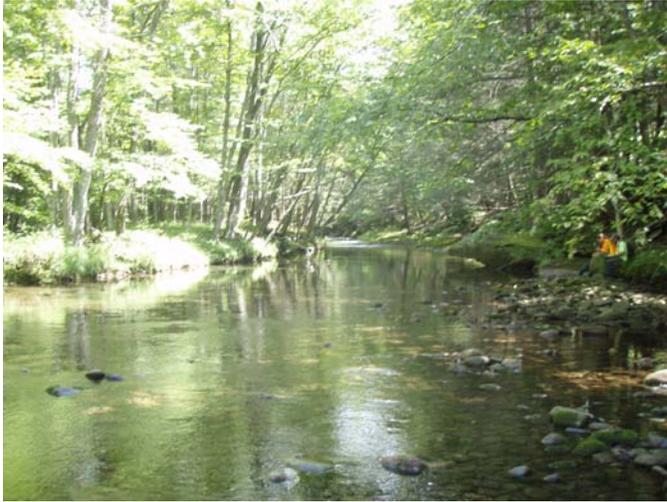
Figure 3 Looking upstream at the beginning of MU10

As the Rondout Creek enters the upstream end of MU10, the channel runs along a high ledge on the left, with the bed elevation also controlled by bedrock. The valley floor is relatively pinched at this location, although the channel has a narrow but well-connected alluvial floodplain on the right (Figure 2), part of the historical deposition created by sediment supply and backwater from the confluence of High Falls Brook just downstream. Between Stations 26700 and 26400, the channel moves across this floodplain to the right valley wall. The 1905 USGS topo map (Figure 1)

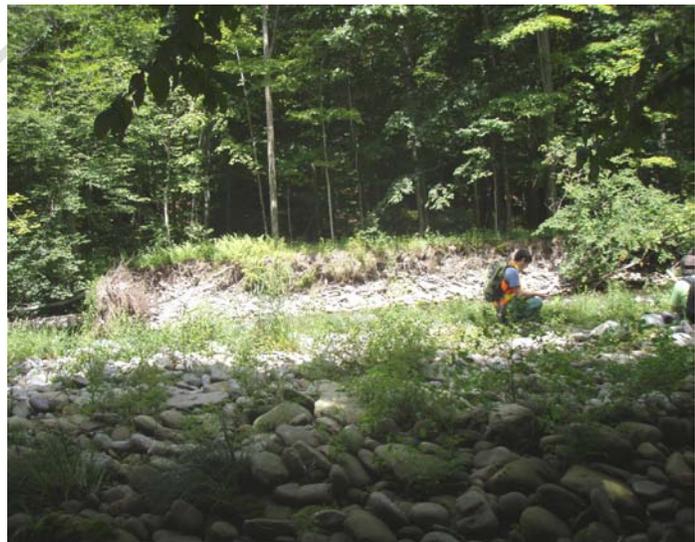
The right bank exhibits moderate erosion in this reach, undermining trees on the bank and creating temporary channel obstructions (Fig. 4). It is recommended that this erosion be monitored and allowed to revegetate on its own.

Figure 4 Moderate erosion, right bank

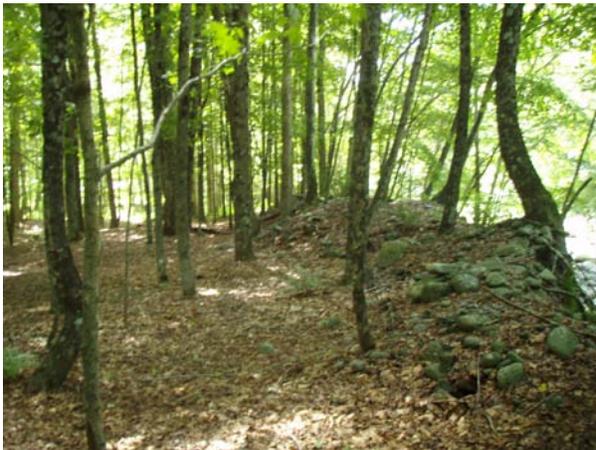
Figure 6 Berm, left floodplain

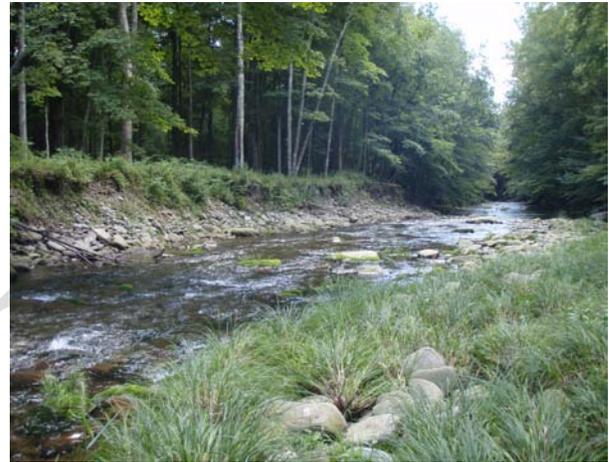
This berming and channel widening has resulted in conditions conducive to bank erosion, and a fairly significant eroding bank runs from Station 25700 to Station 26000, despite a healthy forested riparian zone.

Figure 5 Bank erosion, Stn 25700, left

Recommendations for this reach begin with a hydraulics study of the management unit (and MUs 7, 8 and 9 as well), to include an evaluation of the condition of the berms on the left bank and their effect on channel stability, and an assessment of the sediment transport dynamics within the channel. When berms are structurally sound, they increase velocities in the channel and shear stresses at the margins, resulting in greater probability of bank erosion. However, berms often fail during large flows, with the stream taking unpredictable new courses across the floodplain and threatening residences and infrastructure. If appropriate, *setback berms* should be considered to replace the existing berms. Setback berms, installed some distance back from the channel, allow the stream to use some of the floodplain to carry overbank flows, reducing stream velocities and the likelihood of berm failure, but still keeping floodwaters away from vulnerable property. The capacity of the channel to transport the significant bedload volumes, currently stored in depositional features on the state land upstream, should be evaluated, as MU10 has very little capacity for storing sediment, and therefore must function effectively as a sediment transport reach if it is to remain stable. This study should also address the likely consequences of changes in hydrology predicted by the downscaled global climate models for this region (See Section 3.1 Ecosystem Health), including increased risk to residences and public infrastructure in the valley.

Following this study, and as appropriate, it is recommended that the larger eroding bank be addressed with soil bioengineering treatments. See Section 2.6 for resources available for this work through the Catskill Stream Buffers Initiative.

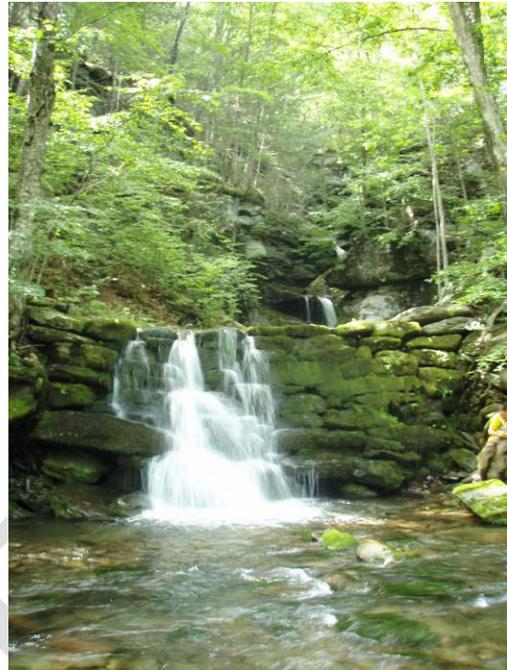
The channel receives several waterfalls and springs from tributaries (Fig. 7) on the right, the largest of which is High Falls Brook, marking the downstream end of MU10.

Figure 7 Waterfall at High Falls Brook

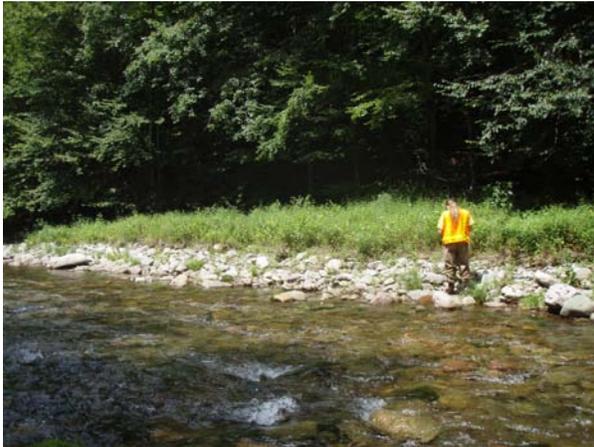
There are no wetlands within this management unit mapped in the National Wetland Inventory (see Section 2.5, Wetlands and Floodplains for more information on the National Wetland Inventory and wetlands in the Rondout watershed). A small wet meadow was noted along the right bank around Station 26700.

Figure 8 Wet meadow, Stn 26700
