Schoharie Creek Management Unit 1

Town of Hunter - Prediger Rd. (Station 159225) to Dale Lane (Station 151439)

This management unit begins at Prediger Road, continuing approximately 7,786 ft. downstream to Dale Lane in the Town of Hunter.

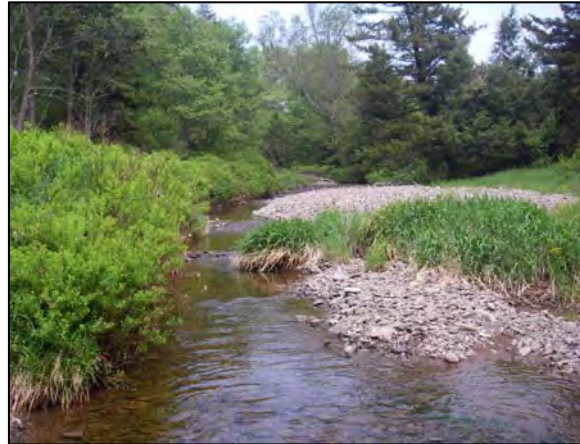
Tributary at Station 155270 – looking upstream

Originating on steep mountainous slopes, this stream drains parts of Roundtop and High Peak Mountains before crossing under

Platte Clove Road where the topography flattens before it enters the Schoharie Creek. As a result of this change in stream slope, the tributary loses its ability to transport sediment gathered from the mountain slopes, and begins to deposit sediment.

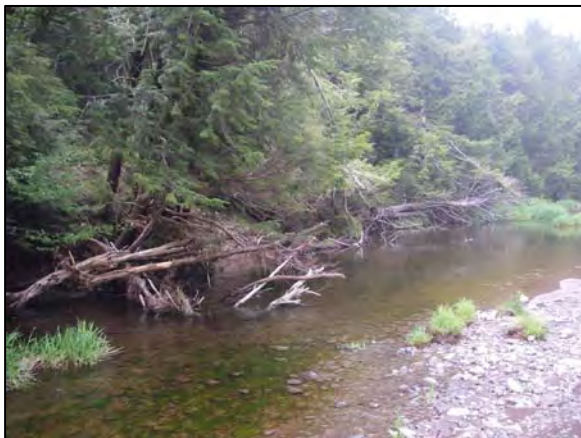
Bank erosion at Station 155250

This increase in runoff and sediment load may have contributed to the streambank erosion directly downstream of the tributary confluence (Station 155250). An area of approximately 1,276 ft² of the left streambank was experiencing erosion. As a result, many mature trees fell into the stream and lined the streambank toe providing some protection against future erosion.

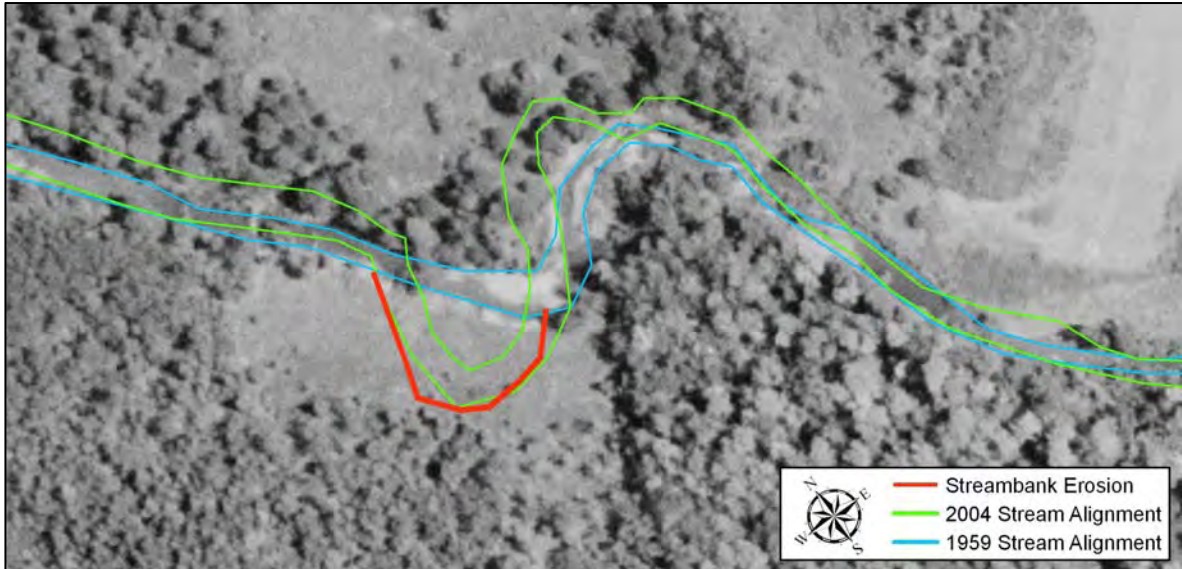
Bank erosion at Station 154070 - Historic stream channel alignments overlaid with 1959 aerial photograph

Downstream, the channel began to meander sharply. As shown in the aerial photo, this meander bend has significantly migrated since 1959, causing a 2,245 ft² area of erosion on the left bank in 2006 (Station 154070 Inset B). As the stream curved, it cut and eroded

into the outside of the meander bend and deposited sediment on the inside of the curve. This is due to the fact that the stream flow moves more rapidly on the outside of the curve and more slowly on the inside of the curve. As the erosion and deposition continued, the curve became larger and more circular. This is a natural process and typically happens slowly over time.

The land adjacent to this erosion appeared to have been cleared sometime prior to 1959 increasing its vulnerability to erosion. The eroding streambank had three clay exposures totaling 130ft. in length. Downstream of this meander the streambanks appeared stable.

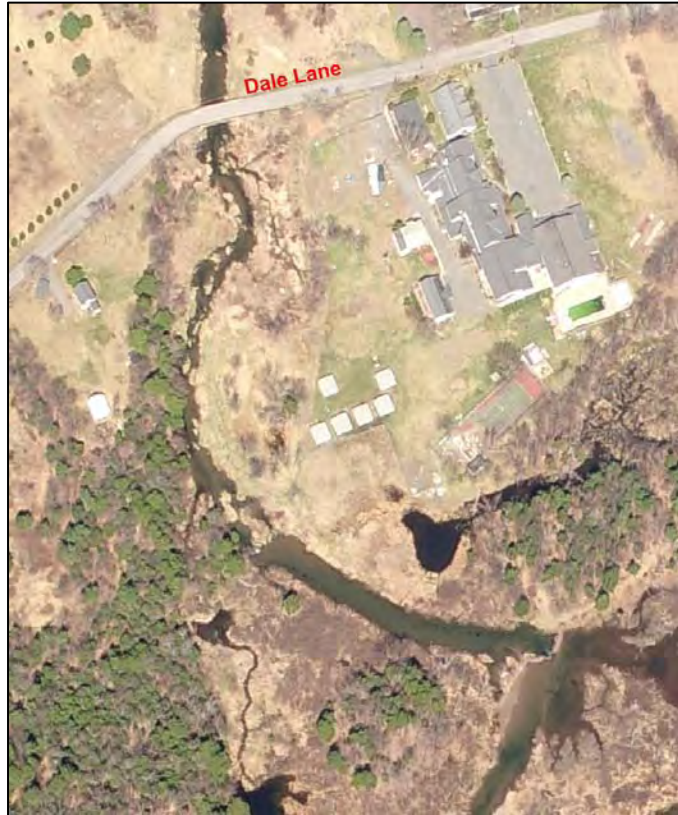
Riparian planting site (Station 152300 – 151750)

At the downstream end of this management unit the land use on the right streambank changed from forested to residential, with herbaceous vegetation in the riparian zone. Mown lawn or pasture does not provide as much resistance to streambank erosion as the deep and dense root structure found in streamside forest. The complex root systems of trees may also act to filter nutrients and pollutants from the septic effluent, if any, from the adjacent residences. Areas where the riparian zone has been maintained in pasture or lawn present opportunities to improve the

streamsides buffer with tree plantings in order to promote a more mature vegetative community along the streambank and in the floodplain. Recommendations for this site include planting native trees and shrubs along the edge of the stream bank and the upland area (Station 152300 – 151750). Buffer width should be increased by the greatest amount agreeable to the landowners, but increasing the buffer width by at least 100 feet will increase the buffer functionality. The dwellings situated in the floodplain should also be relocated, to protect both the private property and water quality.

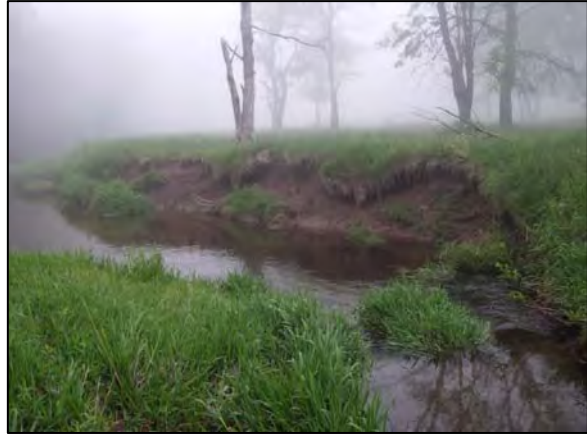
Bank erosion at Station 152000

There were two minor erosion occurrences in this area. The first was located on the right streambank and was approximately 182 ft² in area (Station 152000). The second, with

an area of 135 ft², was located on the right streambank at the very end of the management unit (Station 151590, Inset A). To prevent future erosion, vegetation plantings are recommended for both of these streambanks, including vegetative protection of the toe. Reshaping these streambanks by grading may be necessary prior to planting. This work should be preceded by a more detailed site assessment.

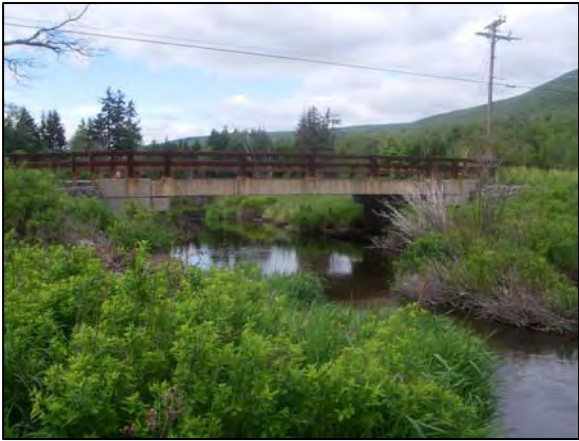
Bridge at Dale Lane

Lane Bridge (BIN 3200970). This bridge may constrict the floodplain at very high flows, but appeared to pass most flows effectively. Flood damage to bridges is typically caused by inadequate hydraulic capacity of the bridge, misaligned piers and/or abutments, or accumulation of debris. As bridges are replaced over time, these issues should be evaluated and adjusted if necessary to lessen the

Gabion baskets were placed at the abutments to provide scour protection. Rock-filled gabions are not generally a recommended management practice by the GCSWCD. They have a tendency to be unsightly, and when installed incorrectly they frequently blow out of the bank and scatter rocks and cages downstream. Their correct use requires professional installation and maintenance.

probability of flood damage by providing a more effective conveyance channel that promotes water and sediment flow through the bridge opening.

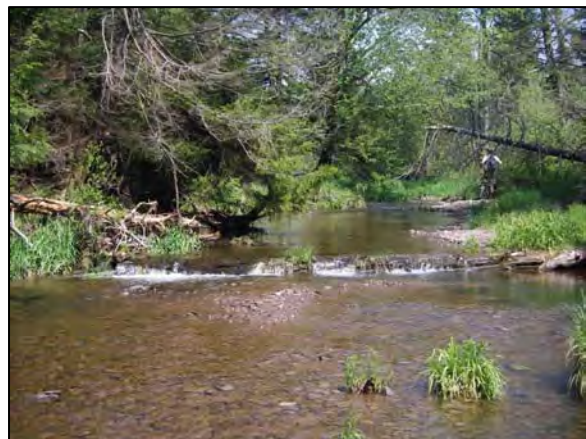
Habitat structure

There were seven fish habitat structures installed in this management unit. Habitat structures were historically installed throughout the Schoharie Creek by the New York State Department of Environmental Conservation (NYSDEC), often in an effort to create scour pools. Scour pools offer deeper holding habitat, and the spillways raise the amount of dissolved oxygen in the water. The structures, most often in the form of a flat log weir perpendicular to the channel, also provided temporary grade

control. In general, due to the horizontal, channel spanning design, they cause water to back up on the upstream side of the structure which can increase sediment deposition. Because most of these structures do not include an area for concentrated flow that provides for sediment transport, sediment deposition often occurs downstream from an initial scour area under the structure. This can cause widening of the channel, which further decreases sediment transport. In some settings, this can promote lateral channel migration, increase stream channel width-to-depth ratios and result in bank erosion up or downstream. In wild streams, these functions – both positive and negative – are performed to a large extent by large woody debris. It is recommended that an aquatic habitat study be conducted on the Schoharie Creek with particular attention paid to springs, tributaries and other potential
