Schoharie Creek Management Unit 7

Towns of Hunter and Jewett – Bridge St.(Station 104521) to Station 91473

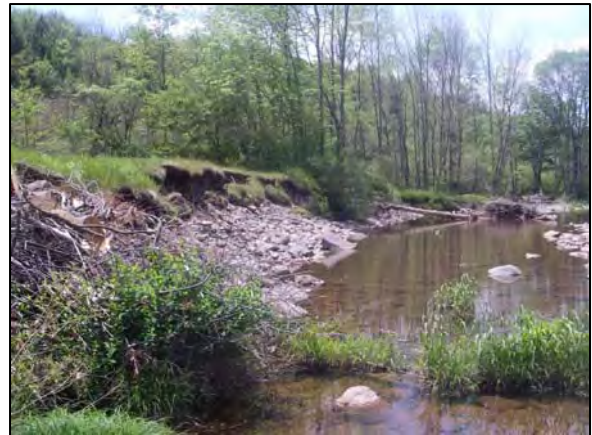
A road crossing had been built across the flood chute to allow the landowner access to their land. This crossing had a low flow channel cut into it but still obstructed higher stream flows. Immediately downstream the left streambank had eroded exposing an area of 950ft². To prevent future loss of land, planting of native trees and shrubs is recommended along the streambank and riparian buffer along with installation of willow *fascines* and sedges along the toe of the bank to provide protection against toe erosion.

Eroding bank and planting site at Station 101130

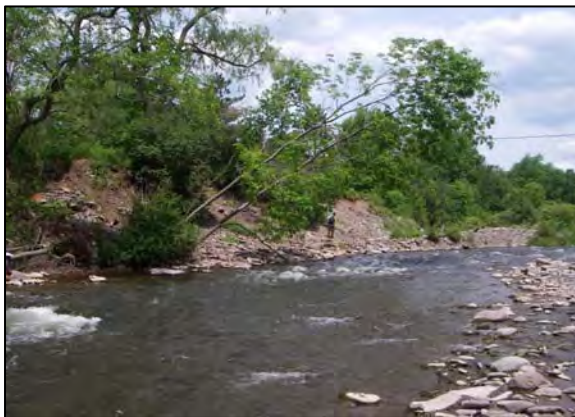
Bank erosion at Station 99700 - looking upstream

Near the downstream end of the flood chute, a piped outfall which drained stormwater from County Route 23A, was located on the right streambank (Station 99700). Stormwater inputs combined with flood chute flows had eroded a large 4561ft² area on the right streambank leaving it unvegetated (Station 99700). This erosion site is also a good candidate for *bioengineering* stabilization techniques, which use plantings to bind stream banks.

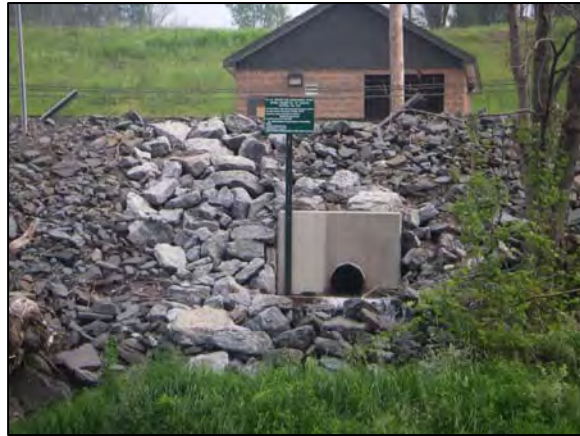
Downstream the stream channel straightens and becomes confined by the County Route 23A embankment on the right streambank and the streambank on the left. Rip-rap had been installed on much of the road embankment (Station 98500-97400). Along this rip-rap was an NYS permitted discharge point, permitted to the Village of Hunter (SPDES permit# NY0241075). This permit allows for the discharge of 0.3259 million gallons per day of treated sanitary wastewater from the Village treatment plant to the Schoharie Creek. The State Pollutant Discharge Elimination System (SPDES) program, administered by NYS Department of Environmental Conservation (DEC), governs discharges to surface and ground waters through the issuance of wastewater and stormwater discharge permits.

SPDES outfall at Station 98300

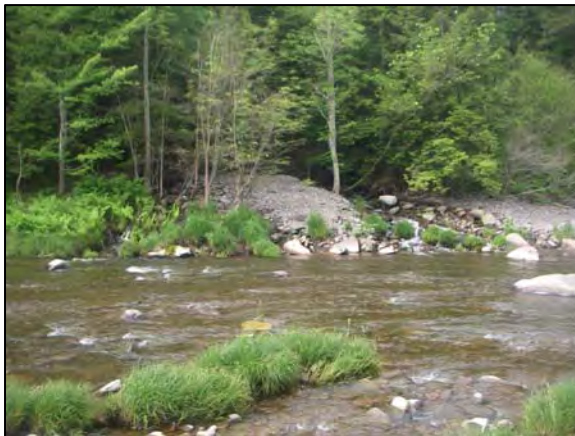
On the left streambank, an unnamed *tributary* entered the Schoharie Creek (Station 98500). This tributary drains the slopes of Hunter Mountain, through Taylor Hollow, before it reaches the flatter topography of the valley floor where it enters the Schoharie Creek. As a

Tributary at Station 98500

result of this stream slope change, the tributary loses its ability to transport sediment gathered from the mountain slopes, and began to deposit sediment at its mouth and into the more gently sloped Schoharie Creek. This is a common feature of confluence areas, which often contain extensive sediment bars, function as important sediment storage areas, and are typically among the most dynamic and changeable areas in the stream system. The

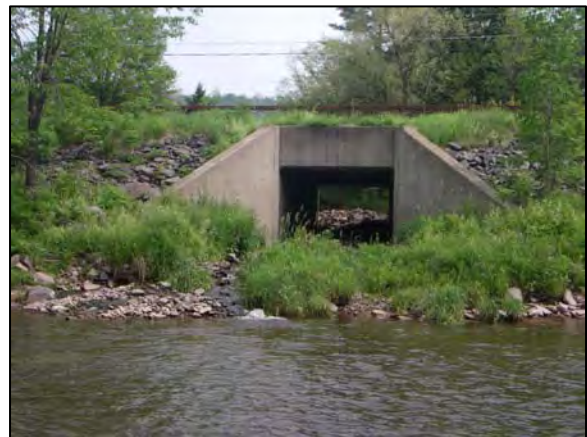
Just upstream from the Deming Rd. bridge another tributary entered the Schoharie Creek from the right streambank (Station 97500). This tributary begins on the East Jewett Mountain Range before flowing under County Route 23A through a large box culvert and joining the Schoharie Creek. As shown in the photo, this tributary also appeared to be a sediment source. This tributary was classified as C by the NYSDEC.

Tributary at Station 97500 - looking upstream

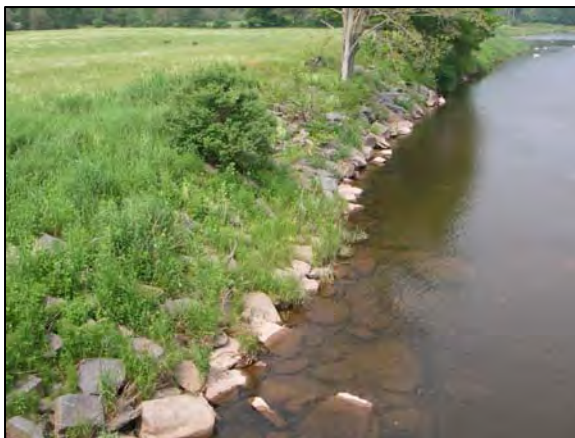
Planting site at Station 97370-95800

effectively. Both bridge abutments had been reinforced with sheet piling and had rip-rap installed on both downstream streambanks. There were agricultural fields on the left streambank (Station 97370-95800). A riparian buffer of native trees and shrubs should be planted along this streambank and corridor. Buffer width should be increased by the greatest amount agreeable to the

landowner. Increasing the buffer width by at least 100 feet will increase the buffer functionality, such as filtering nutrients and pollutants, if any, from the agricultural fields. At the downstream end of the agricultural field was a 4175ft² area of eroding bank (Station 96000). Streambank stability could be improved at this site with the planting of willow fascines and sedges along the toe of the bank, along with native trees and shrubs on the face of stream bank.

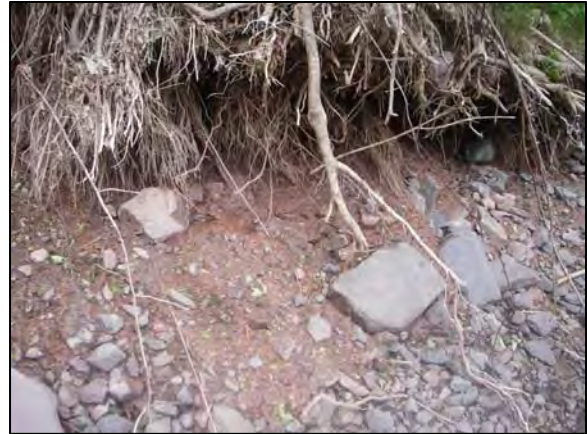
The right streambank of the next meander bend had suffered minor erosion during high flow events (Station 93150). This erosion exposed an 96ft² area of clay/silt.

Clay exposure at Station 93150

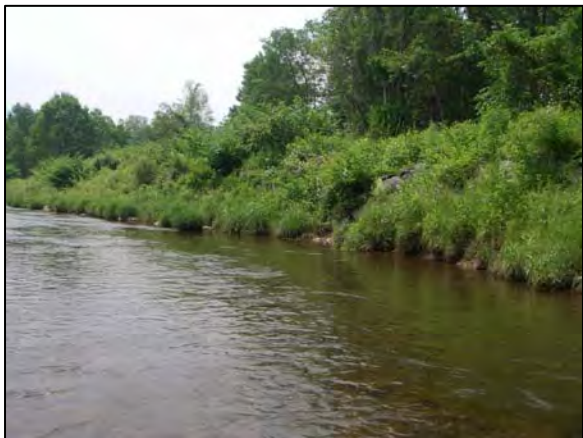
Rip-rap at Station 92040

Along the right streambank rip-rap had been installed (Station 92040). Native vegetation had grown through this rip-rap and will serve to strengthen and increase its longevity while also improving the aquatic habitat of the reach. While this growth occurred naturally, inserting plant material into the soil between rip-rap during or after installation can have the same desired effect.

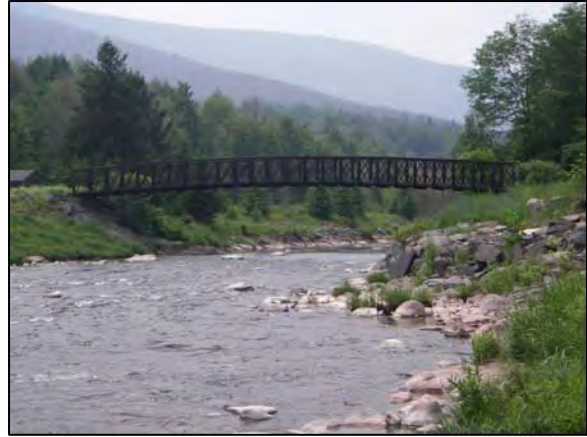
At the end of the management unit the stream passed under a private bridge on an unpaved road (Station 91473). This bridge, built in the mid 1990's, was in good structural condition and appeared to pass most flows effectively. However, during large flood events floodwaters have spread over the right abutment, causing erosion and deposition, then back into the stream channel downstream of the bridge. According to landowner accounts, maintenance of the road and bridge due to stream related problems has cost thousands of dollars. Installation of flood plain drainage, and/or regrading of the right streambank floodplain area to floodplain elevation, at or just above the bankfull stage, could reduce flooding. Leveling this area would decrease the local flow concentration that is currently

Bridge at Station 91473

causing erosion while still providing over bank access during flood flows. The riparian area throughout the reach, including the immediate terrace area should be vegetated with native trees and shrubs. An established riparian community could reduce erosion and flood velocities in the bridge and road access area and discourage further widening of the stream channel. With the exception of planting, in-depth survey and design would be required to implement these recommendations.
