# West Kill Management Unit 1

## Management Unit 1

Between Station 56747 and Station 53971

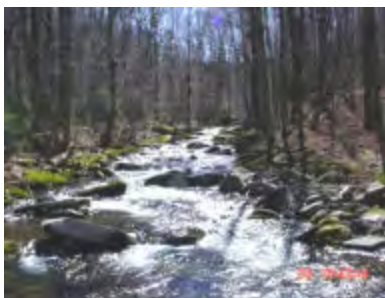
Management Unit 1 begins with a 650 ft. section of B4a stream type, as determined from a monumented survey cross-section at the origin of our Stream Feature Inventory (Station 56747). The channel is moderately *entrenched*, or confined within the stream banks during high flood events. The channel slope is 4.02 %, and the bed material is dominated by gravel, but with abundant cobble and boulders. This reach appears exceptionally stable and should be monitored as a reference reach, for potential future use in design.

**Reference Reach – looking upstream, abundant boulders,**

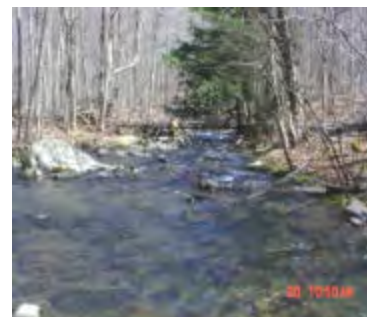
As the channel bends to the right, the channel is somewhat blocked by woody debris, creating a low obstruction potential to the channel just above bankfull stage. As the channel bends back to the left, the *thalweg*, or deepest part of the stream channel, flows up against the right valley wall, adjacent to the NYSDEC hiking trail. The hillslope is being undermined somewhat by toe erosion. This erosion may be the result of backwatering caused by an abandoned bridge abutment just downstream, but is minor and has high potential for recovery without intervention.

**Debris Blockage**

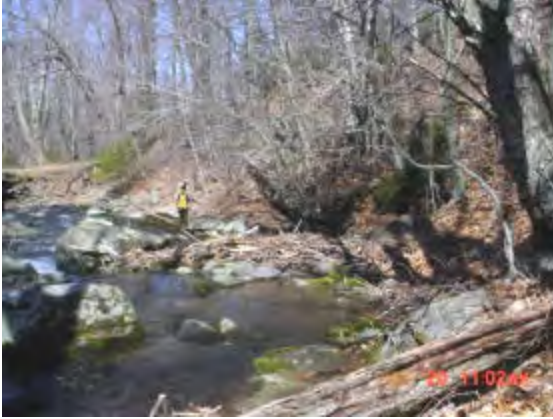
**Bank Erosion – embankment, DEC trail at top of bank**

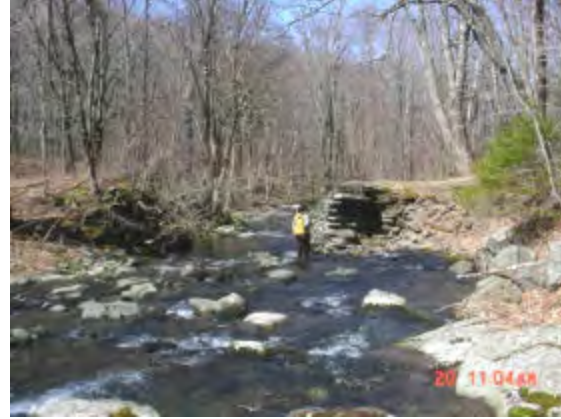
**Abandoned bridge abutments, no deck**

The channel straightens as it approaches the abandoned bridge abutments, and becomes constricted. The floodplain is obstructed by the bridge approaches, and there is evidence of aggradation upstream of the crossing. Gravel deposits upstream of bridges are commonly caused by inadequate sizing of the bridge opening. An undersized bridge opening causes water to back up upstream of the bridge, reducing stream velocity, which results in sediment deposition. In high stage, the floodwater may seek conveyance through alternative paths, forming new channels around the bridge constriction. Even bankfull flows appear to backwater at this bridge, resulting in the upstream aggradation. Additional *floodplain drainage*, using culverts set at the floodplain elevation under the south bridge approach, or removal of the abutments altogether, may help mitigate this problem.

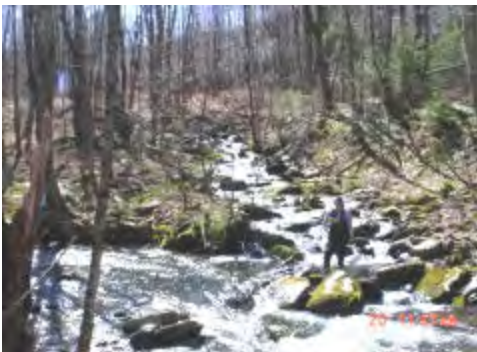
**Tributary**

Downstream of the abutments, an unnamed tributary enters from the left (Inset H, Fig. 4.1.2). Approximately 100 ft. downstream of the confluence, a monumented cross-section has been established (Station 55821). This 1300 ft. reach becomes a less entrenched C4b stream type, with slope diminishing to 2.49 %. Gravel still dominates the substrate.

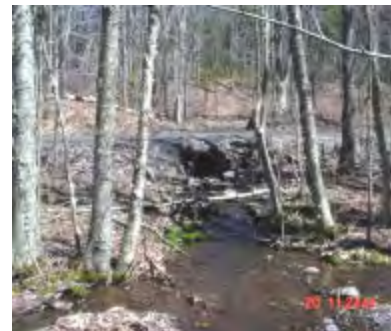
Downstream, an unnamed tributary enters from the right (Inset C, Fig. 4.1.2). This tributary is conveyed under the adjacent dirt road on the right by a culvert (approximate diameter 30”), and becomes *braided*, with several distinct channels, at the confluence with the West Kill.

**Culverted tributary, looking**

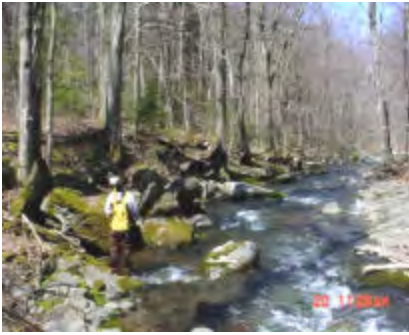
**Minor bank erosion, left bank connected at its confluence.**

Continuing downstream, some minor erosion is evident on the left lower bank (Inset G, Fig. 4.1.2). The toe is protected by natural boulders, and has high potential for recovery without intervention. Downstream, an unnamed tributary enters from the left. The tributary appears stable and well

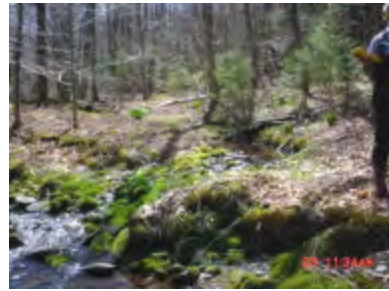
**Unnamed tributary, left bank**

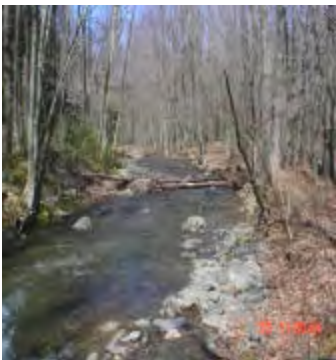
**Debris blockage**

As the stream runs adjacent to the NYSDEC pullout, the gradient drops, as does the floodplain elevation on the right. Evidence of aggradation begins here, with a lateral bar on the left. Exacerbating the aggradational setting is a series of woody debris blockages, which result in backwatering at low flows. Higher flows can access the floodplain on the right. The valley broadens here, with an extensive alluvial terrace on the right.

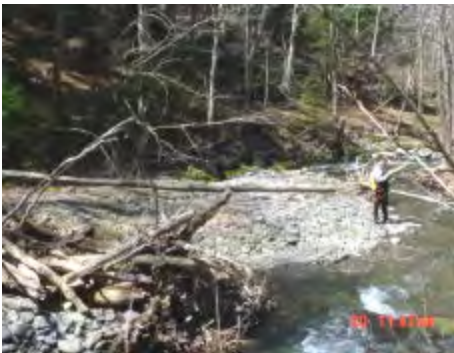
**Inset F, Fig. 4.1.2**

Significant channel management appears to have taken place in this reach over the years. A large gravel bar has formed along the left stream bank. Gravel bars, especially point bars, can help maintain channel stability during flood events. In stable streams the bars will erode away while the channel is in flood stage. The bars then are rebuilt as flow

decreases, helping the stream maintain its stability by reestablishing its pools and riffles. If gravel bars are removed, these processes do not occur and instead, the flood water often dissipates its energy by eroding banks and scouring the stream bed.

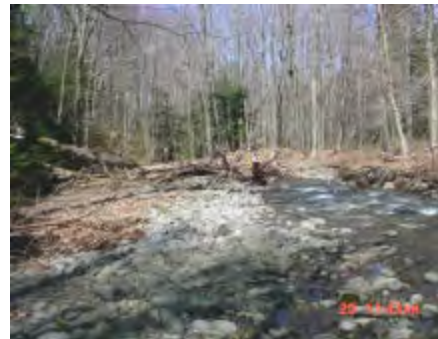
**Woody debris blockage, obstructing and extensive lateral cobble bar with an associated headcut at the downstream end**

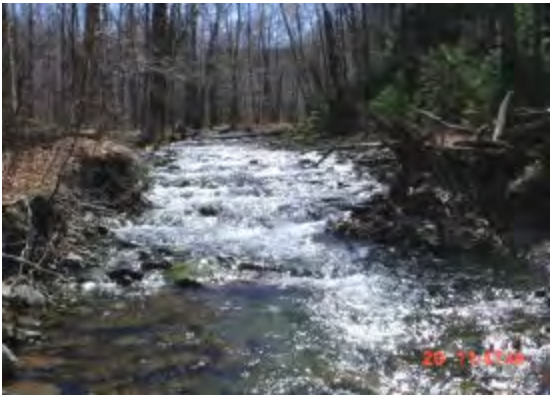
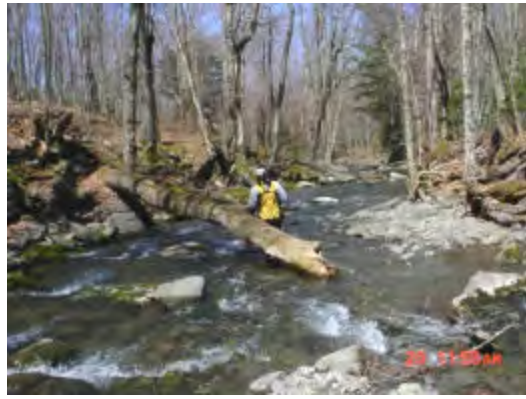
**Debris blockage – low flow obstructions**

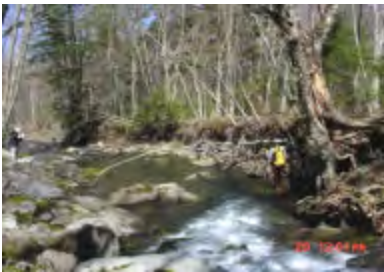
**Bank Erosion – Inset B, Fig. 4.1.2**

Throughout this reach there are headcuts and undercut banks, indicating a recent history of incision. A headcut near the upstream end of the reach appears to have stabilized, with large boulders armoring the bed. Downstream, the right bank is undercut extensively, with some loss of trees from the stream bank.

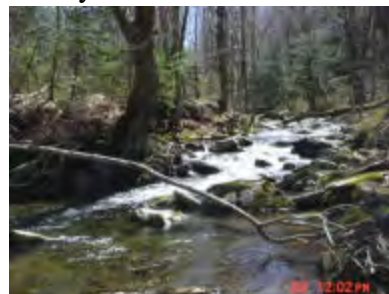
**Naturally stabilized headcut**

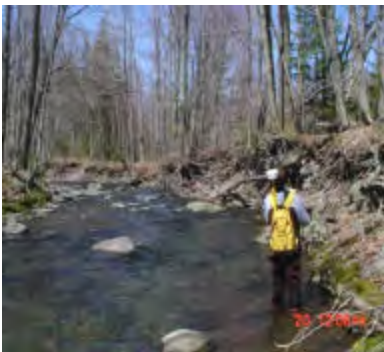
**Bank Erosion**

As the channel bends to the left, there is increasing toe scour on the right. Historic channel maintenance is evident, with stone walls and side castings. The inside of the meander bend (left) maintains some floodplain connection at higher flows.

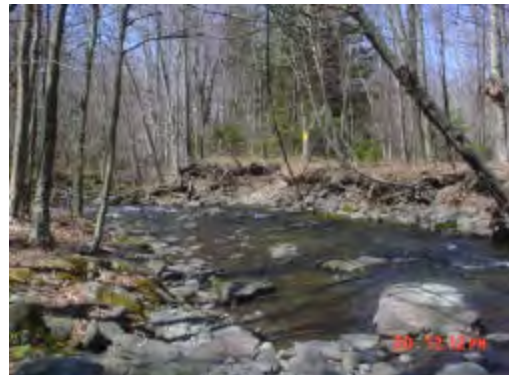
Downstream on the right bank, riparian vegetation narrows at a cleared field used as a horse pasture (Inset E, Fig. 4.1.2). Also on the right bank there is an inactive rubbish heap, with cans and bottles.

**Pasture on right bank**

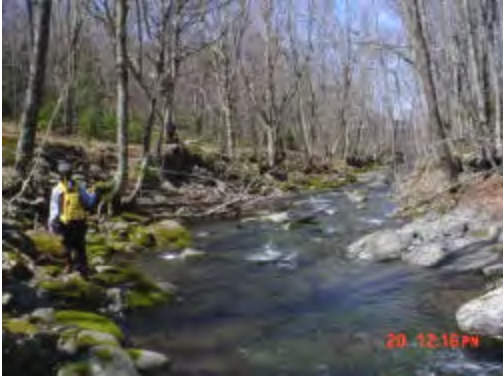
As the channel bends back to the right, woody debris on the left bank presents minimal flow obstruction.

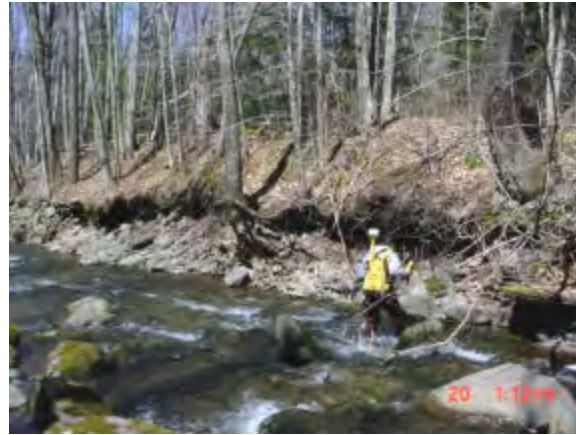
#### **Bank Erosion – right bank**

Continuing downstream, toe scour is eroding the right bank (Inset A, Fig. 4.1.2). As the channel enters Management Unit 2, it bends to the right, with toe scour and associated bank erosion on
