West Kill Management Unit 3

Management Unit 3

Between 51153 and 48476

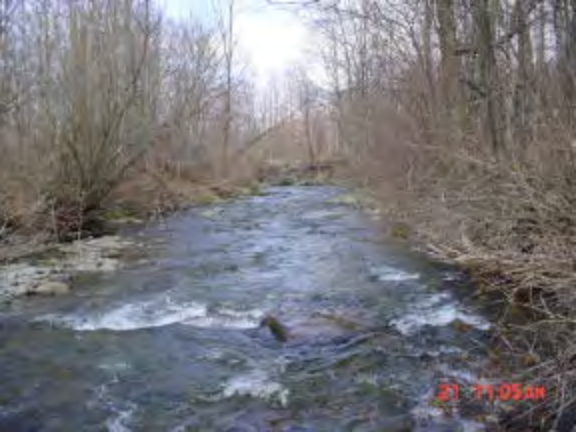
Looking downstream from top of MU 3

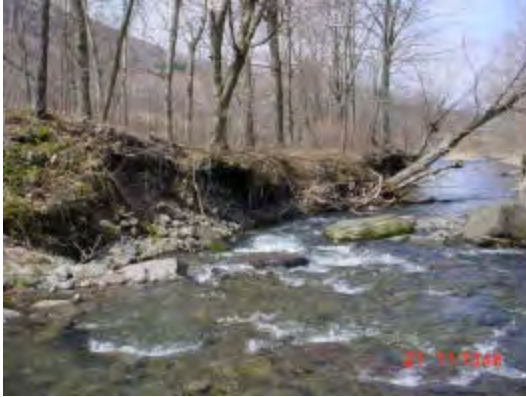
Rip-rap, dumped and stacked at road embankment

These processes are evident in the head-cut, rip rap and minor bank erosion documented just downstream of the monumented cross-section. Large rocks appear to have stabilized the head cut, but several types and ages of rip-rap indicate repeated treatment of embankment failure. This armoring has directed erosive forces to the opposite bank, resulting in bank erosion (Inset H, Fig. 4.3.2). Undercutting of the adjacent flood terrace has led to overhanging and leaning trees, and introduction of sediment. Two culverts drain a local residence and driveway from the right (both 18" dia.). Both are stabilized with rock outfall protection, although one of them is perched.

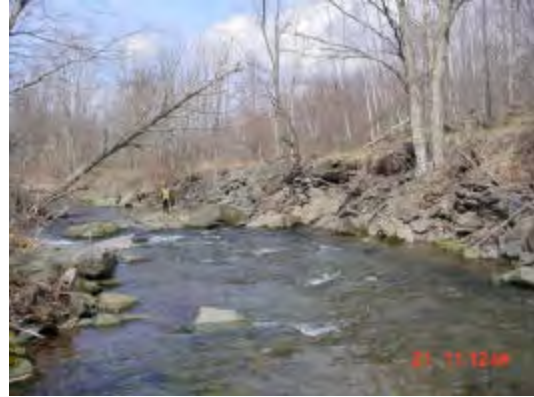
Bank Erosion - some debris introduction, scoured toe and over-hanging vegetation, headcut near up stream end of erosion

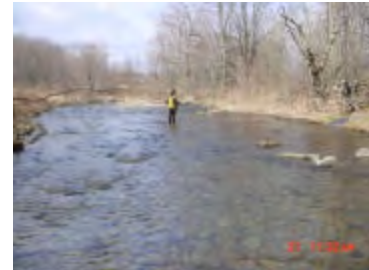
Continuing downstream, *aggradation* has raised the base elevation of the channel, reconnecting it with its floodplain and moderating the entrenchment. Two monumented cross-sections (Stations 50592, 49843) document 1200 ft. of B3c stream type. The slope decreases to 1.8%, and the bed becomes dominated by cobble.

Aggradation - near road embankment, could threaten road in the future

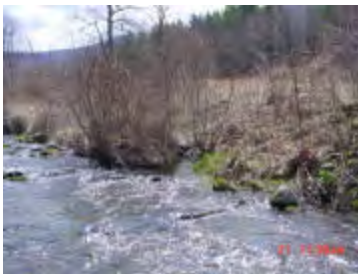
Tributary, and series of beaver ponds along drainage way

Evidence of beaver activity, observed in an unnamed tributary that enters from the left bank, suggests that this aggradation could be the result of temporary impoundment of the stream.

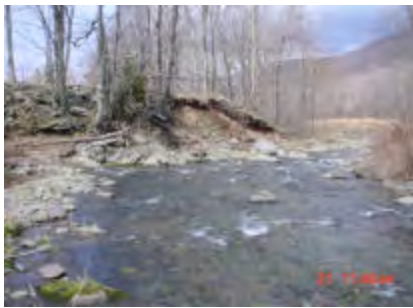
Erosion

Such erosion is observed just downstream, as the channel bends to the right at a high terrace on the left, and heads into a fairly steep riffle. This erosion has been monumented as a Bank Erosion Monitoring Site (BEMS, Station 03-50144). In a prioritization of twenty-one BEMS sites throughout the West Kill watershed (see Section 3.3, Watershed Inventory and Assessment), this site ranked Low Priority. The *thalweg*, or deepest part of the stream channel flows up

against the glacial till terrace here, with substantial boulders—that appear to be placed—providing some toe protection. The unvegetated banks are contributing sediment through both *wet and dry ravel*, and yielding a significant suspended sediment load during high flow events. Clay inputs into a stream are a serious water quality concern because they increase *turbidity*, degrade fish habitat, and can act as a carrier for other pollutants and pathogens.

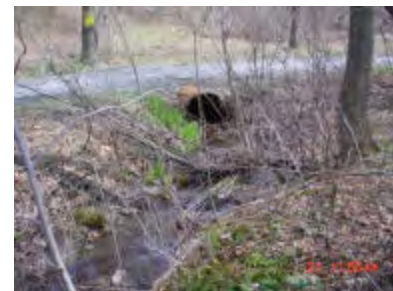
As the channel is turned back to the left by the embankment of Spruceton Road, a small unnamed tributary enters from the right through a culvert under the road (see station 050). The tributary flows on a broad flood plain, and there is a 2' head cut at the bottom of the riffle, this marks the beginning of a more entrenched reach downstream. Slope increases modestly.

Culvert, right

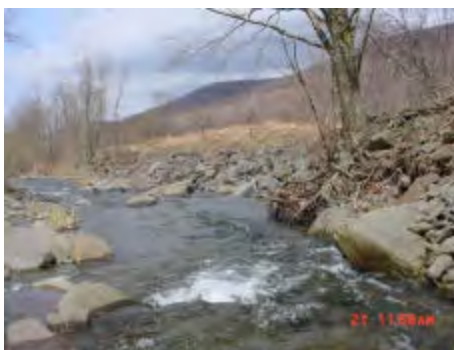
Rip-rap, right, several types and ages

Headcuts are a typical response to bank hardening, as erosive power is deflected to the bed of the channel, leading to incision. The rip-rap installation just downstream may be responsible for incision here. The channel is confined by the road on the right and the terrace on the left here, producing a markedly straight section for 800 ft. The rip-rap on the right (252 ft.) is of several types and ages, alternating between side castings at the upstream end, dumped rip-rap in the middle, and stacked stone at the downstream end. This indicates repeated treatment of embankment

failure. There is no vegetative buffer here between stream and road.

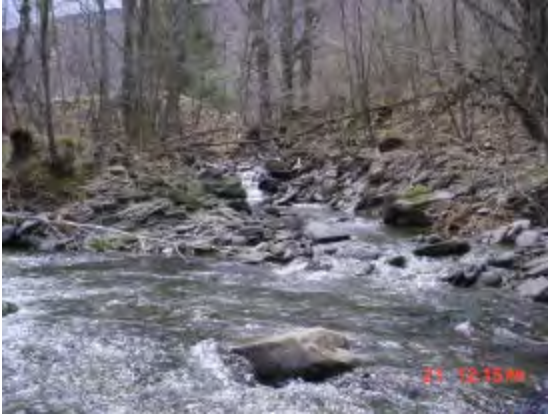
Tributary, left

An unnamed tributary (0.46 mi^2) enters from the left off the terrace, with a stable connection at the confluence. Beyond a low bench on the left, a stacked rock wall angles toward the stream. As the wall encroaches on the floodplain, entrenchment increases, and stream type changes to F3 for 1124 ft., or the remainder of Management Unit 3.

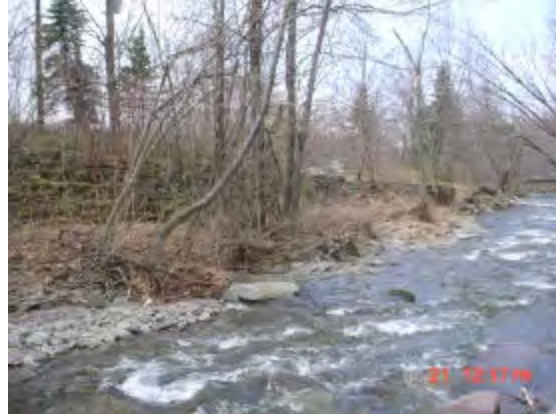
Stacked rock wall

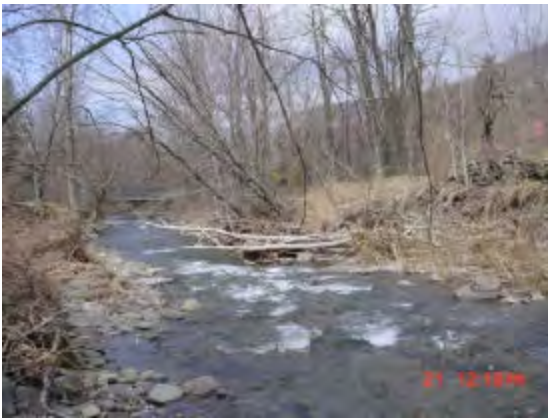
Debris Jam

Downstream of the rip-rap on the right, a low bench emerges at the base of the road embankment, vegetated with willow. A small headcut and scour pool appears to be associated with a fallen tree on the bench near the approach to the Wolff Road (TH147) bridge downstream. While woody debris is valued as a feature of good fish habitat, it can present a threat to infrastructure, potentially obstructing conveyance through bridges. Stream managers, highway departments and homeowners must strike a balance between these competing objectives. Removal of the tree is recommended here to reduce potential threat to the bridge and continued scour of the bench at higher flows.

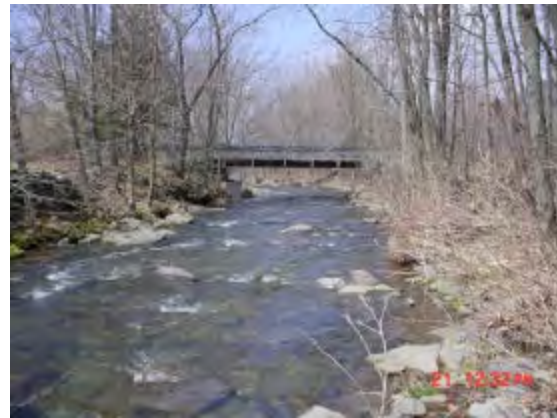
Wolff Road Bridge (TH 147)

Downstream of the fallen tree on the right, the vegetative buffer on the bench and road embankment improves. The tree line on the left narrows as the stacked rock wall impinges on the channel. A poured concrete scour wall protects the left abutment of the Wolff Road bridge (Station 49325) (Inset C, Fig. 4.3.2), and may be an indication of previous channel degradation. The right abutment is stacked rock. The bridge appears to

pass bankfull flows without significant backwater; higher flows are confined throughout the reach by the generally entrenched conditions.

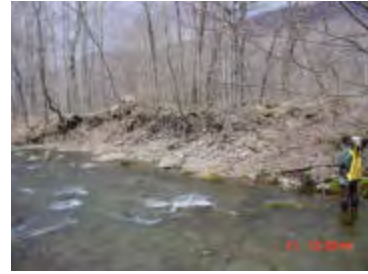
Downstream of the bridge, the right bank is experiencing minor erosion as Spruceton Road diverges from the West Kill (Inset B, Fig. 4.3.2). This erosion site, which may be associated with accelerated flows downstream of the bridge, is a good candidate for remediation using vegetative toe and bank protection. Stream slope is decreasing here, and a stable bench protects the left bank. Vegetative buffer improves on both sides.

Bank Erosion

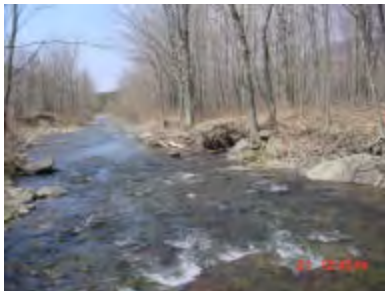
Small debris jam at habitat structure

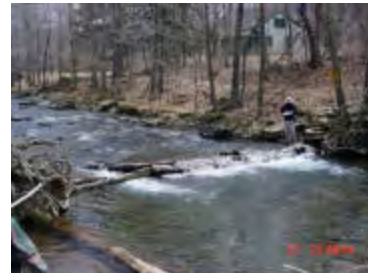
Habitat Structure

pools offer deeper holding habitat, sometimes with associated cover, and the spillways raise the level of dissolved oxygen in the water. These structures, often in the form of a log weir perpendicular to the channel, also provided grade control. Because they provide only minimal lateral control, however, higher flows frequently flank these structures. In some settings, this can promote lateral channel migration, increase width-to-depth ratios and result in bank erosion, as is seen here. In wild streams, these functions – both positive and negative -- are performed to a large extent by large woody debris. The structure is being flanked on both channel banks, and while still providing grade control upstream, is beginning to be compromised, with throughflow and underflow near right bank.

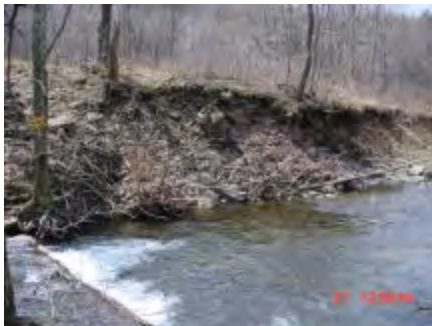
Bank Erosion, left (Inset F, Fig. 4.3.2)

Minor toe scour erosion associated with this structure is evident on both the left (60 ft.) and right (20 ft.) banks. On the right, the erosion is exacerbated by a collection of large woody debris. As the structure continues to deteriorate, these banks are likely to revegetate and stabilize over time. Downstream, previous erosion of the left bank has left a short lateral bar with abundant

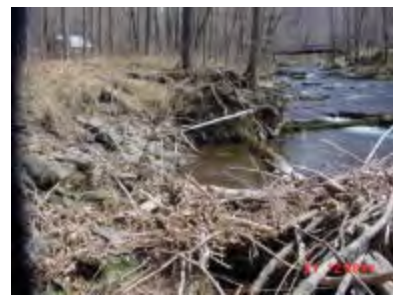
Bank Erosion, right

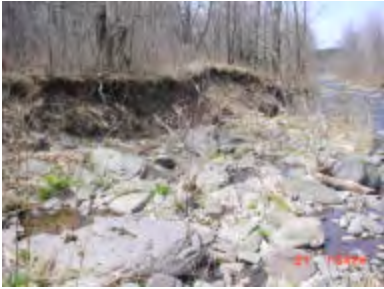
Bank Erosion, left

boulders and some willows, stabilizing the toe for a short distance, but erosion (73 ft.) again occurs as the bar recedes and the channel narrows.

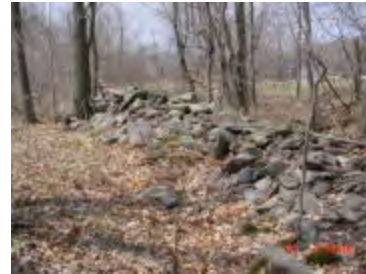
On the right, a berm of side cast, large cobble material - set back at upstream end, approaching the channel downstream -- progressively narrows the available floodplain.

Berm

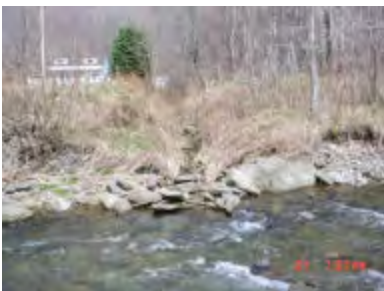
Tributary, right

Moving downstream, Spruceton Road has diverged from the West Kill sufficiently to allow for a residence and horse paddock on the right. A small, unnamed tributary borders the edge of the paddock, well-connected coming off the low floodplain, which appears stable, but highly channelized. There is some evidence at the confluence of nutrient enrichment; possible sources should be investigated.

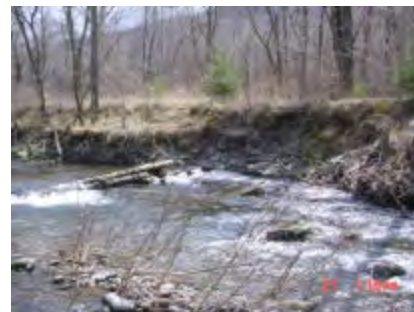
Another NYSDEC habitat structure (Station 48610) (Inset A, Fig. 4.3.2) just downstream of the monumented cross-section exhibits similar conditions to the one just upstream: the structure is compromised at both ends, causing minor bank scour at both left and right banks. Management Unit 3 ends approximately 134 ft. downstream of this structure.

Habitat structure, left bank scour
