West Kill Management Unit 4

Stream Feature Statistics

Management Unit 4
Between Station 48476 and Station 46365

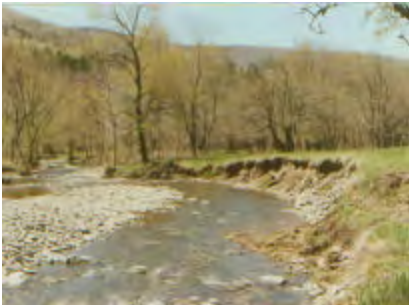
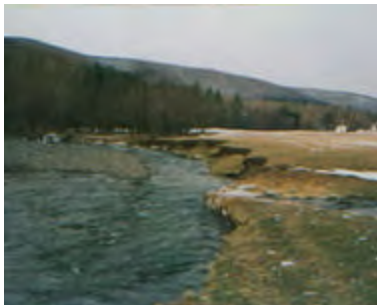
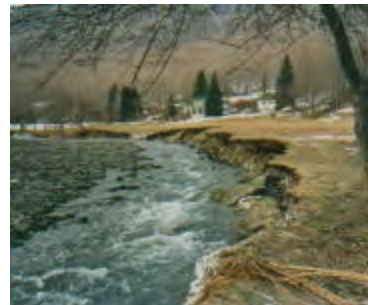
Erosion after the January 1996 flood

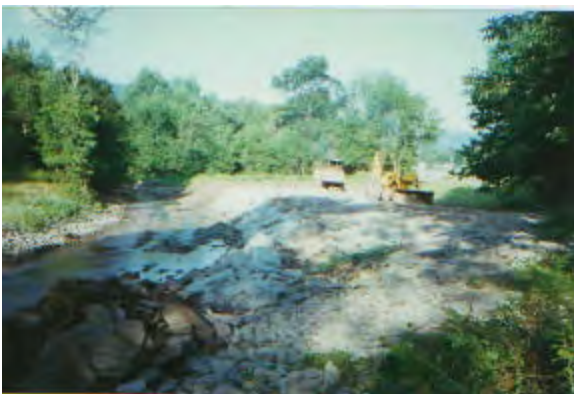
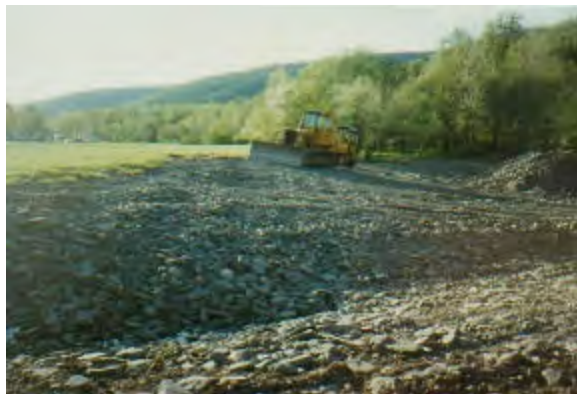
Flood repair, Ben Barcone's property

According to available NYS DEC records there was one stream disturbance permit issued in this management unit following the flood of 1996, to stabilize 50 ft. of streambank with revetment.

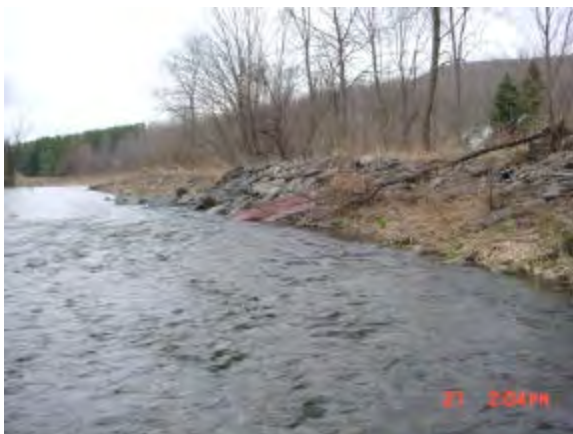
Rip Rap, right bank

As the channel slope drops, aggradation becomes evident, and a 59 ft. section of rip rap, dumped in place, has been installed on the right bank (Inset H, Fig. 4.4.2). The rip rap is in poor condition, but, protects against possible lateral channel migration in response to the aggradation.

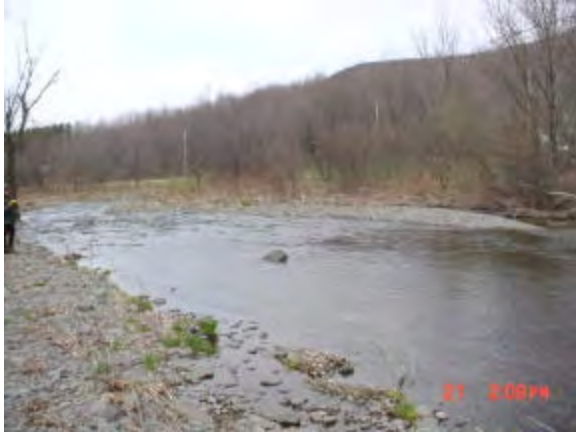
Aggradation, channel split

Continuing downstream, aggradation becomes progressively more severe, eventually resulting in a distinct, two-thread channel divergence, near Station 48250 (Inset D, Fig. 4.4.2). Proceeding down the right channel thread, a monumented cross-section is established at Station 48060, which crosses over the vegetated island and the left thread as well, documenting this 1576 ft. reach of D4b streamtype. This type of channel morphology, typical of aggradational settings, is characterized by multiple, shifting channel threads, excessive

bankfull channel widths, low entrenchment, and gravel-dominated streambeds, often with vast gravel deposits. Usually unstable, these stream types are very highly sensitive to disturbance, have poor potential for recovery from their aggradational condition, and exhibit very high sediment supply and streambank erosion potential.

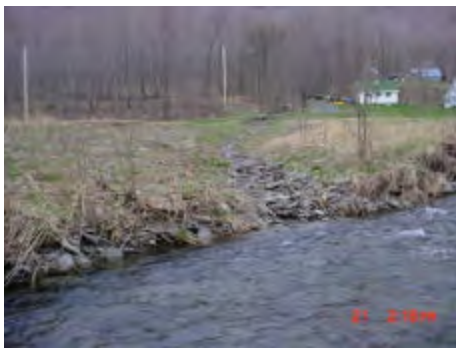
Tributary

A channelized unnamed tributary enters across a mown field on the right. The channel is trapezoidal with laid-back banks, evidence of recent excavation and ongoing maintenance. Its connection is stable.

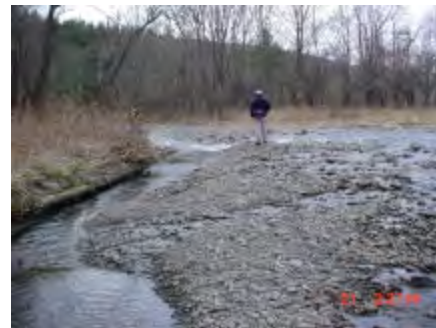
On the left bank of the right channel thread, the thalweg, or deepest part of the channel, flows against a section of log cribbing (Inset C, Fig. 4.4.2). The cribbing is failing at the downstream end, and is largely buried by gravel deposits, indicating the magnitude of aggradation here.

Log Crib Wall

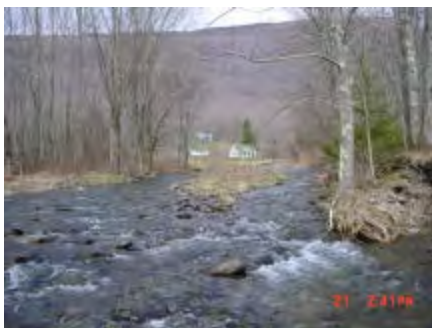
Mid-channel bar, looking up right thread

Downstream of the cribbing, a mid-channel bar has formed (Inset B, Fig. 4.4.2). The floodplain beyond both banks is forested, with evidence of frequent inundation and historical channel avulsions.

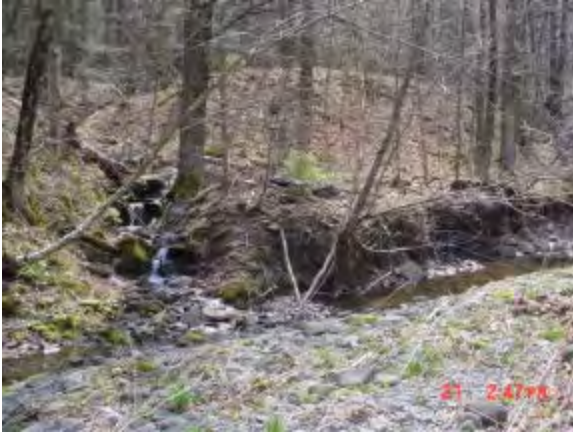
Perched tributary

Backtracking to the divergence and proceeding down the left channel thread, a perched tributary enters from the terrace on the left, with evidence of a headcut up to the terrace edge, but which appears to have stabilized.

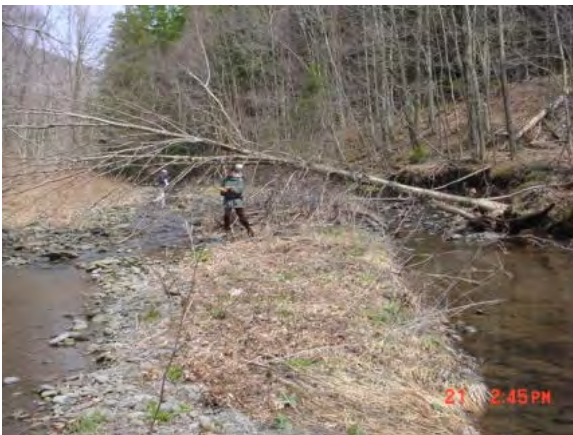
Debris jam

Downstream of the tributary, a mid-channel bar has formed, forcing flows up against the right and left streambanks. Scour of these banks has undermined trees on both banks, creating woody debris obstructions to flows in the left channel thread. A monumented cross-section (Station 47576) documents approximately 800 ft. of D3b stream type. The slope decreases to 2.0%, and the bed becomes dominated by cobble.

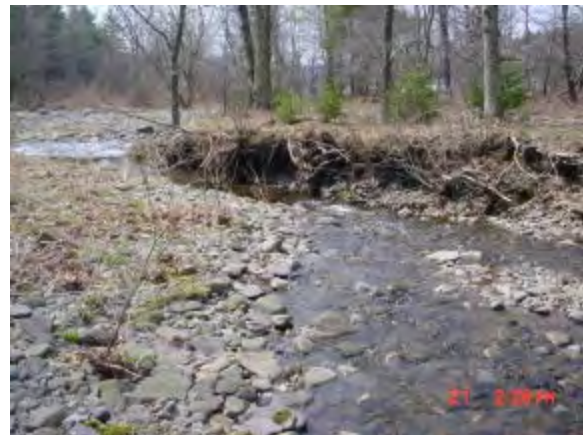
Bank scour near convergence

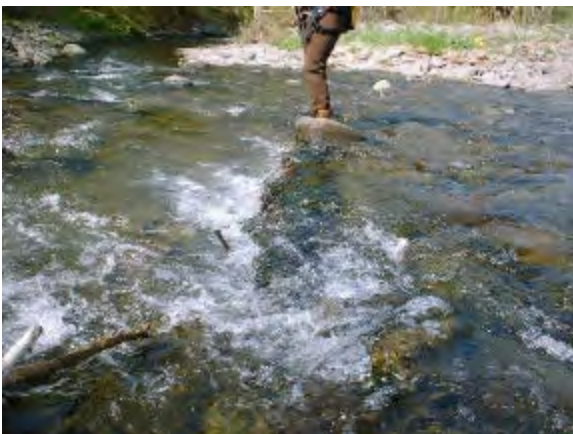
Remnants of habitat structure or crib wall

As the threads converge (Station 47400), a remnant habitat structure or crib wall, in very poor condition, is exposed in the streambed. The channel then bends to the right and regains its capacity to transport sediment as slope and entrenchment increase.

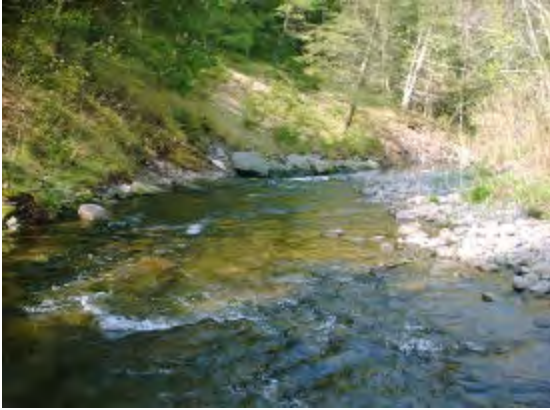
Rip rap, left bank

At the outside of this meander, the channel flows up against the valley wall, scouring the toe. Rip-rap has been installed at the toe of the bank, but erosion continues at the upstream and downstream ends of the revetment. The bank appears to be sliding over the rip-rap, and scarps are evident on the hillslope. Clay-rich till is exposed in the bed and bank here, and a small headcut at the upstream end of the rip-rap indicates that the channel may be incising. Relic side-channels are observed in the floodplain on the right.

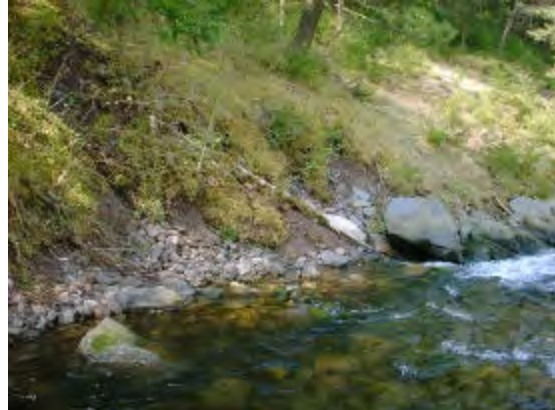
**Toe protection only, small headcut
at head of riprap**

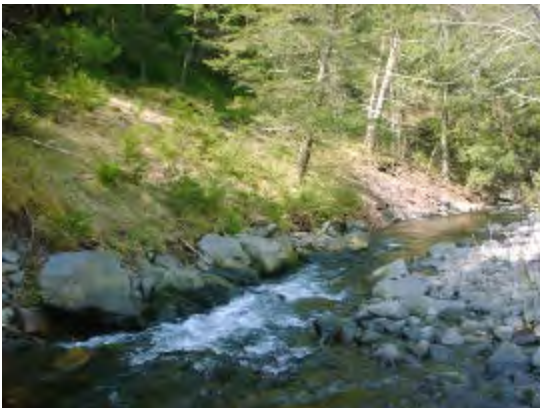
Erosion extending downstream of rip rap

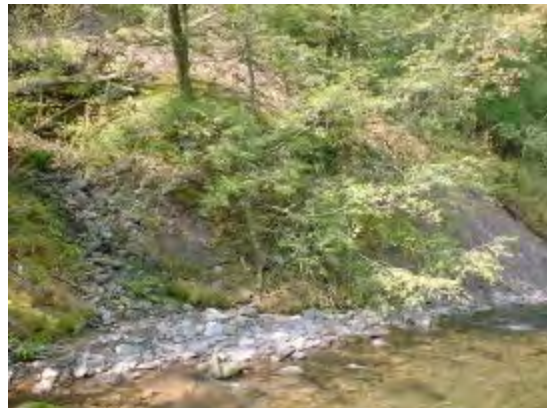
Landslide, with minor toe scour

Downstream of the rip-rap, leaning trees and scarp lines indicate mass wasting of the clay-rich till hillslope. Sliding material has moved vegetation to the stream edge for a short length, but downstream a large section of hillslope is actively eroding. This site is documented as a Bank Erosion Monitoring Site (BEMS 04-47032). In a prioritization of twenty-one BEMS sites throughout the West Kill watershed (see Section 3.3, Watershed Inventory and Assessment), this site ranked Low Priority. The *thalweg*, or deepest part of the stream channel flows up against the hillslope here. The hillslope appears to be mobilized by emergent groundwater and drainage problems, and then is being undermined by toe scour, leaving sections of the stream bank unvegetated. The *glacial till* soils have a high silt and clay content, yielding a significant suspended sediment load during high flows. Clay inputs into a stream are a serious water quality concern because they increase *turbidity*, degrade fish habitat, and can act as a carrier for other pollutants

There is one Bank Erosion Monitoring site in MU4 (BEMS 04-47032), a relatively large failure contributing significant amounts of fine soil and clay, as well as some mature trees, to the creek. This failure could constitute a severe flood hazard for downstream reaches due to the potential for uprooted trees to be introduced into the stream from the eroding stream bank during large floods. These trees can create debris jams at bridges or mid-channel bars and may shift the flow pattern of the stream, threatening roads and residential properties. This site has been treated with rip-rap toe protection, although this revetment does not appear to be adequately addressing suspected geotechnical stability problems at the Bank Erosion Monitoring Site.

and pathogens. Further investigation of the geotechnical and water quality issues at this site is recommended.

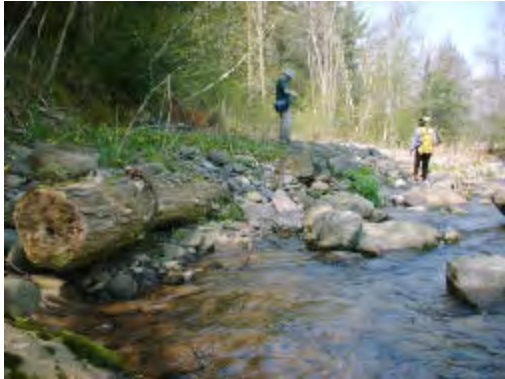
Remnants of log cribbing

The introduction of material from the hillslope has produced a lateral bar downstream of the erosion on the left partially burying remnants of log cribbing, in poor condition. As the reach straightens on approach to the Ad Van Road bridge, a low, wetland terrace develops on the left. A monumented cross-section (Station 46621) documents 535 ft. of C4 stream type. The slope decreases to 1.83%, and the bed becomes dominated by gravel again. A relic channel confluences from the right, and red filamentous algae was observed in the

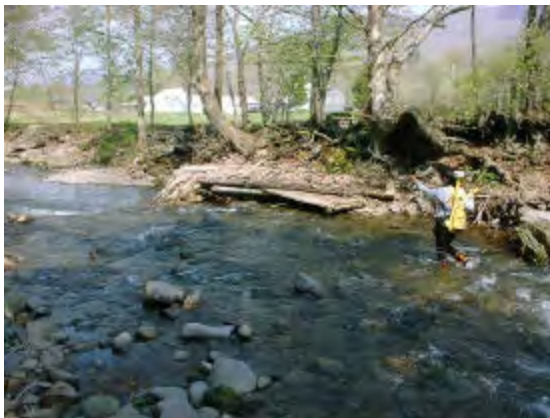
Habitat Structure

Remnants of a habitat structure, consisting of two channel-constricting wings and a log sill, are found at Station 46580. Habitat structures were historically installed throughout the West Kill mainstem by the New York State Department of Environmental Conservation (NYSDEC), often to create scour pools. These scour pools offer deeper holding habitat, sometimes with associated cover, and the spillways raise the level of dissolved oxygen in the water. The structures, often in the form of a log weir perpendicular to the channel, also provided grade control. Because they provide only minimal lateral control, however, higher flows frequently flank these structures. In some settings, this can promote lateral channel migration, increase width-to-depth ratios and result in bank erosion. This is not observed here, however. In wild streams, these functions – both positive and negative – are performed to a large extent by large woody debris.

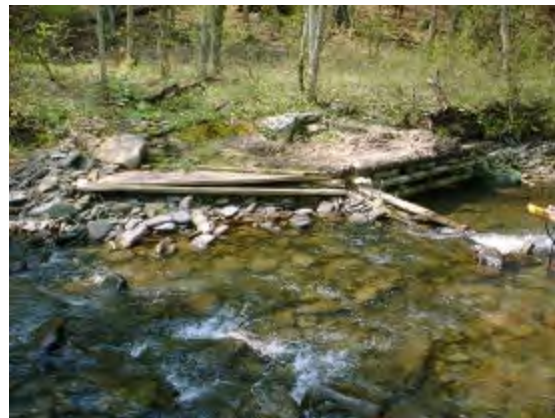
Wing deflector and log sill habitat structure

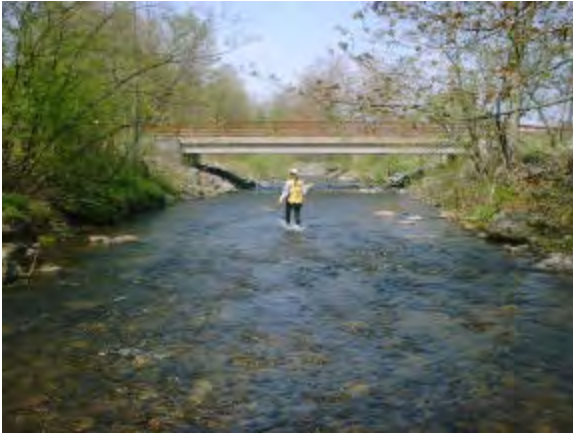
Ad Van Road bridge

Approaching the end of the management unit, the approaches of the Ad Van Road bridge crossing constrict the floodplain at very high flows, but pass most flows effectively (Inset A, Fig. 4.4.2). Substantial abutment protection was documented, and no abutment scour was observed.
