West Kill Management Unit 5

Stream Feature Statistics

Management Unit 5

Between Station 46365 and Station 42743

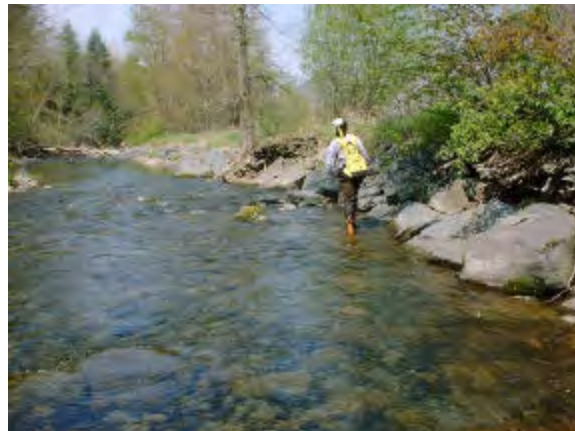
Immediately downstream of the habitat structure, a 244 ft. long installation of rip-rap begins on the right bank (Inset D, Fig. 4.5.2). The riparian buffer beyond the rip rap installation is in poor condition, with mown grass to the edge of the bank. The risk to bank stability can be minimized by maintaining mature trees along the stream margin, including a critical buffer zone extending approximately 75 ft. from the centerline of the stream (Fig. 4.5.4). The risks and benefits associated with management of streamside vegetation will depend partly on the current channel conditions, and local channel surveys are recommended at each site. Recommendations for this area include interplanting of the rip rap, and enhancement of the riparian buffer with planting of ecologically appropriate tree and shrub species in the adjacent mown field.

Rip Rap, right

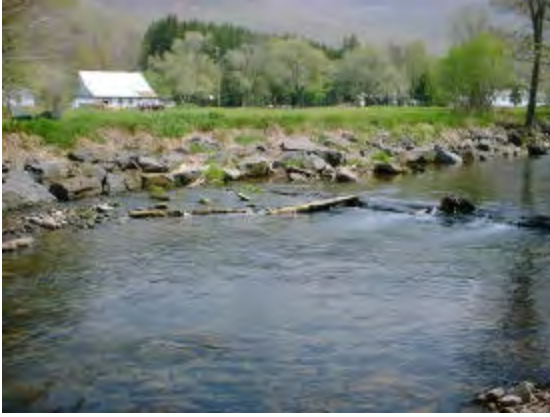
Downstream of the Ad Van Rd. Bridge, the start of this Management Unit, a log habitat structure is found (Station 46300). Habitat structures were historically installed throughout the West Kill mainstem by the New York State Department of Environmental Conservation (NYSDEC), often to create scour pools. These scour pools offer deeper holding habitat, sometimes with associated cover, and the spillways raise the level of dissolved oxygen in the water. The structures, often in the form of a log weir perpendicular to the channel, also provided grade control. Because they provide only minimal lateral control, however, higher flows frequently flank these structures. In some settings, this can promote lateral channel migration, increase width-to-depth ratios and result in bank erosion up- or downstream. In wild streams, these functions – both positive and negative – are performed to a large extent by large woody debris. The structure is in good condition, with mild aggradation upstream of the structure, and a deep scour-pool downstream. The channel constricting wings are in good condition with evidence of minor scour of the left bank. The structure has a ramp on the invert sill to promote sediment transport and to prevent the bed from collapsing into the scour hole downstream and abandoning the grade control component of the structure, as has been seen on other similar structures. The structure has been maintained by NYSDEC within the past 7 years.

Habitat structure, right, looking upstream

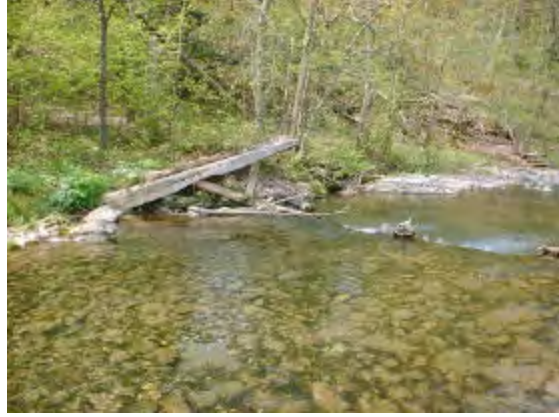
Left

Near the mid-point of the rip rap installation, another habitat structure (Station 46150) is found. Aggradation at the structure has buried the right channel constricting wing, while the left wing appears to have been damaged by high flows. The grade control sill is intact, but may promote erosion at the right as aggradation continues.

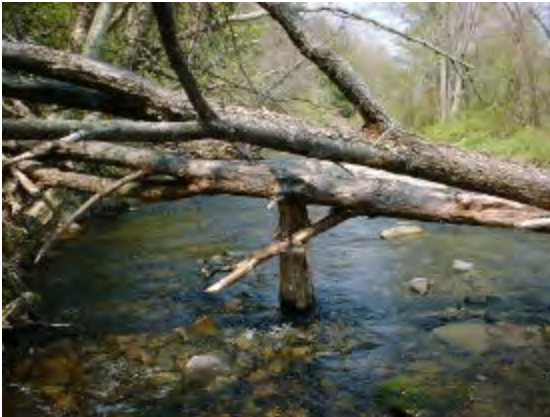
Debris jam

A debris jam, pictured above, is located at the downstream end of the rip rap installation. A large maple tree, fallen from the right bank, appears to have been jacked up and supported by a log. The log appears to have been placed to reduce the obstruction at low flow, but still presents an obstruction at the right bank, which increases with stage.

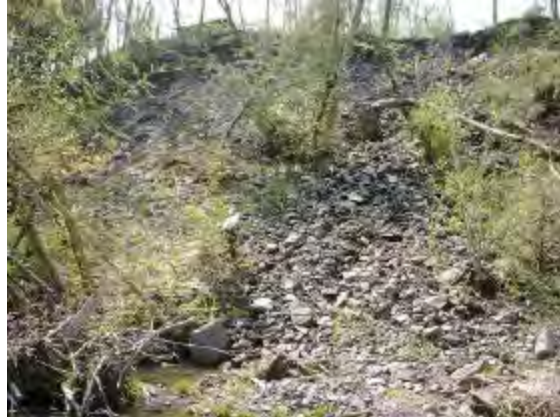
Large slope failure

The debris jam marks the upstream extent of a 167 ft. long, 58' high, slope failure on the left bank. This bank was significant enough to warrant detailed investigation as a Bank Erosion Monitoring Site (BEMS #05-45915). In a prioritization of twenty-one BEMS sites throughout the West Kill watershed (see Section 3.3, Watershed Inventory and Assessment), this site ranked Low Priority. The *thalweg*, or deepest part of the stream channel flows up against the glacial terrace here (Inset H, Fig. 4.5.2). The hillslope is being undermined by toe erosion, leaving sections of the stream bank unvegetated. The exposed *glacial till* deposits have a high silt and clay content, contributing sediment through both *wet and dry ravel* and yielding a significant suspended sediment load during

high flows. Clay inputs into a stream are a serious water quality concern because they increase *turbidity*, degrade fish habitat, and can act as a carrier for other pollutants and pathogens.

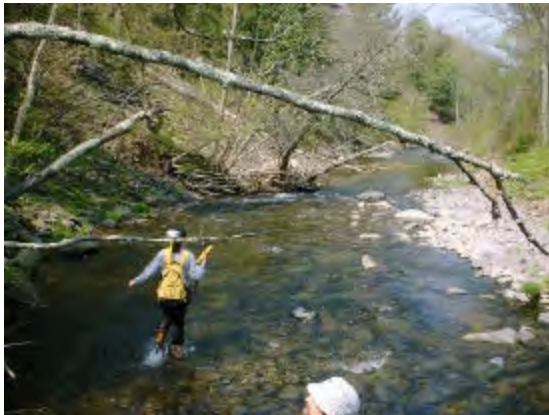
Debris jam, left

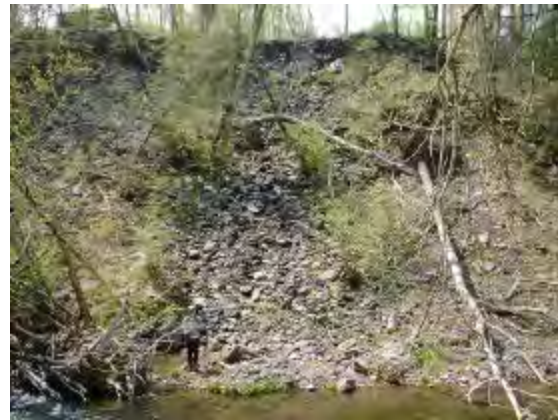
Tributary, Spring on large slope failure

At the base of the hillslope failure, stream borne debris has collected on trees slumped from upslope, presenting an obstruction through all flows. A small unnamed tributary flows over this hillslope from the flat above, creating a debris cone and undermining the stability of the bank (Inset H, Fig. 4.5.2). A storage shed, serving a residence approximately 200 ft. back from the edge of the failure, is potentially threatened by the erosion. Groundwater is piping through the hillslope, further destabilizing the site. Without intervention, the tributary is likely to headcut at the edge of the bank, resulting in gullying. Recommendations for this site include addressing the tributary flow, either through redirection or outfall protection, and further assessment of the mechanism of failure. Full restoration at this site would likely involve establishment of a well-vegetated bench on the left, possibly with rock vanes to direct stream flows away from the bank, and revegetation of the bank face. In-depth survey and design would be required to plan a stream restoration project at this site.

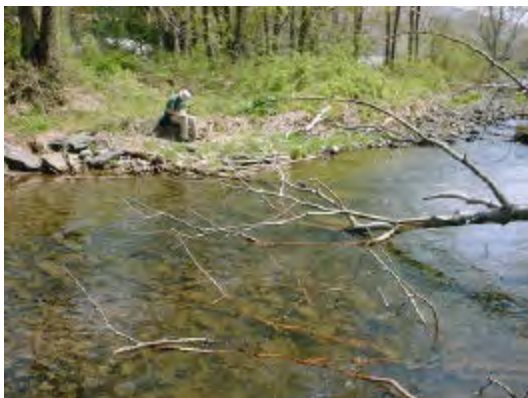
Remnants of log habitat sill, right

Opposite the eroding bank remnants of a habitat structure (Station 45910) were documented on the right. The structure is in very poor condition, with minimal evidence of a sill remaining, and the left portion missing entirely. It is likely that, when it functioned as grade control, this structure encouraged lateral migration of the channel to the left. In its current condition, it increases near bank shear stress, adding to the instability problems. The stream has good access to the floodplain here, and the site is a public fishing access point.

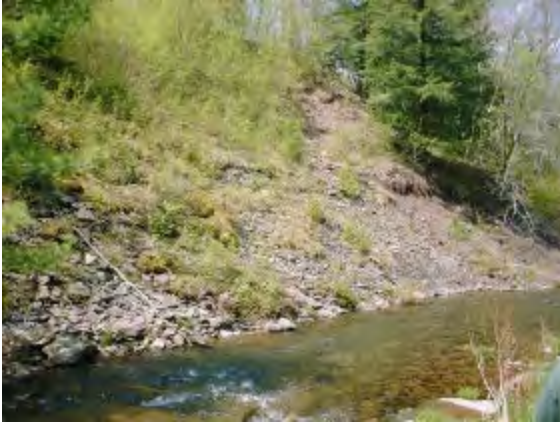
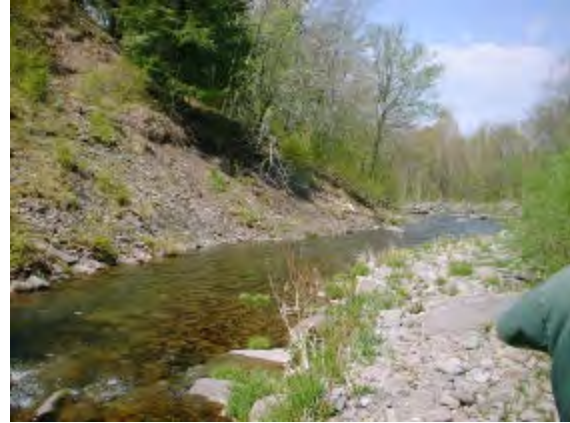
Erosion, left

As the glacial till terrace forces the channel to the right, further bank erosion, 111 ft. long, by 35 ft. high, was documented (Inset C, Fig. 4.5.2). Although it is contributing excessive sediment load to the stream, this slip is showing signs of self recovery, and was not monumented.

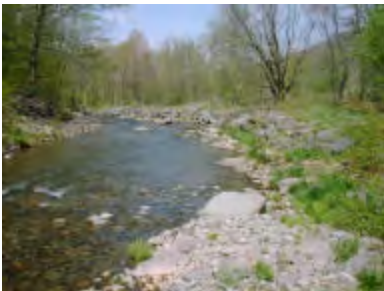
Rip rap, right

Continuing downstream, entrenchment increases again, and a 276 ft. installation of placed rip-rap protects the right bank. The installation is in good condition. Along this rip-rap, another relic habitat structure was documented. No channel-constricting wings were evident, and the sill was somewhat compromised. Downstream of the rip

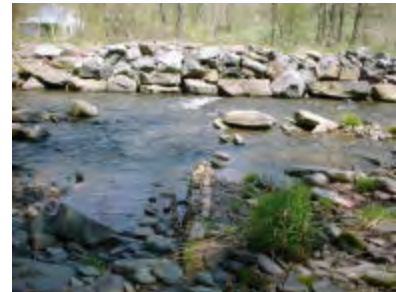
Habitat log sill, no wings at either bank

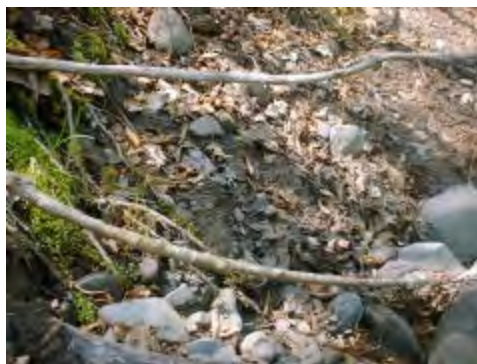
Clay exposure

Up- and downstream, numerous exposures of lacustrine clay were observed in the streambed (Inset G, Fig. 4.5.2). Clay inputs into a stream are a serious water quality concern because they increase *turbidity*, degrade fish habitat, and can act as a carrier for other pollutants and pathogens.

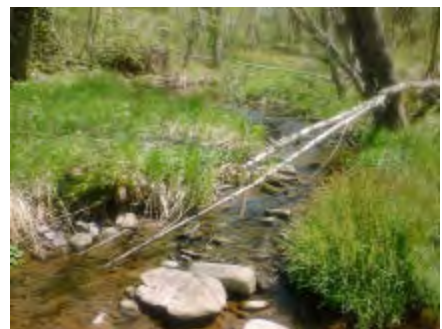
Tributary, right

A small unnamed tributary enters, right, over a bench vegetated with sedges. The confluence is well-connected.

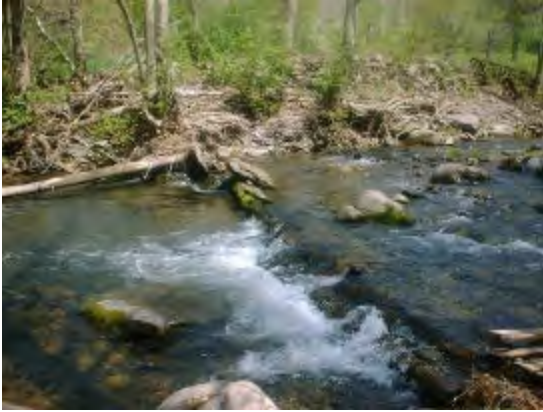
Habitat structure

Another habitat structure, observed at Station 44950, remains in fair condition with the log sill intact, but with its wing ramps mostly gone. Just downstream of the habitat structure, another small unnamed tributary enters from a well-connected, vegetated floodplain on the right.

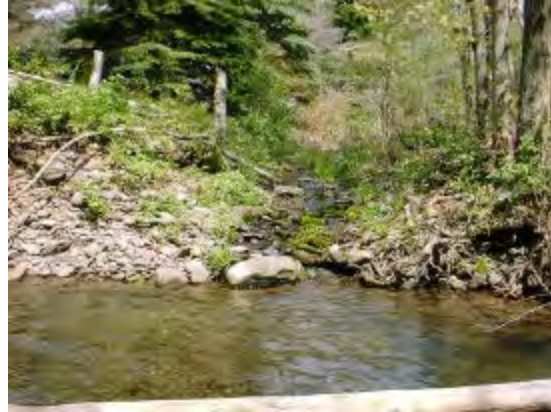
Tributary, right

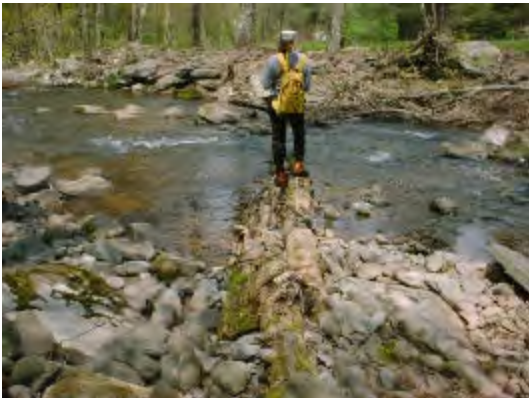
Habitat log sill, breached on right

Remnants of another habitat structure (Station 44850) are evident on the left bank. Downstream of the habitat structure, a 62 ft. length of stacked rock wall protects the right bank, and perhaps blocks a relic channel. This wall appears old, with mature trees growing through it. Some undercutting of the left bank has produced a small obstruction of woody debris.

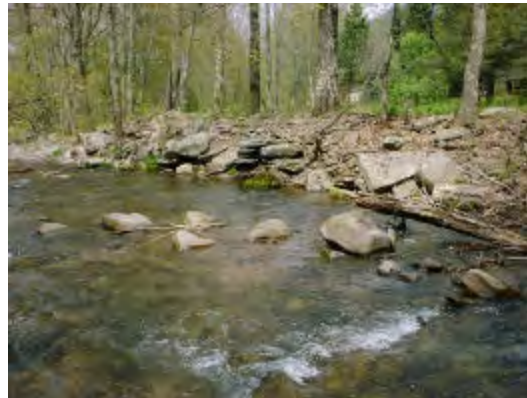
Stacked rock wall, right

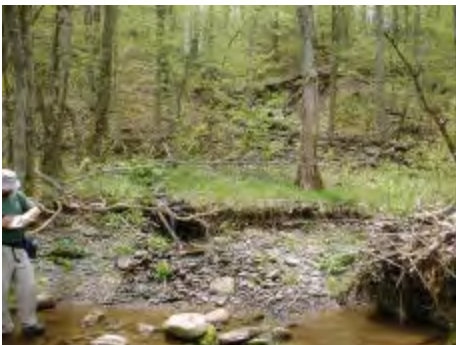
Tributary, left

Another small, unnamed tributary enters from the left, over a low terrace. Beyond this terrace, the tributary flows over a steep sideslope, with evidence of headcutting and gullying. The tributary appears to be contributing a significant amount of silt and turbidity, and the streambed is somewhat embedded downstream of the confluence. Investigation of the source of this sediment is recommended.

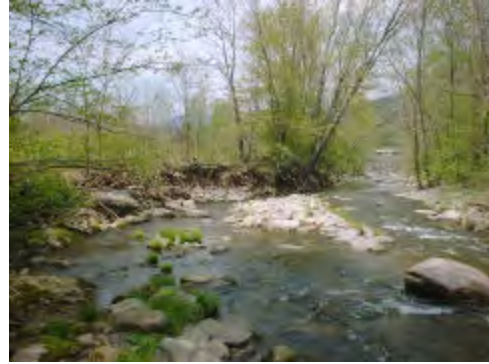
As the quality of the riparian buffer on the left declines, the bank becomes undercut for 124 ft., leaving large, overhanging trees that may become a debris problem. Multiple relic threads act as overflow channels on the floodplain, right, as evident from sandy deposits throughout this well-forested floodplain. Excessive access to the floodplain on the right, exacerbated by the downstream channel geometry and rip-rap, may be contributing to aggradational conditions in this reach. Recommendations include improvement of the riparian buffer on the left.

Erosion, left

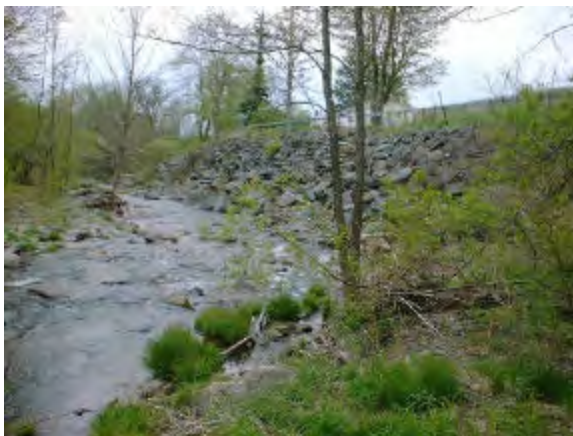
Rip rap, CR6 road embankment

As the channel comes back against County Route 6, it makes a hard left bend against a 178 ft. installation of dumped rip-rap. The rip-rap is in good condition, but there is no buffer between the stream and the roadway. Recommendations for this area include interplanting of the rip rap.

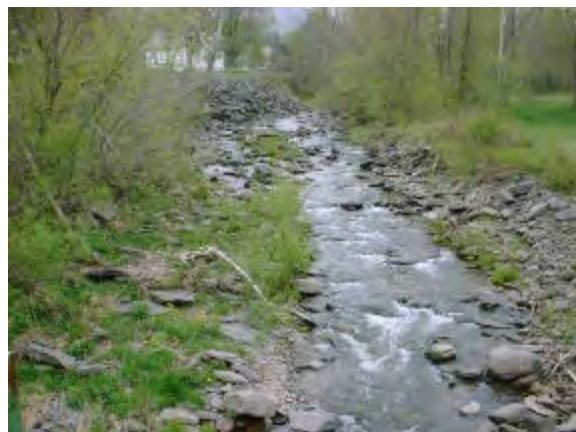
Approaching the bridge at Janet Place, the channel becomes increasingly entrenched, and streamtype changes back to a 1257 ft. reach of B3c streamtype to the end of the management unit (Inset F, Fig. 4.5.2). Willows are beginning to establish at the toe of both right and left banks upstream of the bridge, and a low bench is developing on the right. Although there is only minimal abutment protection, there is only minimal scour evident at the footings of the abutments.

Approach to bridge at Janet Place, looking upstream

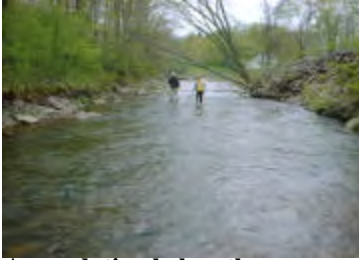
Aggradation below the Janet Place bridge

Continuing below the bridge, the streambed shows evidence of aggradation and channel grading. A stacked rock wall on the right, at the top of the bank. This has minimal impact at most flows due to some connectivity with the floodplain on the left. The riparian buffer is poor on the right bank, but better on the left. Near the

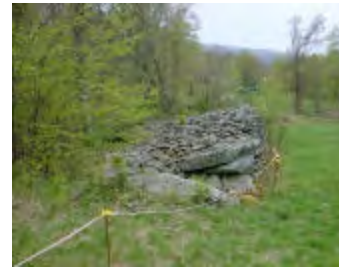
Stacked rock wall on right

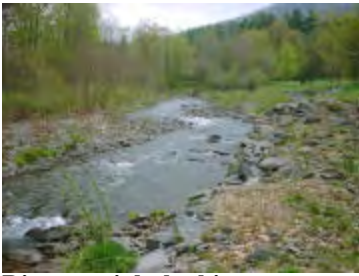
Rip rap, right looking upstream

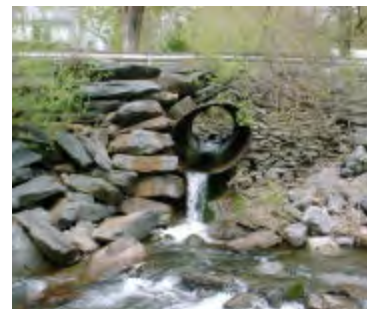
The channel bends back to the left as it approaches the Baker Road bridge, and Herdman Brook (0.8 mi²), a major tributary, enters through a 60" culvert on the right. Both the culvert and its headwall and outfall protection appear somewhat compromised.

Herdman Brook confluence

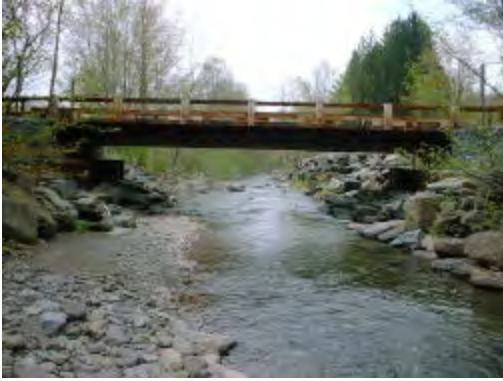
Bridge at Baker Road

The Baker Road bridge (Inset A, Fig. 4.5.2) has protection at both abutments, the abutments are new and in good condition, but there is evidence of significant historic and ongoing scour and channel incision. The Herdman Brook culvert is perched high above the invert of the West Kill, and photography from 2000 shows cracked abutments that may have been compromised by abutment scour. Flows above bankfull appear to backwater at the bridge, exacerbating the upstream aggradation. An undersized bridge opening causes water to back up upstream of the

bridge, reducing stream velocity, which results in sediment deposition. Additional *floodplain drainage*, using culverts set at the floodplain elevation under the south bridge approach, may help mitigate this problem.
