# West Kill Management Unit 6

**Management Unit 6**  
Between Station 42743 and Station 39851

**Management Unit Description**

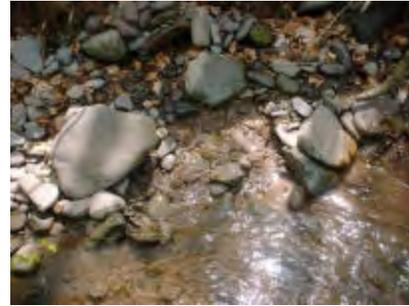
Continuing downstream, a 251 ft. installation dumped riprap protects the County Rte. 6 road embankment on the right (see Inset G, Fig. 4.6.2). Lacustrine clay is exposed in the bed at the toe of the left bank, and groundwater seeps from the bank over these exposures.

**Clay exposure, left**

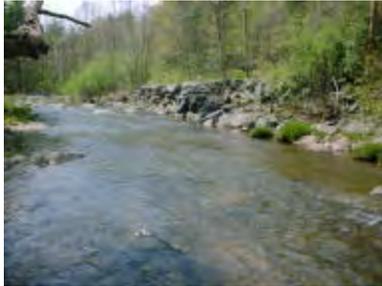
**Aggradation adjacent to stacked rock wall**

Continuing downstream, the channel is aggrading, an artifact of backwater resulting from a debris jam further downstream that has since been moved to block an overflow channel (see Inset C, Fig. 4.6.2).. Near the downstream end of the straight reach, another 121 ft. section of stacked rock protects the road embankment. An 18" culvert enters on the right carrying road drainage and flow off the hillslope to the north under Spruceton Road (County Route 6). The culvert is without outfall protection, the headwall is in poor condition, and the confluence with the West Kill is perched, also without outfall protection, creating a high potential for headcutting. Vegetative stabilization is recommended here.

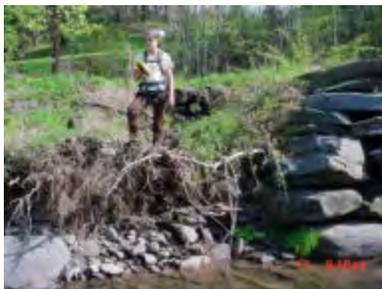
**Culvert outfall**

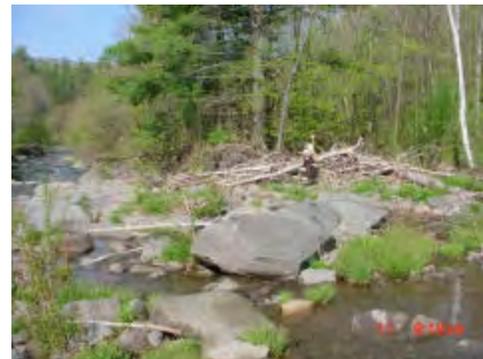
At the downstream end of the stacked rock, the channel bends to the left, where a large woody debris jam blocks what had been a cutoff channel on the right. Historical channel alignments indicate that this overflow channel was created during the flood event of 1996. The split flow created ineffective sediment transport and aggradation. There is evidence of efforts to fill the overflow channel with debris and direct flow to the left.

**Debris jam, aggradation at head of overflow channel, right**

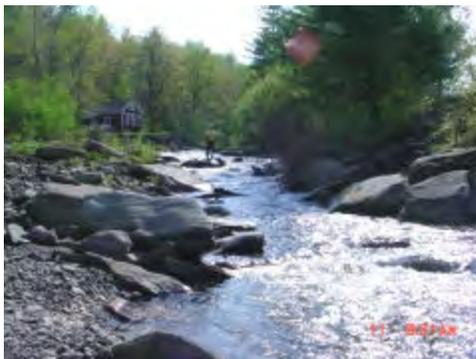
**Headcut at divergence of overflow channel and debris jam**

This aggradation creates a hydraulic drop at its downstream end, resulting in a *head cut*. Headcuts are short, steep sections that migrate upstream as they progressively erode the bed. However, there is abundant large, native rock present at the headcut, apparently placed, as well as in the channel downstream, and the site exhibits high potential for self recovery. This was confirmed

during the 2005 inventory. A short, steep riffle is developing here. It is recommended that the site be monitored to ensure that recovery continues. Entrenchment increases at the downstream end of the headcut, but lessens as access progressively increases to the floodplain on the right.

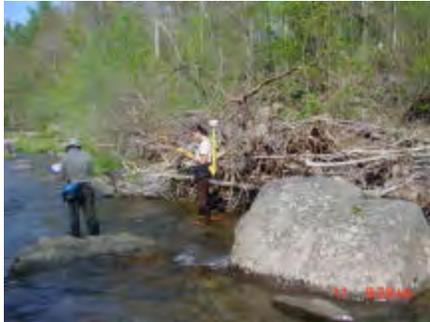
**Lateral debris jam, right**

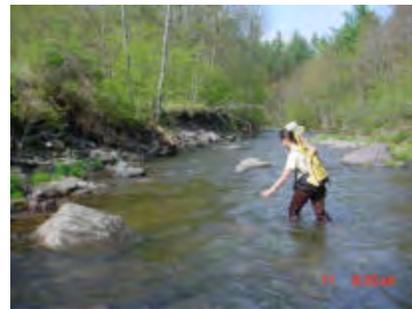
As the treeline on the left bank narrows to nothing along the mown field, the bank becomes undercut. Plantings of trees and shrubs along the streambank are recommended to help stabilize the bank and buffer the stream from the horse pasture. The reach appears overwide, and aggradation was observed downstream. Erosion of this bank has been monumented as a Bank Erosion Monitoring Site (BEMS Station 06-41388). In a prioritization of twenty-one BEMS sites throughout the West Kill watershed (see Section 3.3, Watershed Inventory and Assessment), this site ranked Low Priority. The *thalweg*, or deepest part of the stream channel flows up against the left bank here, undercutting the adjacent mown field. As there is no serious threat to infrastructure or water quality, and as the pressure on the bank may be mitigated if the debris jam on the right upstream is gradually cleared through deterioration and higher flows, the recommendation here is to continue monitoring the bank.

**Bank Erosion, left bank**

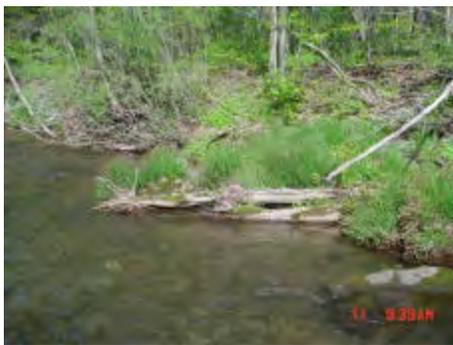
**Remnants of habitat structure, right**

As the riparian buffer improves on the left, the remnants of a NYSDEC habitat structure (Station 41250) are observed on the right, with associated aggradation just upstream. Habitat structures were historically installed throughout the West Kill mainstem by the New York State Department of Environmental Conservation (NYSDEC), often to create scour pools. These scour pools offer deeper holding habitat, sometimes with associated cover, and the spillways raise the level of dissolved oxygen in the water. The structures, often in the form of a log weir perpendicular to the channel, also provided grade control. Because they provide only minimal lateral control, however, higher flows frequently flank these structures. In some settings, this can promote lateral channel migration, increase width-

to-depth ratios and result in bank erosion up- or downstream, as is seen here. In wild streams, these functions – both positive and negative – are performed to a large extent by large woody debris.

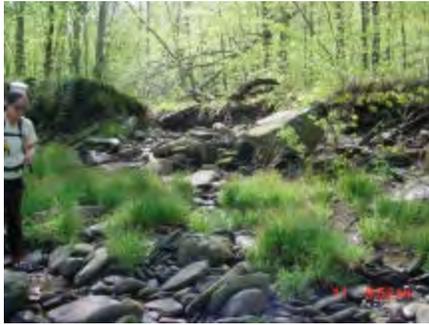
**Tributary, left bank**

A small unnamed tributary enters from the left, with the confluence somewhat perched, just upstream of the head of a 258 ft., low installation of rip-rap on the left, intended to protect a large slope failure on the outside of a meander bed to the right. Some channel aggradation is evident here (see Inset F, Fig. 4.6.2).

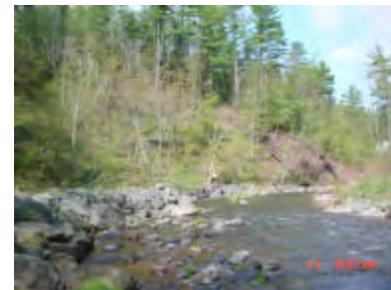
The channel is being turned here by the clay-rich, morrainal till of the terrace wall, and the toe of this bank is being scoured, with deep pools resulting, and causing the rip-rap to fail in places. The large structural failure is being exacerbated by the deposition of slash and timber from forest clearing and road development taking place on the terrace slope. The resulting slide is introducing considerable woody material into the stream. This erosion has been monumented as a Bank Erosion Monitoring Site (BEMS Station 06-40777). In a prioritization of twenty-one BEMS sites throughout the West Kill watershed (see Section 3.3, Watershed Inventory and Assessment), this site ranked at the top of the Medium Priority class, due in part to its size, potential threat to the road above and the quantity of woody material it is introducing to the stream. The *thalweg*, or deepest part of the stream channel flows up against the terrace here. The hillslope is being undermined by toe erosion, leaving sections of the stream bank unvegetated. The *glacial till deposits* have a high silt and clay content, contributing sediment through both *wet and dry ravel* and yielding a significant suspended sediment load during high flows. Clay inputs into a stream are a serious water quality concern because they increase *turbidity*, degrade fish habitat, and can act as a carrier for other pollutants and pathogens.

**Rip-rap toe protection of slope failure, left bank**

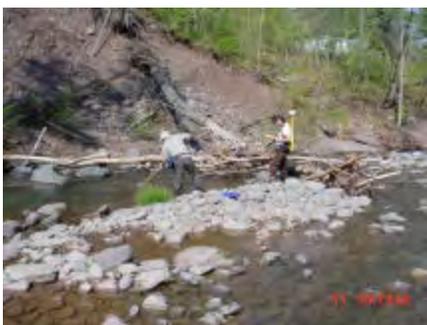
**Debris jam**

At the toe of the slope failure, a debris jam delivered off the slope obstructs the flow. This obstruction may encourage the development of a bench at the toe of the failure; there is good conveyance around the right of the jam, and access to the floodplain on the right. Alternatively, this material may accentuate scour at the toe. Which scenario occurs will depend on the sequence and magnitude of the flows over the next few years, as well as chaotic dynamics like additional collection of large woody debris and the size of material slumping out of the bank.

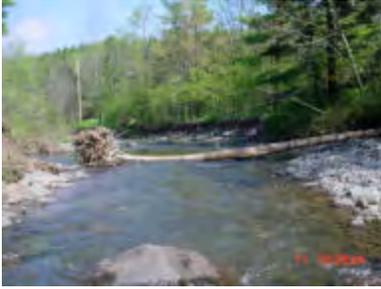
**Debris jam**

Another fallen tree downstream presents a more significant problem for conveyance across the point bar on the right, and directs flow toward the eroding bank (see Inset B, Fig. 4.6.2).

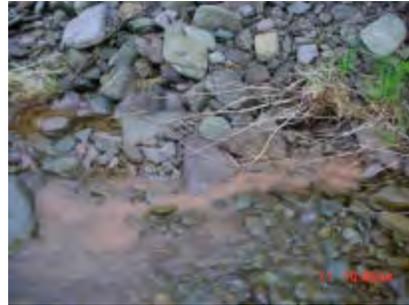
As the channel meanders back to the left, 260 ft. of bank cutting along the floodplain on the right was observed, exposing a deposit of clay till in the bed and bank in several locations. Groundwater seeps across the top of this clay deposit. This erosion is associated with, and would be included as part of any treatment of the BEMS 06-40777 site.

**Clay Exposure in bed, right**

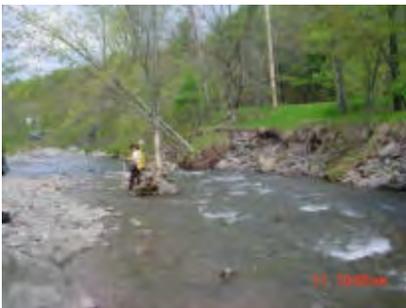
**Debris Jam**

the channel becomes confined by the County Route 6 embankment on the right, the dominant bed material changes to gravel, and the slope drops to 0.9%. A single line of trees buffers the stream from the road on the right, and erosion is undermining these as well. One tree is deposited here in the middle of the channel (see Inset E, Fig. 4.6.2).

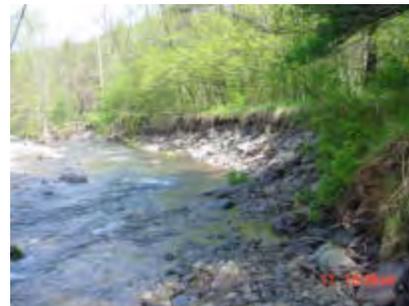
**Bank Erosion, right bank**

Full Restoration is recommended for this site. This would likely involve establishment of a well-vegetated bench on the outside of each meander, with rock vanes to direct stream flows away from the banks and to establish grade control, and revegetation of the bank faces. In-depth survey and design would be required to plan a stream restoration project at this site.

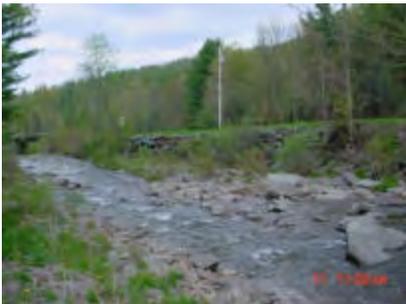
**Stacked Rock Wall, right**

Further downstream, the embankment of CR6 bar has been stabilized with a 122 ft. section of stacked rock wall on the right. A lateral bar has developed at its toe, and willows are colonizing it.

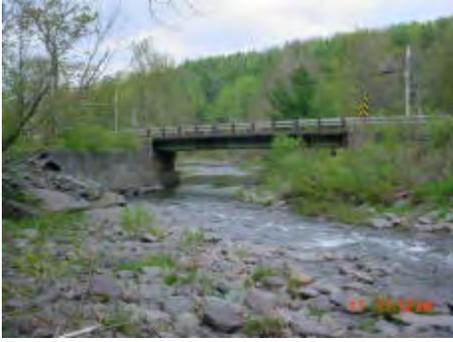
**County Route 6 Bridge**

At the County Route 6 bridge, the road turns to the left and the West Kill bends to the right, but the alignment remains diagonal, requiring a long wing wall upstream left, and significant scour protection, which includes a flow directing rock structure. Despite this design, the left bridge abutment is severely scoured. There is aggradation upstream, likely due to backwatering exacerbated by the poor alignment.
