West Kill Management Unit 8

Management Unit 8

Between 36944 and 34845

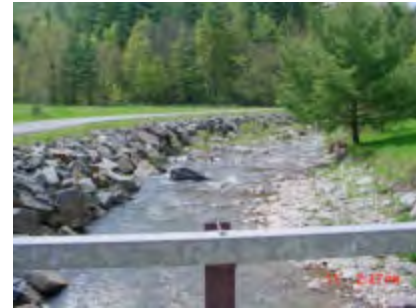
View from Aufarth Road Bridge, start of MU8

Aufarth Road bridge marks the upstream extent of Management Unit 8 (MU8). Management Unit 8 begins with a 344 ft. section of F3 streamtype, continuing from Management Unit 7 (MU7) where a monumented cross-section near the end of MU7 (Station 37179) documents the F3 streamtype. F streamtypes are entrenched, or confined within their banks at high flow. Channel slope is 1.3%, and the bed material is dominated by cobble.

The rip-rap at the left of the photo also continues from Management Unit 7 (Inset H, Fig. 4.8.2). The rip-rap protects the Aufarth Road Bridge abutments, and the County Route 6 embankment. It is made of large, angular quarry stone and is in good condition. This reach has virtually no riparian vegetation to buffer the stream from the potential thermal impacts and road runoff. The end of the rip-rap installation marks the transition from the F3 stream type to B3c. Recommendations here include interplanting of the rip-rap, and enhancement of the riparian buffer using ecologically appropriate tree and shrub species. The vegetative treatments will extend the longevity of the rip-rap installation, enhance the function of the riparian buffer, and improve fish habitat in this reach.

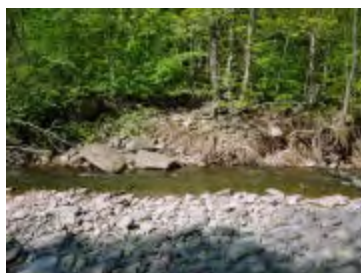
Bank Erosion

Just downstream of the rip-rap, bank erosion is evident on the left bank (Inset G, Fig. 4.8.2). The erosion is mild, and the buffer of trees, though quite narrow, offers a dense root mat which improves this bank's resistance to erosion. From a riparian buffer perspective, the vegetation here is inadequate to protect the stream from road runoff

pollutants. Despite the density of the soil stabilizing root mass, this bank erosion poses a threat to Greene County Route 6 due to its proximity to the roadway. A vigorous colony of willow between the end of the rip-rap and the start of the eroded bank may present material to stabilize the toe of the road embankment, using willow fascines and stakes crafted from locally harvested materials.

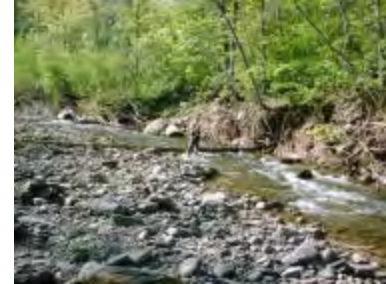
Debris Jam

A small debris jam is observed along the eroded bank. A single tree obstructs all but the lowest flows, but is fairly light and likely to be mobilized in a moderate flow event.

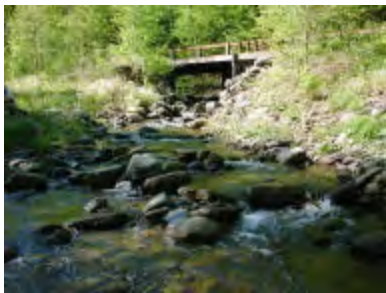
Tributary confluence, left

Mink Hollow, a 1.2 mi² tributary, joins the West Kill near station 36200 from the left. It passes under County Route 6 through a small bridge (Inset F, Fig. 4.8.2), and is well connected to the West Kill at its confluence.

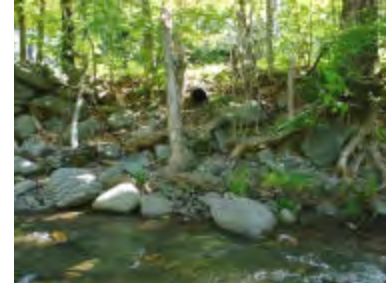
Culvert, right

A culvert emerges from the right bank, opposite the Mink Hollow

Tributary. The culvert appears to convey upland drainage from a residential area on the terrace at stream right. Although the culvert is perched and has only minimal outfall protection, no erosion was observed at the outfall.

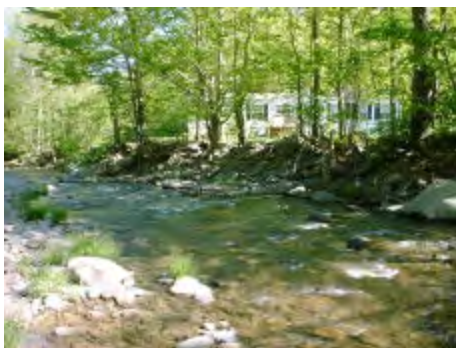
Rip Rap, right

Immediately downstream of the culvert, a 200 ft. long rip-rap installation is found on the right bank (Inset D, Fig. 4.8.2). The rip-rap protects a stream side residence, located on the terrace just beyond the rip-rap. The rip-rap is made of rounded river stone, and armors the bank against erosive flows delivered by both the West Kill and the Mink Hollow tributary.

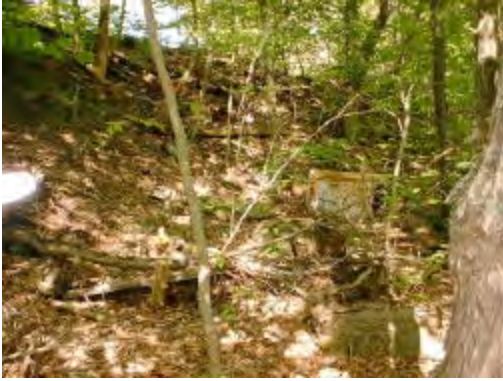
Road side dumping on stream

Continuing downstream, appliances and trash are found dumped on the left stream bank, as Greene County Route 6 peels away from the stream side. Appliances, trash and other refuse often contain metals, lubricants and various chemicals that can be detrimental to water quality. The dumpsite also degrades the aesthetic quality of this reach. Removal of the trash and appliances is recommended in order to protect water quality and limit further soil contamination.

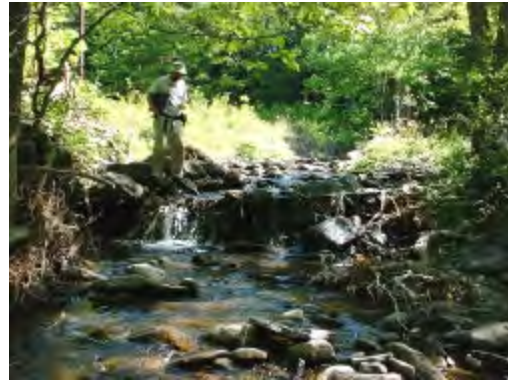
Tributary, right

Opposite the dumpsite, an unnamed tributary finds its confluence with the West Kill (Inset C, Fig. 4.8.2). The 0.9 mi² catchment appears to deliver moderate sediment loads, however, and a headcut is noted in the tributary near the confluence, which could result in accelerated sediment delivery as incision extends upstream. Recommendations for this tributary would include installation of a grade control structure at its mouth to prevent headward migration of the degradational processes noted here. The catchment for this tributary includes a recently developed residential subdivision; stormwater impacts upstream in this tributary should be investigated, both in terms of hydrology and water quality.

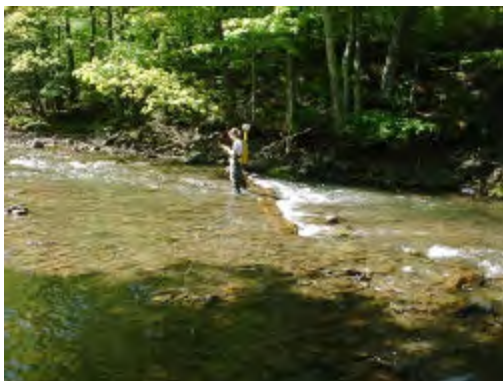
Habitat Structure

A habitat structure near station 35800 is partially buried in the stream bed. Habitat structures were historically installed throughout the West Kill mainstem by the New York State Department of Environmental Conservation (NYSDEC), often to create scour pools. These scour pools offer deeper holding habitat, sometimes with associated cover, and the spillways raise the level of dissolved oxygen in the water. The structures, often in the form of a log weir perpendicular to the channel, also provided grade control. Because they provide only minimal lateral control, however, higher flows frequently flank these structures. In some settings, this can promote lateral channel migration, increase width-to-depth ratios and result in bank erosion up- or downstream. In wild streams, these functions – both positive and negative – are performed to a large extent by large woody debris. This log structure forms a "V" pointed downstream, which spreads flow and appears to promote channel widening. The structure is in poor condition and is no longer likely to have a significant impact on channel process.

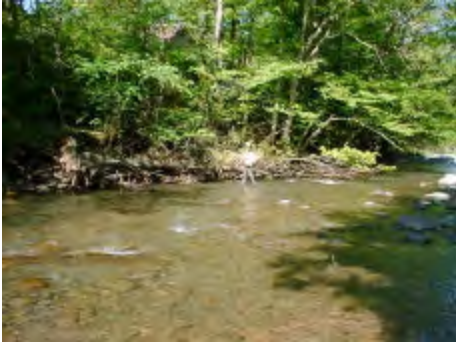
Debris Jam

A debris jam located approximately 50 ft. downstream of the habitat structure lies against the left bank. The jam presents only a minimal obstruction through the range of flows, and appears to provide some measure of bank protection.

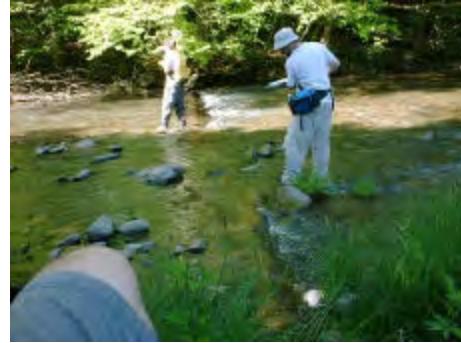
Habitat Structure

Another habitat structure is found near station 35710. This log sill is in good condition, and appears to widen the channel cross section.

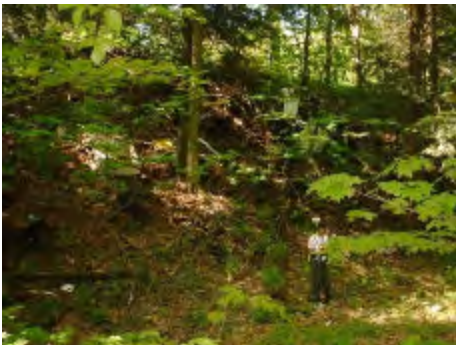
Dump Site, right

A second dump site was discovered, in this management unit, approximately 85 ft. downstream of the monumented cross-section at station 35615. This site again consists of appliances and other trash that may threaten water quality. Removal of the refuse is recommended.

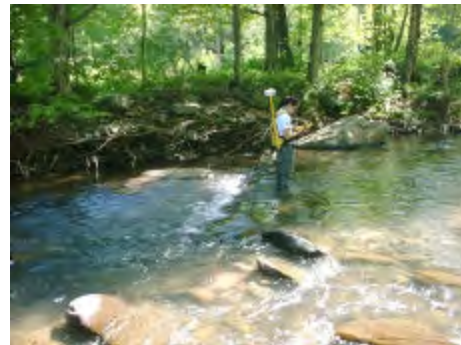
Habitat Structure

A third habitat structure was documented in this management unit at station 35530 (Inset B, Fig. 4.8.2). The log structure appears to have been similar to the “V” shaped structure described at station 35800. The structure is intact at the right bank, but there were no remnants of the structure evident at the left bank.

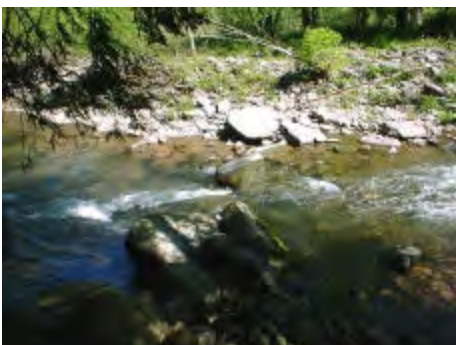
Rock grade control

Three rock grade control weirs were found in this Management Unit between stations 35500 and 35100. The weirs are formed from native rocks that appear to have been pushed into place. The structures provide effective grade control, and no adverse impacts are evident.

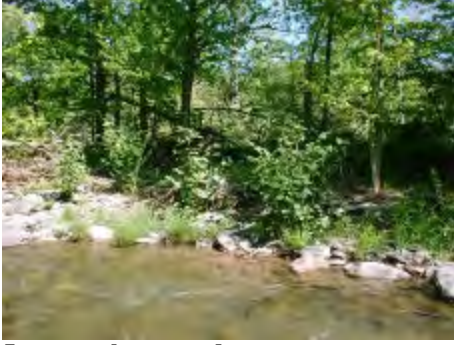
Three occurrences of Japanese knotweed were located in this Management Unit between stations 35450 and 35200 at the time of the 2004 walkover. The colonization of knotweed in MU8 was confined to the right bank of this reach. Knotweed spreads rapidly in favorable soil and moisture conditions, and removal of the noted occurrences is recommended to prevent proliferation of the species. A program of eradication of Japanese knotweed throughout the West Kill valley is recommended.

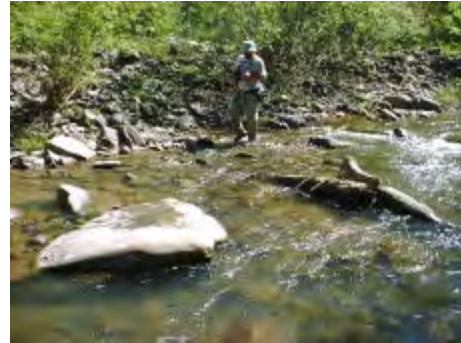
Habitat Structure

The last habitat structure (station 35050) located in MU8 is a log sill buried at the right bank, with the center protruding from the streambed (Inset E, Fig. 4.8.2). No remnants of the structure are evident at the left bank.

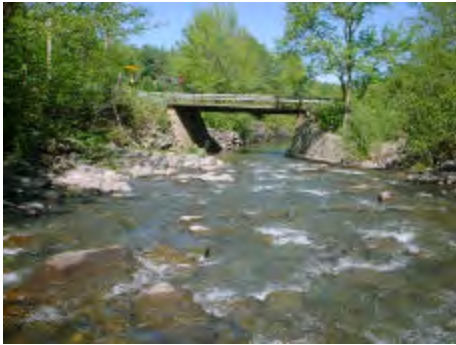
Bridge at Tumbleweed Ranch Road

As the channel approaches the terminus of MU 8 at the Tumbleweed Road Bridge (Inset A, Fig. 4.8.2), entrenchment increases, and the stream type transitions to B3c for the remaining 155 ft. of MU8. This stream type change is documented by a monumented cross-section (Station 34647) near start of Management Unit 9.

The bridge at Tumbleweed Ranch Road has concrete wing walls and rock placed at the inlet to protect the abutments from scour. Bedrock spans the entire channel bottom between the abutments, providing grade control.
