# West Kill Management Unit 9

## Stream Feature Statistics

**Management Unit 9**  
Between Station 34845 and Station 32092

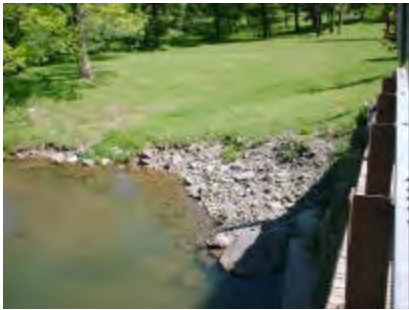
**Backeddy scour, right**

Management Unit 9 (MU9) begins with a 145 ft. section of C1 stream type, but quickly transitions to a 150 ft. reach of B3c stream type as entrenchment increases somewhat, documented by a monumented cross-section at Station 36414. The channel invert under the bridge is a deep bedrock pool, providing grade control but shifting the erosive forces laterally onto the streambanks. While stream flows can access the floodplain at a mown lawn on the right, just downstream of the bridge, entrenchment increases somewhat downstream, and the floodplain is interrupted longitudinally. The channel bends gently to the right, with a point bar on the right, which has been scoured at the bridge outlet by backeddy scour.

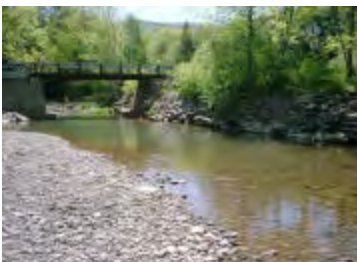
**Stacked rock wall, left**

A 500 ft. length of revetment protects the embankment of Greene County Route 6 on the left with a mix of stacked rock, log cribbing and dumped rock rip-rap, which appears progressively more compromised as you move downstream.

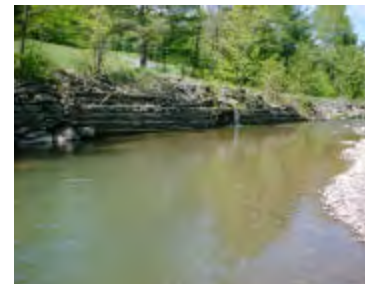
**Log cribbing, left bank**

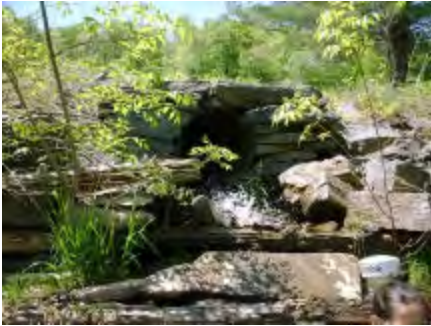
**Tributary confluence, perched, left**

A small unnamed tributary enters, left, through a perched 24” culvert under the road, with a stacked rock headwall in good repair and good outfall protection (see Insert H, Fig. 4.9.2). Downstream of the tributary the cribbing transitions to dumped rip-rap over failing cribwall, with no apparent toe protection, and then to material apparently sidecast during channel grading (Inset D, Figure 4.9.2). There is no significant riparian buffer between the channel and the road.

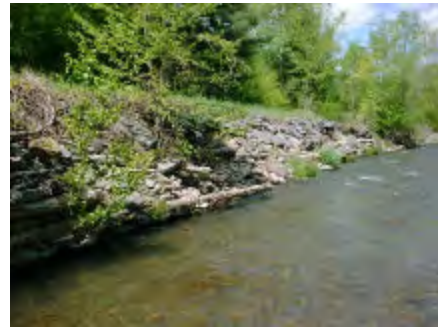
**Dumped rip-rap over failing crib wall**

Recommendations for this site include interplanting the revetment with ecologically appropriate trees and shrubs to improve buffer function and bank stability. A monumented cross-section (Station 34647) documents this B3c reach, with entrenchment increasing, but channel slope dropping to 0.8%.

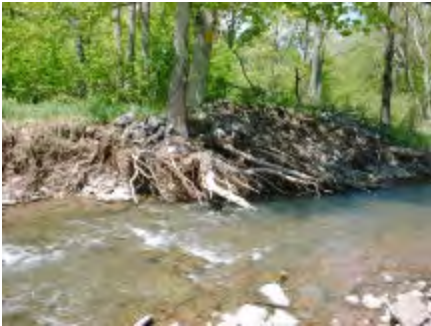
**Bank cutting, left**

As the channel bends right, it becomes overwidened as a result of downstream aggradation and a significant drop in channel slope (see Insert D, G, Fig. 4.9.2). The result is 153 ft. of bank cutting on a low, well-rooted terrace at the outside of the meander bend, left (Inset G, Figure 4.9.2). Channel grading has likely exacerbated the overwide conditions here, but the point bar on the right appears to be vegetating with willows which may serve to narrow the channel,

and an improvement of the riparian buffer on the right mitigates the erosion. As a result, the problem does not appear severe, and *passive restoration*, or letting the channel reestablish its own equilibrium, is recommended for this site, and for the reach in general. The site was not monumented as a Bank Erosion Monitoring Site.

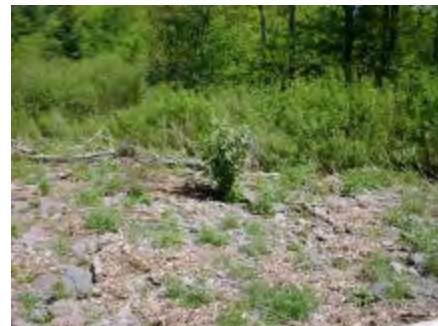
A small stand of Japanese knotweed (*Fallopia japonica*) also occurs on the point bar, however, and it is recommended that a watershed-wide program of eradication of this invasive exotic be undertaken. Japanese knotweed has become a widespread problem in recent years in the Catskills. Knotweed shades out other species with its dense canopy structure (many large, overlapping leaves), but stands are sparse at ground level, with much bare space between narrow stems, and without adequate root structure to hold the soil of streambanks.

**Japanese knotweed on bar, right**

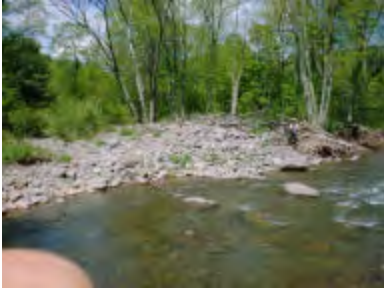
**Debris jam, left**

A small pile of woody debris on the left bank marks the head of a channel divergence at the back of a point bar on the left, as the channel crosses over and begins to meander back to the left.

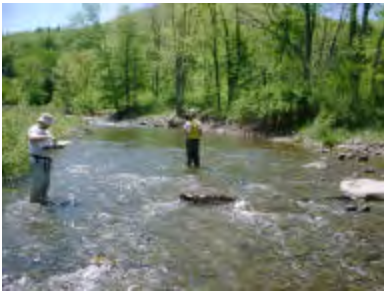
**Aggradation**

locations on the floodplain. The low entrenchment, aggradational conditions might have been typical of more of the West Kill prior to European settlement, before the stream was confined by roadways and cleared agricultural fields, and when beavers and their dams played a predominant role in floodplain development. The aggradational conditions here are due to a pinch in valley morphology downstream,

around Station 33000, which constricts very large floods, and may have resulted in local ponding of glacial meltwater. A small stand of Japanese knotweed was documented on the left

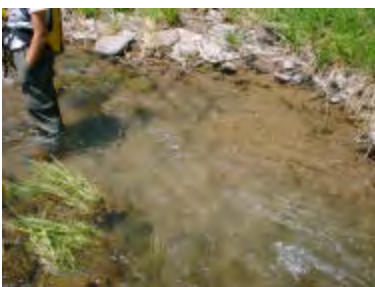
Continuing downstream, a large exposure of lacustrine clay was observed in the stream bed on the right. Clay inputs into a stream are a serious water quality concern because

**Clay exposure**

they increase *turbidity*, degrade fish habitat, and can act as a carrier for other pollutants and pathogens.

Clay exposures and sediment from streambank and channel erosion pose a potential threat to water quality in West Kill Creek. Clay and sediment inputs into a stream may increase *turbidity* and act as a carrier for other pollutants and pathogens. There was one significant clay exposure documented in this management unit, which should be further investigated for its causes and severity.

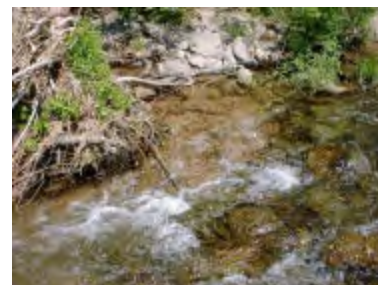
**Clay exposure**

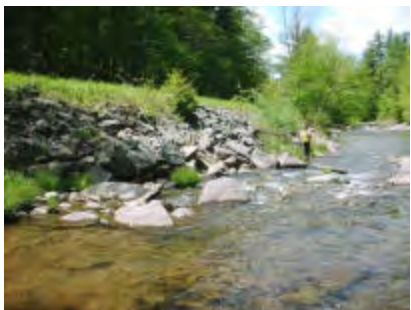
some roadway drainage. The channel is confined by both the valley walls and Greene County Route 6, which bends back to the stream here, and runs immediately adjacent to the channel, protected by a 181 ft. installation of dumped rip-rap, in good condition. There is no buffer along the roadway (see Insert C, Fig. 4.9.2). The channel still maintains sufficient floodplain connectivity and width to pass moderately sized storm flows, as the stream steepens through this valley pinch point. A monumented cross-section (Station 33029)

**Rip-rap along Route 6, left**

documents an increase in channel slope to 1.54%, and the bed material becomes dominated by gravel here, indicating a transition to this 1108 ft. reach of C4 stream type. The stability of the C4 stream type is very dependent on the stabilizing influence of riparian vegetation, and interplanting of the revetment here is recommended to improve buffer functions, increase the longevity of the rip-rap and improve fish habitat in this reach.

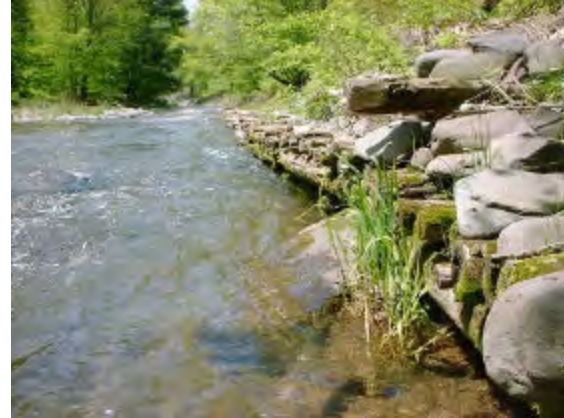
**Crib wall of log and rock, right**

A 24" culvert carrying road drainage enters from the left, with a stacked headwall in stable condition and good outfall protection. Just downstream, remnants of log and rock crib wall, still partly functional, protect the terrace bank on the right (see Insert F, Fig. 4.9.2).

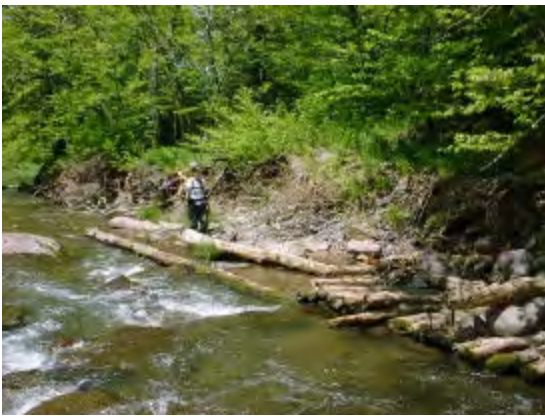
**Erosion at downstream end of crib wall**

Proceeding downstream, a 115 ft. section of the terrace bank is experiencing minor erosion at the downstream end of the log cribbing on the right. This erosion is exacerbated, if not directly caused, by streambed aggradation resulting from backwater at the bridge downstream (Inset B, Figure 4.9.2). The site was not significant enough to be monumented as a Bank Erosion Monitoring Site. A small stand of Japanese knotweed was observed on the left bank.

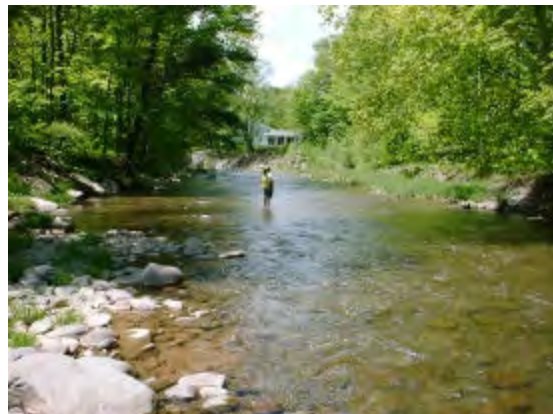
A monumented cross-section here (Station 32476) documents a decrease in channel slope to 0.67%, but the bed material remains dominated by gravel, indicating a continuation of the C4 stream type. Aggradation continues through this reach; backwatering of flood flows at the Greene County Route 6 bridge crossing is caused as much here by *form roughness*, created by the hard bend of the channel to the left just upstream of the bridge, as by an undersized opening at the bridge. The aggradation ends at a steep riffle heading into the bridge opening.

**Aggradation from bridge backwater**

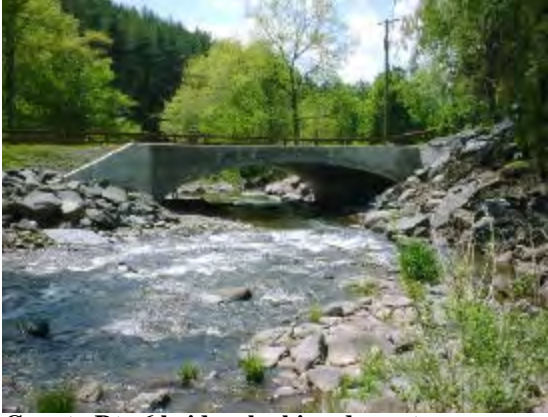
County Rte 6 bridge, looking downstream

While the relatively new Greene County Route 6 bridge (Insets A and E, Figure 4.9.2) passes bankfull flows readily, larger flows are constricted by the structure. Gravel deposits upstream of bridges are commonly caused by inadequate sizing of the bridge opening. An undersized bridge opening causes water to back up upstream of the bridge, reducing stream velocity, which results in sediment deposition. In high stage, the floodwater may seek conveyance through alternative paths, forming new channels around the bridge constriction, as appears to happen occasionally at this site. Additional *floodplain drainage*, using culverts set at the floodplain elevation under the east bridge approach, may help mitigate this problem. The upstream abutments are protected by formed concrete wingwalls and rip-rap on both the right and left.
