# West Kill Management Unit 12

## Management Unit 12

Between Station 26957 and Station 23489

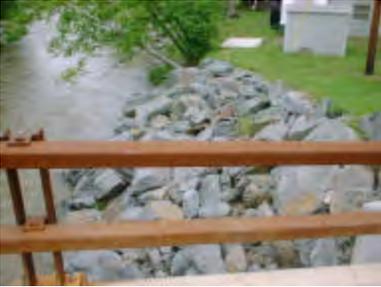
**Rip-rap, right, looking downstream**

The bridge at Shoemaker road has poured concrete abutments protected on the right, both upstream and downstream, by large rip-rap. The rip-rap appears relatively new and is in good condition. The left abutment is poured on bedrock, and has no additional scour protection.

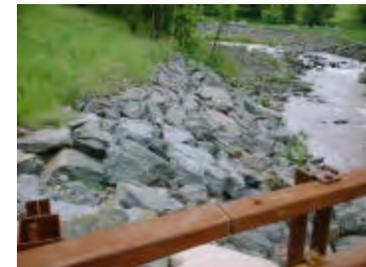
**Rip-rap, right, looking upstream**

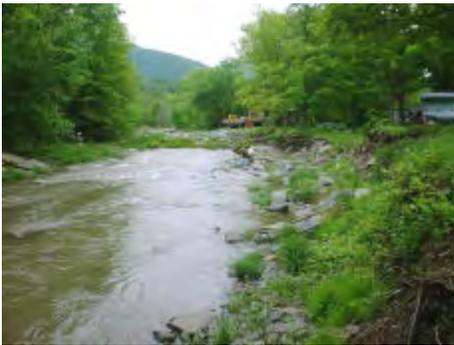
**Bank erosion, right**

Bank erosion is evident starting immediately downstream of the rip-rap, and extending 303 ft. This erosion threatens three residential structures situated not more than twenty feet from the top of the bank. This bank is introducing moderate amounts of woody debris to the system, as mature trees on the terrace are undercut and fall into the channel. This erosion has been monumented as a Bank Erosion Monitoring Site (BEMS Station 12-26669). In a prioritization of twenty-one BEMS sites throughout the West Kill watershed (see

Section 3.3, Watershed Inventory and Assessment), this site ranked Medium Priority. The *thalweg*, or deepest part of the stream channel flows up against the terrace here. The terrace is being undermined by toe erosion, leaving sections of the stream bank unvegetated. *Exposed lacustrine clay* deposits found here have a high silt and clay content, contributing sediment through both *wet and dry ravel* and yielding a significant suspended sediment load during high flows. Clay inputs into a stream are a serious water quality concern because they increase *turbidity*, degrade fish habitat, and can act as a carrier for other pollutants and pathogens. A tree, fallen from the eroded terrace, forms a woody debris blockage. The tree presents an obstruction at all flows.

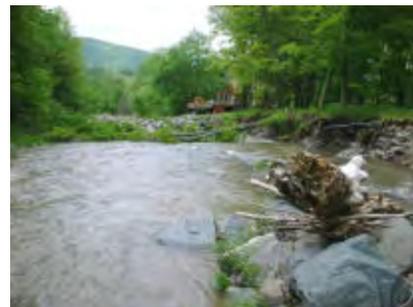
**Debris Jam**

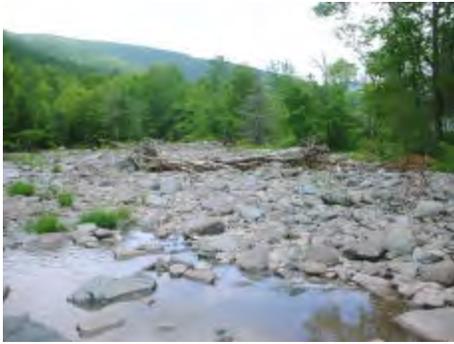
**Debris Jam**

As the channel becomes more connected with its flood plain, point bars are apparent, indicating a transition to C type stream. A second debris jam is located approximately 200 feet downstream of the erosion on the right point bar. The debris presents no obstruction at low flow, appears loose and floatable, and is likely to be mobilized in future flows (see Inset H, Fig. 4.12.2). This area, from the Shoemaker Road bridge to Station 26200, has been restored as a component of Demonstration Project #1 (see Section 5, West Kill Stream Restoration Demonstration Project).

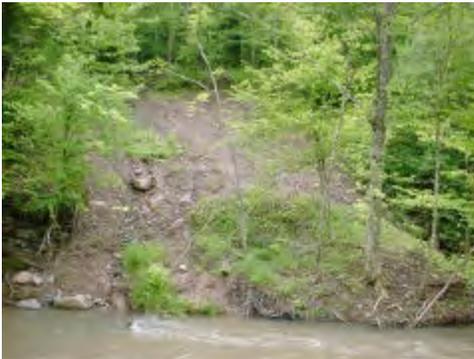
**Bank Erosion, right**

As the channel meanders to the right against the bedrock left bank, a landslide slumps over a bedrock toe. This surficial slide appears to be triggered by upland drainage issues. The slope is composed of high clay content glacial tills (Inset G, Fig. 4.12.2). This erosion has been monumented as a Bank Erosion Monitoring Site (BEMS Station 12-25688). In a prioritization of twenty-one BEMS sites throughout the West Kill watershed (see Section 3.3, Watershed Inventory and Assessment), this site ranked Medium Priority. Recommendations for this site include investigation of the drainage issues resulting in the slide.

There are two Bank Erosion Monitoring sites in MU12 (BEMS 12-26669 and 12-25688). The first has been treated as part of the West Kill Demonstration Restoration Project #1. Investigation of the drainage issues causing the landslide at the second site is recommended.

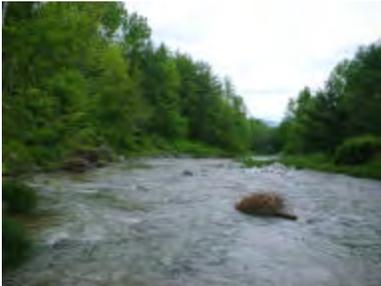
**Bank Erosion, left**

A 275 ft. length of eroded bank begins immediately downstream of the bedrock. The slope failure also appears to be associated with upland drainage issues, and the slide introduces moderate amounts of woody debris to the system. The bank has a high clay content, and appears to be active, as areas of thick herbaceous vegetation are interlaced with exposures of fresh, bare earth. This site was not monumented as a Bank Erosion Monitoring Site.

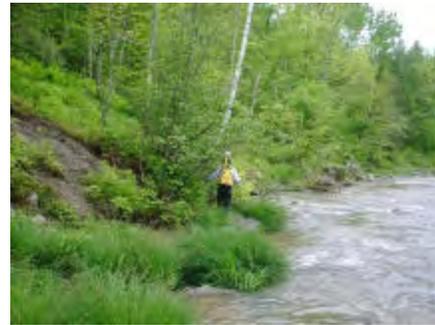
**Bank Erosion, left**

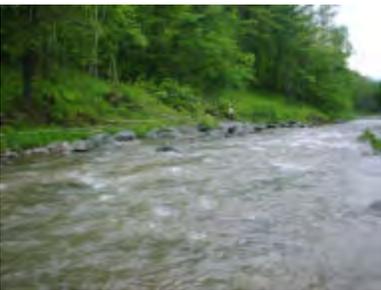
**Rip-rap**

The downstream extent of the bank erosion has had rip-rap installed at the toe. The rip-rap is in poor condition, and the landslide persists despite the stabilization effort.

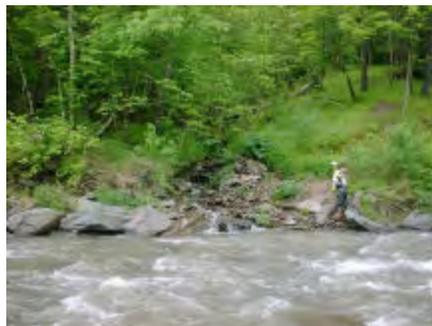
As the erosion ends, an unnamed tributary flows over the rip-rap on the left. The tributary channel is steep, entrenched, but well vegetated. Heavy debris and sediment noted in the channel suggest that a headcut may be actively migrating in this tributary.

**Tributary, left**

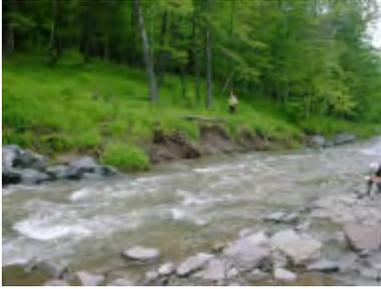
**Bank erosion, left**

As the long rip-rap installation comes to an end, more erosion is evident on the left bank. The bank appears to be mass wasting, with clay rich materials slumping from high on the relatively low gradient, well vegetated bank. Toe scour exacerbates the geotechnical failure mechanisms. This site was not monumented as a Bank Erosion Monitoring Site.

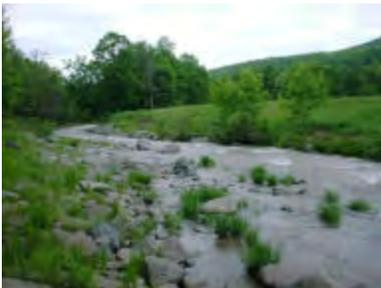
A rip-rap installation begins near station 25175 on the right bank, and extends downstream approximately 425 ft. The bank has dense herbaceous vegetation, but very little woody vegetation. A pasture beyond the rip-rap is mown to the edge of the bank, leaving no forest buffer between the pasture and the stream. The risk to bank stability can be minimized by maintaining mature trees along the stream margin, including a critical buffer zone extending approximately 75 ft. from the centerline of the stream. The risks and benefits associated with management of

**Rip-rap, right**

streamside vegetation will depend partly on the current channel conditions, and local channel surveys are recommended at each site. Recommendations for this area include interplanting of the rip-rap, and enhancement of the riparian buffer with planting of ecologically appropriate tree and shrub species in the adjacent mown field. The vegetative treatments will extend the longevity of the rip-rap installation, enhance the function of the riparian buffer, and improve fish habitat in this reach.

One area that presents opportunities for riparian buffer enhancement lies between stations 25200 and 24700. The right bank here is rip-rapped and the pasture beyond the rip-rap is mowed to the edge of the field, leaving no buffer between the pasture and the channel. Recommendations for this site include planting native trees and shrubs along the edge of the stream bank and the upland area. Buffer width should be increased by the greatest amount agreeable to the landowners, but increasing the buffer width by at least 35 feet will increase the buffer functionality and improve stream bank stability while still allowing a significant pasture area.

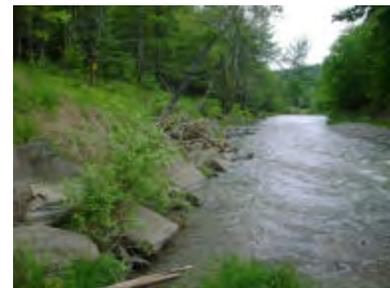
Another rip-rap installation begins near station 24790 on the left bank. This 215 ft. long treatment offers toe protection to the bank, is in fair condition, and is becoming intergrown with willow, which should further stabilize the site.

**Rip-rap, left**

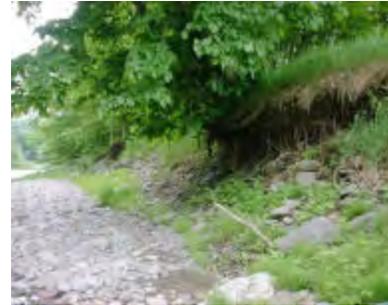
The height of the right bank increases through this reach. As the channel becomes more entrenched, indicating transition to F type stream, erosion is evident on the right bank. A sizable gravel bar has formed at the toe, minimizing near bank shear-stress. This bank appears to be trending toward recovery. A large basswood tree, however, remains undercut at the top of the bank. Clay-rich glacial till lies along the toe of this entire bank (Inset C, Fig. 4.12.2). This site was not monumented as a Bank Erosion Monitoring Site.

**Bank Erosion**

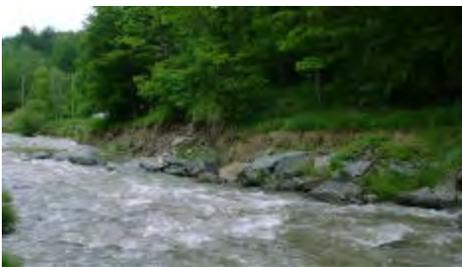
**Riprap**

Rip-rap has been installed along 211 ft. of the right bank near station 24100. The rip-rap protects an abandoned building, setback somewhat on the terrace. Bank erosion behind the rip-rap has compromised the installation and left close to half of the treatment in the active channel, with flow on both the front and back side of

the rock. The rip-rap is in poor condition overall. This site was not monumented as a Bank Erosion Monitoring Site; however the addition of a monumented monitoring station is recommended.

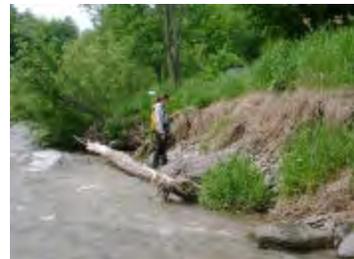
**Debris, right**

quality. Two debris jams were noted in the reach along this rip-rap and erosion.

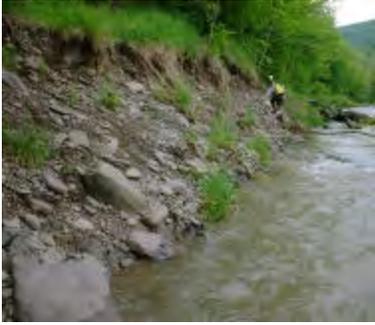
**Bank Erosion, looking upstream**

The erosion at the downstream end of the rip-rap appears to be exacerbated by the flow obstruction created by the damaged rip-rap (see Inset B, Fig. 4.12.2). To monitor the erosion of this streambank it will be added to the BEMS sites. The toe of this erosion is composed of clay rich glacial till, posing a threat to water

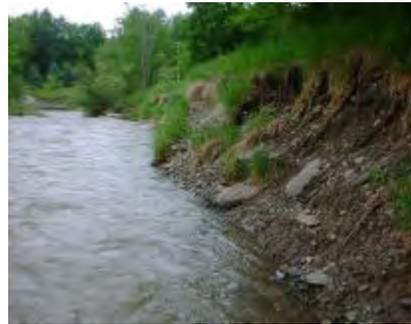
**Bank Erosion, looking downstream**

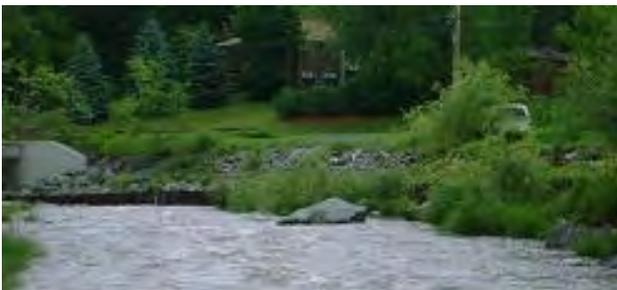
**Rip-rap, upstream of bridge**

rapped upper banks. The treatment extends both up and downstream of the bridge, and appears fairly new and in good condition. Riparian vegetation, however, is non-existent. Recommendations here include interplanting of the rip-rap, using ecologically appropriate tree and shrub species. The vegetative treatments will enhance the function of the riparian buffer, and improve fish habitat in this reach.

As the channel makes a sharp bend to the left on its approach to the Long Road Bridge, the right bank is heavily armored with a sheet pile toe and rip-

This treatment will also be beneficial at the Long Road bridge approach.

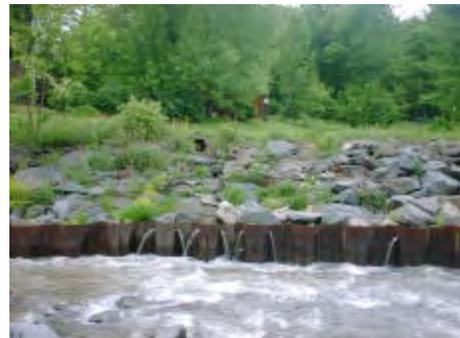
Two culverts convey drainage under County Route 6, and outfall onto the riprap (see Inset A, Fig. 4.12.2). One of the culverts conveys road drainage, and the other conveys an unnamed tributary. The culverts are perched, but have ample outfall protection.

**Culvert**
