West Kill Management Unit 13

Management Unit 13
Between Station 23489 and Station 20415

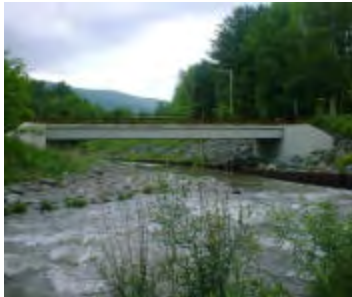
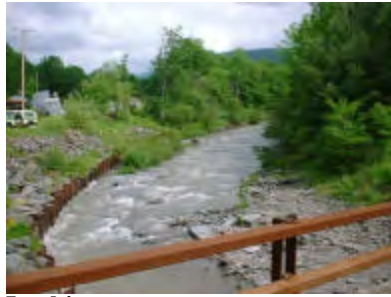
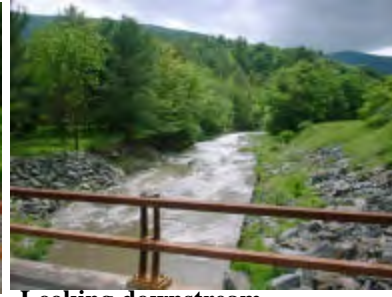
The Long Road bridge marks the start of Management Unit 13. This bridge appears new and is in excellent condition. The span of this bridge is adequate to pass relatively high flows without channel constriction, but the channel meander just upstream of the bridge creates form roughness resulting in significant backwatering (Inset D, Fig. 4.13.2)

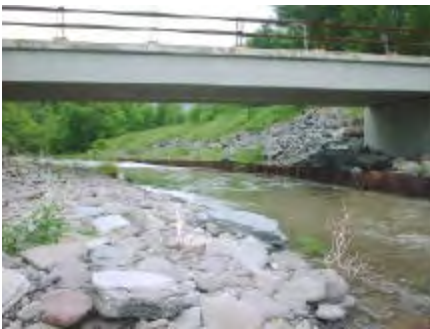
Riprap downstream of bridge, right

The right bank downstream of the bridge is reinforced with steel sheet pile at the toe, and rip-rap to the top of the bank. This treatment extends from above the bridge to approximately 275 ft. downstream of the bridge.

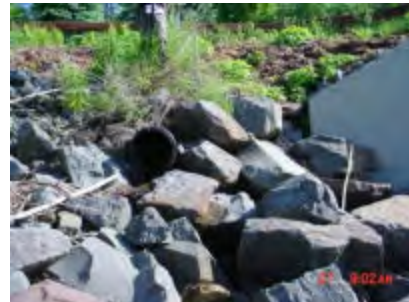
Culvert

A perched culvert near the wing-wall of the bridge conveys road drainage under Greene County Route 6, and outfalls onto the rip-rap.

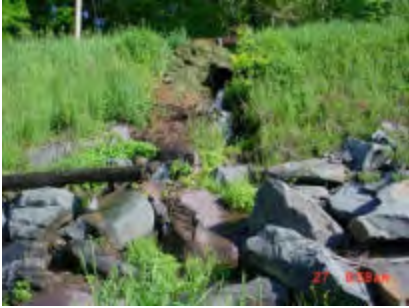
Culvert

A second culvert under Greene County Route 6 conveys an unnamed tributary, and also outfalls onto the rip-rap.

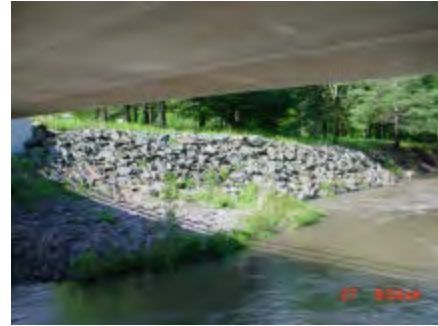
Rip rap

The left bank downstream of the bridge is also rip-rapped for a distance of approximately 130 ft. The rip-rap appears to be new and is in good condition, however, the size of the stone is rather small for this setting.

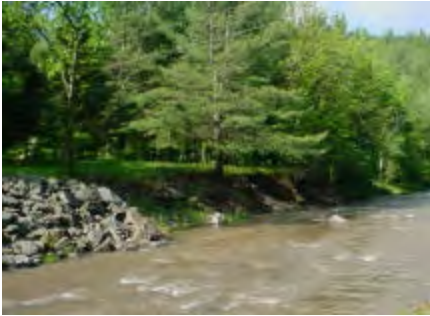
Bank Erosion

Immediately downstream of the rip-rapped left bank, 128 ft. of bank erosion is observed. Riparian forest at the top of the bank may become threatened by continued erosion. A clay exposure at the toe of this bank is the first of five significant clay exposures identified between stations 23300 and 22900

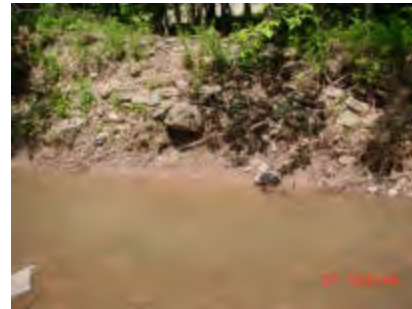
Clay Exposure

(See Also Inset H, Fig. 4.13.2). Clay inputs into a stream are a serious water quality concern because they increase *turbidity*, degrade fish habitat, and can act as a carrier for other pollutants and pathogens.

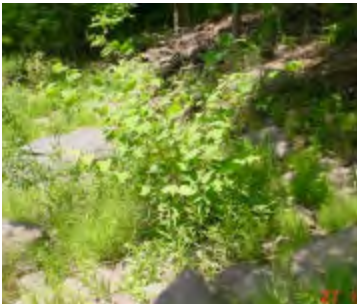
Knotweed

During the 2004 and 2005 inventory, one stand of Japanese knotweed (*Fallopia japonica*), an invasive, exotic shrub species that can grow rapidly to crowd out more beneficial streamside vegetation, was observed here on the right bank. A program for eradication of Japanese knotweed throughout the West Kill valley is recommended. Just downstream of the knotweed, a monumented cross-section (Station 23131) verifies the F3 stream type.

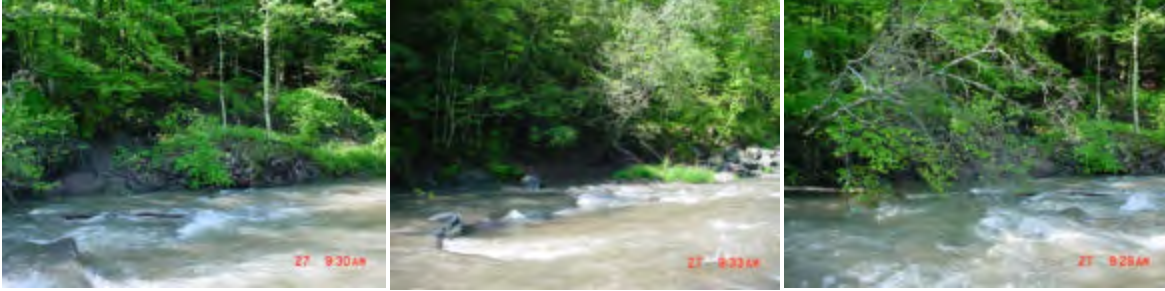
Bank erosion, left

Immediately downstream of the tributary confluence, bank erosion is active on the left bank. This 148 ft. long slump failure has very high glacial till content. Two of the lacustrine clay exposures, mentioned above, lie at the toe of this failure. This failure has potential for significant woody debris introduction as sliding persists despite thick vegetation and root mat.

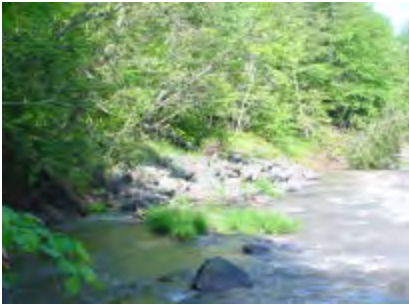
Rip-rap, left

Rip-rap has been installed for 103 ft. just downstream of the erosion, and is bounded on the downstream end by erosion as well. The rip-rap is intended to protect the toe of the slumping bank. The installation appears new, adequately sized, and in good condition.

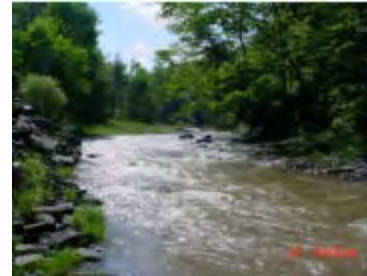
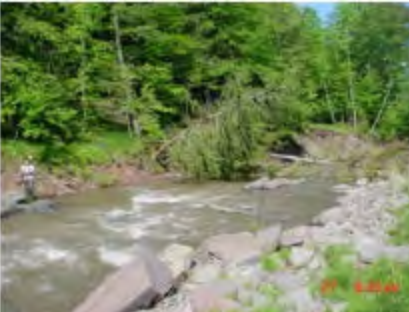
Bank erosion, left

Down stream of the rip-rap, erosion continues for an additional 292 ft. The slump failure transitions to surficial terrace erosion. Clay rich glacial till is observed at the toe along the entire length of failure. This failure experiences extreme near bank stress,

introduces excessive debris load, and has very low recovery potential (see Inset G, Fig. 4.13.2). This bank was significant enough to warrant detailed investigation as a Bank Erosion Monitoring Site (BEMS #12-22596). In a prioritization of twenty-one BEMS sites, throughout the West Kill watershed (see Section 3.3, Watershed Inventory and Assessment), this site ranked Medium Priority.

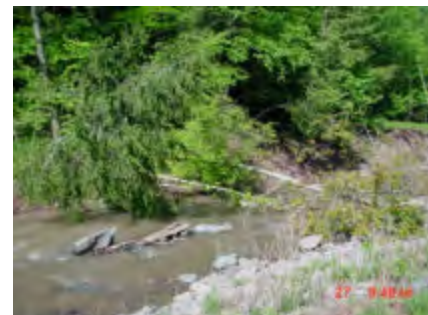
Debris Jam

A debris jam along this bank is evidence of the high volume of debris being introduced as a result of the undercutting of mature trees at the top of the bank. These trees span the channel, but create an obstruction at high flow (see Inset G, Fig. 4.13.2).

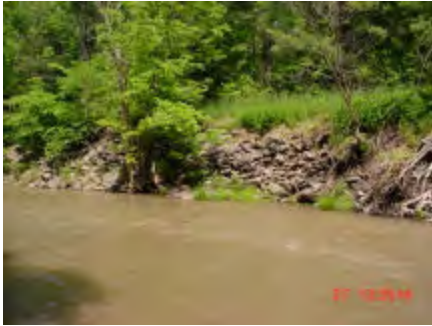
Log Cribbing

As the channel again flows adjacent to Greene County Route 6, remnants of log cribbing in very poor condition are observed along approximately 335 ft. of the right bank.

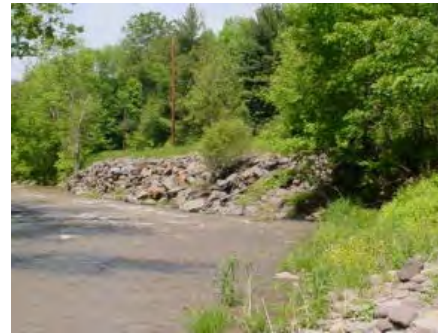
Riprap, right

Rip-rap on the right bank has been installed to replace the center portion of the failing log

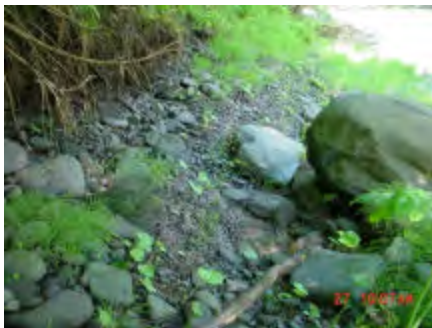
Clay exposure, left

A glacial till exposure was documented on the left bank opposite the rip-rap. It is located at the toe of old healed erosion, with a lateral bar formed between the low flow channel and the exposure.

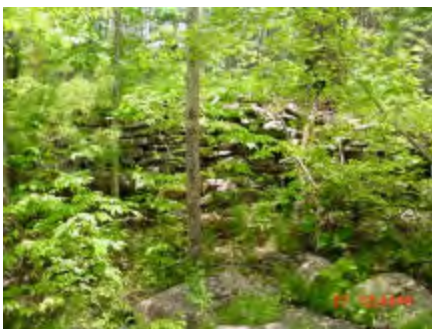
Stacked Rock

A stacked rock wall stabilizes the road embankment just downstream of the tributary. The installation is old, and in poor condition. A narrow but well vegetated bench has formed at the toe of the stone wall.

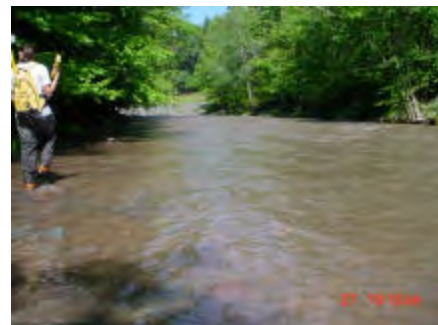
Aggradation is noted immediately upstream of a significantly modified reach of channel. Gravel deposition, as seen here, is an expected channel response to marked changes in dimension, pattern, profile or roughness.

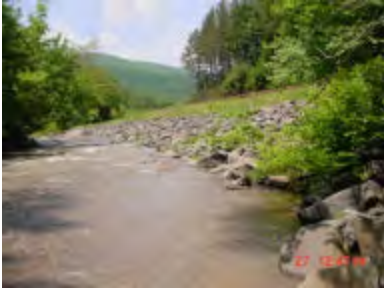
Rip-rap

In this case, rip-rap installed to stabilize Greene County Route 6 has modified the channel dimension, profile and roughness.

Damage to County Route 6 in 1996 and 1999 prompted rip-rapping of the entire channel cross-section along 450 ft. of the West Kill (Inset C, Fig. 4.13.2). The resulting channel has a reduced channel width and slope, and increased roughness, all contributing to a backwater

condition in the reach immediately upstream. As a result, flow depths through the treatment during high flows were significantly increased, triggering a headcut at the outfall of the treatment. As the headcut migrates with future flow events, it is likely to destabilize the project, and threaten Greene County Route 6 once again. The coarse rock material used to line the channel also resulted in subsurface flow through the treatment during dry periods, forming a migration barrier and virtually eliminating aquatic habitat. Recommendations for this area include restoration of appropriate channel dimensions and slope, while not compromising the integrity of the structural measures installed to stabilize the adjacent roadway. Finer material should be applied to the channel to fill voids in the coarse rip-rap, and to promote surface flow through the treatment during low flows. Interplanting of the rip-rapped road embankment to enhance the longevity, aesthetic quality, habitat value and buffering capacity of the treatment is recommended.

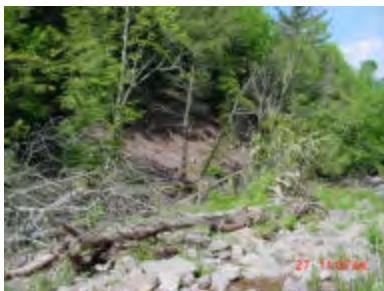
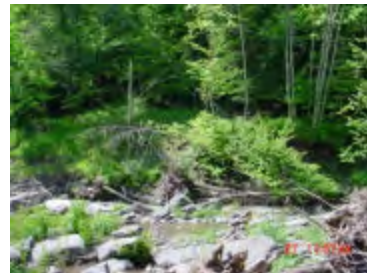
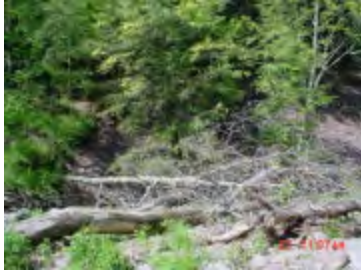
Bank erosion, left

Along the outside of a bend back to the right, 474 ft. of extreme bank failure (see Inset E, Fig. 4.13.2) has been monumented as a Bank Erosion Monitoring Site (BEMS Station 13-21106). In a prioritization of twenty-one BEMS sites throughout the West Kill watershed (see Section 3.3, Watershed Inventory and Assessment), this site ranked High Priority, and rated as the second most severe erosion site in the West Kill watershed. The *thalweg*, or deepest part of the stream channel flows up against the glacial terrace here. The hillslope is being undermined by toe erosion, leaving large sections of the high bank unvegetated. The *exposed ice contact deposits* and *lacustrine* soils have a high silt and clay content, contributing sediment through both *wet and dry ravel* and yielding a significant suspended sediment load during high

flows. The high volume of clay inputs into the stream from this site are a water quality concern, increasing *turbidity*, degrading fish habitat, and acting as a carrier for other pollutants and pathogens.

Full restoration is recommended for this site. This would likely involve establishment of a well-vegetated bench on the right with rock vanes to direct stream flows away from the left bank, and revegetation of the bank face. Geotechnical assessment, in-depth survey and design would be required to plan a stream restoration project at

this site. A comprehensive engineer's report, West Kill Flood Mitigation Project, was prepared for this site, and is available at the Greene County Soil and Water Conservation District.

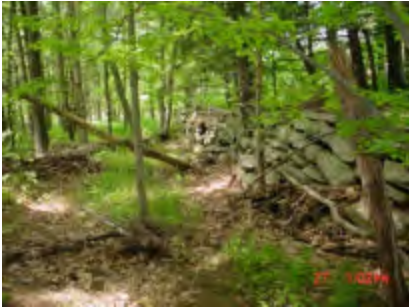
Stacked Rock Wall

Proceeding downstream, set back on the bankfull bench on the right, 96 ft. of stacked rock wall retains the Greene County Route 6 embankment. The wall is in good condition. A forested buffer separates the wall from the channel, and debris on the bench suggests frequent inundation.

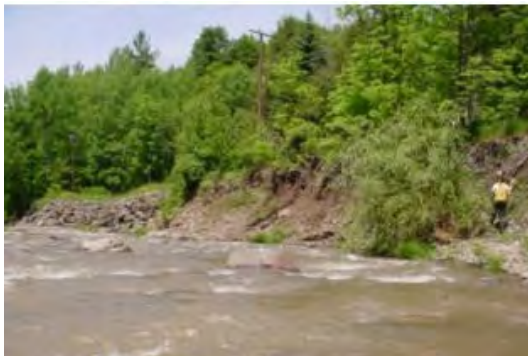
Bank erosion, right

As the channel straightens, 190 ft. of erosion is observed on the right bank where a section of the stacked rock wall has been undermined by toe scour, leaving the bank largely unvegetated. This was not monumented as a Bank Erosion Monitoring Site.

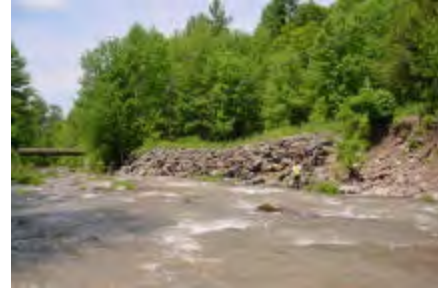
Stacked rock wall, right

Downstream of the erosion, 178 ft. of stacked rock wall retain Greene County Route 6. There is no buffer between the bank and the road. Recommendations here include replacement of the lost revetment and planting of a riparian buffer using ecologically appropriate tree and shrub species between the road and the top of bank to enhance the function of the buffer, and improve fish habitat in this reach.

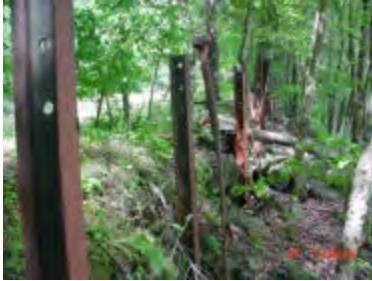
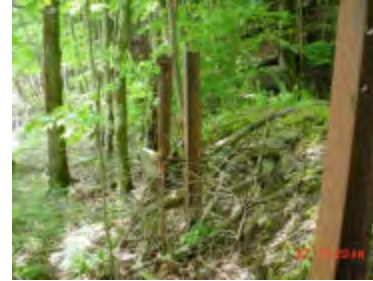
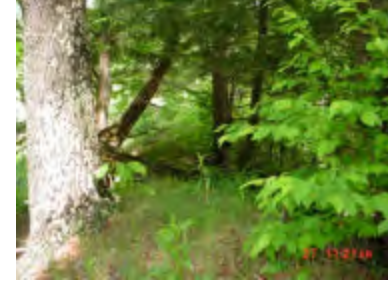
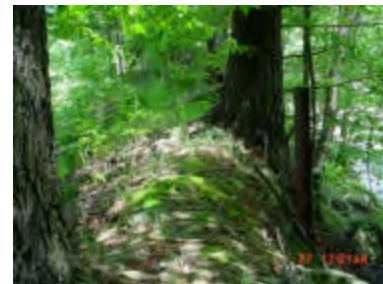
Berm, left

Continuing downstream, an earthen berm was documented on the left. Sections of the berm have been retrofitted with flashboards mounted on salvaged rail road track stanchions, of which only remnants remain. A pond behind was noted behind the berm. Berms such as this, while created with the best of intentions, tend to raise flood elevations and increase the erosive power of the stream. It is recommended that the berms should be evaluated for their influence on floodplain connectivity and stream entrenchment, and that removal should be considered where there is significant deleterious impact.

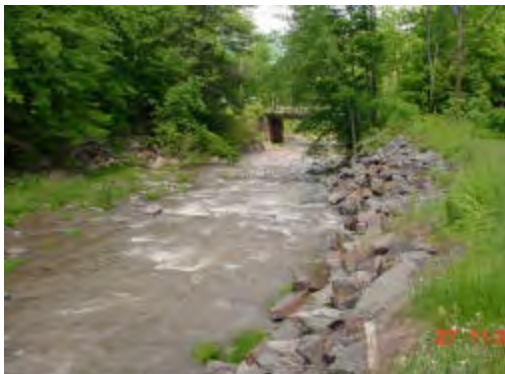
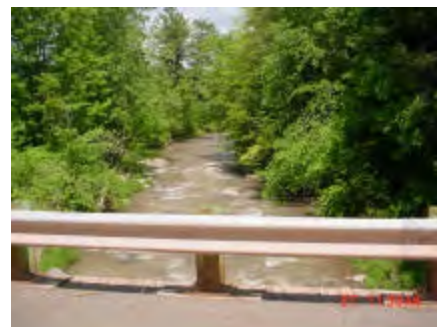
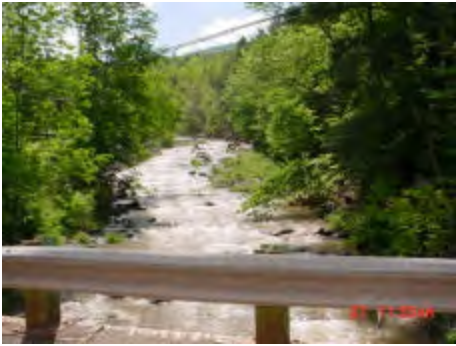
Greene County Route 6 bridge

Management Unit 13 ends at the Greene County Route 6 bridge. The berm concentrates flood velocities on the bridge and inhibits flooding around, and increases stress on, the bridge. These conditions could threaten the stability of the bridge.

This bridge is scheduled for replacement. Recommendations for this site include coordination with the Greene County Highway Department to integrate replacement of the bridge into a comprehensive restoration, as proposed in the West Kill Flood Mitigation Project report, mentioned above.
