# West Kill Management Unit 16

**Management Unit 16**  
Between Station 16010 and Station 14742

**Management Unit Description**

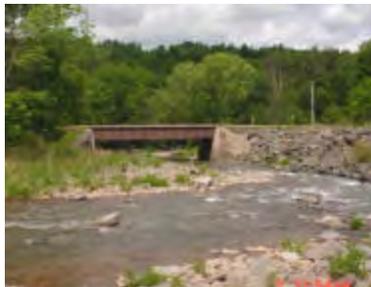
**NYS Route 42 bridge**

NYS Route 42 bridge (Inset D, Fig. 4.16.2) marks the upstream limit of Management Unit 16. The alignment of this bridge is poor, creating a sharp bend to the left as the channel approaches the bridge opening and a sharp bend to the right as the channel departs from the bridge. The sharp bend in combination with poor floodplain drainage through the NYS route 42 road fill results in backwater and aggradation upstream. Recommendations at this site include modification of the stream approach to the bridge, and installation of flood plain drains under NYS Route 42.

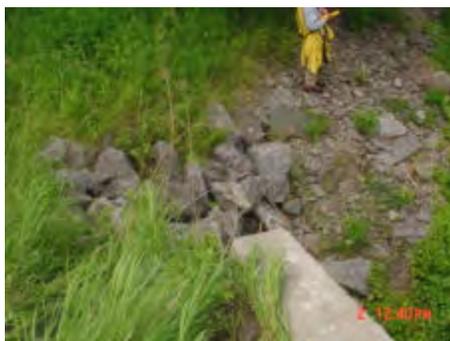
**Riprap, left and right**

Downstream of the bridge, a short (23 ft.) installation of rip rap lies on the left bank, providing nominal scour protection to the bridge abutment. Rip-rap is also found on the right bank, extending from Management Unit 15, protecting the right bridge abutment.

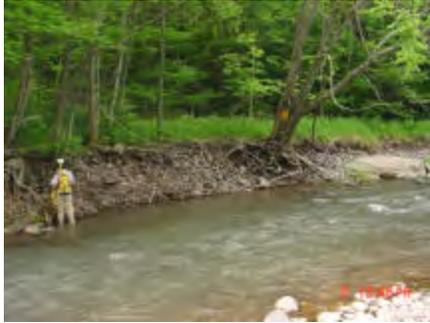
**Bank erosion, left**

Erosion begins as the cribbing ends, and continues for 38 ft. along the left bank. The erosion is fairly minor, but is actively undermining mature trees on the terrace. This erosion was not monumented as a Bank Erosion Monitoring Site.

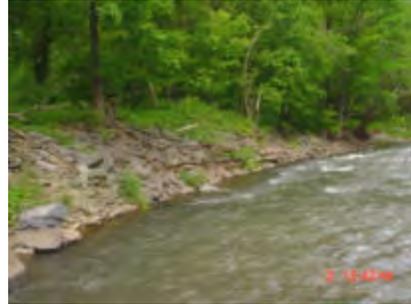
**Log cribbing, left**

Remnants of log cribbing (Inset H, Fig. 4.16.2) are noted along 111 ft. of the left bank, starting near Station 15920. The revetment is in very poor condition, with only a few logs and the cobble backfill remaining.

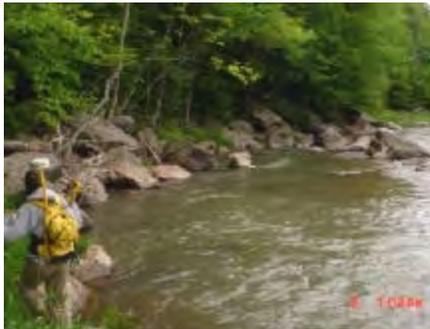
**Rip-rap, left**

Rip-rap (Inset G, Fig. 4.16.2) is installed along 237 ft. of the left bank, starting immediately downstream of the tributary. The treatment is extremely old, and appears to be made

of native stone collected from adjacent uplands. A gravel road lies on the terrace beyond the rip-rap.

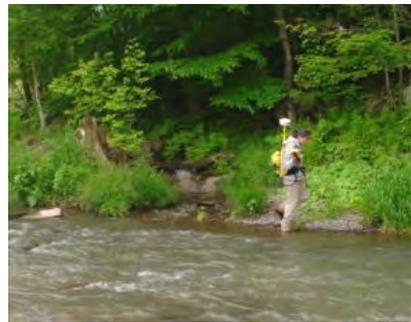
**Tributary, left**

An unnamed tributary joins the West Kill from the left near Station 15720. The mouth of the tributary is well connected and densely vegetated.

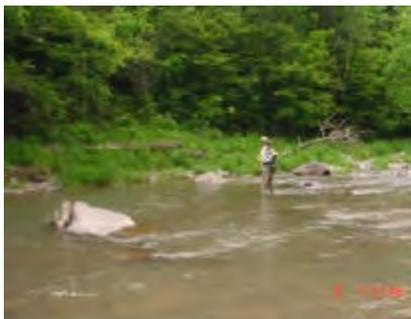
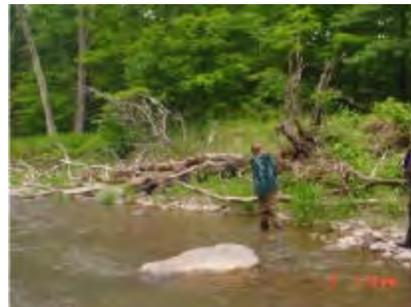
**Debris jam**

A debris jam is found near Station 15470. Large woody debris lies at stream left and right. The logs are aligned parallel to flow, against the banks, creating a minimal obstruction, and providing some measure of bank protection.

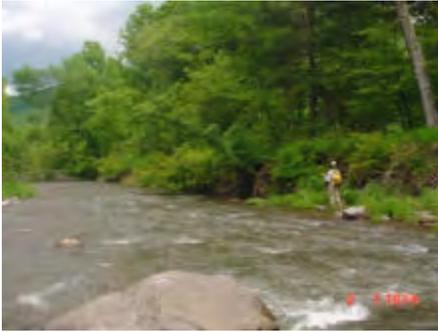
**Bank erosion, right**

Bank erosion (Inset C, Fig. 4.16.2) begins on the right bank near Station 15425, extending 416 ft. downstream. Dense shrubby vegetation obscures the near-vertical bank face. Woody vegetation on the terrace is undercut, and becoming entrained as debris load. The riparian buffer beyond the erosion consists of a narrow strip of shrub and herbaceous vegetation, giving way to lawn just a few feet from the top of the bank. Erosion of the right bank has been

(BEMS Station 16-15177). In a prioritization of twenty-one BEMS sites throughout the West Kill watershed (see Section 3.3, Watershed Inventory and Assessment), this site ranked Low Priority. Vegetative toe treatments are recommended for this site to improve bank stability and reduce sediment yield resulting in aggradation downstream. Riparian buffer enhancement is recommended for the lawn area at the top of the terrace. The risk to bank stability can be minimized by maintaining mature trees along the stream margin, including a critical buffer zone extending approximately 75 ft. from the centerline of the stream (Fig. 4.16.4).

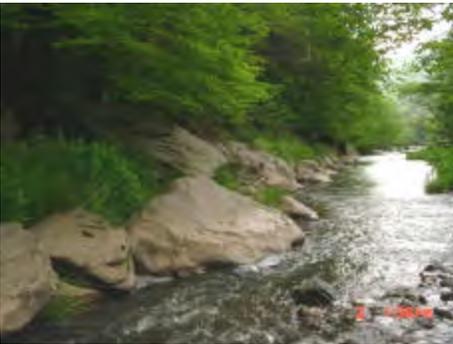
**Rip Rap, left**

Rip-rap (Inset F, Fig.4.16.2) has again been installed to protect 208 ft. of the left bank at the toe of the embankment of the gravel road. The rip-rap is very old, but in good condition.

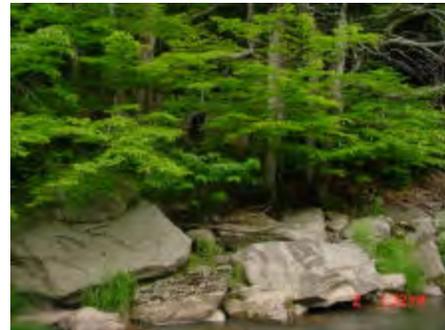
**Culvert, left**

A culvert drains the gravel road and outfalls onto the rip-rap. The culvert is perched, but the rip-rap provides adequate outfall protection.

During the 2004 inventory, one stand of Japanese knotweed (*Fallopia japonica*), an invasive, exotic shrub species that can grow rapidly to crowd out more appropriate streamside vegetation, was observed at the outfall of the culvert. A program for eradication of Japanese knotweed throughout the West Kill valley is recommended.

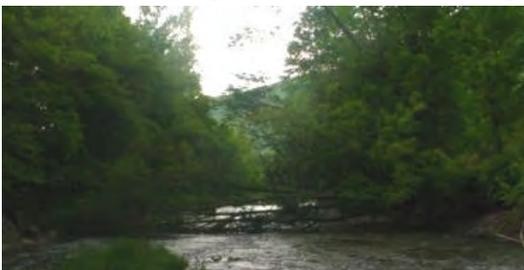
**Debris Jam**

Trees fallen from the undercut right bank form a debris jam at the downstream end of the rip-rap. The trees create a flow obstruction throughout the range of flows, and are promoting scour of the left bank downstream of the rip-rap.

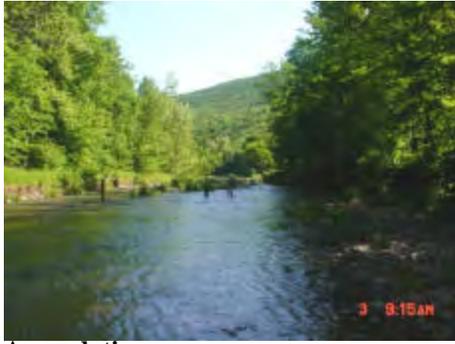
**Aggradation**

Aggradation (Inset E, Fig. 4.16.2) is apparent downstream of the eroded right bank. The aggradation results in cutting at the left and right banks, entraining small amounts of debris. The aggradation is likely to be associated with excess sediment load supplied by the eroding bank. In stream plantings of ecologically appropriate shrub and herbaceous species is recommended for this site, in combination with reduction of local sediment inputs, to promote development of a narrower, deeper bankfull channel with the capacity to convey the delivered sediment.

Extensive terrace erosion in middle reaches of the unit results in active aggradation in the downstream reaches of the unit. Erosion active along the aggradational reaches is unlikely to self-correct as toe scour will persist while the channel widens. In stream plantings are recommended to promote a more efficient sediment transport condition.

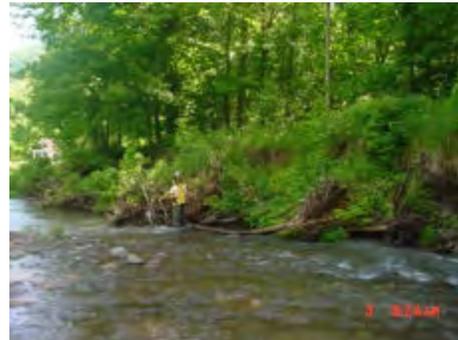
**Debris Jam, right**

As the channel becomes more connected with the terraces at the left and right, erosion compromises 227 ft. of the right bank. Woody vegetation is being undermined and falling into the stream from the top of the terrace, resulting in another debris jam (Inset A, Fig. 4.16.2) formed at the downstream end of the erosion.

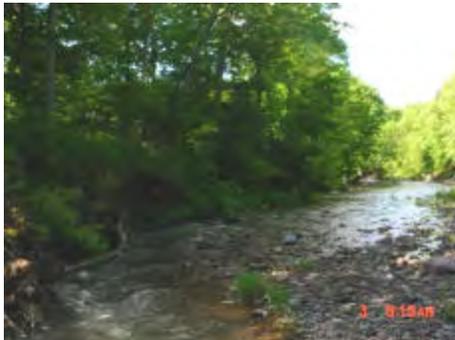
**Bank Erosion, right, looking upstream**

Despite dense, shrubby vegetation on the face of the bank, the recovery potential of this bank is low due to the active aggradational processes here and inadequate width of the buffer on the terrace beyond the erosion. This erosion was not monumented as a Bank Erosion Monitoring Site.
