West Kill Management Unit 18

Stream Feature Statistics

Management Unit 18
Between Station 9304 and Station 7402

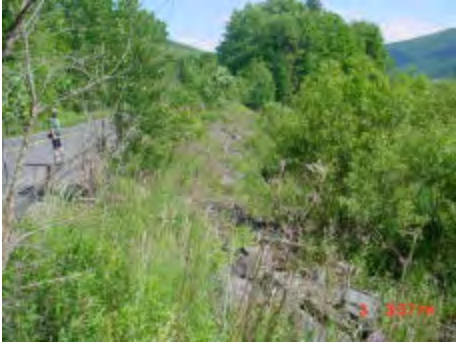
Riprap on road embankment, right

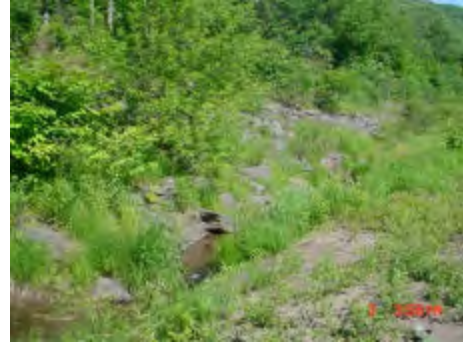
The channel slope is a very flat 0.9 % and the bed material is dominated by cobble. The multiple mid-channel bars upstream converge into a single point bar, with the main channel on the left, and a small overflow backchannel on the right at the toe of the 612 ft. long rip-rapped embankment of the highway.

Riprap on road embankment, right

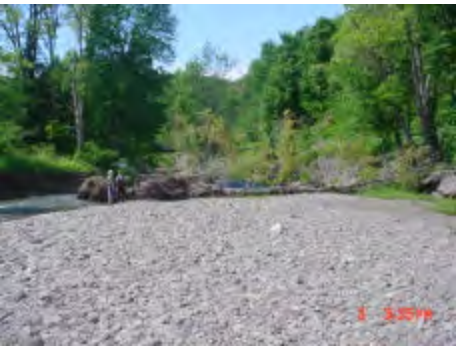
Debris Jam

Large woody debris —large trees with root balls— has collected on this unvegetated bar upstream of the bridge, presenting an obstruction at all flows and adding to the aggradation caused by backwatering at the bridge.

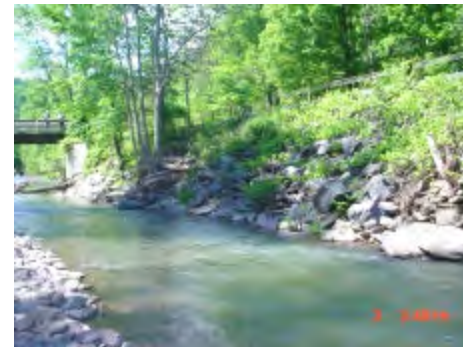
Stacked Rock

The *thalweg*, or deepest part of the channel, bends to the right around this bar, and then flows against the toe of the stacked rock revetment on the road embankment, right (Inset D, Fig. 4.18.2). This 177 ft. of revetment, which extends downstream of the bridge as well, is failing as a result of the toe scour, is in poor condition generally and in need of repair. The rock is undersized, and there is no vegetative buffer between the stream and the road here.

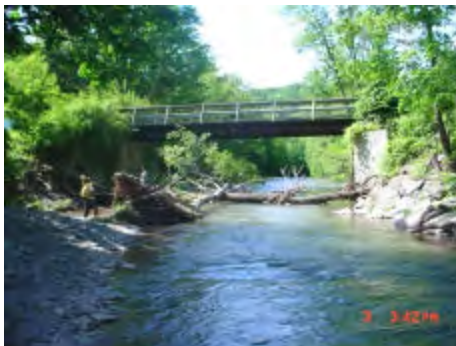
Debris Jam on approach to bridge

Proceeding downstream, more large woody debris has collected, creating an obstruction at all flows directly upstream of the bridge (Inset H, Fig. 4.18.2). These trees, which are likely to accumulate additional material if not removed, represent a potential hazard to the bridge. They are also contributing to significant abutment scour. Removal of this debris is recommended, and the

extent of scour of the abutments should be evaluated.

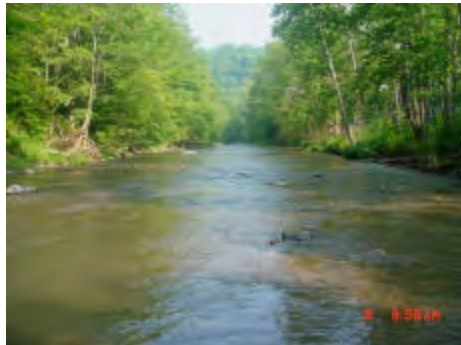
Aggradation downstream of bridge

Downstream of the bridge, the channel appears overwide, perhaps a consequence of channel grading, but apparently stable, despite some aggradation resulting in minor erosion at the base of the road embankment, right (see Insets G and C, Fig.

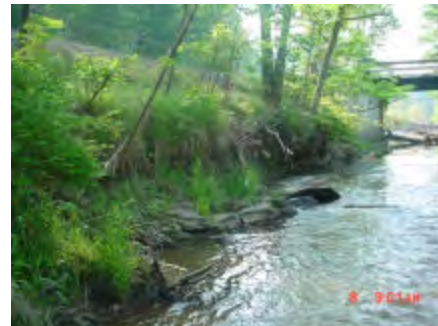
Several trees have been undermined and lay at the channel margin, producing minimal obstruction to flows but creating modest local scour at higher flows. Very little mature vegetation buffers the stream from the roadway, or stabilizes the bank. This site was not monumented as a Bank Erosion Monitoring Site.

Bank erosion, right, looking upstream

Recommendations for the area upstream and downstream of the bridge would include interplanting of the rip-rap, and enhancement of the riparian buffer using ecologically appropriate tree and shrub species. The vegetative treatments will extend the longevity of the rip-rap installation, enhance the function of the riparian buffer, and improve fish habitat in this reach.

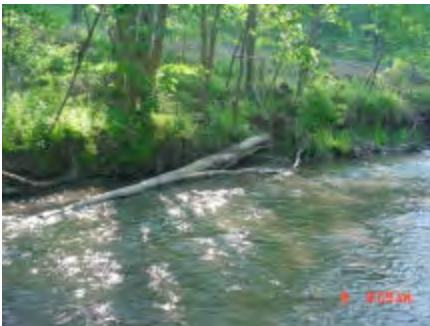
Debris jam

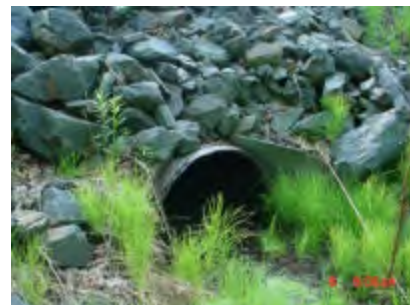
Downstream of this erosion, as the road begins to diverge from the stream, the bank angle moderates and a low floodplain begins to develop on the right. A 24" galvanized culvert on the right, perched and with only vegetative outfall protection and a dumped rip-

Culvert

rap “headwall”, carries a small tributary under NYS Route 42. The tributary flow crosses the narrow floodplain bench, and a significant amount of fine sediment has accumulated at its confluence with the West Kill. Investigation of the source of the sediment is recommended.

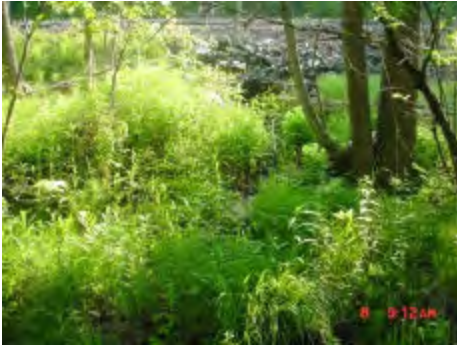
Culvert

Downstream a second culvert carries road drainage from across the highway, and is perched without outfall protection. The mowed field on the left transitions to a mature forest buffer.

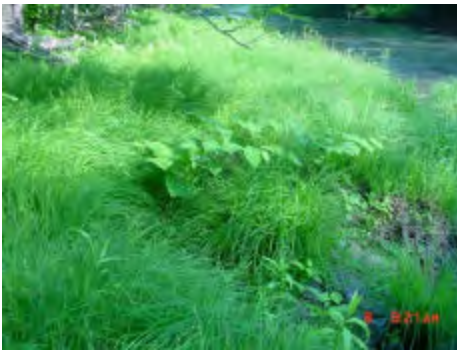
Knotweed

During the 2004 inventory, two stands of Japanese knotweed were documented amongst the sedge at the mouth of this tributary. Japanese knotweed (*Fallopia japonica*) is an invasive, exotic shrub species that can grow rapidly to crowd out more beneficial streamside vegetation, were observed here on the left bank. A program of eradication of Japanese knotweed throughout the West Kill valley is recommended.

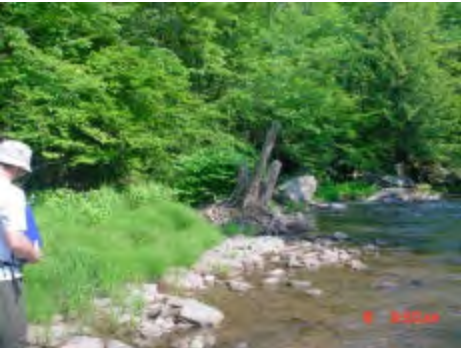
Knotweed

At the end of the unit, a small, isolated stand of Japanese knotweed was observed on the left, on the debris near the tributary confluence.

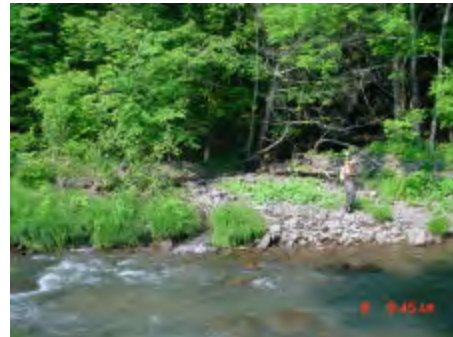
A major tributary, Beach Ridge Brook (1.6 mi.²), confluences on the left, across a well-connected and well-vegetated floodplain. A significant amount of gravel was observed at the mouth, indicating the possibility that the tributary may have recently experienced a headcut.

Beach Ridge Brook confluence, left
