West Kill Management Unit 19

Management Unit 19

Between Station 7402 and Station 4778

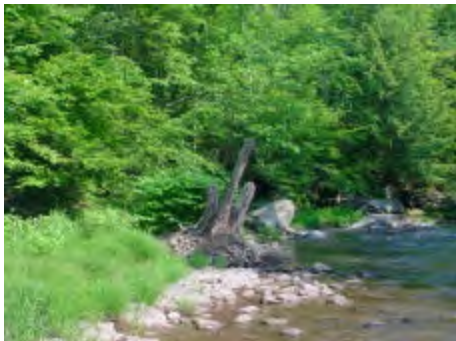
Knotweed on left bench

Management Unit 19 begins as the channel is turned sharply to the right by bedrock in the left bank and bed. The riparian buffer on the left is healthy, but on the right is narrow and somewhat disturbed in the vicinity of the power transformer station. During the 2005 inventory, two stands of Japanese knotweed (*Fallopia japonica*), an invasive, exotic shrub species that can grow rapidly to crowd out more appropriate streamside vegetation, were observed here on right

and left banks, at this bend; by 2005 the number had increased to seven stands. A program of eradication of Japanese knotweed throughout the West Kill valley is recommended. A culvert high on the left bank outfalls over the slope, and carries road drainage from Beech Ridge Road, which meets NYS Route 42 just downstream of the bridge.

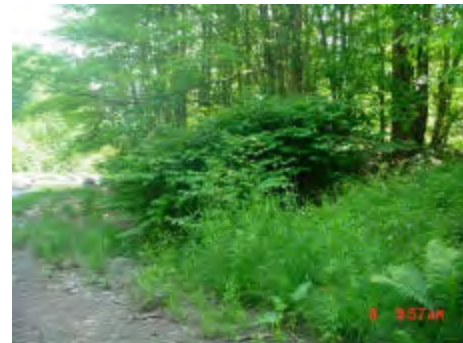
Knotweed stand, right

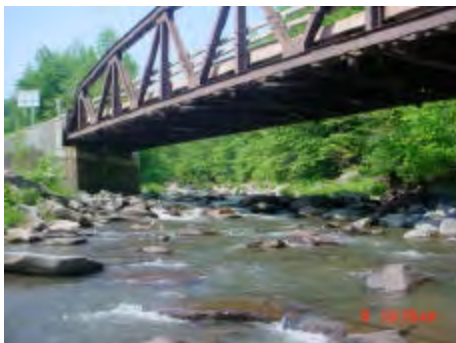
NYS Route 42 bridge, looking upstream

The channel bed is armored with abundant boulders upstream, under and downstream of the NYS Route 42 bridge (#10252000) (see Inset H, Fig. 4.19.2). The abutments and concrete wingwalls are in good condition and despite the skewed angle of the crossing, the span appears sufficient to pass flood flows with little obstruction. There is some evidence of scour on the left and right abutments, and recent addition of dumped rip-rap scour protection on the right. This is the first evidence of possible channel incision in MU19.

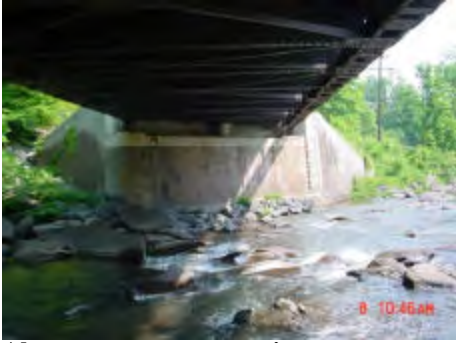
Abutment scour protection

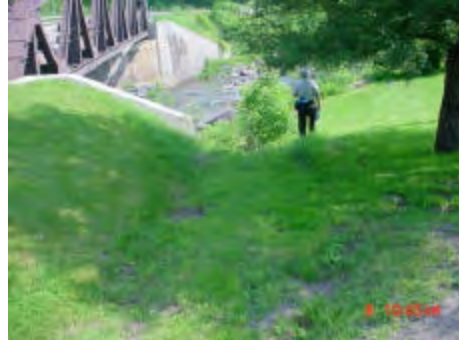
A grassed stormwater swale draining the area around the residence empties into the channel just downstream of the right bridge wingwall. The swale appears to be functioning to trap fine sediment.

Grassed swale at residence

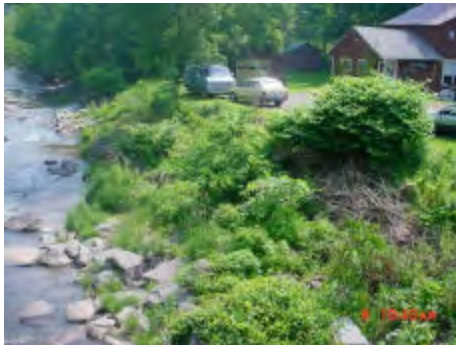
Downstream of the bridge on the right, a residence sits adjacent to the channel on a terrace that confines the channel on the right (see Inset D, Figure 4.19.2). The lawn is mown to the edge of the bank. The terrace bank is covered with a mixture of disturbed herbaceous vegetation and dumped revetment comprised of rock riprap and construction debris. The owner of the residence reports channel incision.

Terrace bank, with Japanese knotweed

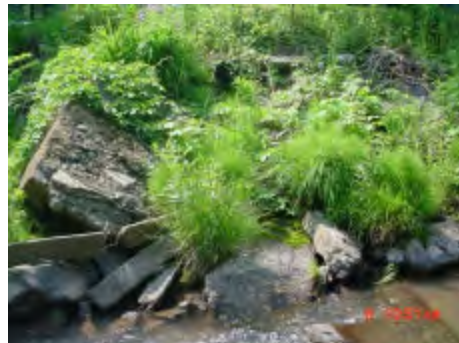
A galvanized culvert, perched, and with no headwall, but with good outfall protection, also drains the residential area on the right.

Culvert outfall over dumped riprap

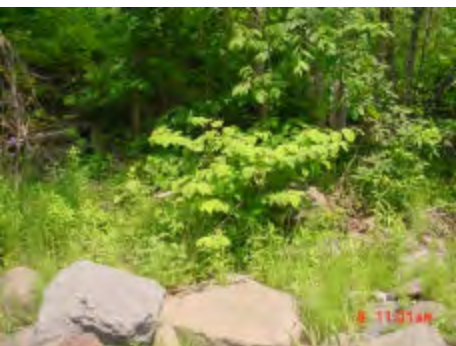
Knotweed, left, on road embankment

Continuing downstream, several additional occurrences of knotweed, on both banks, were observed during the 2004 Stream Feature Inventory; the number of stands observed in the 2005 Inventory had increased notably throughout this unit, especially in the power line right-of-way on the NYS Route 42 road embankment.

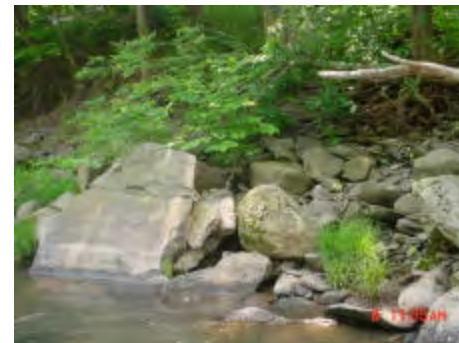
Knotweed, right

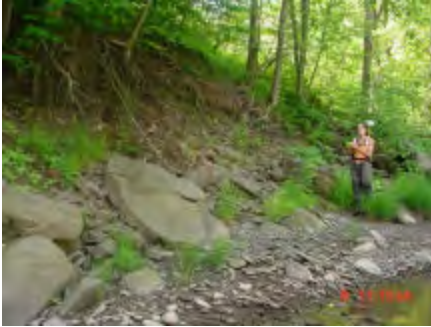
Bank Erosion, left

monumented as a Bank Erosion Monitoring Site, but the second stream morphology classification cross-section runs through this eroding bank. The channel slope here has dropped to 1.1%.

Downstream of the residence, the riparian buffer improves on the right, as the terrace transitions into a continuous hillslope. Minor erosion of this hillslope (77 ft.) was observed. The increased channel confinement here is producing toe scour at higher flows, resulting in the introduction of some trees and clay-rich soil. The site was not

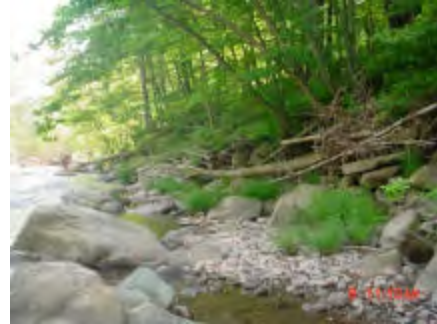
Woody debris at base of slope

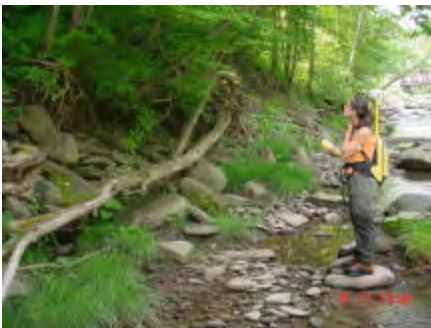
Woody debris along eroding bank

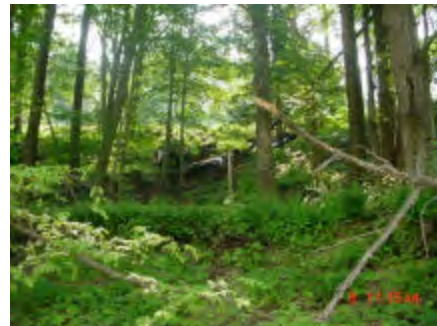
At the downstream end of this erosion, and higher up on this hillslope, a dumpsite was observed, containing old cars, metal and mechanical debris. It did not appear active. Appliances, trash and other refuse often contain metals, lubricants and various chemicals that can be detrimental to water quality.

The dumpsite also degrades the

Dumpsite on hillslope

aesthetic quality of this reach. Removal of the trash and appliances is recommended in order to protect water quality and limit further soil contamination.

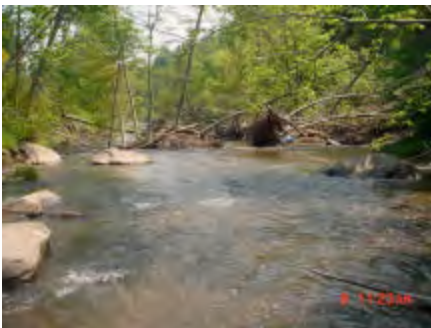
Aggradation upstream of debris

downstream, aggradation of the bed was observed, likely the result of flow obstruction by a major debris jam comprised of abundant large woody material -- trees and rootballs -- introduced into the stream from large failing banks just downstream (See Insets C, G and B, Figure 4.19.2).

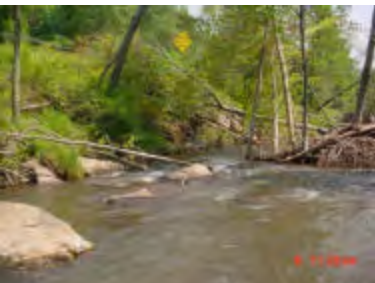
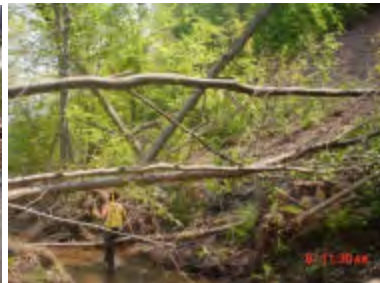
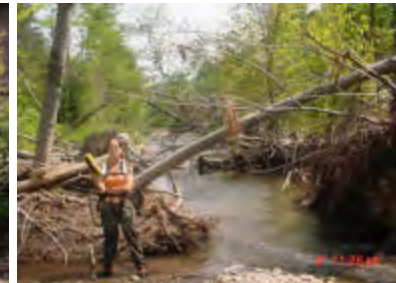
Debris jam at toe of large landslide

This debris jam is a major blockage at the toe of a large landslide on the right. The trees in the channel are creating a severe obstruction at all flows, and represent a serious threat to stability of the channel and the NYS Route 42 embankment. This 772 ft. long erosion site has been monumented as a Bank Erosion Monitoring Site (BEMS Station 19-06005). In a prioritization of twenty-one BEMS sites throughout the West Kill watershed (see Section 3.3, Watershed Inventory and Assessment), this site

ranked High Priority, and in fact, is the highest priority site in the watershed. The *thalweg*, or deepest part of the stream channel flows up against the failing hillslope, which is being undermined by toe erosion, leaving large sections of the stream bank unvegetated. The hillslope, which has multiple scarps, is stratified, with numerous sand lenses exposed by the erosion through which groundwater piping was observed. These exposed *lodgement till* soils have a high silt and clay content, contributing sediment through both *wet and dry ravel* and yielding a significant suspended sediment and bed load during high flows. Clay inputs into a stream are a serious water quality concern because they increase *turbidity*, degrade fish habitat, and can act as a carrier for other pollutants and pathogens.

The conditions at this site present low potential for self-recovery. Full restoration of the site is recommended, necessarily preceded by a geotechnical assessment of the hillslope failure mechanisms. The restoration would likely involve installation of rock vanes to direct stream flows away from the banks, stabilization of at least the lower portion of the bank, and revegetation of the bank face. Because the instability problems at this site are related to sediment transport discontinuities

in MU20, a comprehensive, integrated analysis and treatment of MU 19 and MU20 is recommended. In-depth survey and engineering design would be required to plan a stream restoration project at this site.

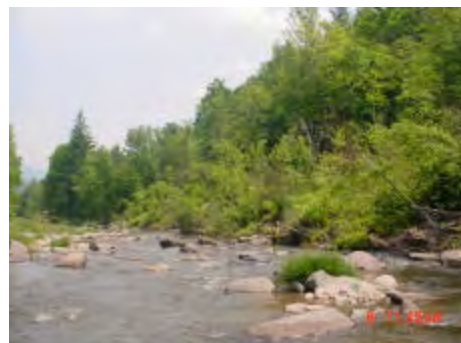
Downstream of the eroding bank, the channel grade flattens further, to 0.9%, as documented by the third monumented cross-section just downstream of the eroding bank. Entrenchment becomes extreme at this point; the reach, however, is aggrading due to the reduction in slope and the excess sediment supply introduced by the landslide. As NYS

Aggrading reach downstream of erosion

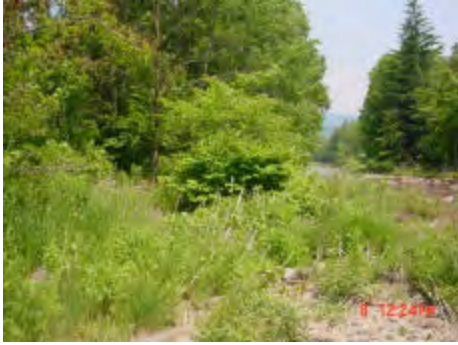
Lateral bar, left

Route 42 bends to the left, a lateral bar develops on the left, sparsely vegetated with sedges and willows.

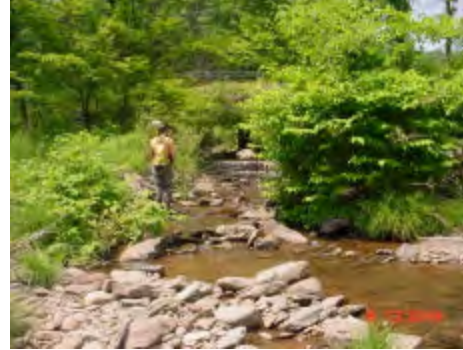
Roarback Brook confluence

Continuing downstream, Roarback Brook (1.7 mi.²) enters across the bar on the left, having passed through a large concrete culvert, controlled with a concrete culvert bottom, under NYS Route 42. This grade control sill extends for some distance beyond the box opening at the downstream end, and the tributary channel then plunges 1.5' into a scour pool, presenting a possible barrier to fish migration into the tributary. A stand of Japanese knotweed was observed at the confluence.

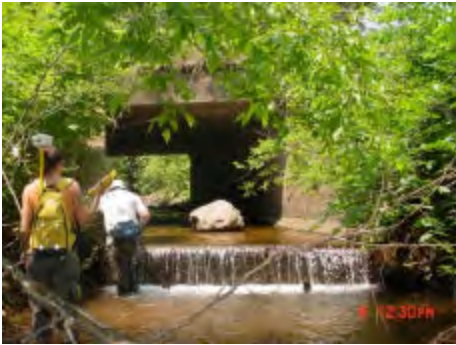
Culvert under NYS Route 42

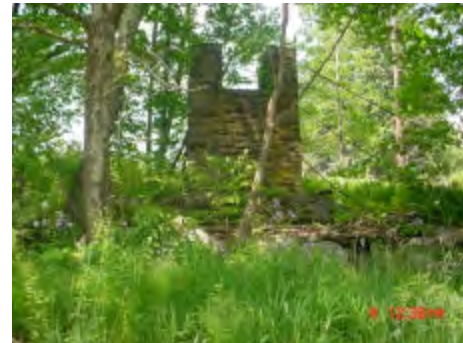
Downstream of the tributary confluence, on the right bank, a stacked stone abutment for a relic cable bridge crossing remains. Across the channel, a spring has been piped, possibly from a cistern back in the floodplain.

Bridge Abutment

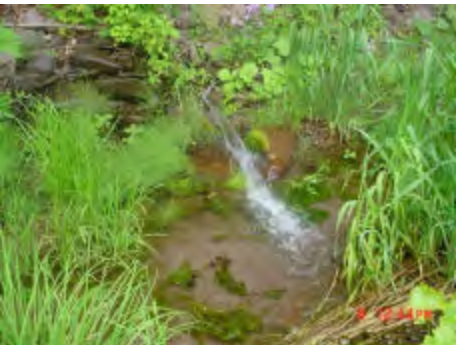
Piped spring

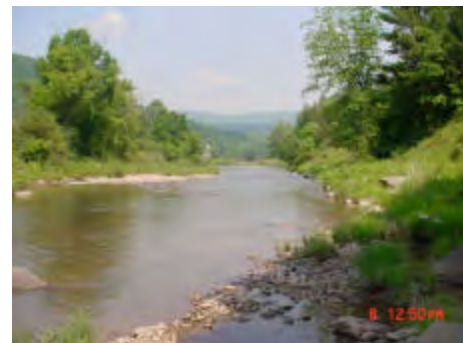
Downstream of the spring, a small, unnamed tributary enters from the right, across a perched but well vegetated floodplain. Aggradation continues through the downstream end of the management unit. Entrenchment diminishes as the channel reconnects with its floodplain right and left, the channel begins to widen and the slope continues to drop.

Aggradation
