# West Kill Management Unit 20

**Management Unit 20**  
Between Station 4778 and Station 2317

This management unit begins approximately 750 ft. downstream of the confluence of Roarback Brook, continuing approximately 2,461 ft., ending approximately 700 ft. upstream of the NYS Route 42 Bridge. The drainage area ranges from 30.7 mi<sup>2</sup> at the top of the management unit to 31.1 mi<sup>2</sup> at the bottom of the unit. The valley slope is 0.83%.

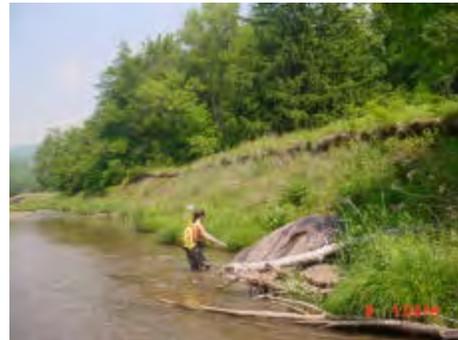
**Bank erosion, right**

These aggradational conditions and poor riparian vegetation have led to erosion of 219 ft. of the alluvial terrace on the right through toe scour. Although there was some evidence of revegetation of the bank face, initial development of a point bar on the left indicates that the site may be trending to a more sinuous morphology (see Inset D, Fig. 4.20.2) in response to the aggradational conditions.

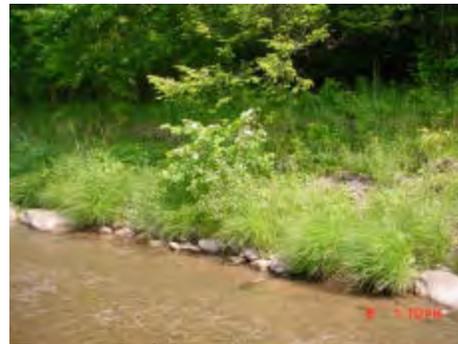
**Knotweed, right**

Japanese knotweed (*Fallopia japonica*), an invasive, exotic shrub species that can grow rapidly to crowd out more beneficial streamside vegetation, was observed here on the both banks. On the right, a small isolated stand was documented near the water's edge, and on the left, a larger stand growing on the floodplain beneath a willow (undetermined *Salix* spp.) canopy.

The floodplain on the left has abundant willows, and this site presents an opportunity to observe competition between the two species. Both species thrive in floodplain conditions, but one, the willow, dramatically increases soil cohesion due to its deeper and denser root structure, and the other, because of its shallow root structure, actually encourages erosion. A program of eradication of Japanese knotweed throughout the West Kill valley is recommended.

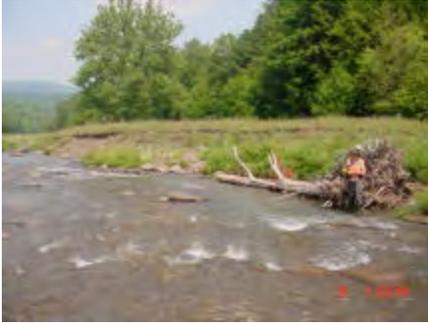
**Bank erosion on alluvial terrace, right**

The large woody debris provides some obstruction at all flows, and may actually be encouraging the revegetation of this alluvial terrace bank, by directing the main flow to the left; some sedge is establishing at the toe.

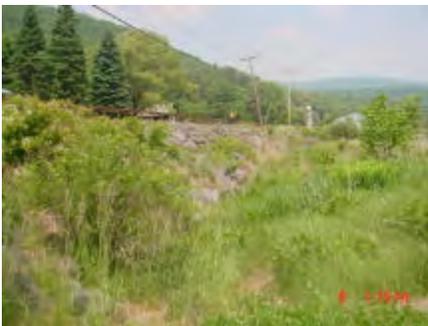
**Riprap along NYS Route 42**

Across the channel, approximately 100 ft. of point bar and floodplain currently separate the active channel from the NYS Route 42 road embankment (Inset G, Fig. 4.20.2), which is protected by 406 ft. of dumped rip rap, in good condition. While a narrow band of the floodplain adjacent to the rip-rap is now well-vegetated, historic aerial photography indicates that the channel flowed against the road here before the 1996 flood.

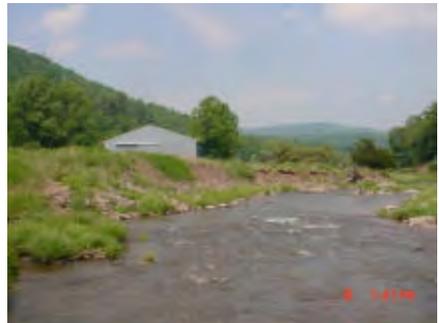
**Bank erosion**

As the channel crosses over to flow against the alluvial terrace on the left, another 240 ft. length of erosion, again caused by toe scour, has exposed a formerly buried dumpsite in the floodplain (see Inset F, Fig. 4.20.2). The refuse appears to be old farm machinery and garbage, and should be removed.

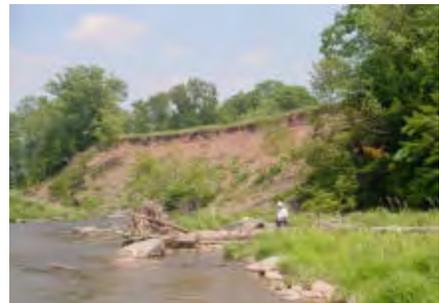
**Large woody debris, right**

Throughout this reach, sedges are establishing at the toe of the banks, and large boulders are fairly abundant in the channel, some of which may be placed. At the tail of the point bar on the right, large woody debris has accumulated, but presents little obstruction of flows.

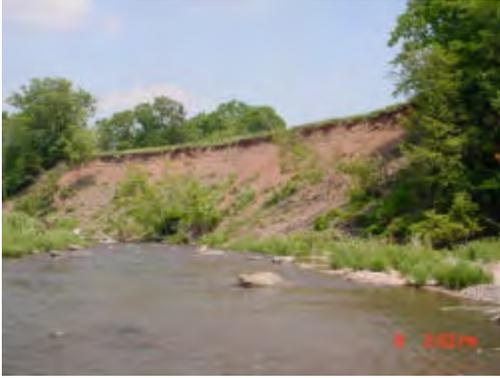
**Eroding glacial terrace, right**

As the channel flows up against the glacial terrace on the right bank (Inset B, Fig. 4.20.2) a high, 415 ft. section of erosion has been monumented as a Bank Erosion Monitoring Site (BEMS Station 20-3358). In a prioritization of twenty-one BEMS sites throughout the West Kill watershed (see Section 3.3, Watershed Inventory and Assessment), this site was ranked High Priority. The *thalweg*, or deepest part of the stream channel flows up against the high hillslope, which is stratified with multiple sand and silt layers, and is being undermined by toe

erosion, leaving most of the stream bank unvegetated. The exposed *lodgement till* soils have a high silt and clay content, contributing sediment through both *wet and dry ravel* and yielding a significant suspended sediment load during high flows. Clay inputs into a stream are a serious water quality concern because they increase *turbidity*, degrade fish habitat, and can act as a carrier for other pollutants and pathogens. Large mature trees continue to be introduced into the channel at the toe of the slope, as the failure enlarges upstream and downstream. The amount of sediment introduced here – including a substantial volume of fine gravel– as well as the obstruction caused by the woody debris, has produced aggradation at the downstream end of the failure, inducing lateral flow.

Full restoration is recommended for this site. This would likely involve establishment of a well-vegetated bench on the right with rock vanes to direct stream flows away from the bank, regrading and then revegetation of the bank face, and establishment of channel geometry throughout the unit to more effectively convey the sediment load.

To ensure that any work at this site is not compromised by excessive sediment supply from upstream, this site should be designed and constructed as part of a comprehensive project including both Management Unit 19 and 20. Due to its valley morphology, MU20 is appropriately a sediment storage area; managing sediment transport and storage issues in a manner that won't exacerbate the instability of the hillslopes in the reaches just upstream will require additional assessment and modeling, as well as in-depth survey and design.

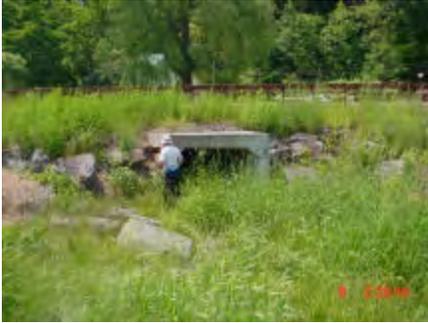
**Culvert**

Route 42 through a small, concrete, closed-bottom box culvert. This tributary ran subsurface through the floodplain at the time of the Inventory.

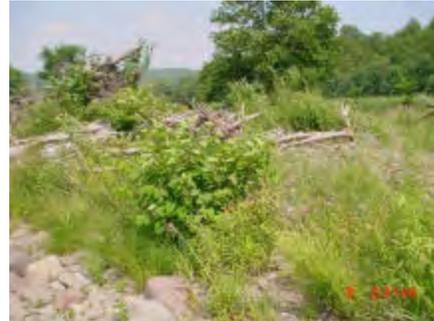
**Knotweed, amid debris**

A mid-channel bar has developed around a live tree now standing in the middle of the channel, which has a large jam of woody debris lodged against it. Additional piles of woody debris have accumulated on the right bar. In total, these debris jams present a major obstruction at bankfull and higher flows. Several stands of Japanese knotweed grow among the debris piles.

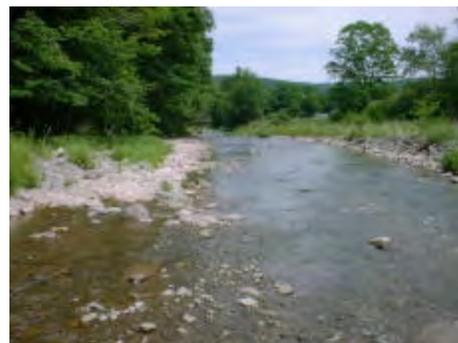
**End of MU20**

At the end of the management unit, the multiple channel threads begin to converge into a narrower single channel, slope continues to increase and the floodplain narrows on the approach to the NYS Route 42 bridge crossing in the final management unit.
