# West Kill Management Unit 21

## Stream Feature Statistics

## Management Unit 21

Between Station 2317 and Station 0

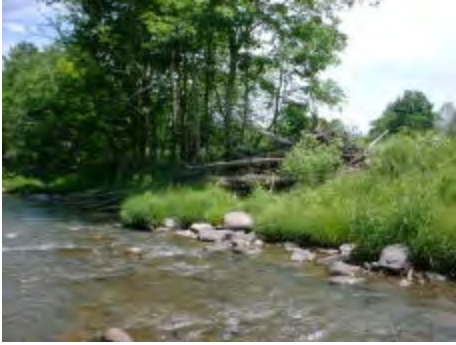
**Woody debris, right**

Proceeding downstream, low benches form on both banks, with abundant sedge on the right and mown lawn on the left. A substantial pile of woody debris has collected on the right bank against a line of mature trees, but does not obstruct low flows and may actually provide some bank protection in higher flows. A monumented cross-section at Station 1908 documents the B3c stream type at this long, straight riffle; the bank angles moderate significantly in the vicinity

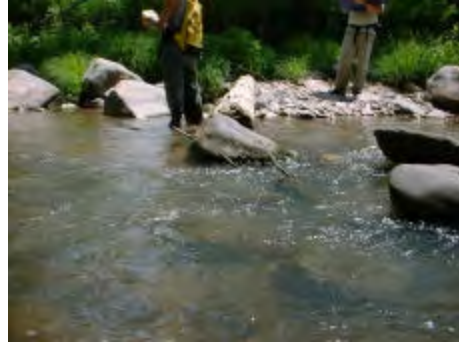
of the house on the left. The remains of a log sill habitat structure were observed (Station 1790) downstream of the classification cross-section, with remnants at the right bank only. A single line of trees buffers the channel on the right from a pasture on the terrace beyond.

**Habitat Structure**

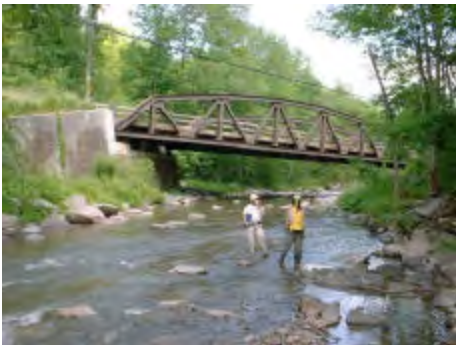
**NYS Route 42 bridge**

Approaching the NYS Route 42 bridge, which crosses the stream at an oblique angle, the channel material becomes finer, and the entrenchment increases (Inset H, Fig.4.21.2).

The bridge has sufficiently long span to pass bankfull flows without significant obstruction. There is some evidence that larger flows backwater, but this may owe more to the hard bend in the channel just downstream of the bridge.

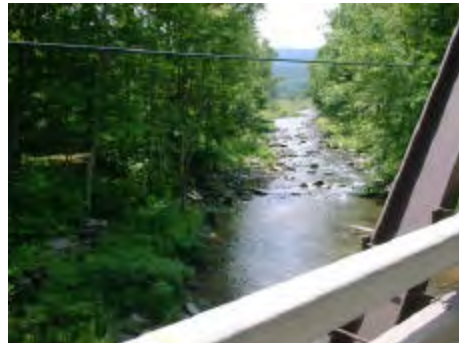
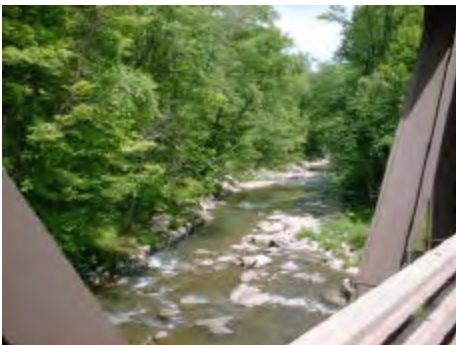
**Looking upstream**

**Looking downstream**

There is little evidence of abutment scour, however, and the wingwalls are protected with sufficient rip-rap. Abutments, wingwalls and deck appear to be in good condition.

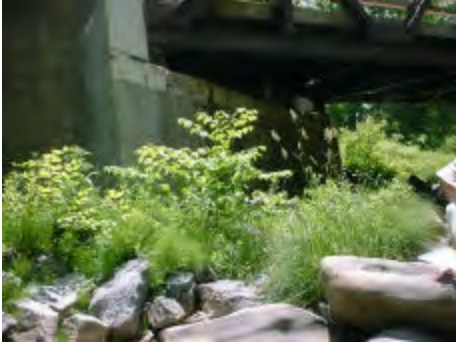
**Knotweed, right**

During the 2004 inventory, one stand of Japanese knotweed (*Fallopia japonica*), an invasive, exotic shrub species that can grow rapidly to crowd out more appropriate streamside vegetation, was observed on the right bank just downstream of the bridge. In the 2005 inventory, however, the number had increased to four upstream and downstream of the bridge. A program for eradication of Japanese knotweed throughout the West Kill valley is recommended.

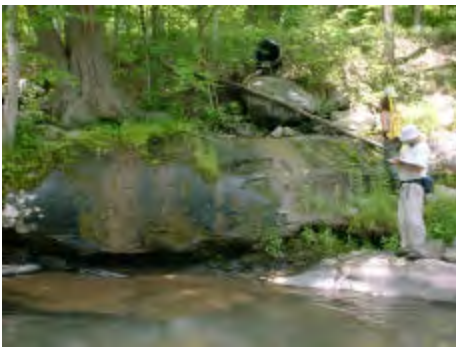
**Culvert**

management unit. A narrow dirt road runs along the left bank, and is the historic north/south road through the valley, with large mature trees on each side. A galvanized 2 ft. culvert, with no headwall and slightly perched, drains the road ditch and the adjacent hillslope, outfalling onto the rock ledge. Springs also seep from the bedrock fractures here.

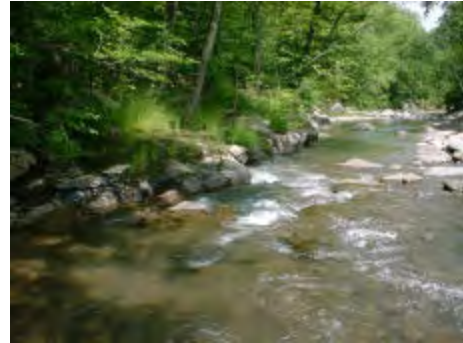
Downstream of the bridge, the channel is turned abruptly by the valley wall. Stacked rock on the left ties the abutment into a bedrock ledge exposed on the bank and left half of the bed (Inset D, Fig. 4.21.2). This bedrock controls the grade to some degree both upstream and downstream in the

**Bed Rock**

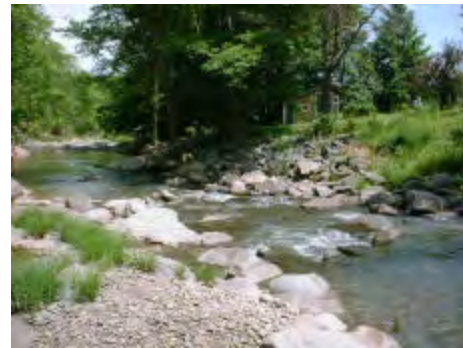
Across the channel, 135 ft. of rip-rap protects a low bank with a residential lawn beyond it, mowed to the edge of the stream (see Inset C, Fig. 4.21.2). The rip-rap also serves as outfall protection for a drainage swale that carries stormwater runoff from across the highway. In addition to exposed bedrock on the left channel bed and bank, abundant large native boulders throughout the channel mitigate bed scour.

**Riprap, right**

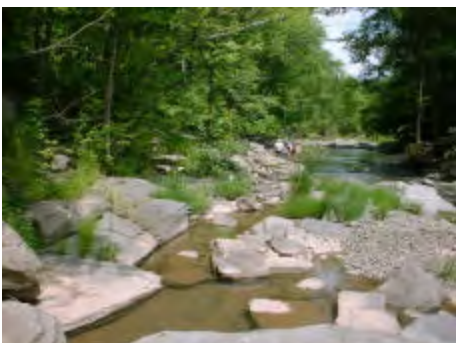
**Bedrock bench, left**

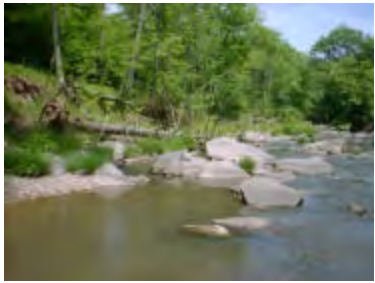
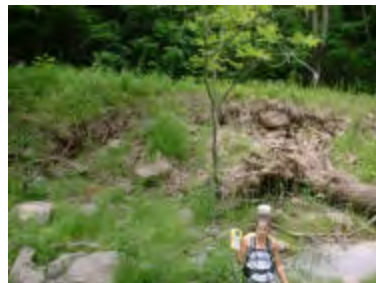
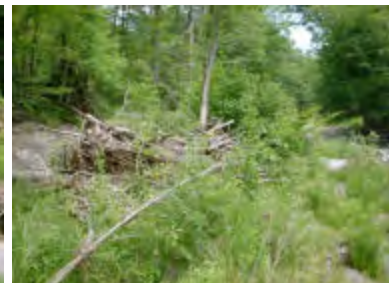
dominated by cobble, but due to the protection provided by abundant boulders and bedrock, the erosional power of large flows is displaced onto the streambanks. On the left, the dirt road embankment has washed out, and a 76 ft. section of dumped rip-rap was recently installed (Inset G, Fig. 4.21.2). The toe of this rip-rap has begun to fail, threatening the installation. Recommendations here include stabilization of the toe of the slope. If bedrock prevents the keying-in of the base of the rip-rap below the channel grade, then stacking rock revetment at least up to bankfull elevation is recommended. This will also reduce both the embankment slope and the narrowing of the channel.

**Erosion, left**

Downstream of the rip-rap on the left, the road embankment continues to erode, and mature trees are being undermined and introduced into the channel at several locations.

Twelve percent of the stream length in this management unit has been treated with some form of revetment. One section of revetment is failing, and this could ultimately threaten a private road which serves as the primary egress for a residence. Stabilization of the toe of this rip-rap installation is recommended.

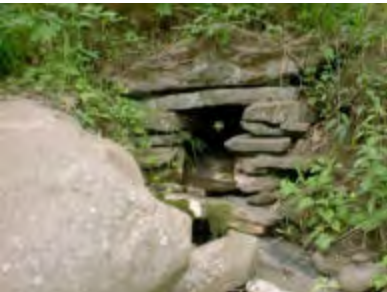
**Stacked rock culvert**

An old, hand-stacked rock culvert carries upslope stormwater drainage under the dirt road and, slightly perched, outfalls onto stacked outfall protection on the dirt road embankment (Inset F, Fig.4.21.2).

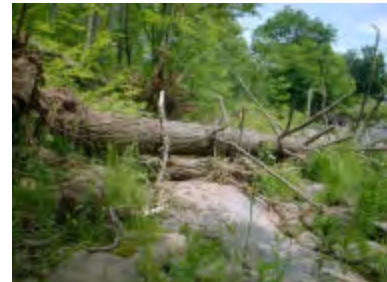
**Large woody debris, left**

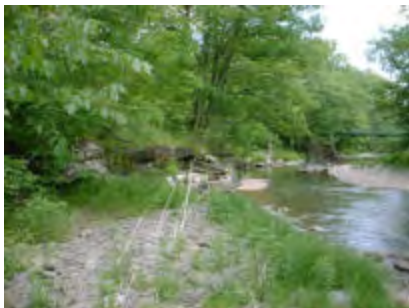
**Lateral bar on outside of meander**

On the outside of this gentle bend to the right, debris jams may be providing some toe protection, as flows are obstructed and a lateral bar appears to be developing, aided by occasional outcroppings of bedrock on the bank and bed.

This may also be contributing to the erosion downstream on the right bank, as the thalweg shifts laterally across the stream. This site was not monumented as a Bank Erosion Monitoring Site. Recommendation for this site is Passive Restoration, allowing development of the bar on the left to stabilize the toe of the slope.

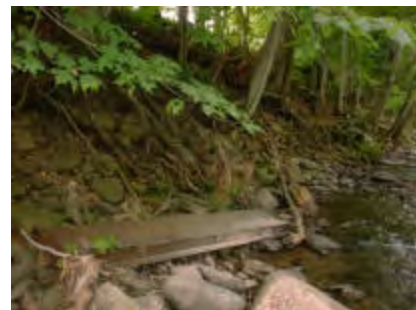
**Erosion at base of well-vegetated bank, right**

Opposite and downstream of the debris jam on the left, a 168 ft. section of the bank is eroding at the edge of a mowed field at Bay Bridge Farm (Inset B, Fig. 4.21.2). At the upstream end of the erosion, the bank is well-vegetated with young trees, but the base of the slope begins to show signs of scour around Station 850. As the mature vegetation transitions to open field adjacent to the stream, erosion of the right bank has been monumented as a Bank Erosion Monitoring Site (BEMS 21-00767).

Assisted Self-recovery is recommended for this site. Minor changes in the bed and bank could significantly shift erosive forces off the bank and eliminate the headcut. The toe of the bank should be protected with larger rock and a low bench should be established with plantings of sedge and willows. The bank and a buffer in the field adjacent to the stream should be replanted with ecologically appropriate trees and shrubs.

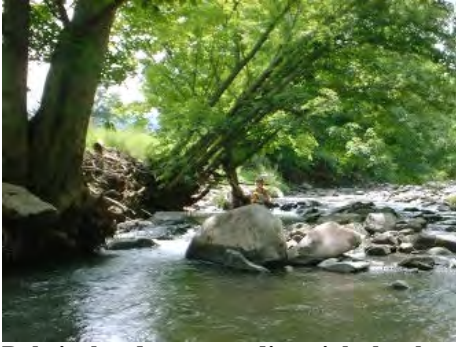
**Debris, headcut at eroding right bank**

In a prioritization of twenty-one BEMS sites throughout the West Kill watershed (see Section 3.3, Watershed Inventory and Assessment), this site was ranked Low Priority. The *thalweg*, or deepest part of the stream channel flows up against the alluvial terrace here, causing toe erosion, and leaving sections of the stream bank unvegetated. Furthermore, most of the remaining trees have been undermined by a headcut that is migrating through the site, exacerbating the toe erosion. The channel slope steepens locally.

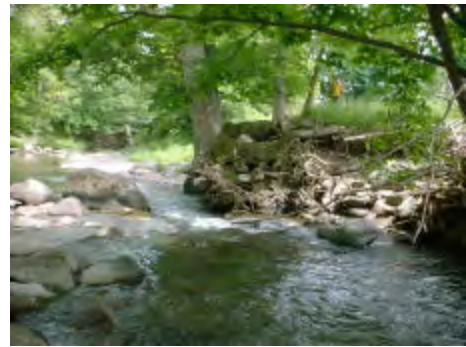
**Looking downstream**

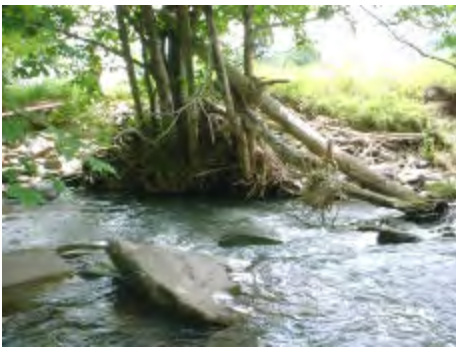
**Debris jam**

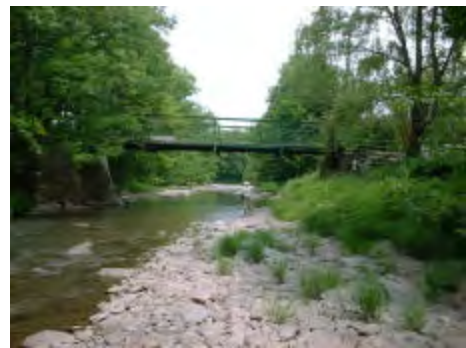
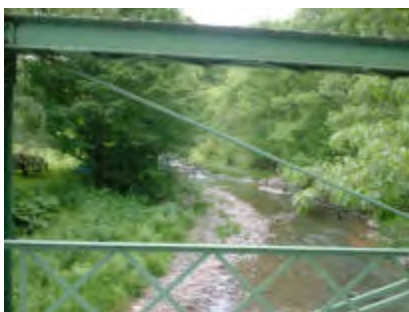
Downstream of the erosion on the right, the channel approaches the private bridge at Bay Bridge Farms. This bridge used to carry the main road, then on the left of the stream, across toward Lexington. The span is adequate to pass bankfull flows without

**Private bridge at Bay Bridge Farms**

**Looking upstream**

obstruction, and the mortared stone abutments are in good condition, with no sign of scour despite a substantial pool under the bridge. The right abutment has rip-rap scour protection.

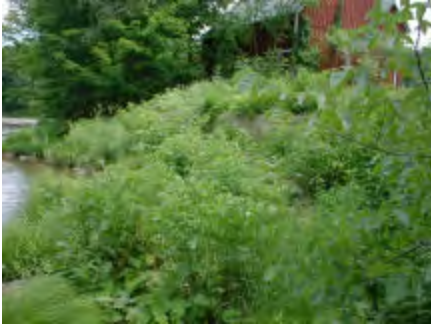
**Crib wall, downstream right**

Downstream on the right, a new cribwall with a well vegetated toe protects the bank against backeddy scour. Just upstream of the left abutment, a 16” galvanized culvert, dry at the time of the inventory, enters with no headwall or outfall protection.

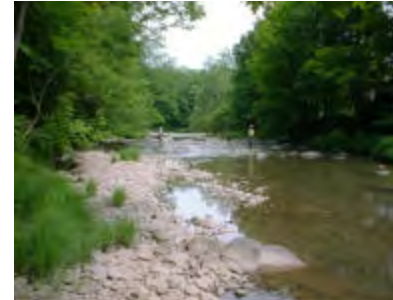
**Aggradation downstream of**

Downstream of the bridge, aggradation is evident, probably the result of backwatering at the confluence of the Schoharie Creek just downstream.

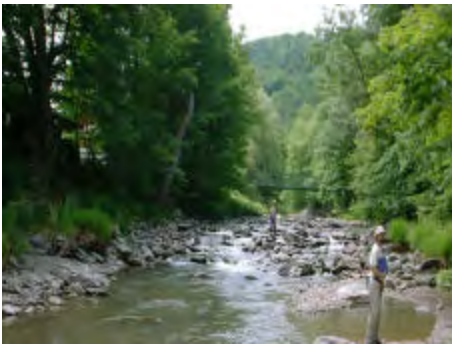
**Small headcut**

Downstream of aggradation, aerial photography and cut benches suggest that a small headcut has migrated headward through the reach. The riparian buffer on both banks here is narrow, but the banks appear to remain stable.

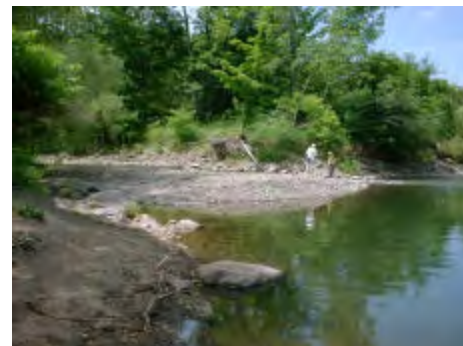
**Confluence of West Kill and Schoharie Creek**

Management Unit 21 ends at the confluence of the West Kill with Schoharie Creek, where backwatering, typical at such settings, has produced aggradation and a deep junction pool.
