**Project Design Report
R.A. Hill Stables Demonstration Project
West Kill Creek**

**December 31, 2006
Prepared by Mark Vian¹ and Joel Dubois²**

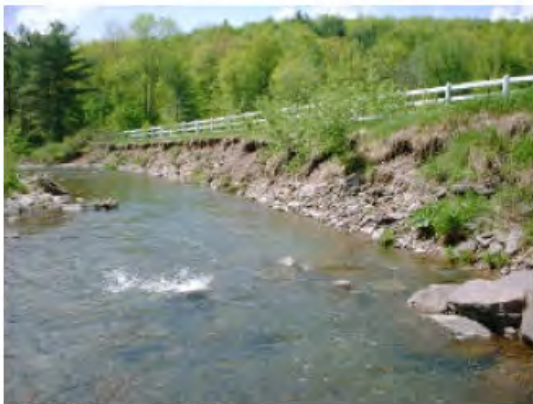
The project addressed bank erosion that had undermined several hundred feet of fencing along a horse pasture on the right bank, and threatened the main drive into the stables. Some sections of the restoration treatment area had become overwidened, and had developed large center bars. The erosion documented at the site during the Stream Feature Inventory conducted during the summer of 2004 worsened significantly as a result of the high flows that occurred in the West Kill watershed in April, 2005.

Bank Erosion, 2004

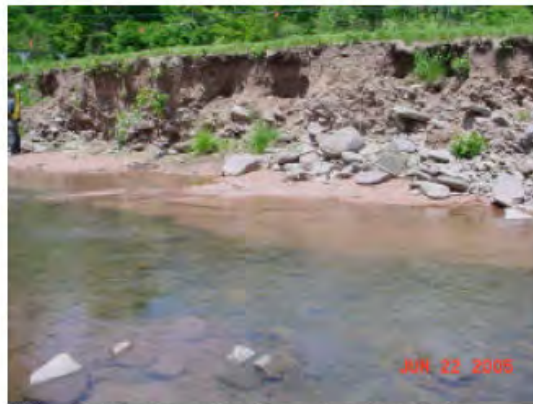
Worsening streambank erosion in 2005

Three stream banks on the site experienced significant erosion during the April 2005 flood. Extensive exposures of lacustrine clay deposits were documented at two of the three eroded banks (see photo above). Entrainment of colloidal clay materials from these deposits represents a water quality concern. Turbidity

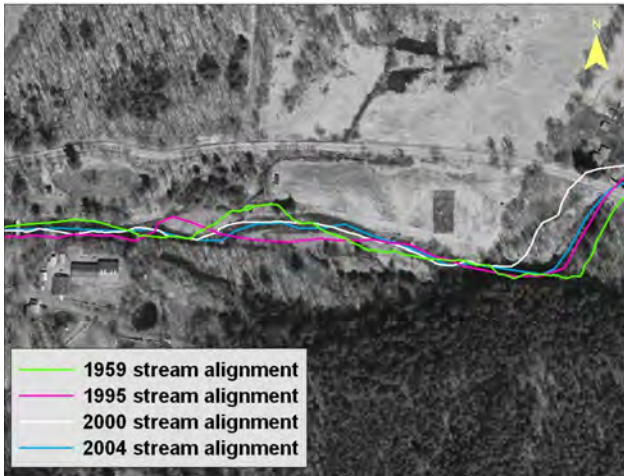
Historic Stream Channel Alignments

This aggradation has resulted in historic lateral adjustment of the channel; most recently, a center bar formed, splitting flow into several channels. The right channel thread incised deeply into the clay deposits, as shown in the pictures in the previous section, and seriously eroded the bank of the horse pasture.

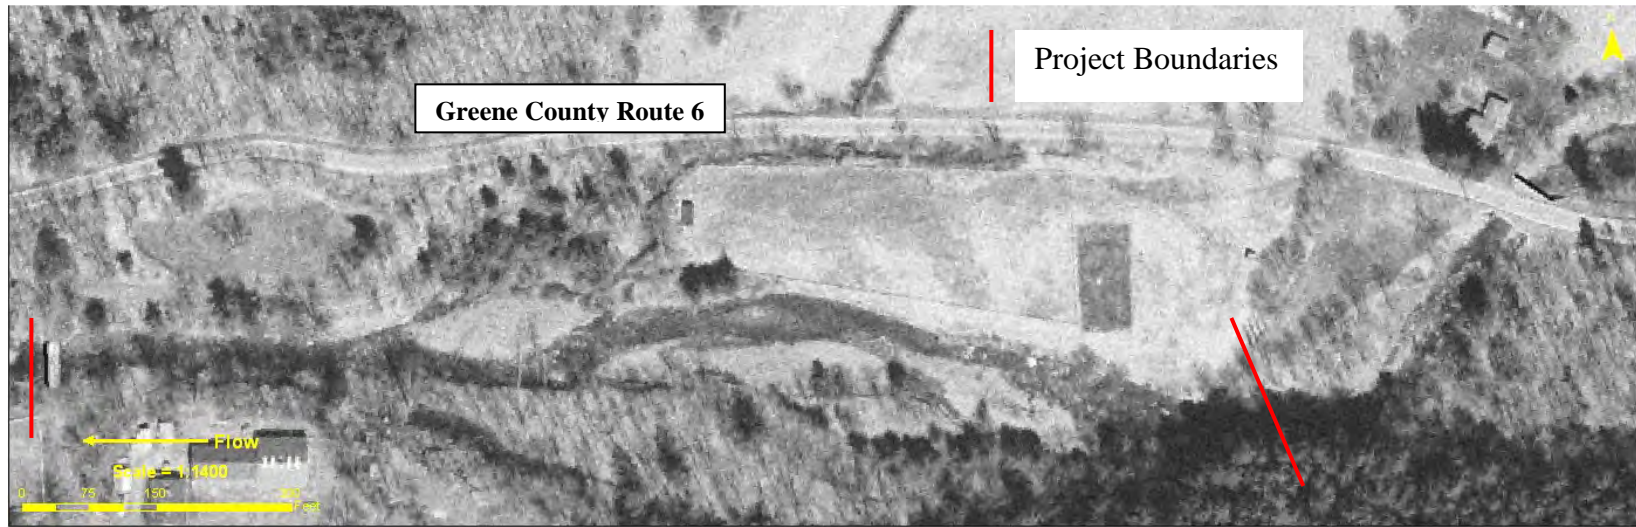
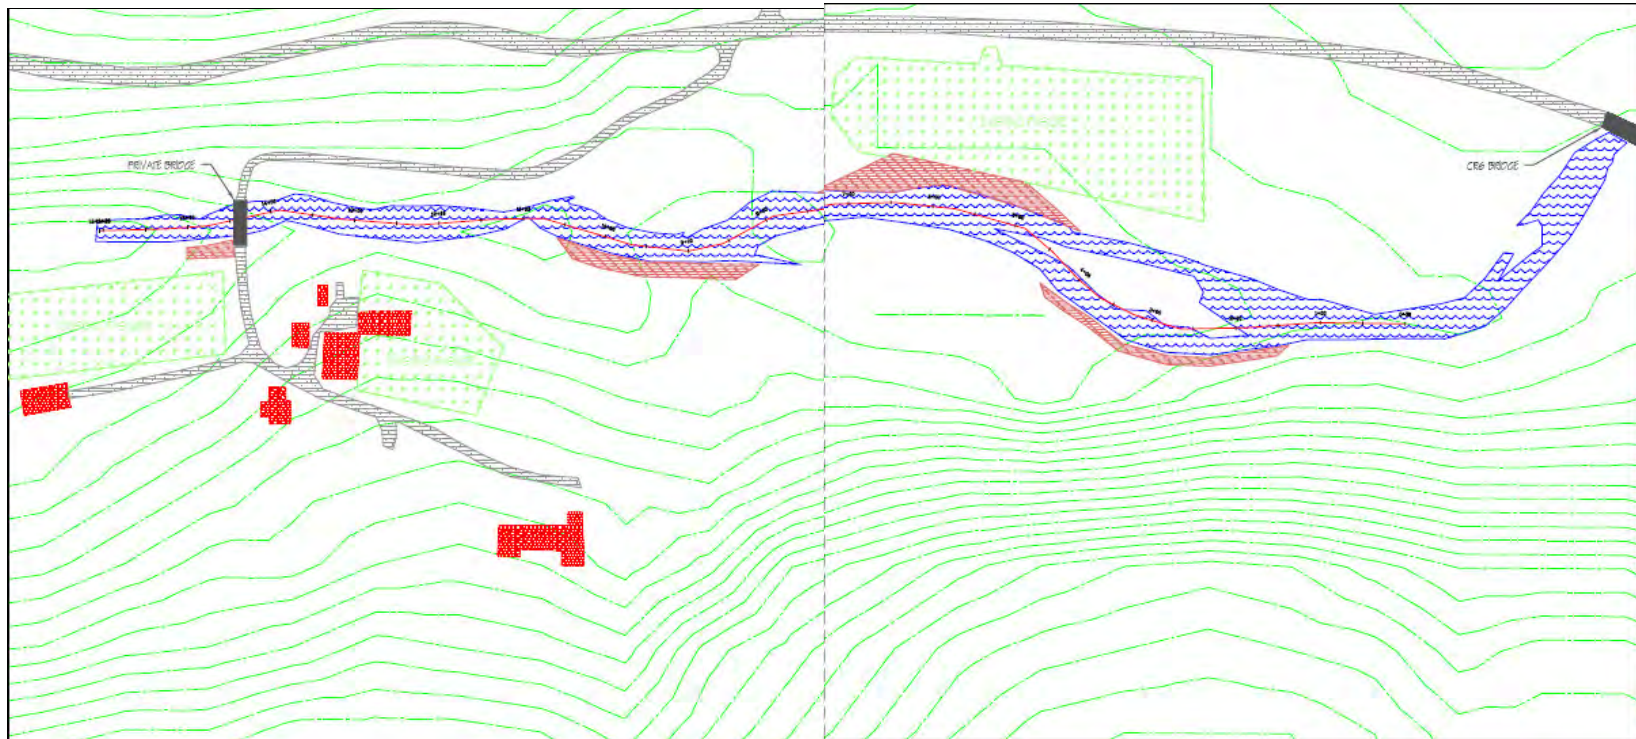
**Above, 2004 Aerial photography showing multiple channels at RAH Stables.
Below, project area with erosion areas showing in shaded red.**

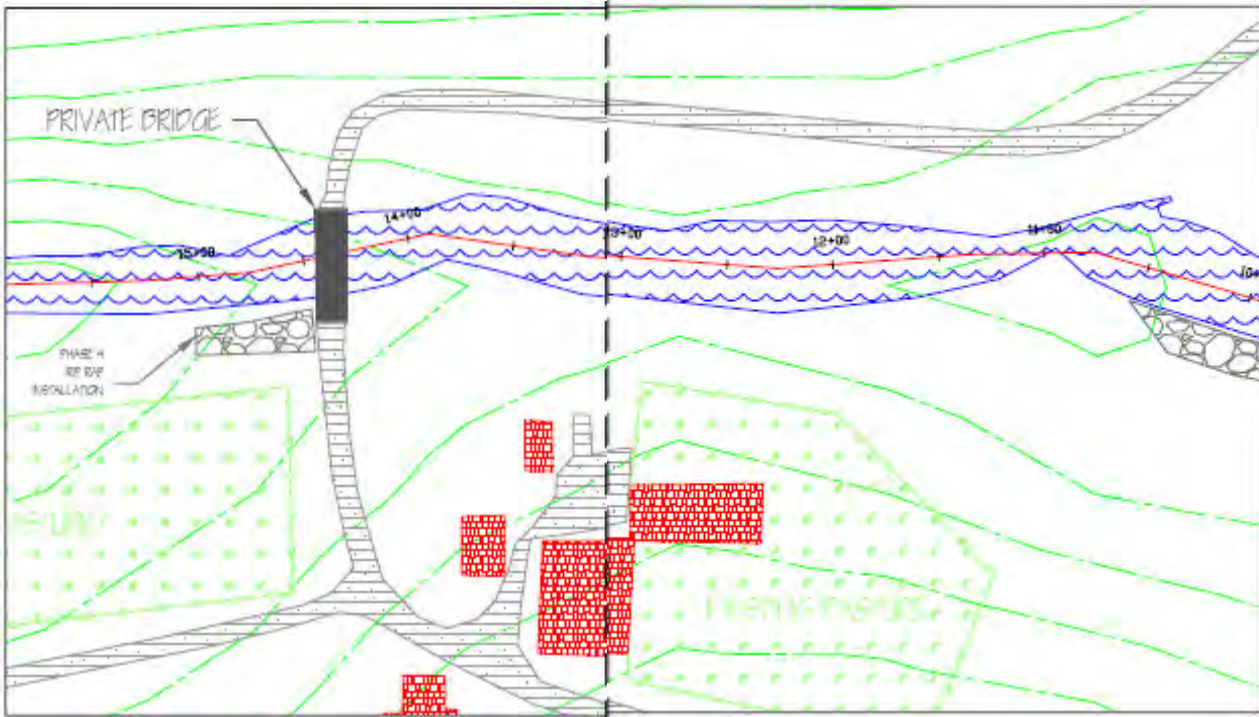
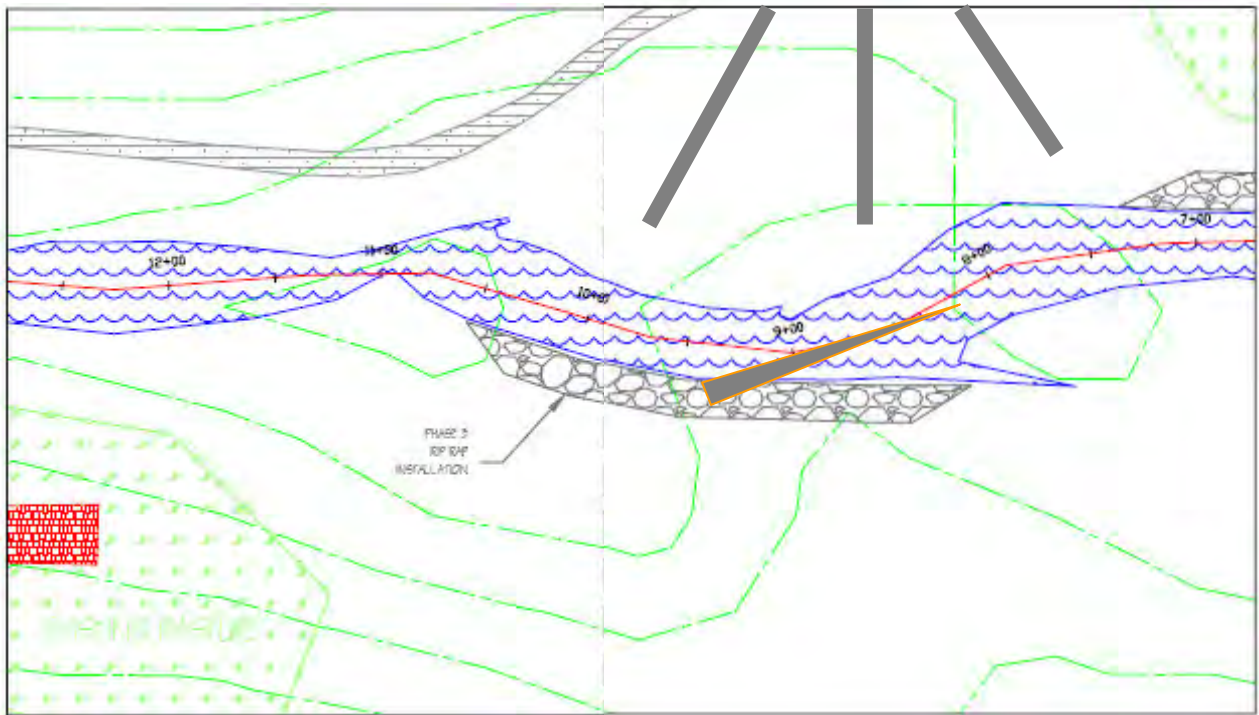
Proposed restoration design, at bridge crossing, above; lowest meander bend, below, with bankfull bench identified as “rip-rap installation”. These areas are also the zones where trees and shrubs were planted. Grey triangles represent approximate locations of rock vanes. Grey bars opposite the vanes at the top and bottom meanders represent approximate locations of rock keys in point bars.

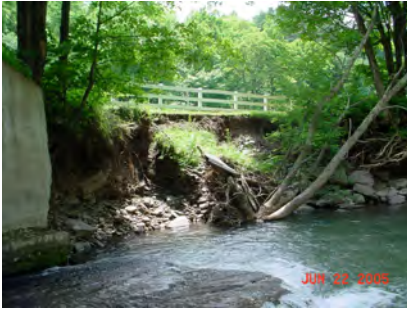
Damage to the private bridge on the site has left the bridge abutments compromised. As the private bridge is the only means of access to the homes and stabling facilities, repair is critical to the safety of the site. Emergency services, such as fire and rescue squad, rely on the bridge for access to the two residential structures as well as the stabling facilities.

Phase 4 consists of repair to the left downstream abutment of the private bridge. This bridge serves as the only access to two residential structures and the stabling facilities of RCH Stables. Repair of the bridge is critical for emergency services access to the homes and stable. Rip rap material will be used to armor the toe of the abutment while also filling voids behind the abutment which resulted from the flooding experienced in the watershed in April of 2005. A short piece of erosion downstream of the abutment will be armored with rip rap to ensure the stability of the bridge abutment.

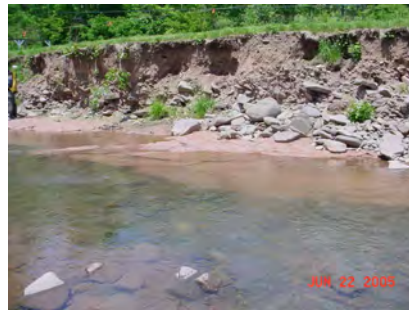
Three stream banks on the site experienced significant erosion during the April flood. Extensive exposures of lacustrine clay deposits have been documented at two of the three eroded banks. Entrainment of colloidal clay materials poses a significant health concern from a water quality perspective. Turbidity resulting from flowing water in direct contact with clay can degrade drinking water quality, and the aesthetic quality of the water resource. In addition to the water quality impacts on the site, the erosion has undermined the pasturing facilities of eroding banks will allow for continued use of the facilities. special concern to the project compromised pasture is their facility.

The mitigation strategy selected for the problems described above will include installation of bankfull terraces along the face of each eroding stream bank. The bankfull terrace will be constructed of appropriately sized rock material to protect the bank from continued erosion at high flow. The terrace will serve to reduce the overall slope of the bank while also reducing the velocity and shear stress exerted by high flows on the toe of the upper bank. The terrace will also provide a location for vegetation to establish. The terrace will be installed at a stage where the roots of the vegetation will be able to access adequate moisture to promote healthy growth. The root structure of the vegetation that will establish on the terrace will further reinforce the banks against erosion. As the remainders of the upper banks are currently sloped steeper than the angle of repose for the soil conditions on the site, vegetative reestablishment is unlikely without intervention. The upper banks will be sloped to an angle that will allow vegetation to establish, and will also be reinforced with erosion resistant rock material.

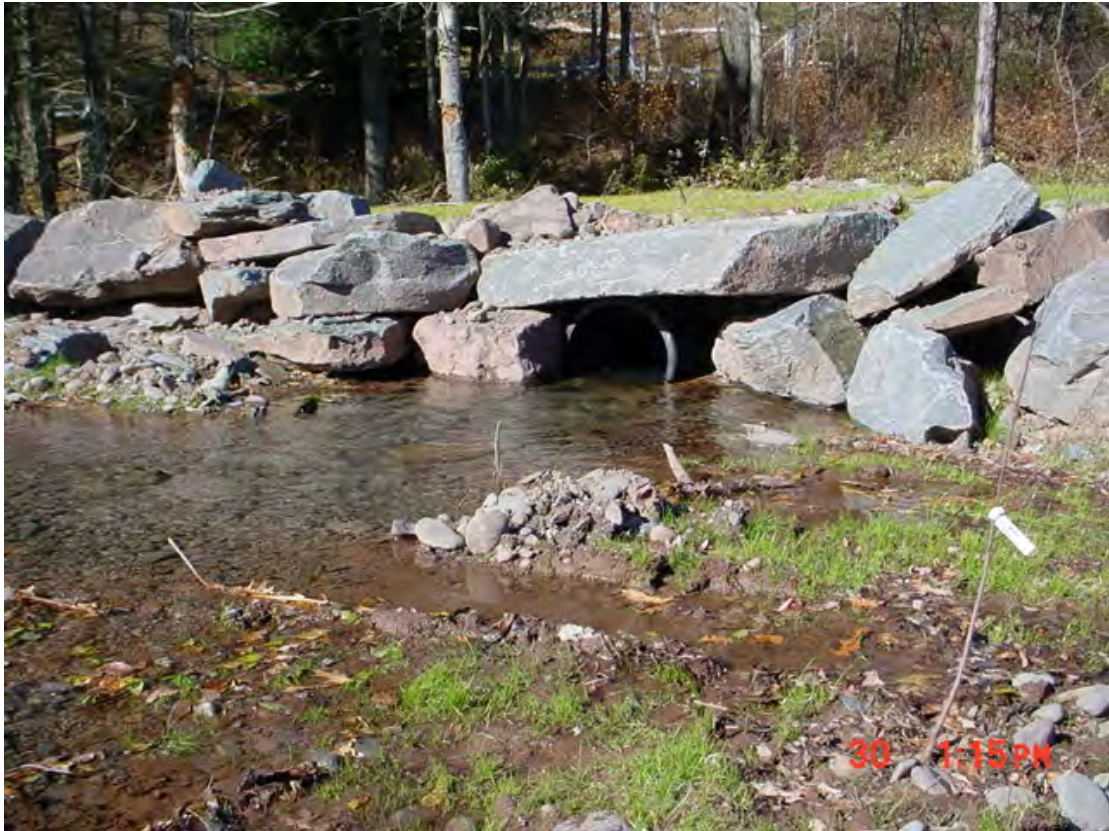
Figure E1 Small tributary confluence through culvert

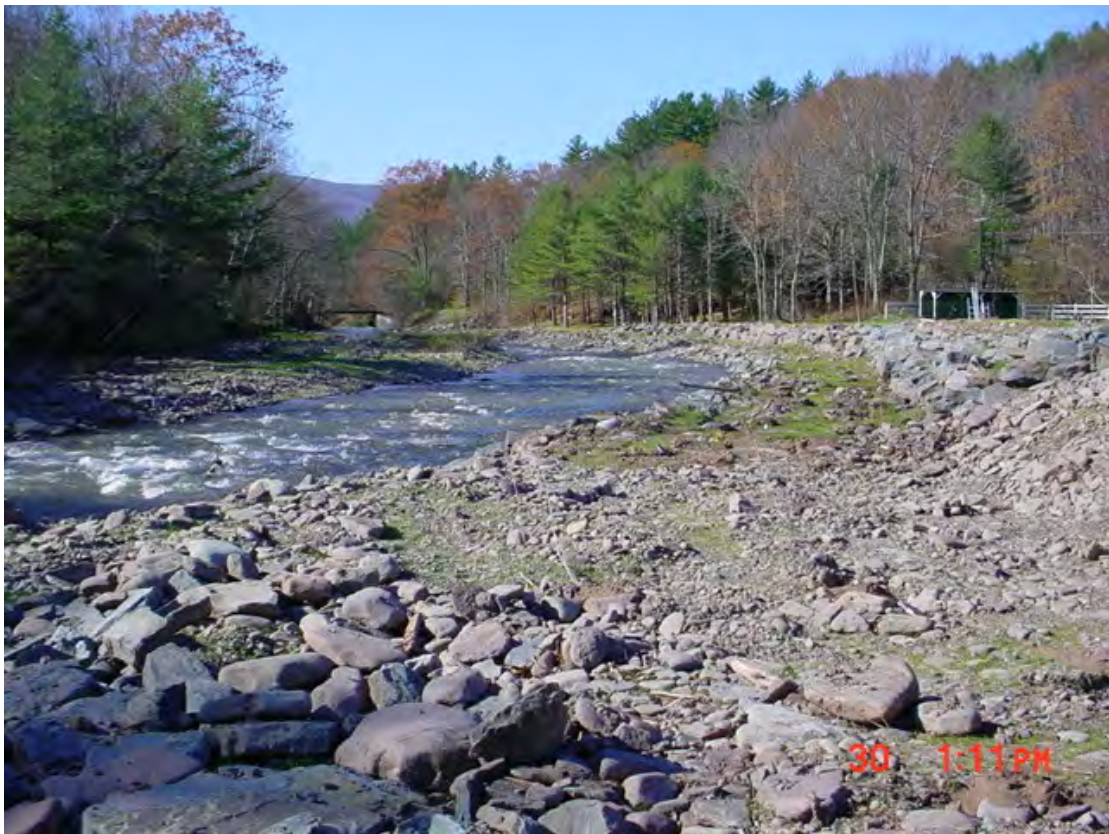
Figure E2 Bankfull bench, and backslope adjacent to pasture, looking downstream

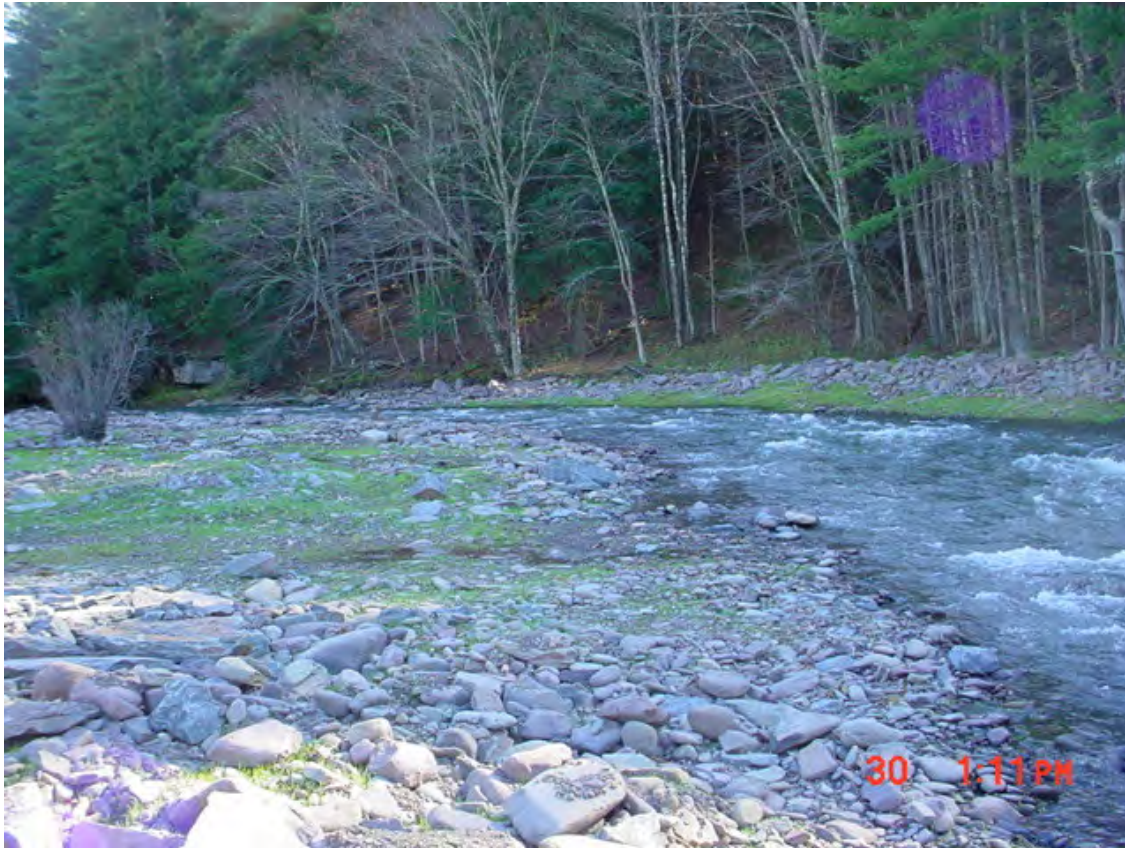
Figure E3 Looking upstream from right bench at pasture

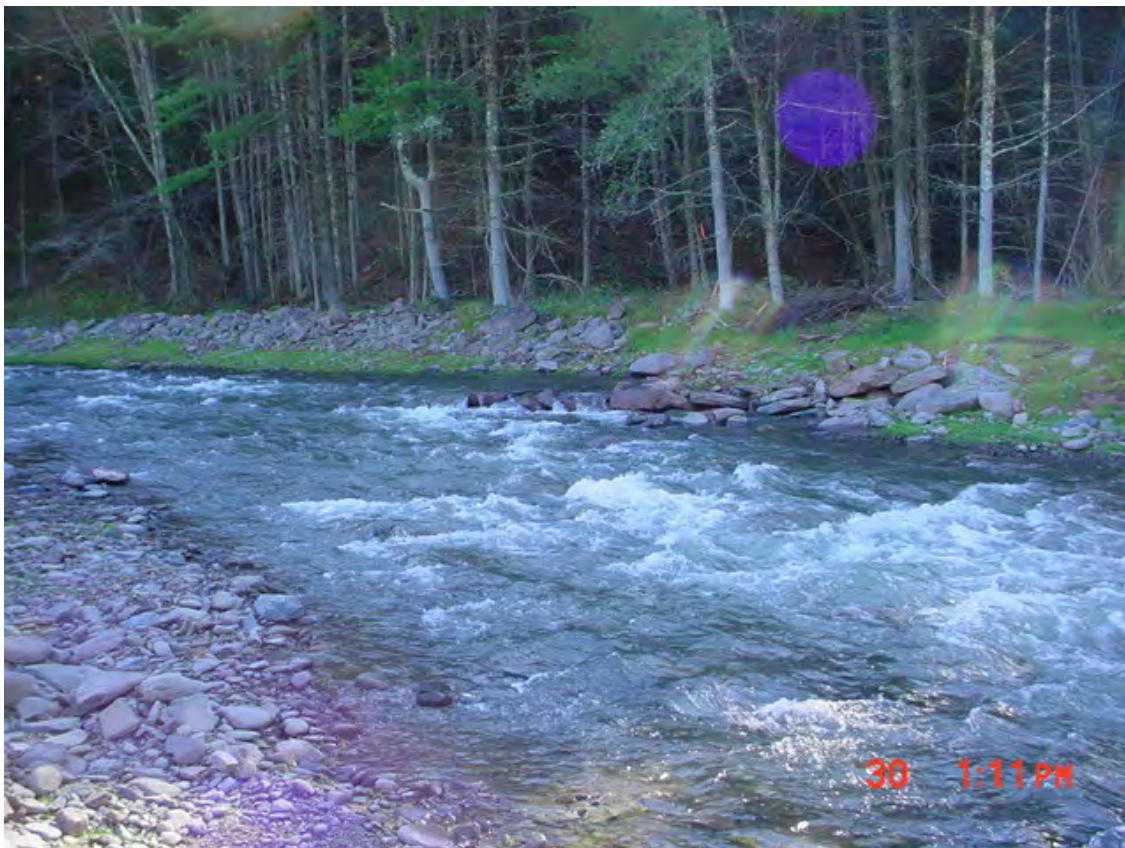
Figure E4 Looking upstream at top rock vane on left bank

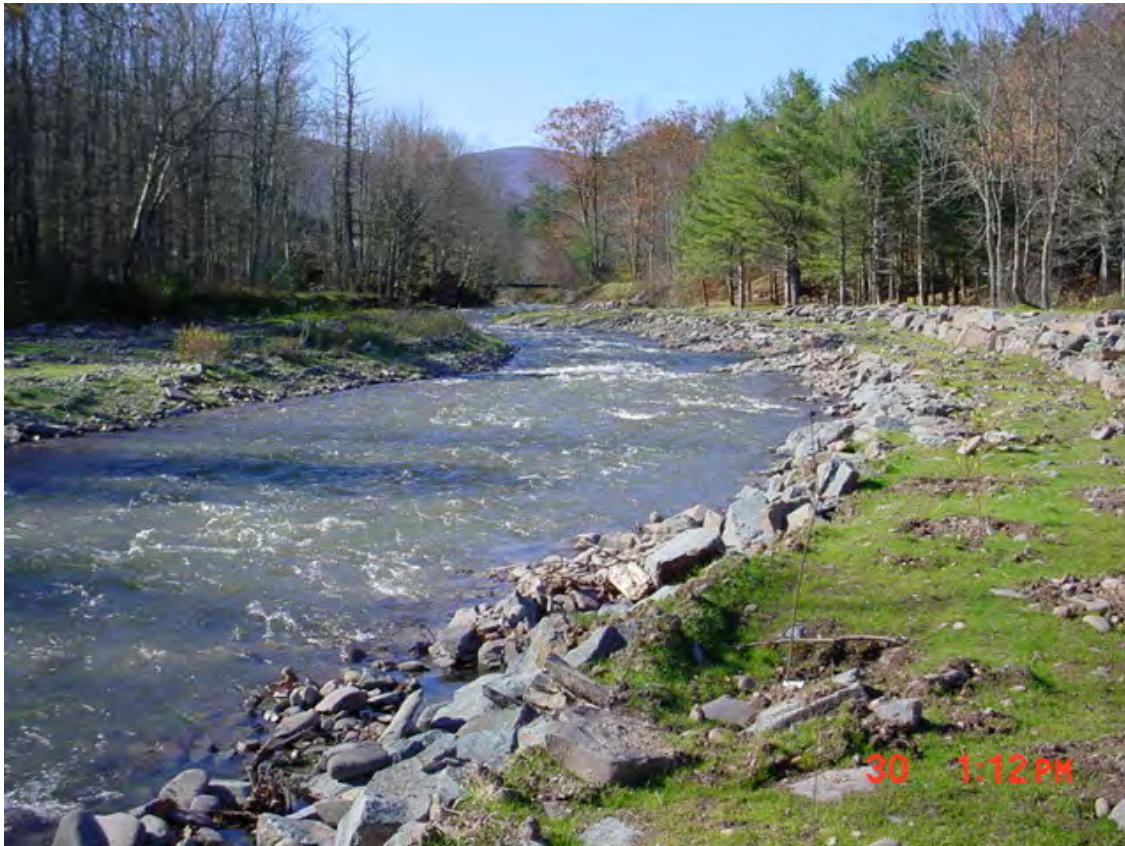
Figure E5 Right bankfull bench, near bottom of pasture

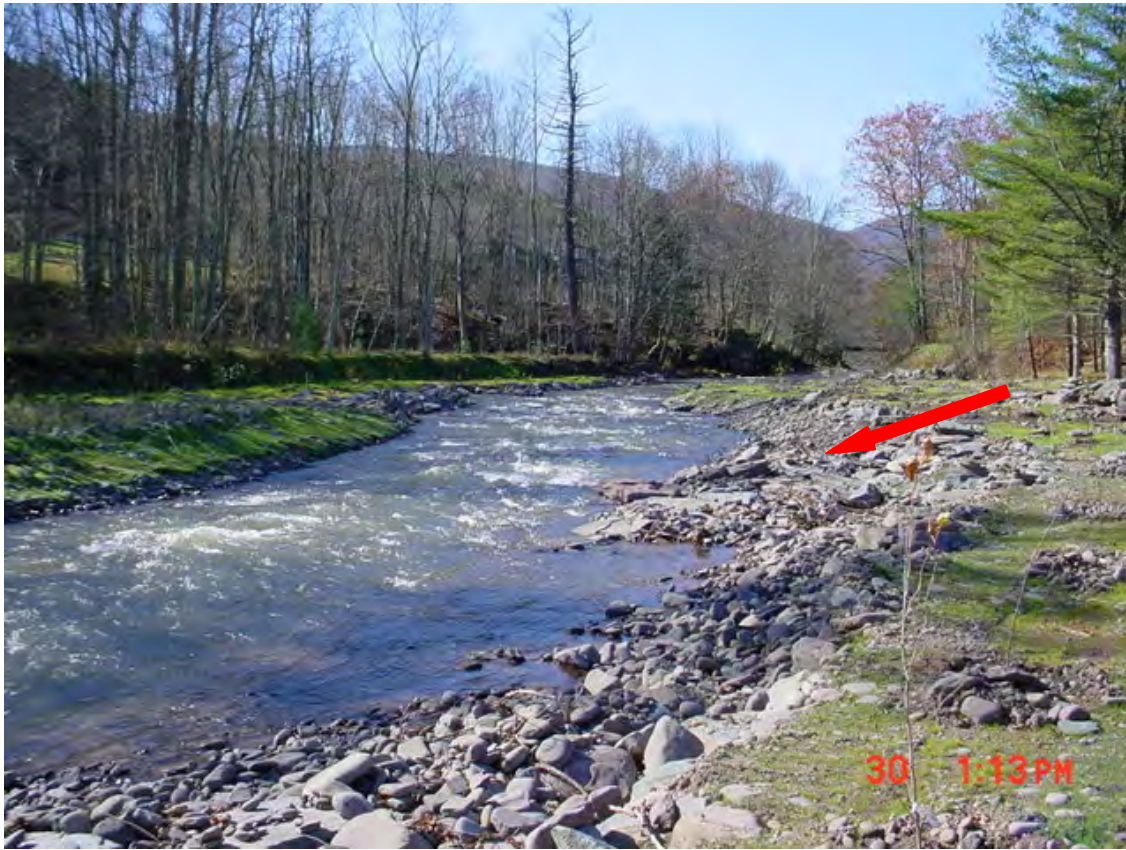
Figure E7 Lower rock vane on right

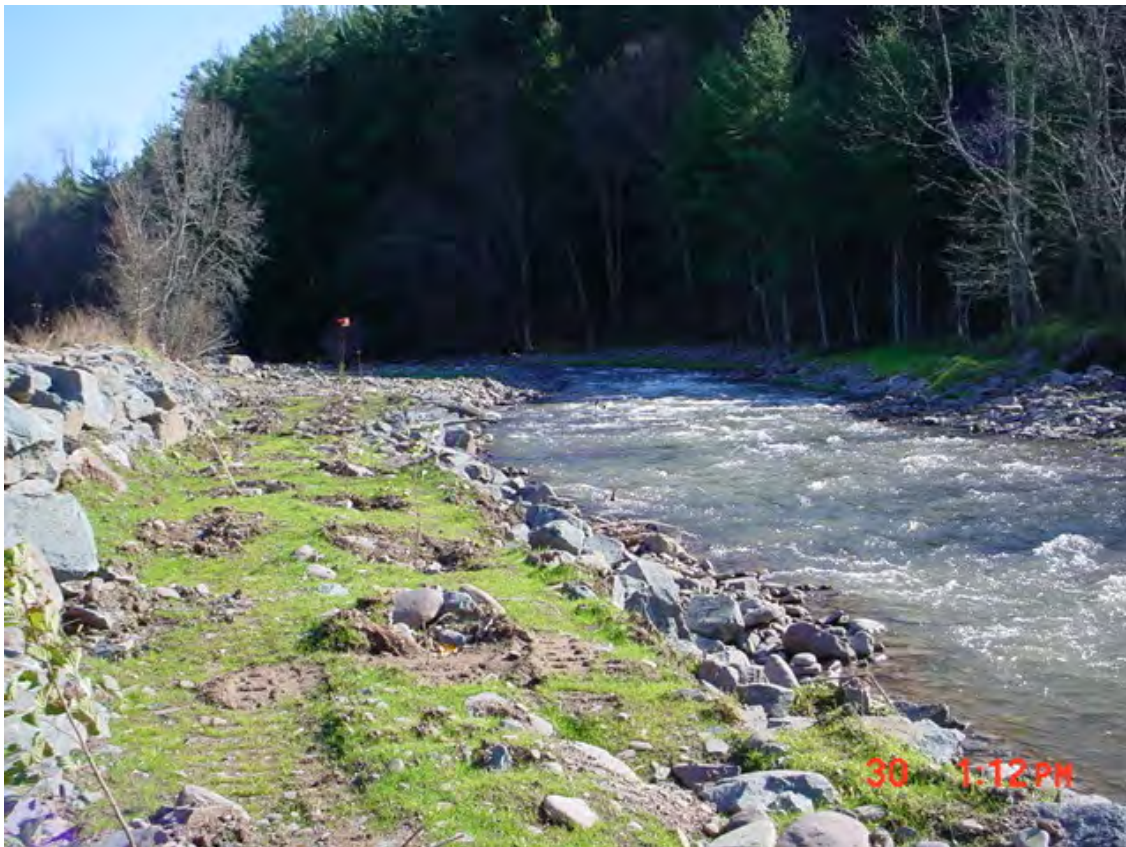
Figure E8 Right bankfull bench, showing tree and shrub plantings

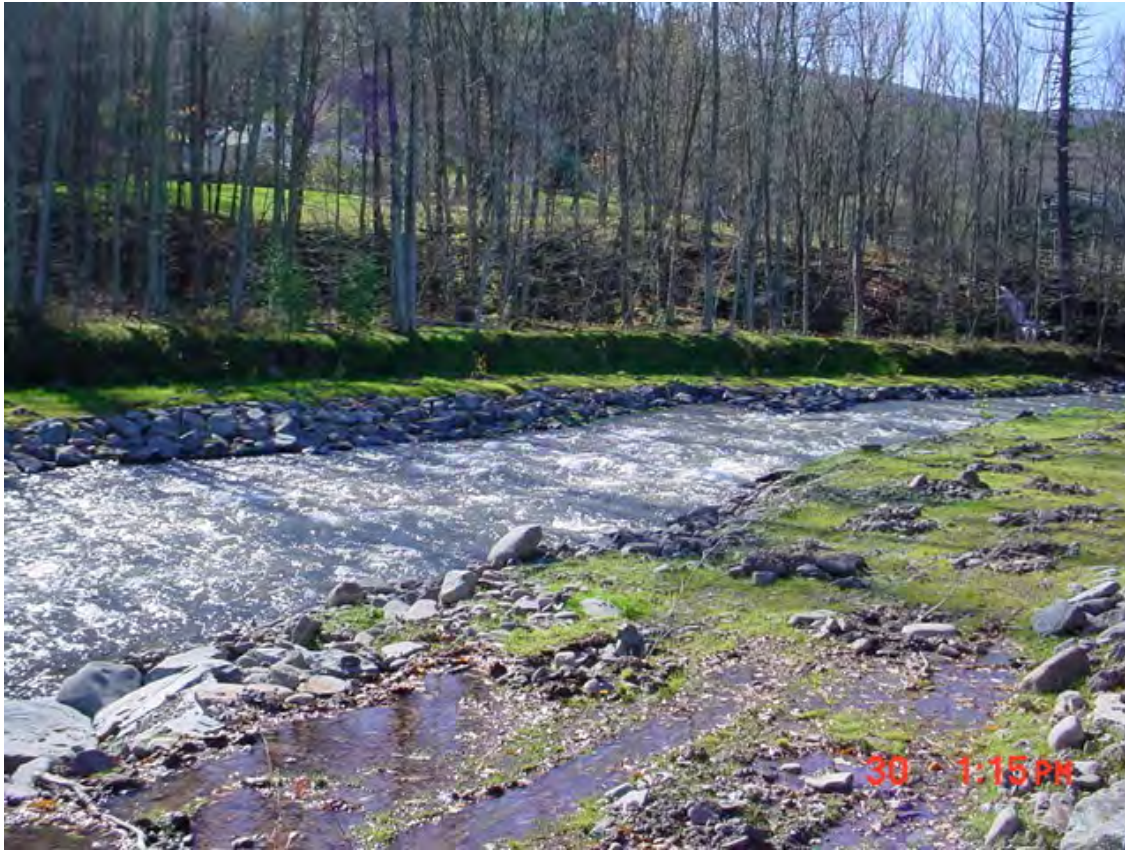
Figure E9 Lower bankfull bench, left

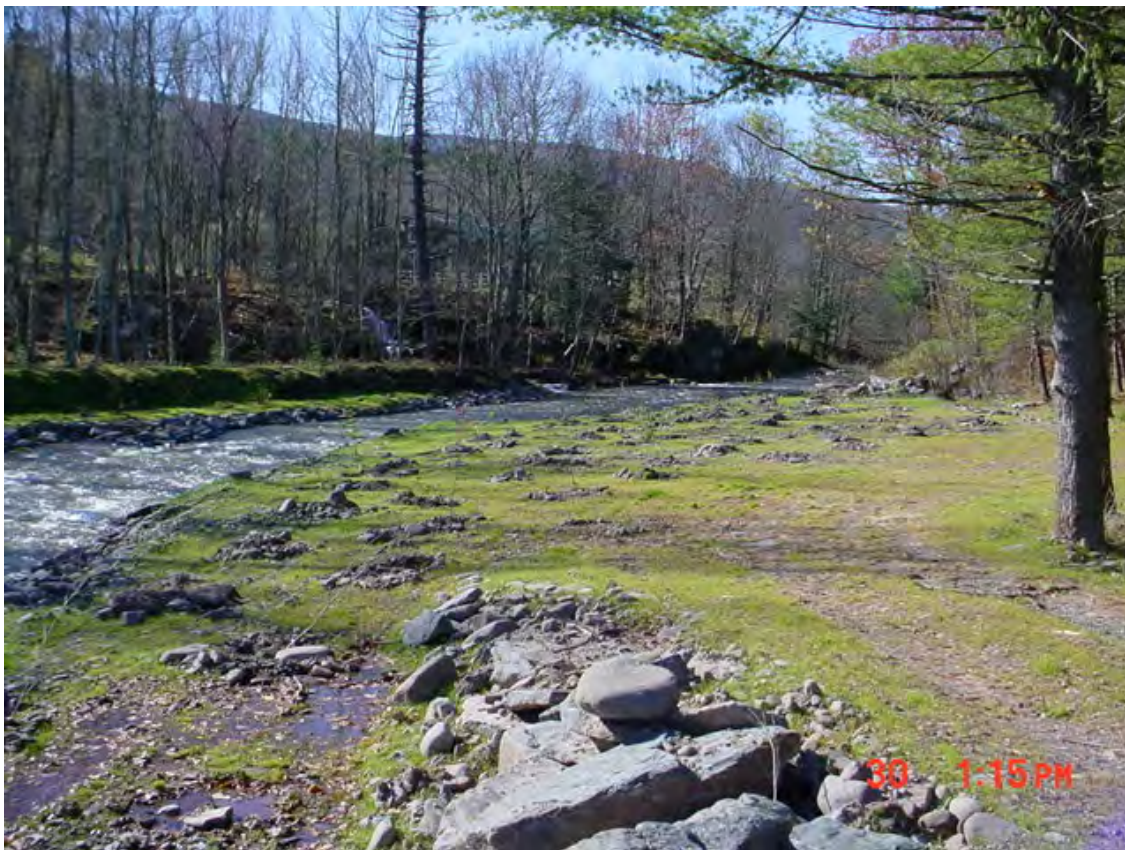
Figure E10 Point bar opposite lower bench, with plantings
