# Neversink River East Branch

## MANAGEMENT UNIT 10

EAST BRANCH MANAGEMENT UNIT 10  
BETWEEN STATION 40080 AND STATION 34900

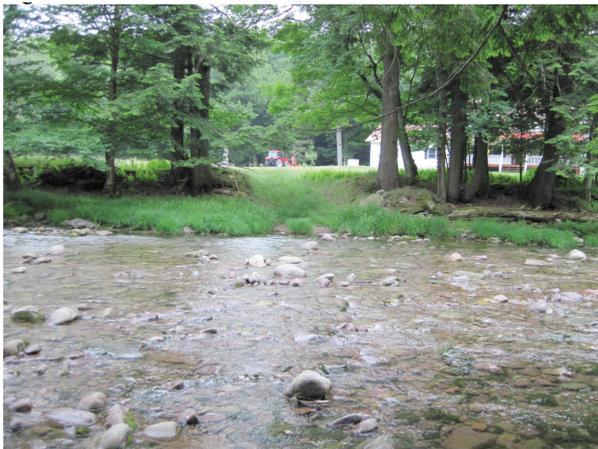
At Station 39790 vegetation has been cleared on both banks to allow for a recreational crossing to be maintained. (A186) Large woody debris has also begun to accumulate and cause obstructions to flow in this area, first evident at Station 39720 where a tree trunk has become lodged on the right bank. (B95) Fallen trees are also causing obstructions on the left bank at Station 39600, (B98) and on the right bank at Station 39370. (A188) The size of these woody debris deposits illustrates the power that the stream has to move large materials under high flows.

*Recreational crossing (A186)*

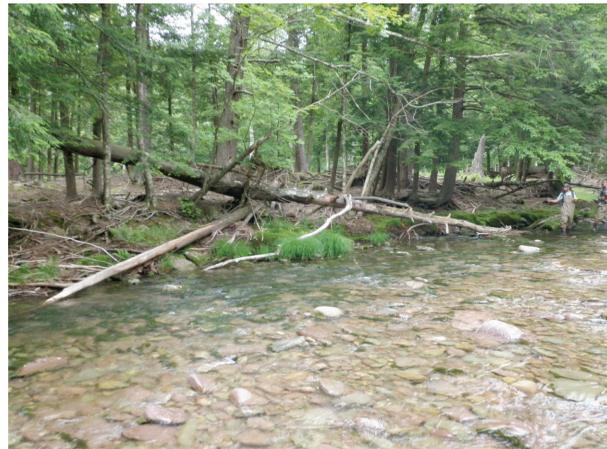
*Woody debris accumulation on right bank (B95)*

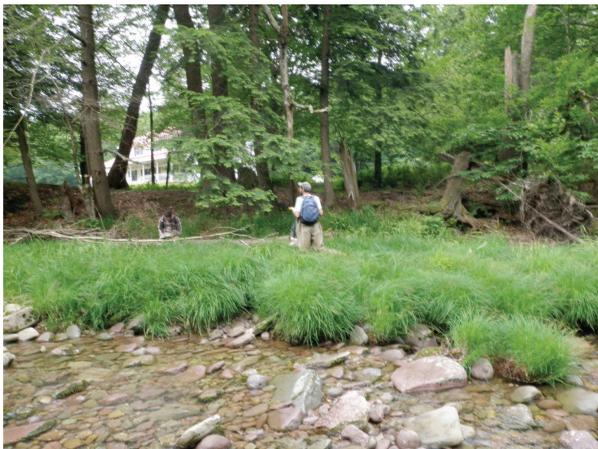
*Fallen trees causing obstructions on left bank (B98)*

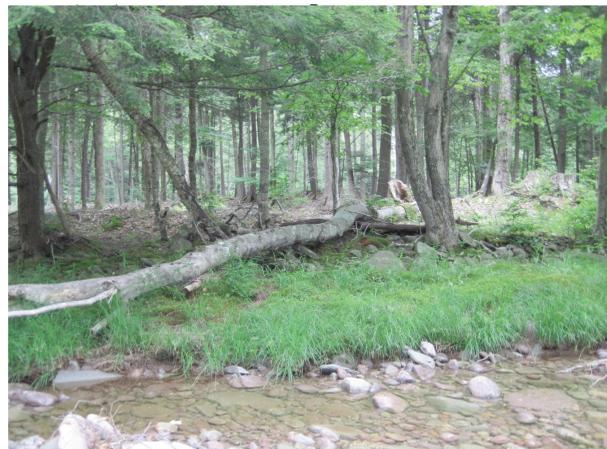
*Fallen trees causing obstructions on right bank (A188)*

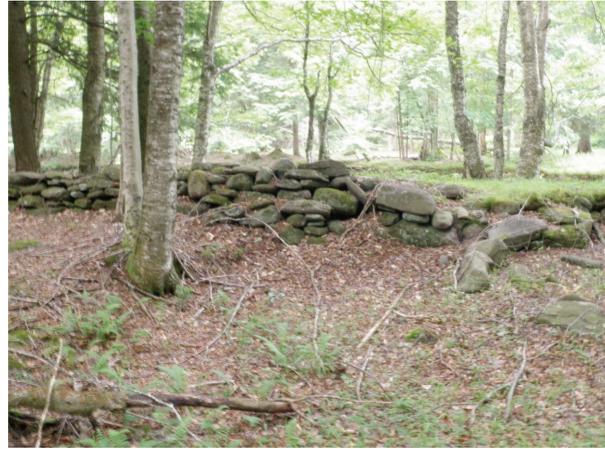
An old stone berm begins on the right floodplain at Station 39125, continuing approximately 185-feet to Station 38940. This berm is set back from the stream 100-feet and was most likely intended to prevent flooding on Denning Road. It is now overgrown with roots and woody vegetation, indicating that it has not been maintained in many years. (B100)

*Old stone berm on right floodplain (B100)*

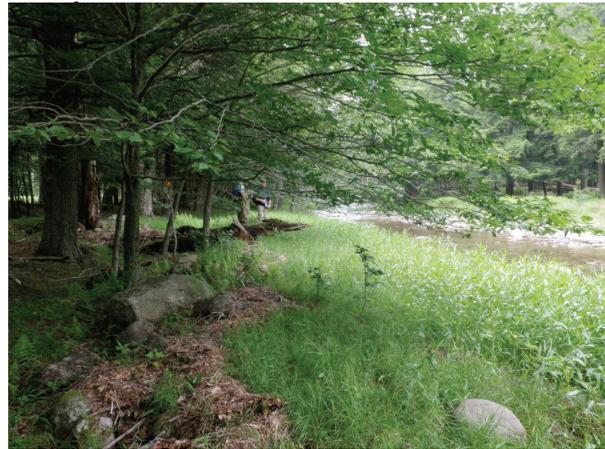
Another larger berm begins along the right bank at Station 38800, ending nearly 400-feet downstream at Station 38440. (B104) The side cast stream materials in this berm along with the shallow and overwidened channel in this reach suggest that the stream may have been cleared with a bulldozer at some point in the past. Directly in front of the berm the bank is actively eroding for approximately 185-feet from Station 38660 to Station 38475 (BEMS NEB10\_38400). (A193) Cobble sized alluvial materials are exposed along this 7-foot high bank, caused by hydraulic pressure under higher flow events. Recommendations for this bank erosion site minimally include monitoring for significant changes in condition and possible assisted restoration with techniques to stabilize the bank.

*Large berm on right bank (B104)*

Assisted restoration with bioengineering techniques is recommended to stabilize this bank. The second bank erosion site is on the left bank beginning at Station 38380 and continuing approximately 450-feet to Station 37930. Assisted restoration with bioengineering techniques is also recommended for this site. The third begins at Station 36700 on the left bank and continues until Station 36750. Large rocks are beginning to deposit at the toe of this eroding bank, indicating that it is possible for this bank to stabilize without treatment (passive restoration). The final bank erosion site in this management unit begins on the left bank at Station 35600 and is eroding and exposing the root structure of the mature vegetation until Station 35540. It is possible for this bank to stabilize without treatment (passive restoration).

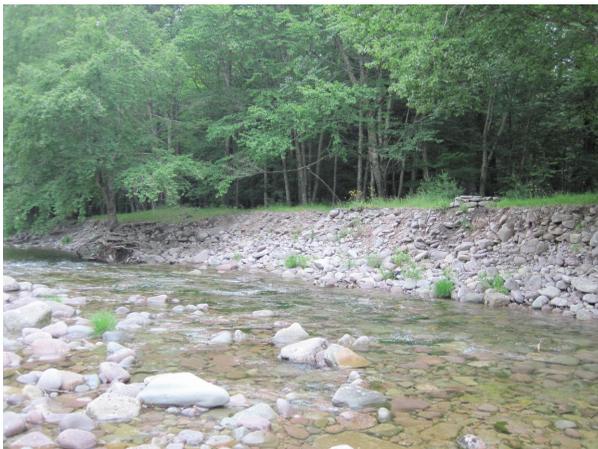
*Overwidened channel and actively eroding bank (A193)*

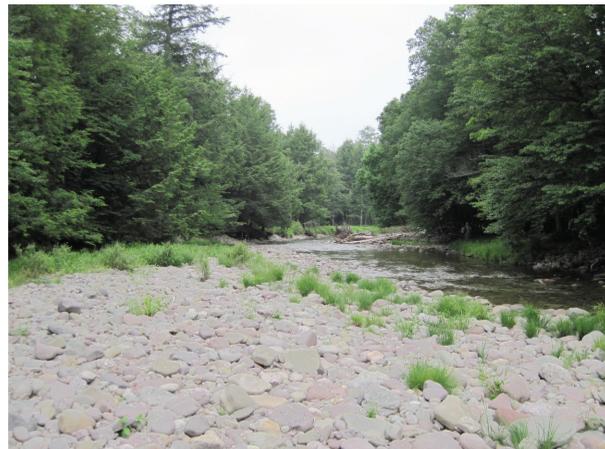
A point bar has formed on the left side of the channel across from the berm and bank erosion sites between Station 38900 and Station 38420. (A198) This bar was formed through the deposition of cobble sized materials. The only vegetation present is an occasional clump of grass or sedges, indicating that this feature is frequently inundated during large flow events.

*Cobble point bar forming on left side of stream (A198)*

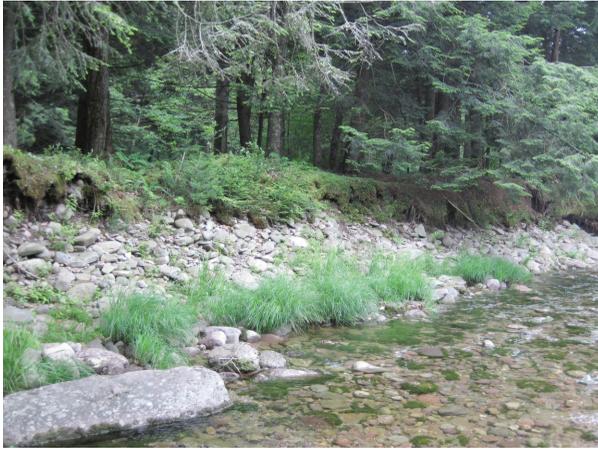
*Erosion of left bank (A200)*

Continuing downstream, the stream begins to meander to the right exposing a long bank erosion section on the left bank beginning at Station 38380 and continuing approximately 450-feet to Station 37930 (BEMS NEB10\_37900). (A200) This bank has been undercut through hydraulic erosion, exposing cobble sized materials and larger silts. (B115) There are several large trees along this bank that are experiencing root scour and have either fallen or are at risk of falling into the stream. Recommendations for this bank erosion site minimally include monitoring for significant changes in condition and possible assisted restoration to stabilize the bank.

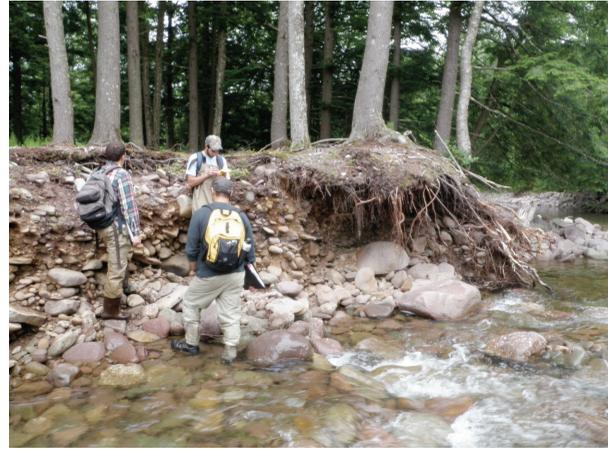
*Undercut left bank exposing cobble and large silt (B115)*

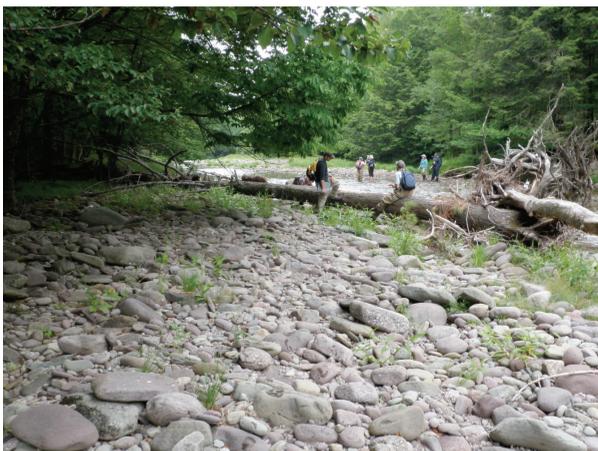
A point bar consisting of cobble sized materials has formed on the inside of the meander bend directly across from the bank erosion site between Station 39330 and Station 37780. (B112) This depositional feature has formed behind a large woody obstruction which extends from the right bank across a large portion of the stream channel. (B108) The bar is frequently inundated under large events, as is evidenced by the lack of any significant vegetative growth. A large tree has fallen from the eroding left bank, spanning the entire width of the stream channel and causing a second obstruction at the downstream end of the point bar. (A204)

*Cobble point bar on right bed (B112)*

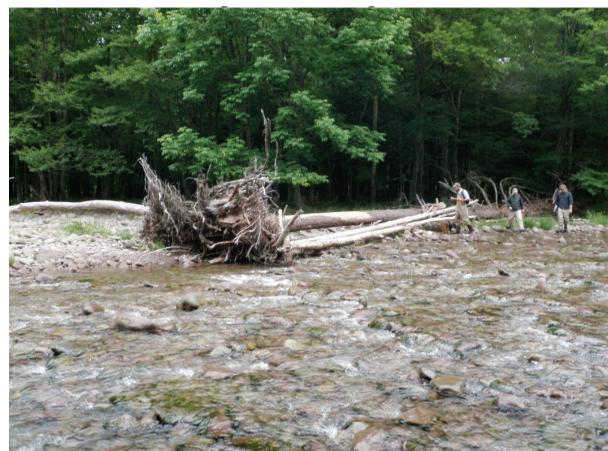
*Large woody obstruction causing point bar downstream (B108)*

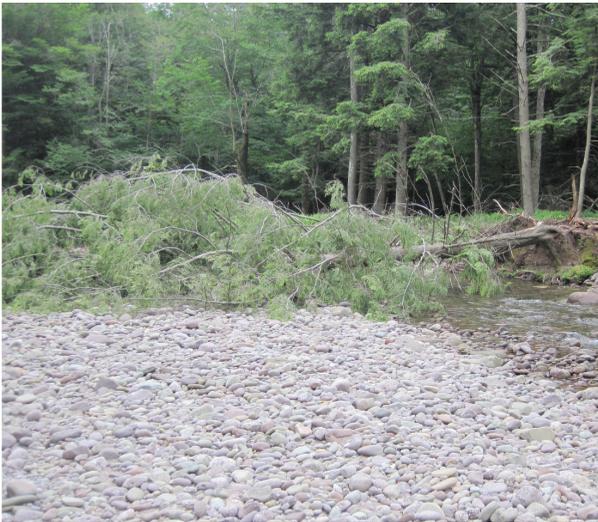
*Obstruction across channel width (A204)*

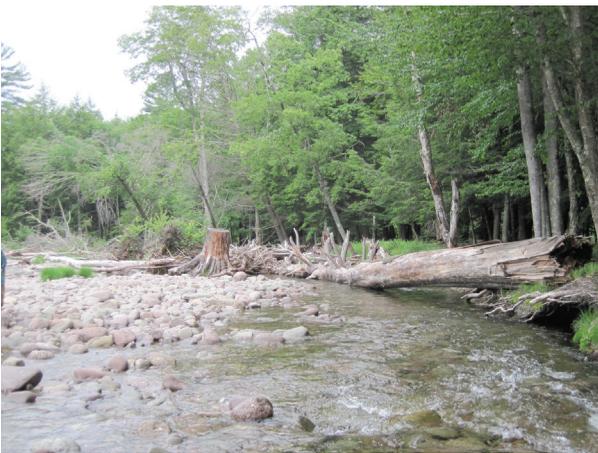
*Woody debris creating log jam (A206)*

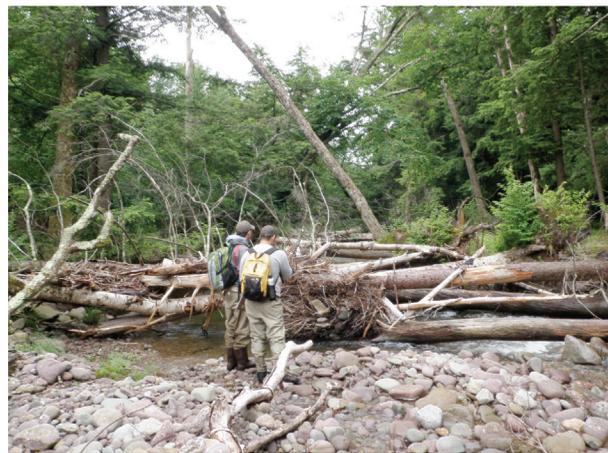
*Woody debris obstructions in main channel (B121)*

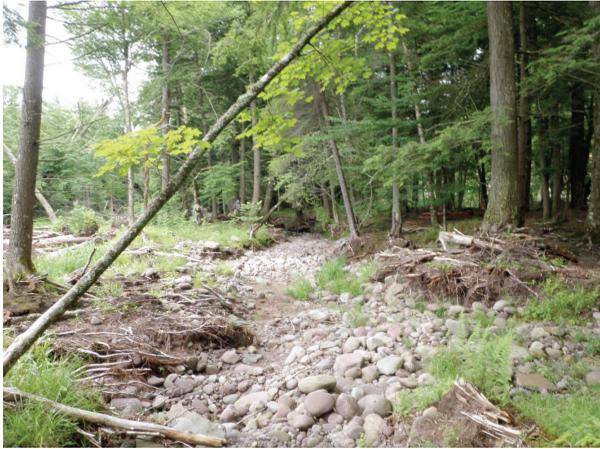
*Diverting side channels caused by obstructions in main channel (B124)*

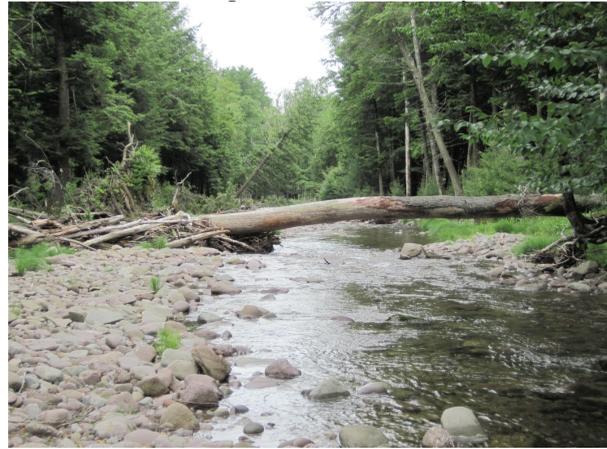
*Looking downstream at obstruction and headcut (A229)*

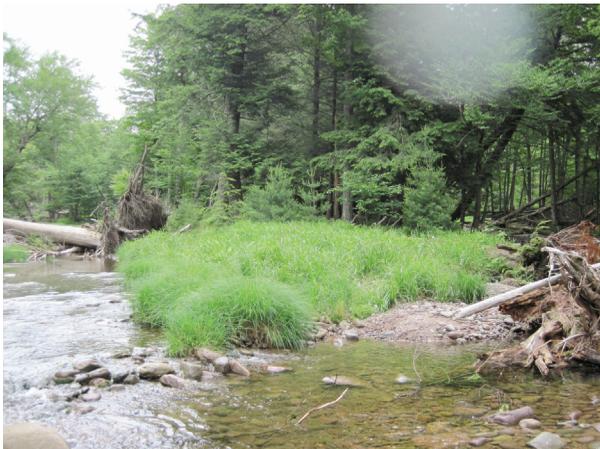
The side channels that diverged at various points along the left floodplain between Station 37300 and Station 37500 make their first convergence back with the main channel at Station 37060. (A223) The trend of large woody debris obstruction continues at this point, where the remnants of three trees have accumulated on the right bank. (B133) This obstruction is causing a headcut directly below, as well as erosion of the right bank both up and downstream. A second convergence of the side channels occurs at Station 36780. (A232) An obstruction in the same general area is resulting in deposition upstream and scour below. (B138)

*Convergence of side channel with main channel (A223)*

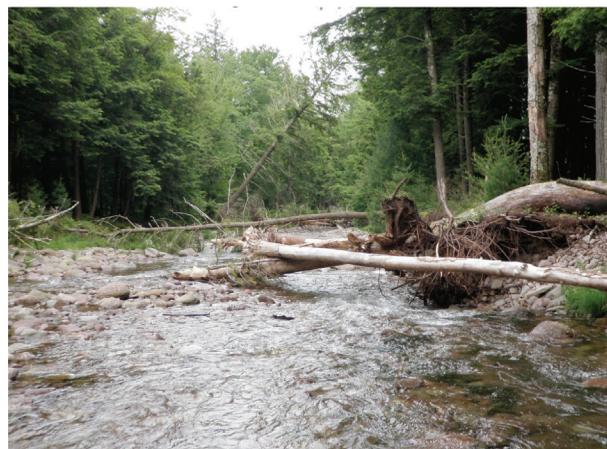
*Large woody debris accumulation on right bank (B133)*

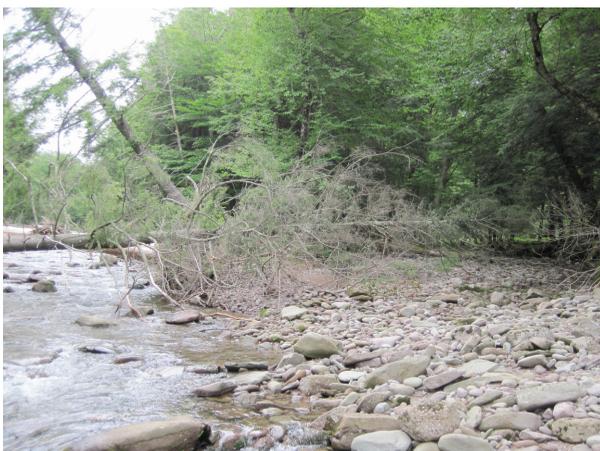
*Second convergence with side channel (A232)*

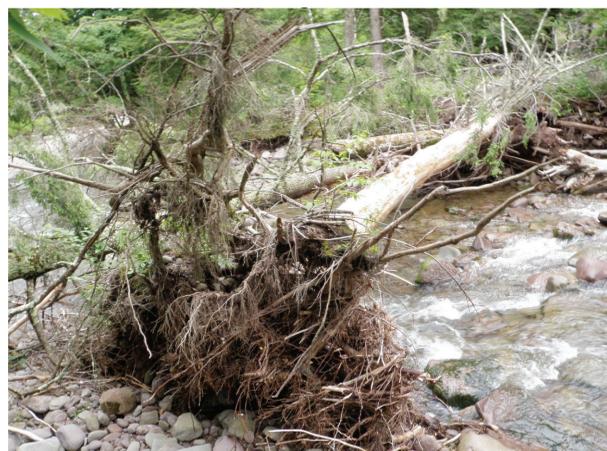
*Obstruction causing deposition upstream and scour downstream (B138)*

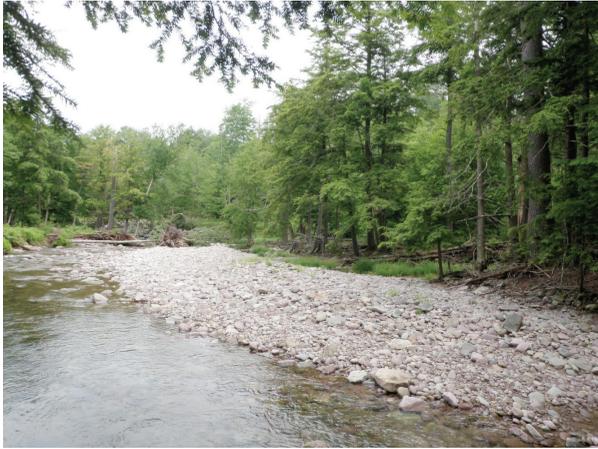
*Point bar forming on right bank (B141)*

At Station 36720 the stream begins to meander to the right flowing perpendicular to Denning Road. A point bar consisting of cobble sized materials and averaging 50-feet in width begins along the right bank at this station, continuing approximately 270-feet to Station 36450. (B141) A large tree that has deposited near the downstream end of the bar at Station 36500 is causing an obstruction to high flows, further contributing to this depositional area. (B150) On the opposite side of the stream, erosion of the left bank begins at Station 36720 and continues until Station 36450 (BEMS NEB10\_36400). Hydraulic erosion has exposed cobble sized alluvial material at the toe of this bank. (A238) Large rocks are beginning to deposit at the toe of this eroding bank, indicating that it is possible for this bank to stabilize without treatment (passive restoration). However, it is recommended that this site be monitored for changes in condition.

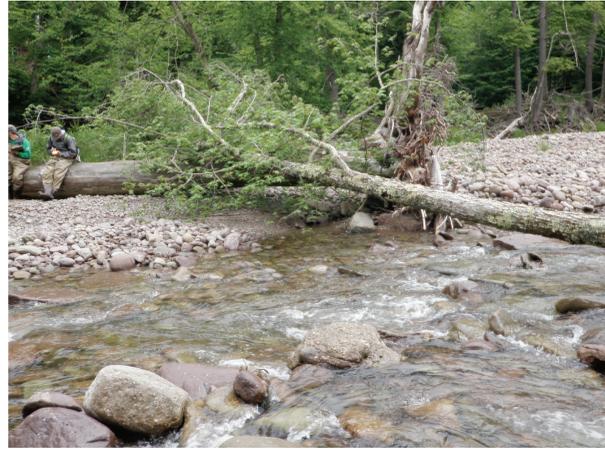
*Large tree deposited during high flows causing deposition (B150)*

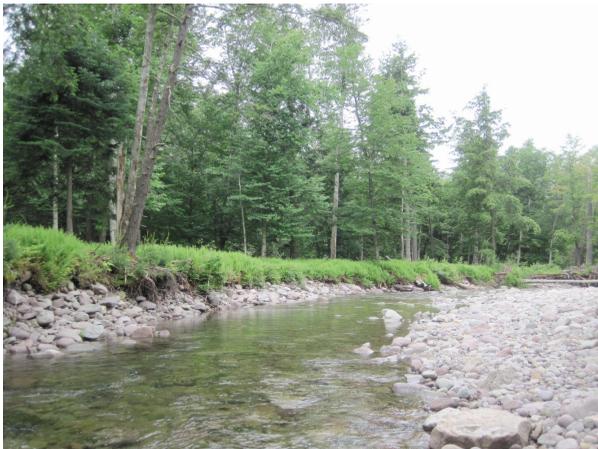
*Erosion of left bank exposing cobble (A238)*

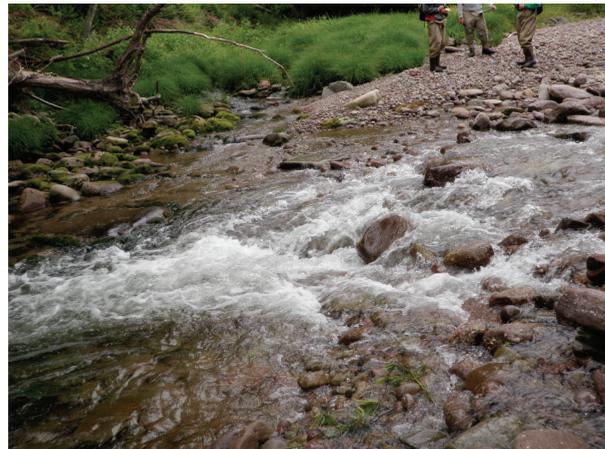
*Small tributary convergence (B148)*

A small unnamed tributary enters the main channel at Station 36450 which most likely carries drainage from the floodplain. (B148) The stream channel takes a hard left turn at this point and continues running parallel to road for the remainder of the management unit. There is very little riparian

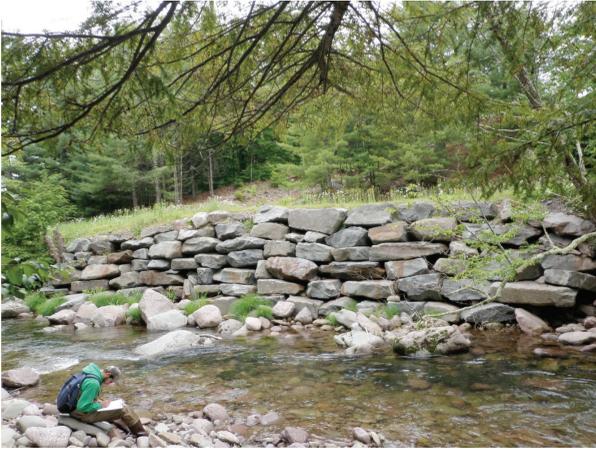
*Stacked rock wall on right bank protecting Denning Road (B152)*

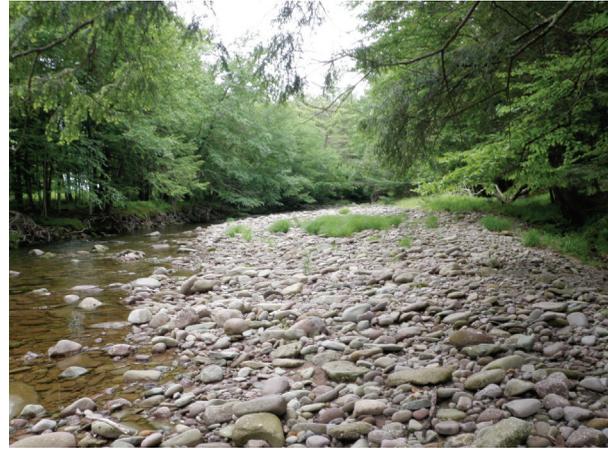
*Cobble side bar on left side of channel (B161)*

Continuing downstream, the channel takes a slight turn to the left at Station 36100 and moves further away from the road. A cobble side bar has formed on the left side of the channel beginning at this station and continuing downstream until Station 35800. (B161) At Station 36010 a large woody obstruction has deposited on the bar. (B157) A transverse cobble bar begins along the right side of the channel at Station 35600, continuing approximately 150-foot downstream until Station 35450. (A247)

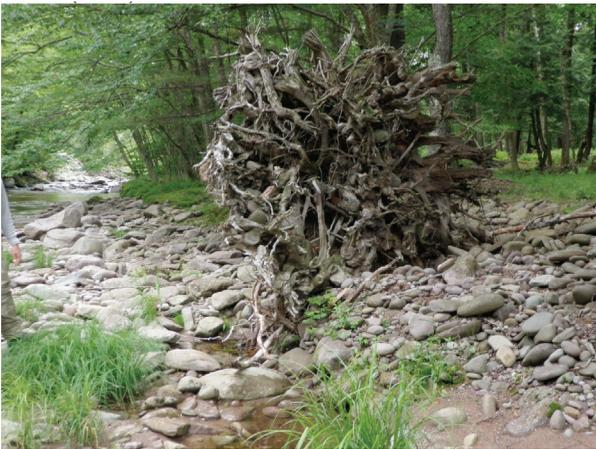
*Large woody obstruction deposited on side bar (B157)*

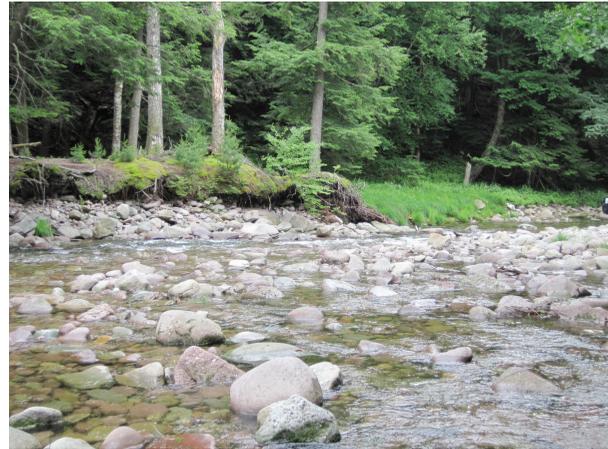
*Side bar beginning on right side of channel (A247)*

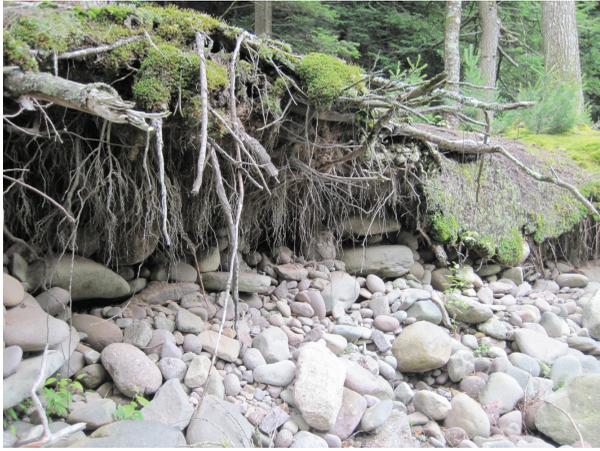
*Hydraulic erosion of left bank (A244)*

At Station 35600 across from the depositional bar the left bank is eroding and exposing the root structure of the mature vegetation until Station 35540 (BEMS NEB10\_35500). Hydraulic pressure put on the bank during higher flow events is entraining the cobble sized alluvial material. (A244) Despite the severe appearance of this erosion, large rocks are beginning to deposit at the toe and are providing some armoring of the eroding bank. The sod mats which have been undercut are now slumping down over the exposed bank sediment, offering additional protection and stabilization. (A245) It is possible for this bank to stabilize without treatment (passive restoration). However, it is recommended that this site be monitored for changes in condition.

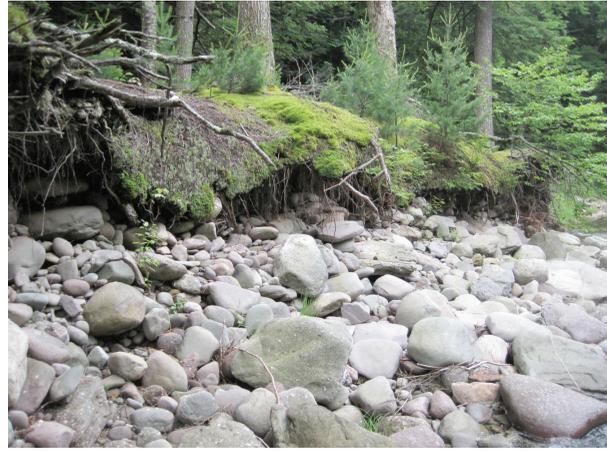
*Large cobble restabilizing bank (A245)*

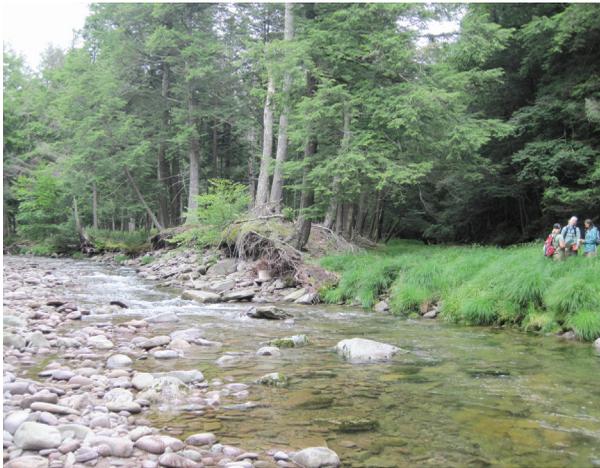
*Relict side channel entering from left floodplain (A251)*

Downstream of the eroding left bank at Station 35520 there is evidence of a relict side channel entering from the left floodplain. (A251) At Station 35420 the stream flows up against the left valley wall and is controlled on the left bank and channel bottom by this feature for the remainder of the management unit, continuing into EBMU9. (B163) The channel begins to aggrade at Station 35170 as a result of a

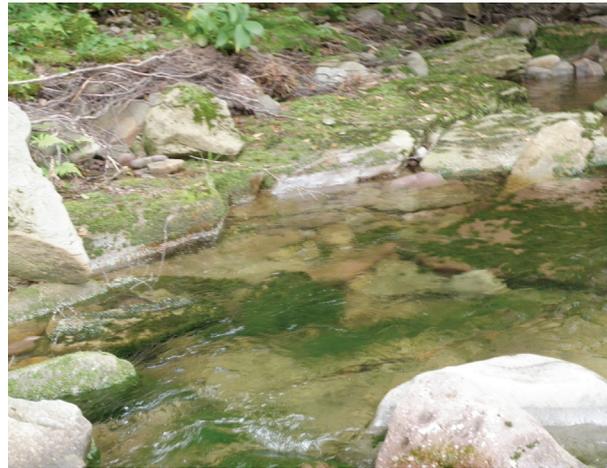
*Bedrock control along stream bed and left valley wall (B163)*

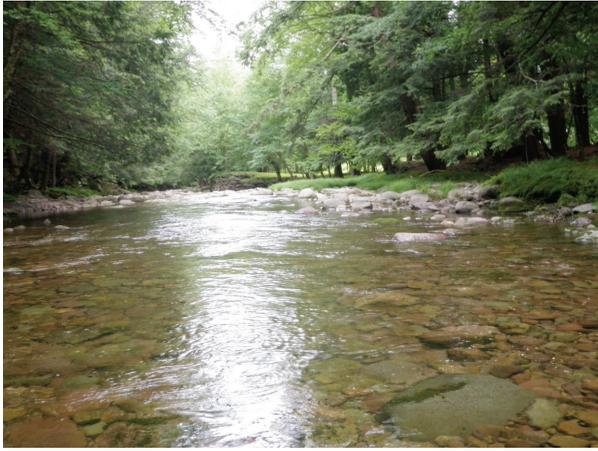
*Channel wide deposition (B168)*

backwater effect from the Erts Brook tributary confluence downstream. Evidence of this channel wide deposition continues for approximately 100-feet until Station 350700. (B168)

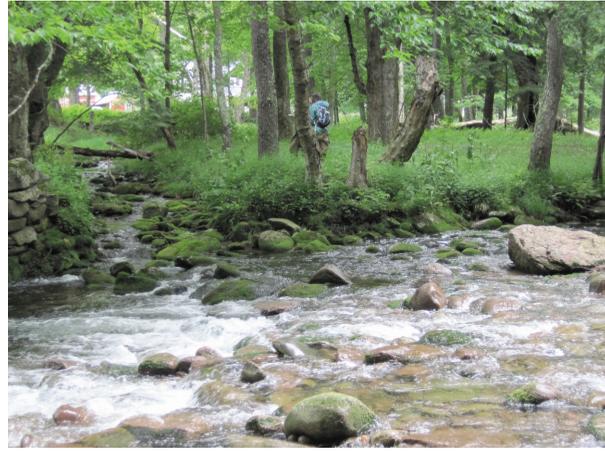
*Erts Brook convergence (A259)*

EBMU10 ends at Station 34900 where Erts Brook converges from the right floodplain. (A259) Erts Brook is a perennial tributary which crosses under Denning Road approximately 700-feet prior to its confluence with the East Branch of the Neversink River, making it a potential source for contaminants from road runoff.
